Bank Erosion Survey of the Illinois River Volume 1

by
Nani Bhowmik and David Soong

December 2000

Illinois State Water Survey
Watershed Science Section
Champaign, Illinois

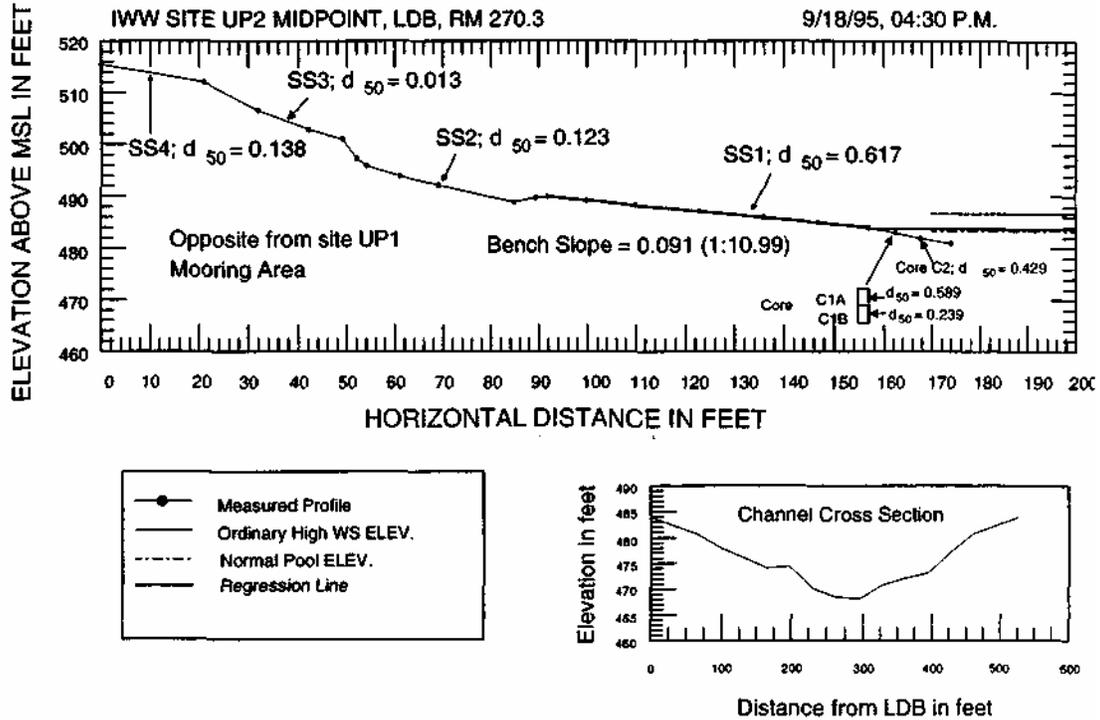
Figure 40. Bank section at site UP2, midsection

The bench slope was 1V:11H, and the bench was covered with noncohesive sandy soil. This site can be classified as type 5 (see figure 25 and table 9). The scarp was above OHWE stage. Erosion could have occurred during flood stages. The base of the scarp showed sand deposits indicating that seepage at the base could weaken the bank. Waves and currents could remove/transport failed soils that mantle the bench.

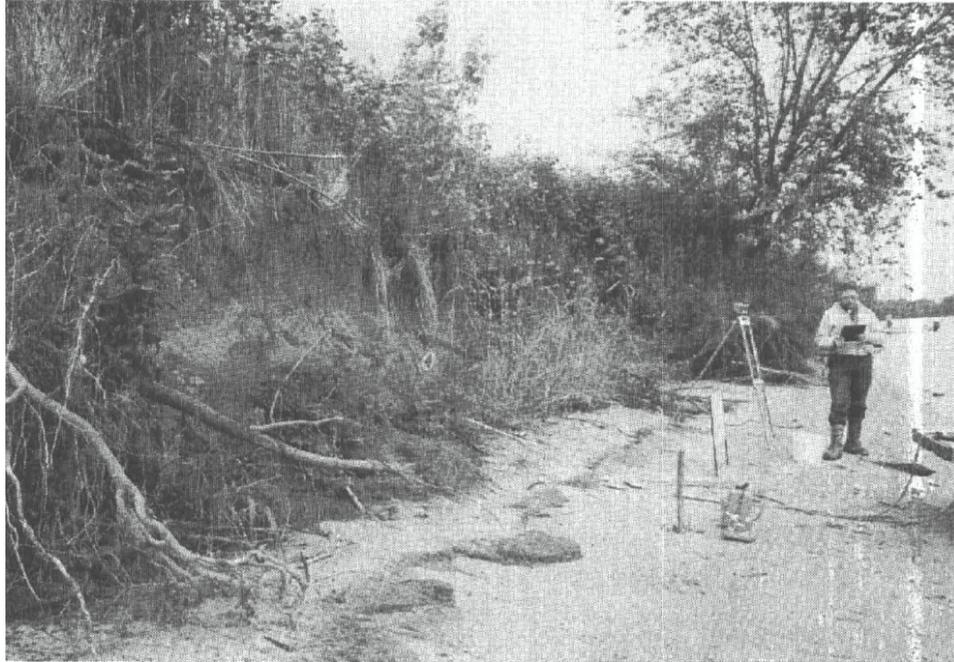
Figure 45. Site UP4 on the Illinois River

At the midsection, the d_{50} varied from 0.035 mm at the top of the bank to 0.185 mm for the top portion of a core sample at a water depth of about 2 feet. The bank scarp consisted of cohesive materials, and the sediments were of fine sand fairly consistently at three sections. Gradation plots of bank soils and nearshore sediment are presented in appendix C. The detailed cross section and coordinates are shown in appendix D.

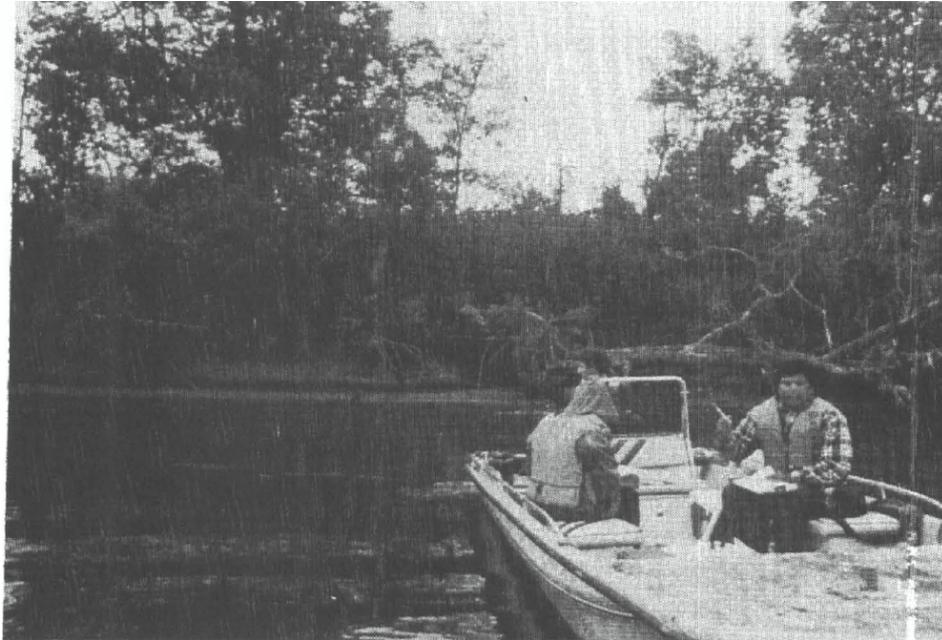
Figure 47. Site UP5 on the Illinois River

This is at the bank opposite site UP4. Figure 44 shows the position of the site on a GIS-based map of the Illinois navigation chart, and figure 47 is a photograph of the site. Site UP5 is in a straight reach downstream from a mild bend. Bhowmik and Schicht (1980) marked this site as an erosion site and indicated dredge material displacement on this bank. A one by one loaded barge passed in the upstream direction while the team was on the bank. Although the barge slowed down at the site, the drawdown induced by this traffic event was approximately 1.5 feet vertically. Four or five large waves with crests approximately 0.9 feet higher than pool level came in after the drawdown.

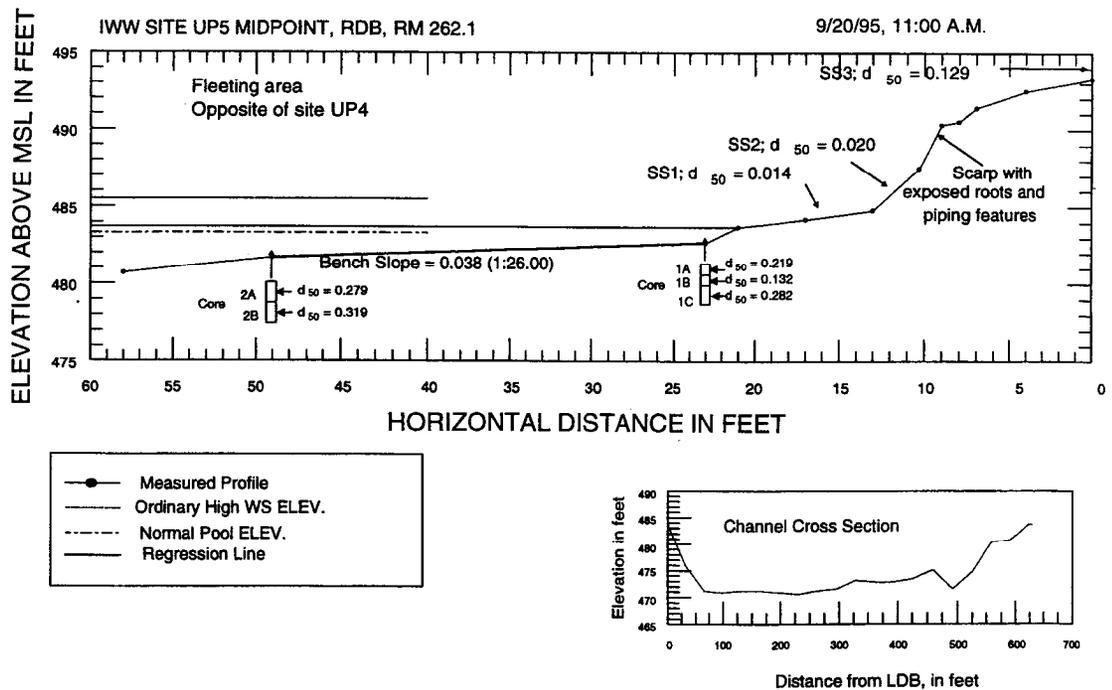
Figure 48. Bank section at site UP5

The bench slope was IV:26H. Some algae were observed on the subaerial bench. This site is classified as a combination of types 4 and 5 (see figures 24 and 25, and table 9). Banks are susceptible to erosion by tractive forces from flows at OHWE or during floods. Piping, seepage, and weathering could loosen the bank soils, which are then subject to removal by currents and waves. At this site, traffic-induced currents and waves can erode failed soils and recently deposited sediments within bench areas during periods of NP stages.

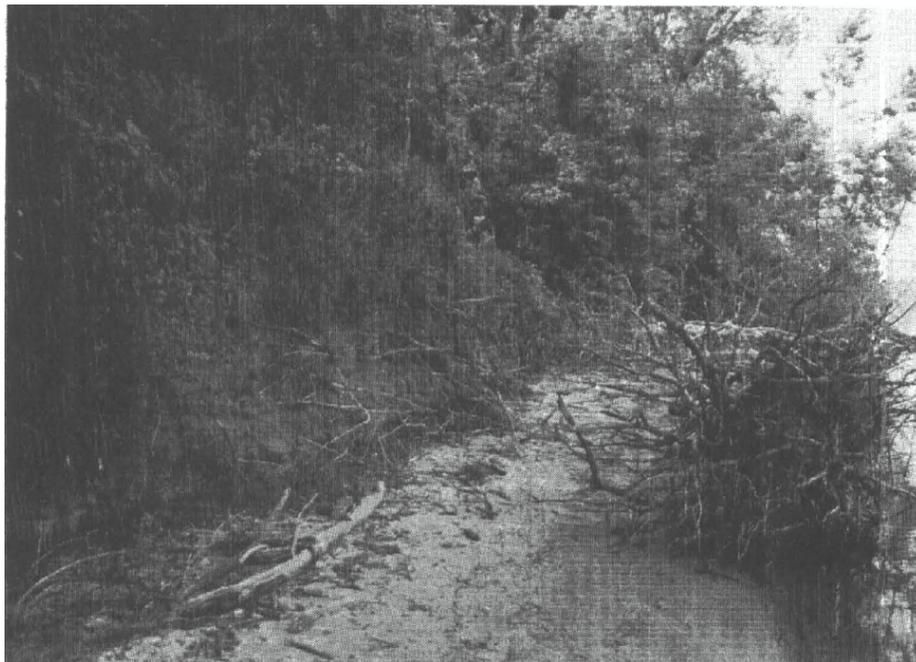
Figure 52. Site 2 on the Illinois River

Figure 53 shows the measured bank section and a reduced cross section. The OHWE is 459.5 ft-msl and NP is 458.5 ft-msl. According to 10-year stage data (table 17), stages with 25 percent or less exceedence frequencies will reach the base of the scarp, and any stage higher than OHWE elevation will be on the scarp.

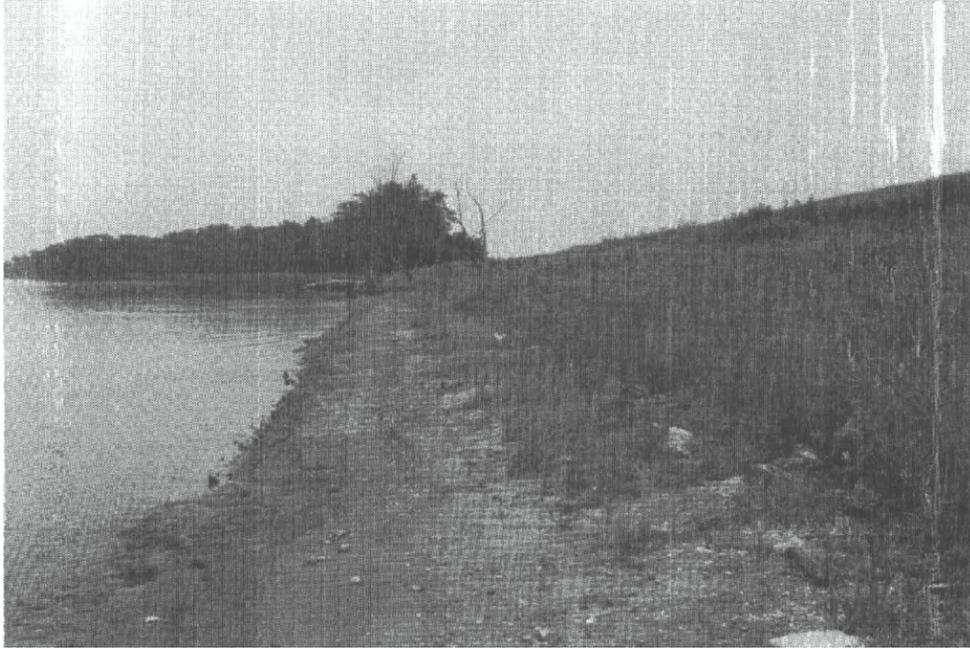
Figure 65. Site 7 on the Illinois River

Site 7 is at the Hennepin Levee System, about 400 feet from the sailing line, and no tributaries enter the site. Bhowmik and Schicht (1980) noted almost the entire riverbank from the Upper Twin Sister Island to site 6 as eroding bank. Hagerty's observation (1988) was similar to that of Bhowmik and Schicht (1980), but the erosion reaches indicated by Hagerty (1988) were shorter and were shown mostly on the RDB. Hagerty (1988) also noted erosion on both the Upper and Lower Twin Sister Islands on the sides facing the channel. The back side (facing the levee) of Upper Twin Sister Island also had a long reach of overhanging matted roots as noted by Hagerty (1988).

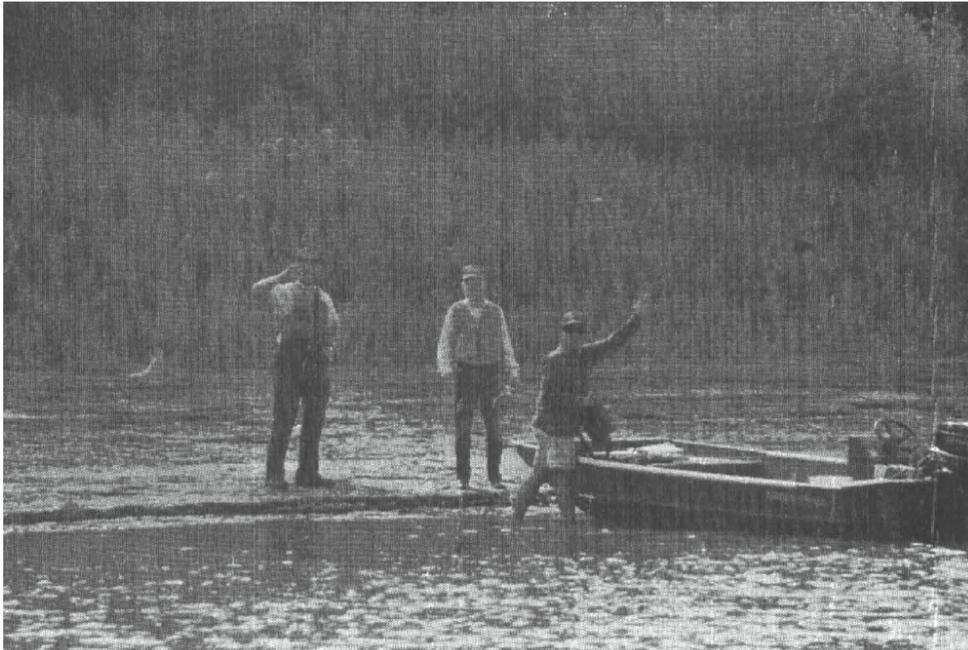
Figure 79. Site 12 on the Illinois River

This site is located on the LDB at RM 154.4 on the inside of a mild bend; a sharp bend is downstream from the site. A power plant across the river has docking facilities for barges. The Lake of the Woods is located approximately 1,000 feet behind this bank. Figure 76 shows the position of the site on a GIS-based map of the Illinois navigation chart, and figure 79 is a photograph of the site.

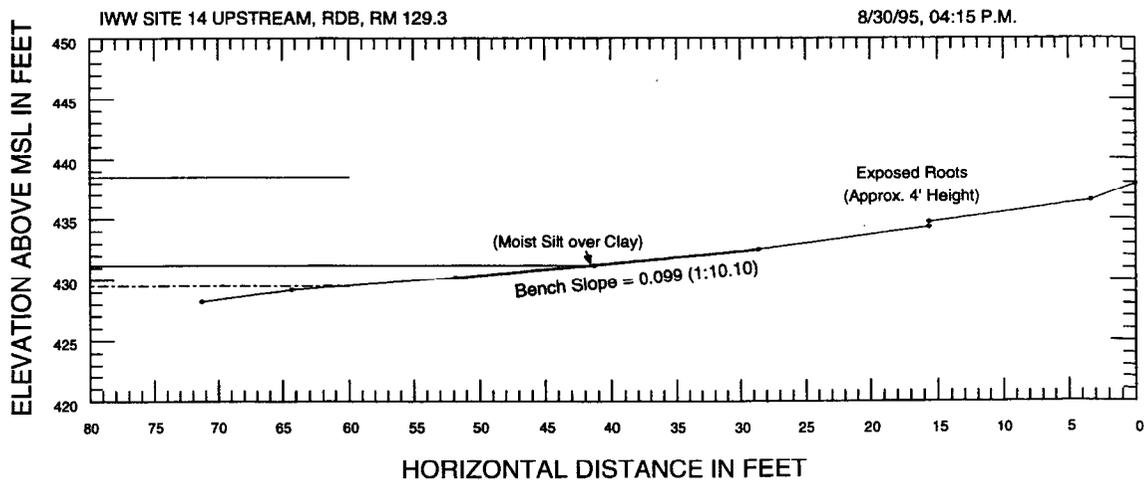
Figure 86. Bank sections at site 14

Bench slopes varied from 1V:10.1H at the upstream section to 1V:7.9H at the midsection. The slope for the subaqueous bench was 1V:14.5H below a water's edge scarp at the downstream section. The site is classified as type 4 (figure 24 and table 9). The subaerial bench was wet due to poor drainage. Wave wash, in combination with piping, appeared to have created the downstream small scarp on the bank. Rework and transport of failed soils and recently deposited sediments at stages within the normal range of pool-level fluctuations could be significant.

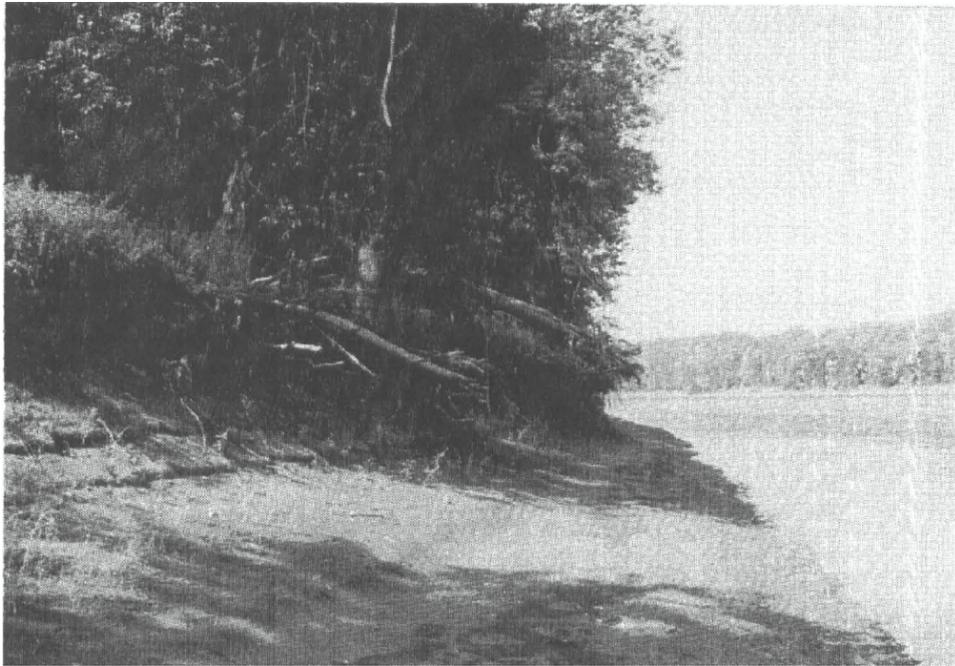
Figure 91. Site 16 on the Illinois River

Trees were present at the bank crest, and the bank had an almost vertical scarp. Fine roots extended over the upper portion of the bank. At the bottom of the scarp, sparse vegetation had grown on the berm. A bare bench with a series of small scarps extended to the water's edge. The bench is covered with desiccated clay and holes dug by microorganisms. A passing barge generated fairly large bow-push and drawdown, stranding some juvenile fish on the bench.

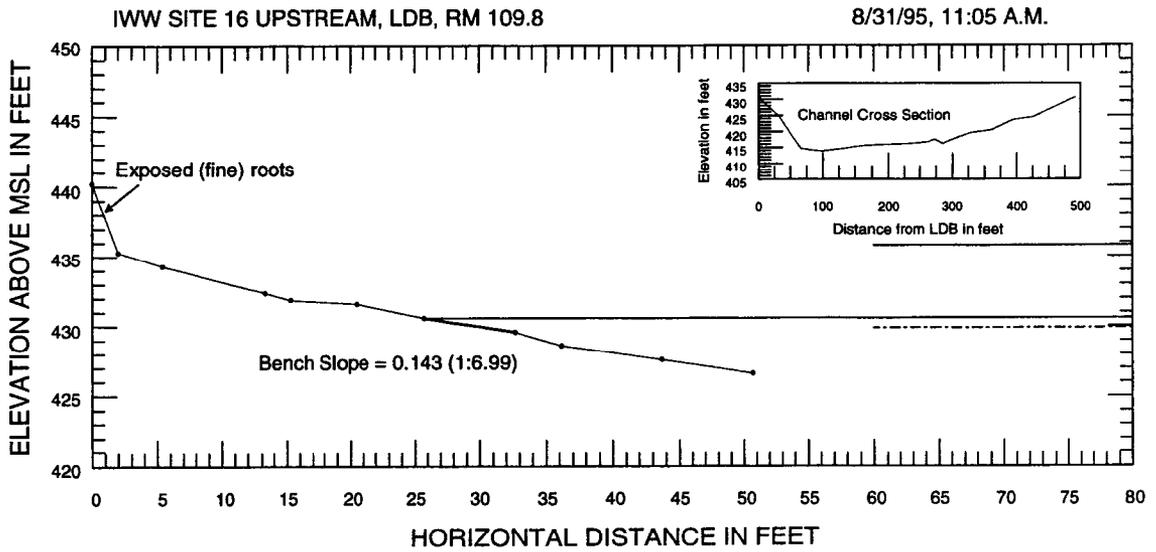
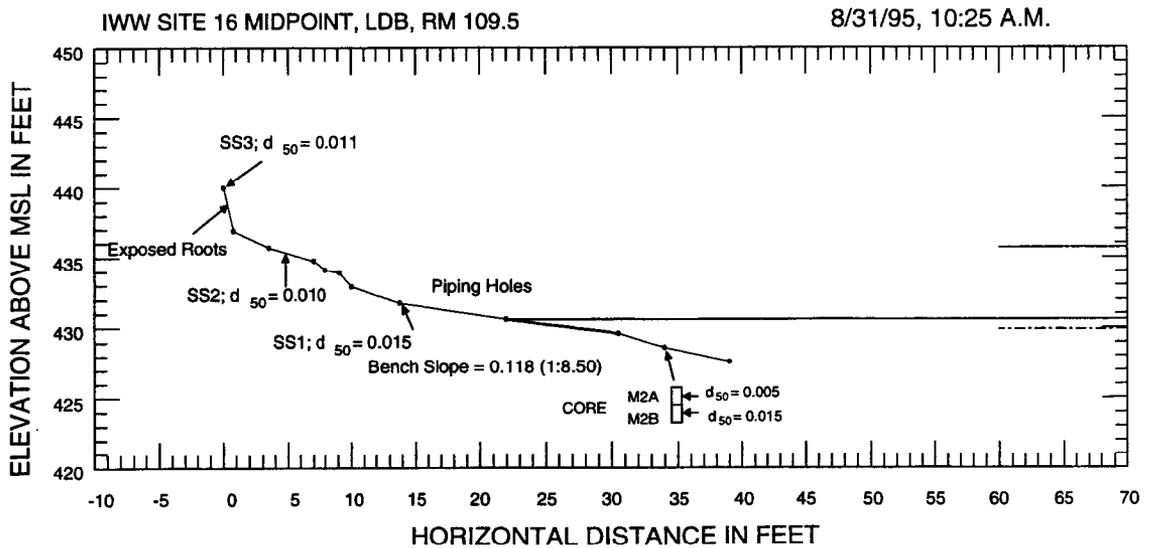
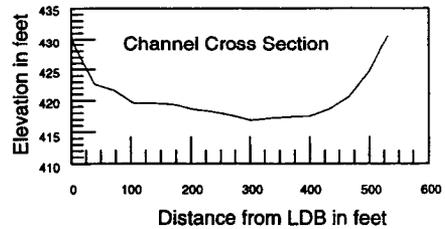
Figure 92. Bank sections at site 16

Bench slopes varied from 1V:7.0H at the upstream section to 1V:14.5H at the downstream section. The upstream section and midsections are classified as type 2, and the downstream section is classified as type 3 (figures 22 and 23 and table 9). Rework and transport of bench materials occur at stages within the normal range of pool-level fluctuations. Erosion of in-place soils occurs at stages above OHWE. Seepage and piping affect the extent of failure during recession periods when the river stages can drain.

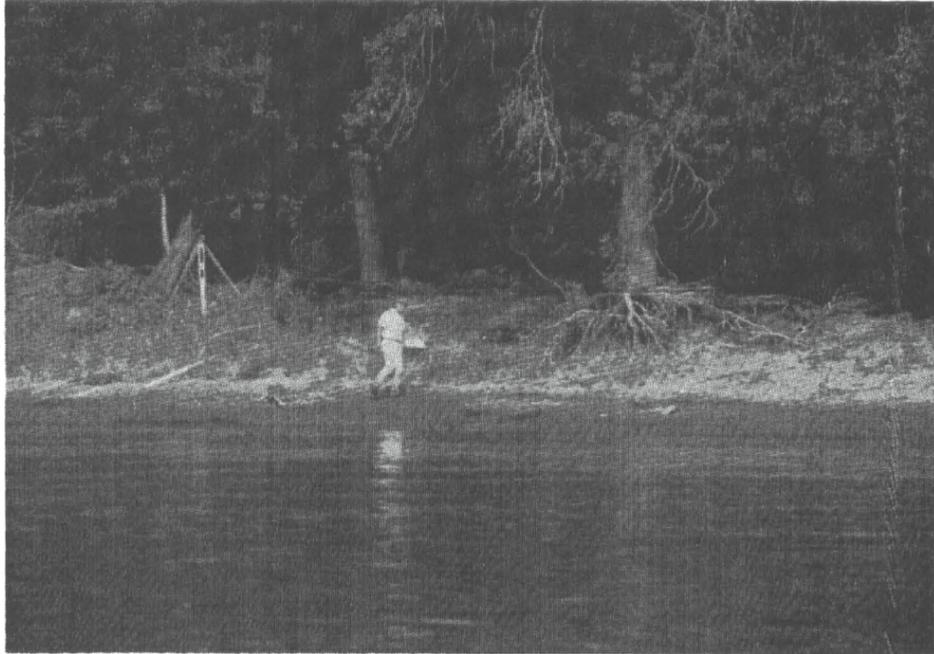
Figure 93. Site 17 on the Illinois River

This site is located at the outside of the bend across the river from site 16. The whole area is within Anderson Lake Conservation Area. Figure 90 shows the position of the site on a GIS-based map of the Illinois navigation chart, and figure 93 is a photograph of the site.

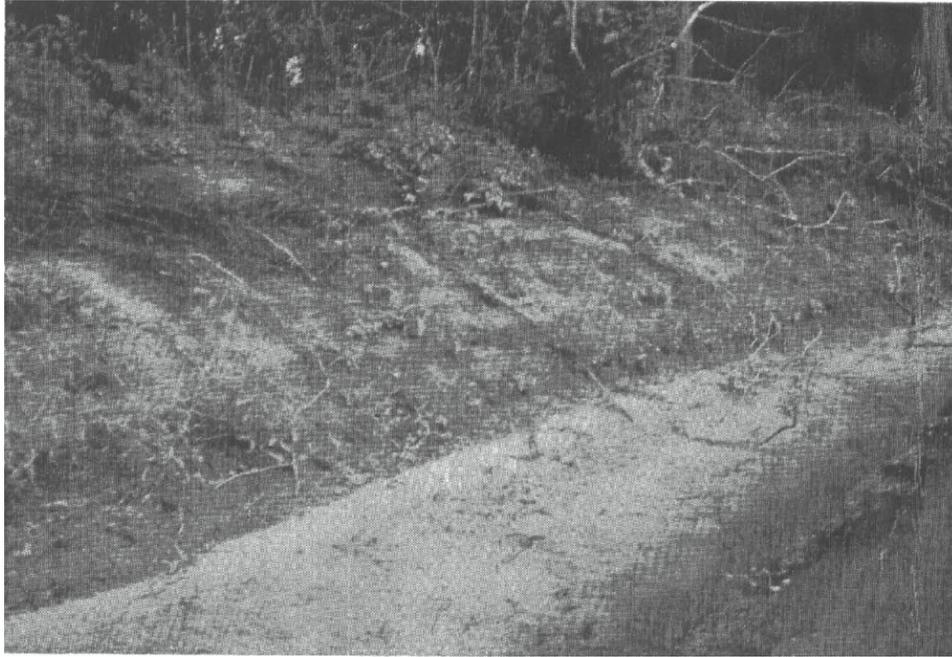
Figure 99. Site 19 on the Illinois River

The site is about 310 feet from the sailing line. A Chicago Burlington & Quincy railroad line is located just behind the site. Hagerty (1988) noted this site as an erosion site, but it appeared to be stable when Bhowmik and Schicht (1980) surveyed. A depression between the bank and the railroad embankment will retain floodwater or rainwater and cause seepage to the bank. The depression was a borrow pit for the construction of the railroad embankment. Some large, dead trees and exposed roots were observed. Velocities were relatively high at a close distance from the shore.

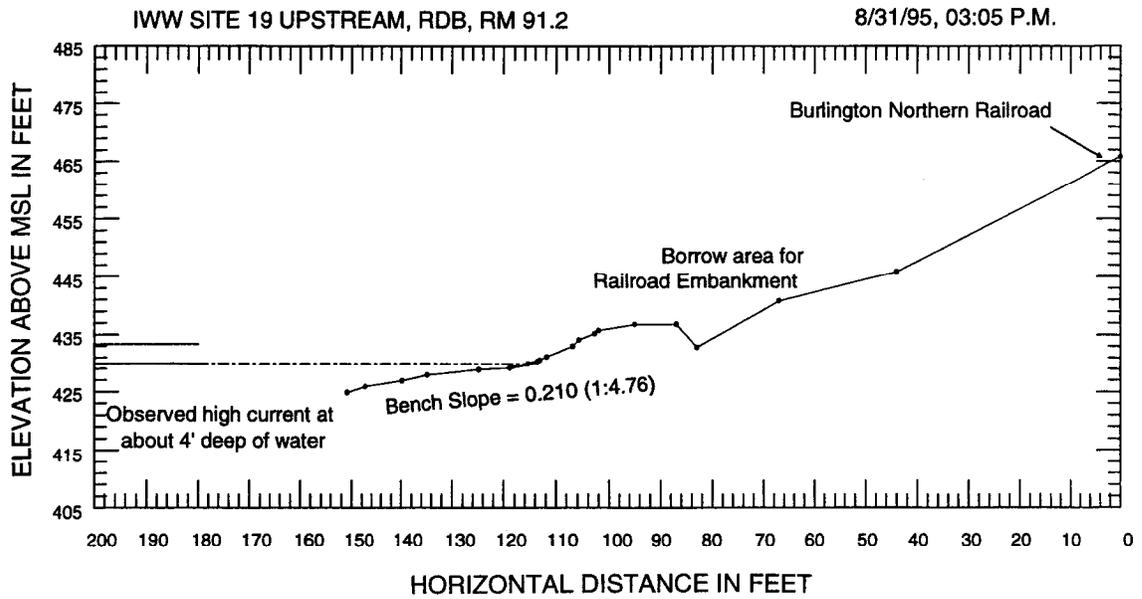
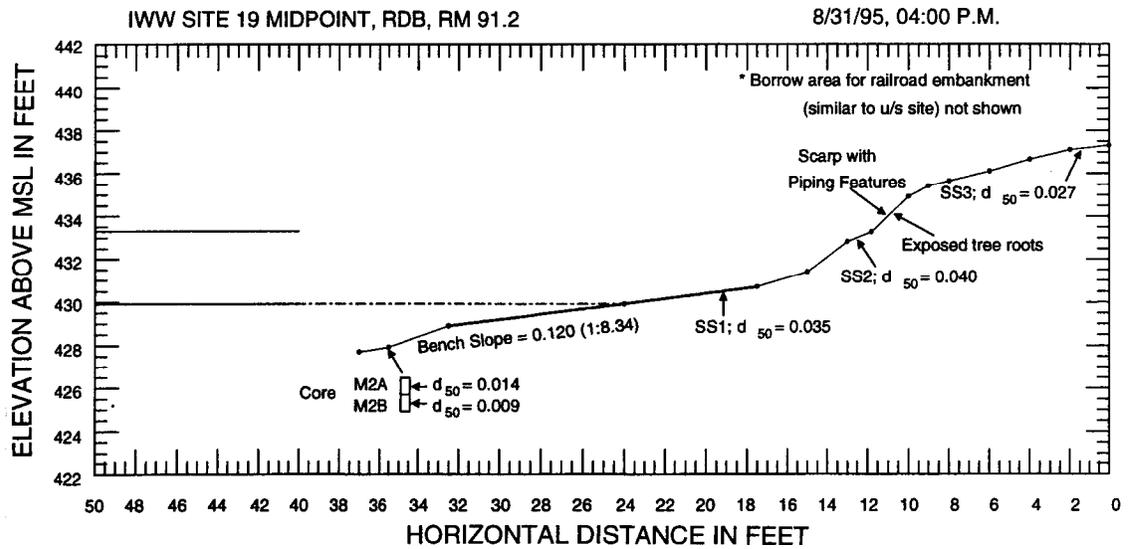
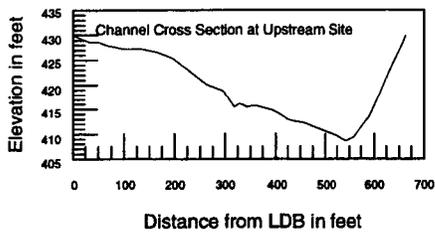
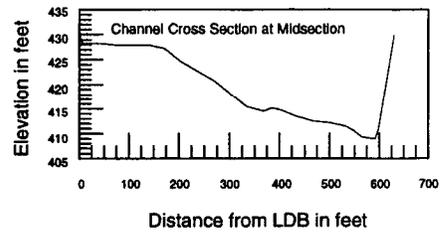
Figure 100. Bank sections at site 19

Bench slopes varied from 1V:4.8H at the upstream section to 1V:10H at the downstream section. This site is classified as a combination of types 2 and 4 (figures 22 and 24 and table 9). Seepage initiated bank failure; rework and transport of failed soils occurred at stages within the normal pool-level fluctuations. Traffic-induced disturbances should be considered because of the closeness to the barge terminal. Rapid drop of depth at mid- and downstream sections may reflect such a factor.
