# Illinois State Water Survey Division

SWS Contract Report 409

## CHANNEL SCOUR INDUCED BY SPILLWAY FAILURE AT LAKE CHARLESTON, ILLINOIS

Champaign, Illinois  
November 1986

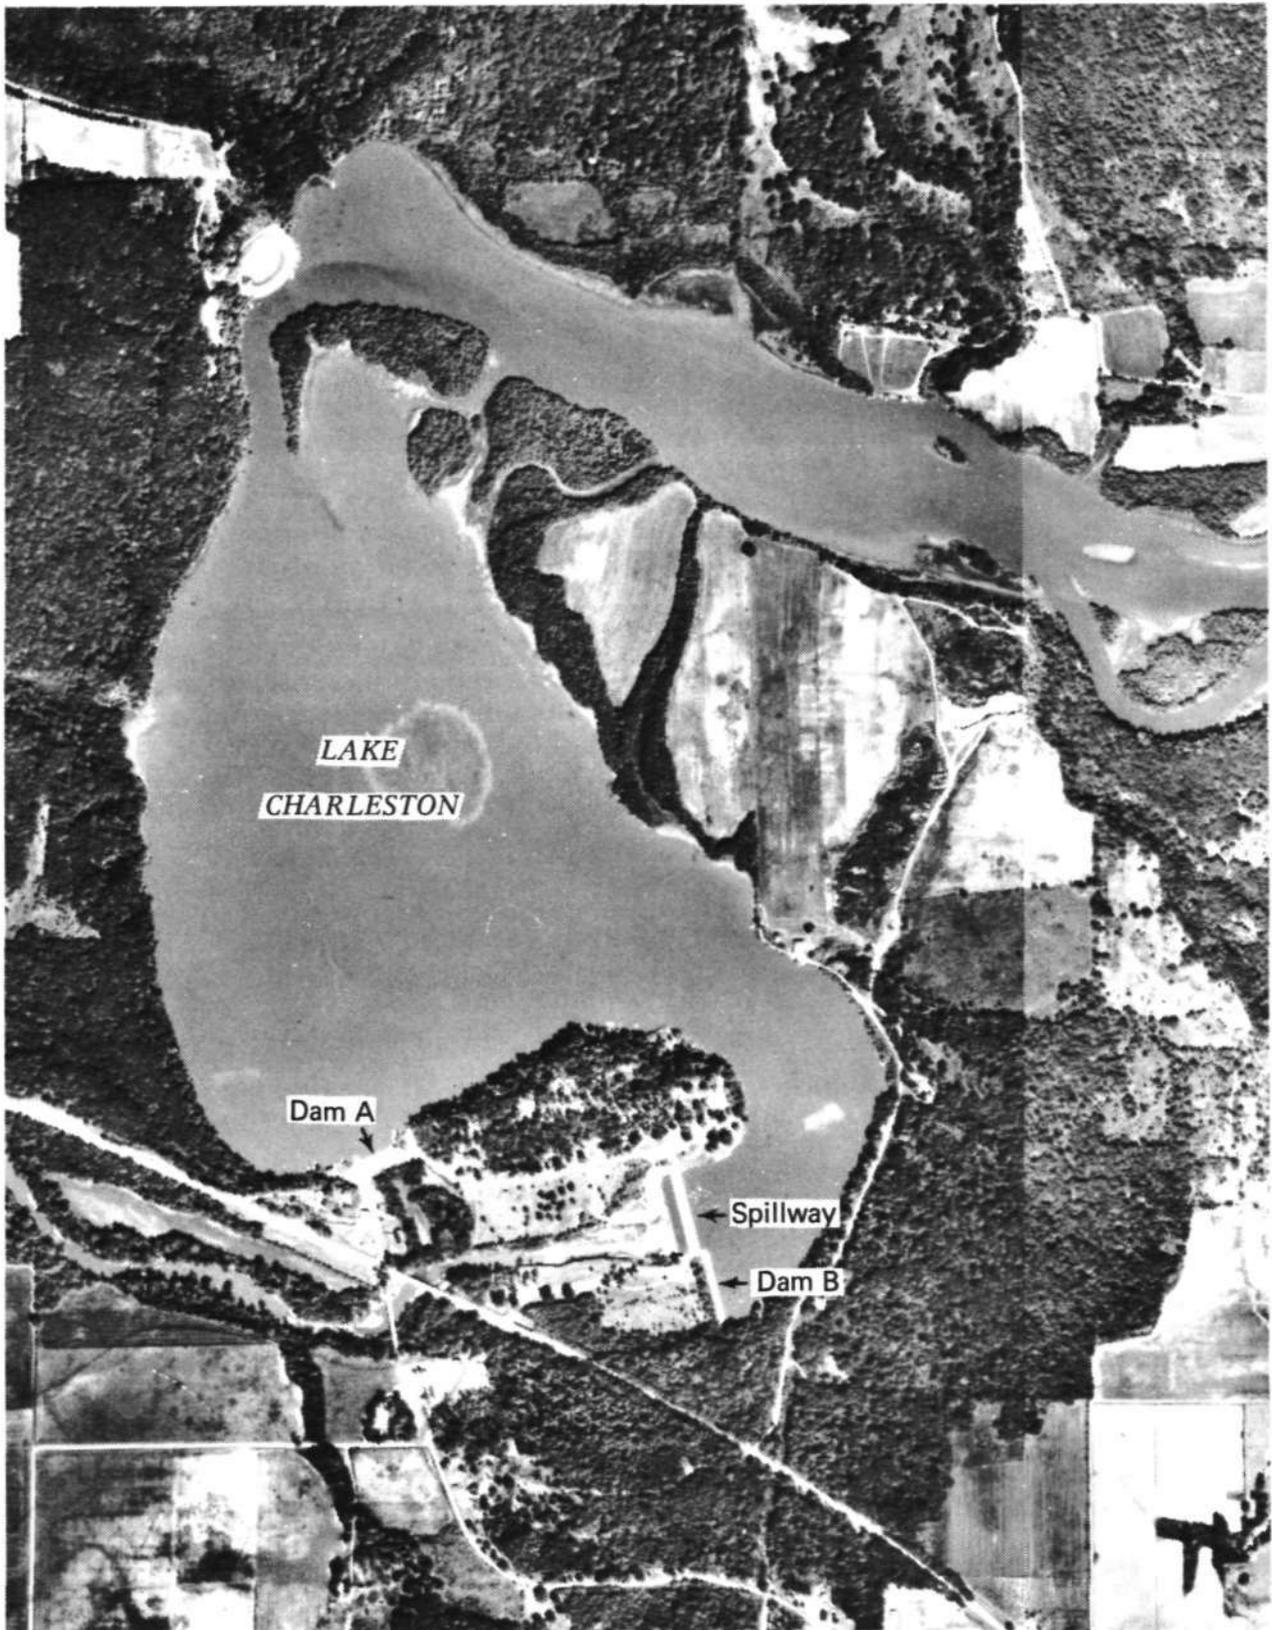
A 420-foot-long uncontrolled overflow spillway is located along "Dam B" as shown in figure 2. A typical cross-sectional view of the spillway is shown in figure 3. The spillway structure consists of an approach apron on the upstream side, a concrete weir at the middle, and 27- and 18-inch-thick slabs on the downstream slope of the spillway. The crest of the spillway at the concrete weir is 579.6 ft msl, and the stilling basin at the downstream end of the spillway is at 557 ft msl. The downstream slope of the spillway below the weir structure is 2.5 to 1 (horizontal to vertical). Under the concrete weir, sheet pilings were driven to an impervious stratum to prevent seepage under the spillway. In 1964 1-foot-high wooden flashboards were installed on top of the weir crest to increase the capacity of the lake. The normal water elevation was thereby increased to 580.6 msl.

Figure 2. The Riverview Dam and Lake Charleston before construction of side channel reservoir and dike

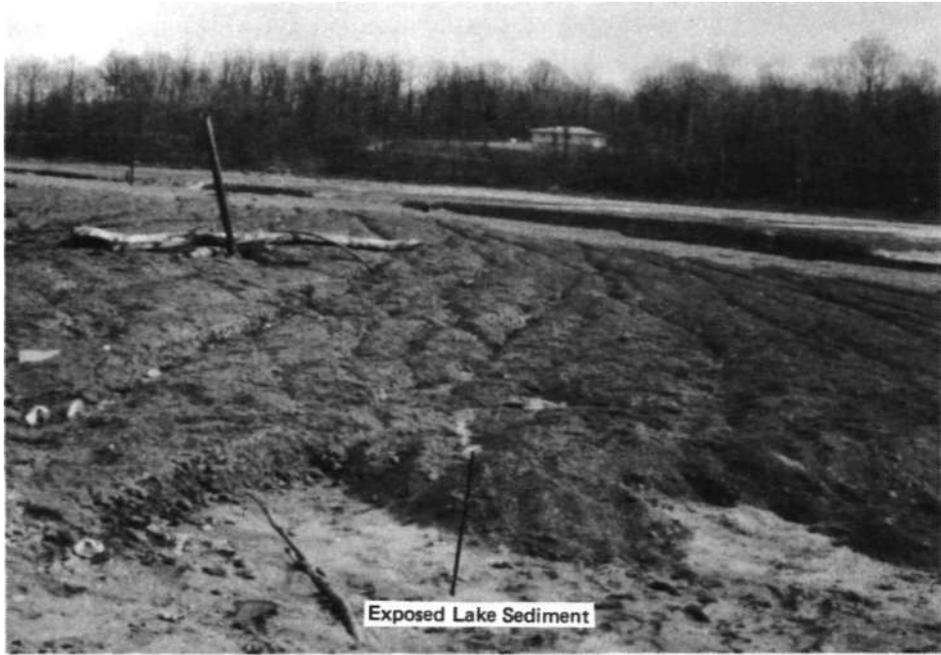
surveys and the survey conducted in 1986. This is important since the history of sedimentation in the lake might otherwise be misinterpreted because of the relatively small amount of sediment left in the lake after the spillway failure. Much of the unconsolidated sediment which accumulated in the lower reach of the lake just upstream of the spillway was washed out during and after the spillway failure. Thus the sediment which remained on the old lake bottom after the spillway failure (figure 4) is not a true measure of the past sedimentation rate in the lake.

Figure 4. Lake sediment remaining on the old lake bottom after spillway failure

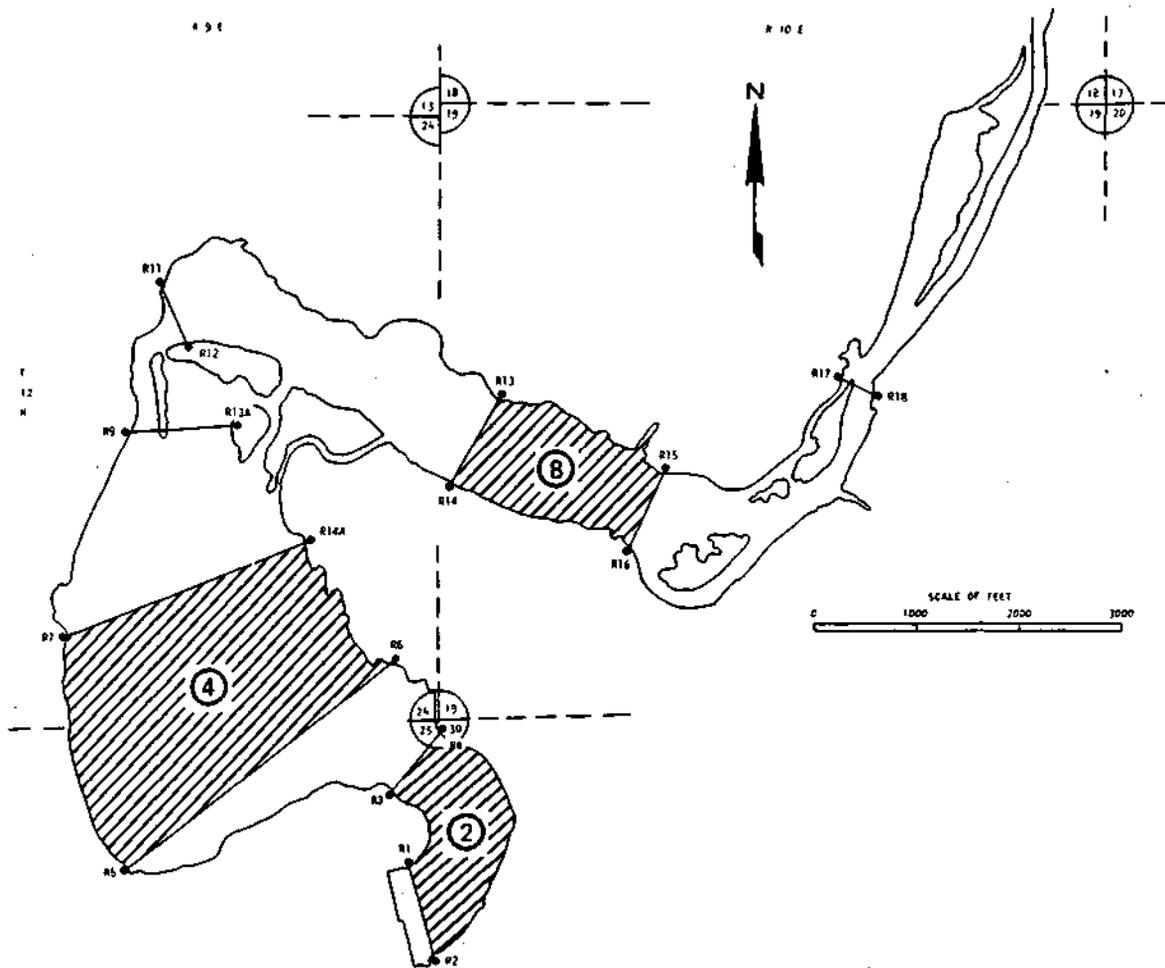
The variations of the sedimentation rates within the lake and the lower sedimentation rate in the lower reaches of the lake are illustrated by comparing the historical sedimentation rate of three segments of the lake. The three segments selected for this comparison are segment 2 in the lower lake, segment 4 in the middle of the lake, and segment 8 in the upper reaches of the lake (figure 5). Information on these three segments, taken from Illinois State Water Survey files, is given in table 2. Segments 2 and 8 each made up about 8 percent of the original lake volume, while segment 4 accounted for 24 percent of the volume. When comparing sediment accumulation in the three segments, shown in table 2, it is obvious that segment 4, which accounted for the larger portion of the lake volume, accumulated much more sediment than the other two segments. However, the sediment accumulation rate in segment 8, which is in the upper part of the lake, was almost twice that of segment 2, which is in the lower part of the lake, even though they had about equal original volume. In terms of average sediment thickness, the rate was the highest for the upper segment (segment 8) and the lowest for the lower segment (segment 2), with that of the middle segment being somewhere between the two.

Figure 5. Locations of segments 2, 4, and 8 in the old Lake Charleston

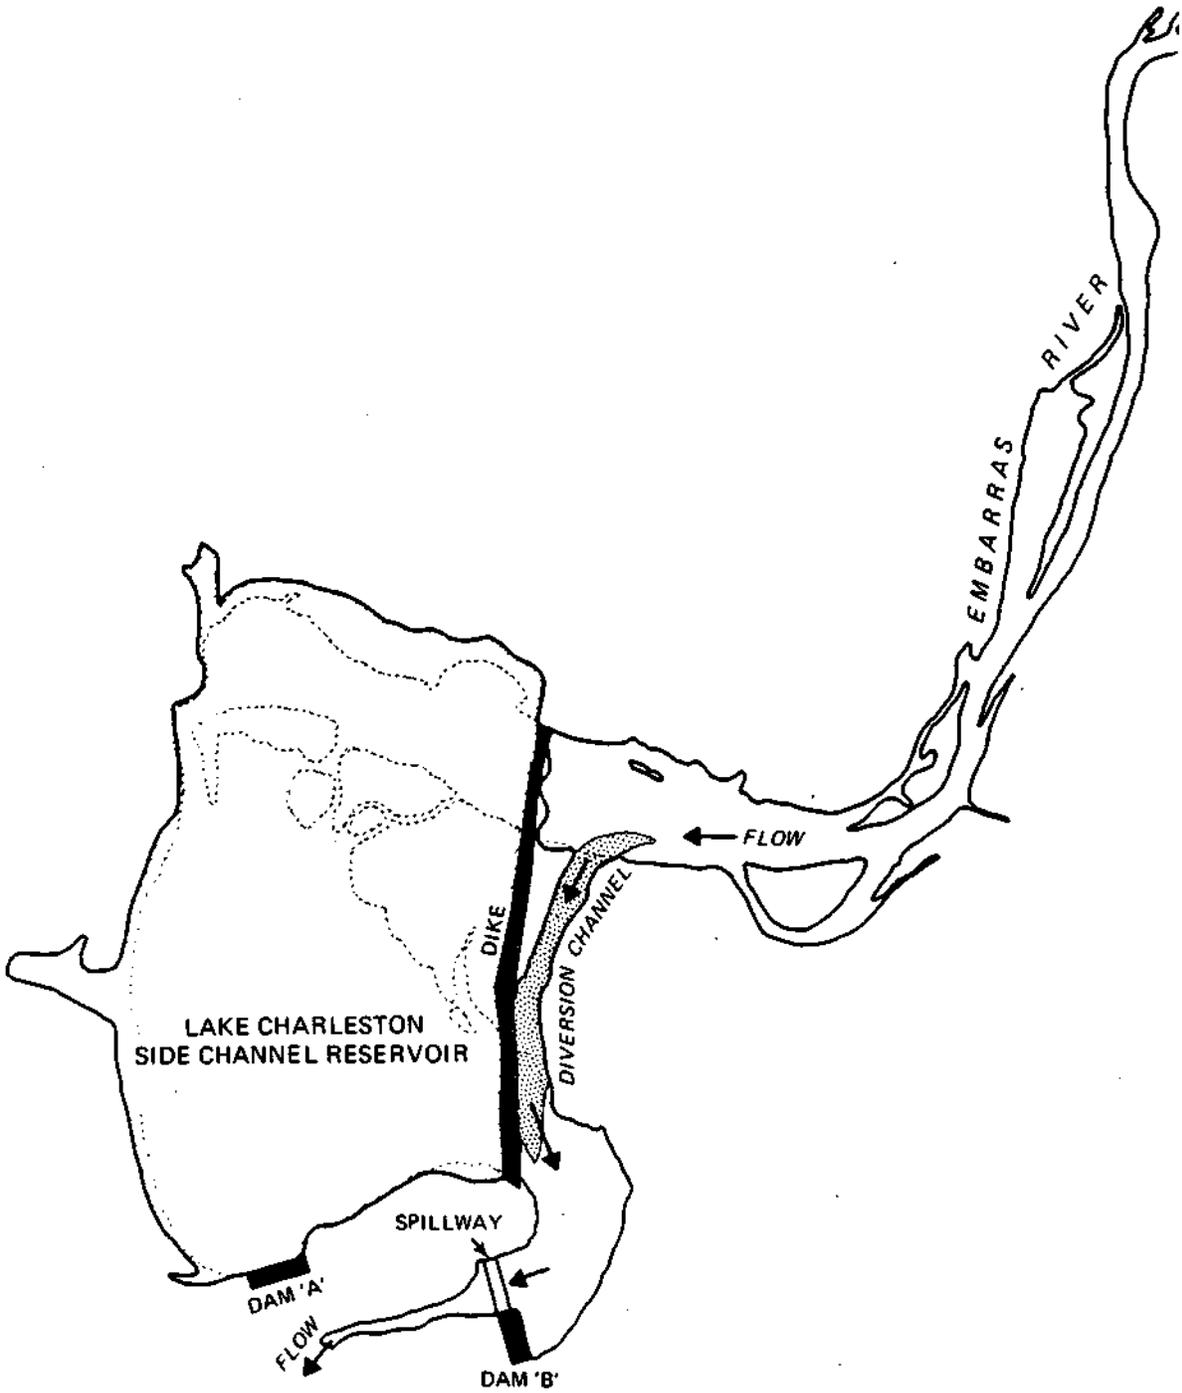
Because of lake capacity loss due to sedimentation and increased water demand, from 1975 to 1980 the city investigated various alternatives to increase the water storage capacity available to the city. These alternatives included building new reservoirs at several other locations in the area, and the idea of a side channel reservoir at the site of the old lake, which was finally selected and implemented in 1980-1982. The creation of the side channel reservoir involved building a dike across the lake as shown in figure 6 to isolate the western portion of the lake from the rest of the old lake, and constructing a diversion channel on the eastern side of the dike to divert the Embarras River flow directly to the spillway area. A photograph of the side channel reservoir, dike, and diversion channel is shown in figure 7.

Figure 6. Side channel reservoir at Lake Charleston

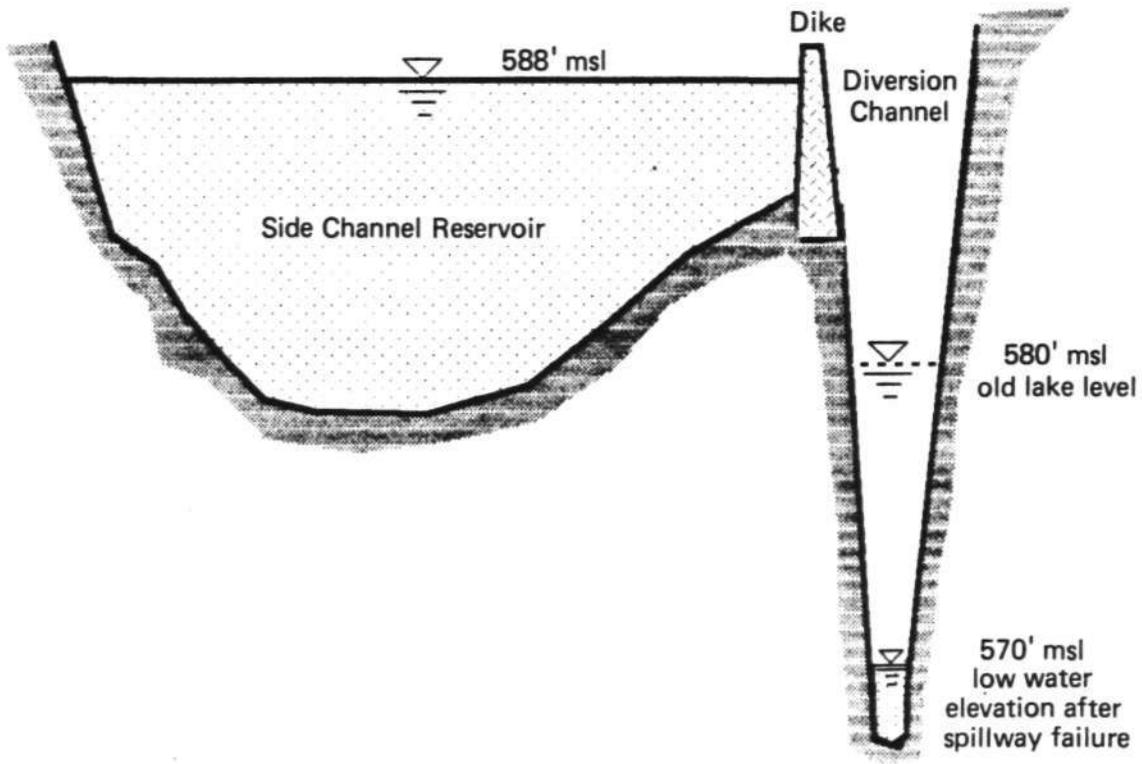
The side channel reservoir was designed to hold water up to an elevation 8 feet higher than the mean pool elevation of the old lake as shown in figure 8. Water from the Embarras River is pumped to the reservoir to keep the water level at a desirable elevation (588 ft msl). The design capacity of the side channel reservoir is estimated to be 3680 ac-ft. With the expected reduction of the sedimentation rate in the side

Figure 8. Cross-sectional view of side channel reservoir, dike, and diversion channel

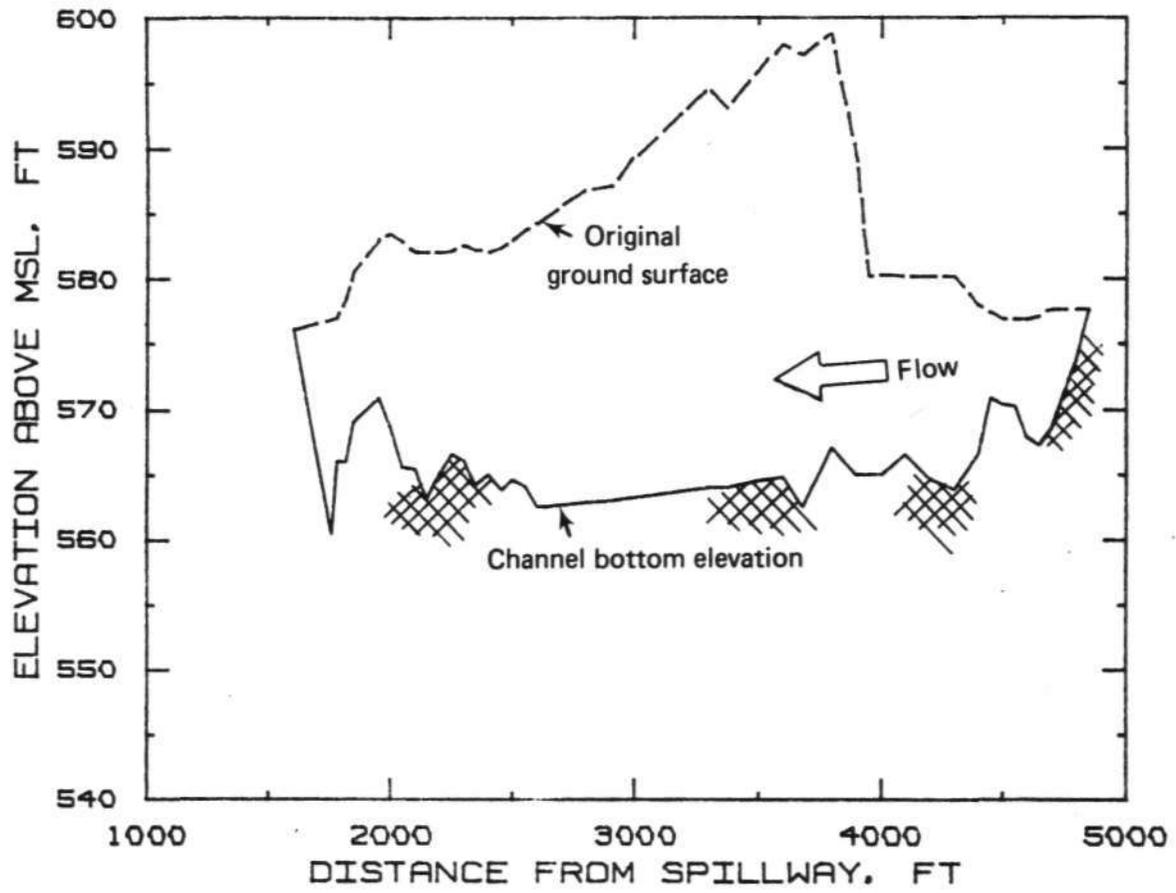
Figure 9. Profile of the diversion channel in Lake Charleston

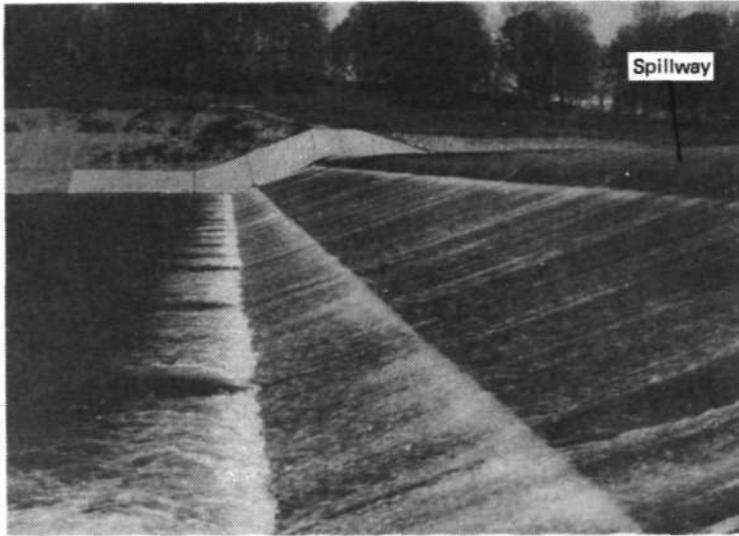
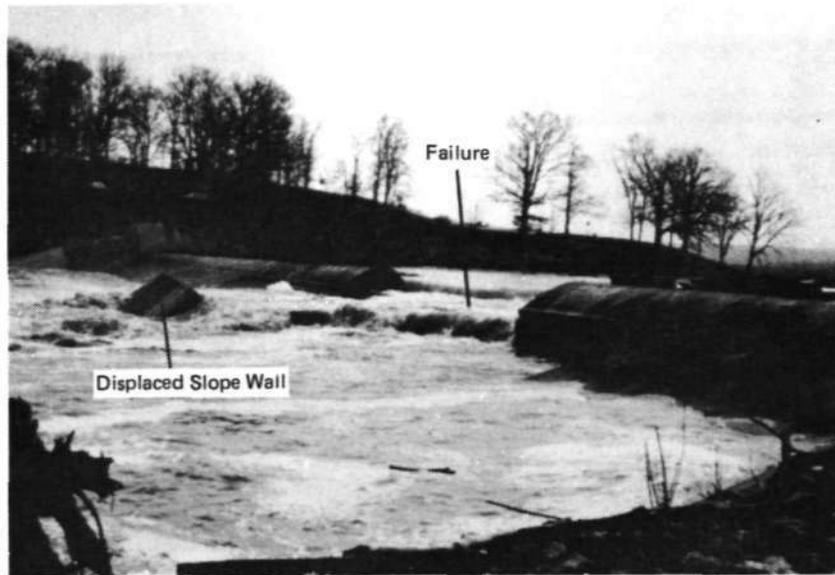
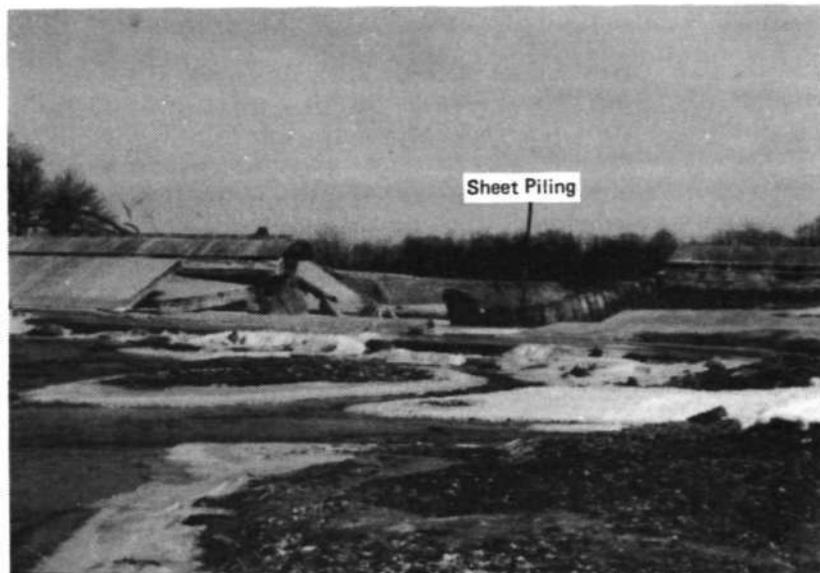
In late November 1985, parts of the spillway located along Dam B failed during a moderate flood. The initial sign of the spillway failure was the displacement of slopewall panels on the downstream slope of the spillway. The panels were eventually moved further downstream and the fill material underneath the spillway at the breach was eroded, exposing the sheet piling below. Figure 11 shows the spillway before and after failure. The scour hole which developed just upstream of the spillway, referred to as a "sinkhole," is shown in figure 12. As the scouring moved further upstream, the deep channel shown in figure 13 was formed.

SPILLWAY BEFORE FAILURE

SPILLWAY AFTER FAILURE

Figure 11. Lake Charleston spillway before and after failure

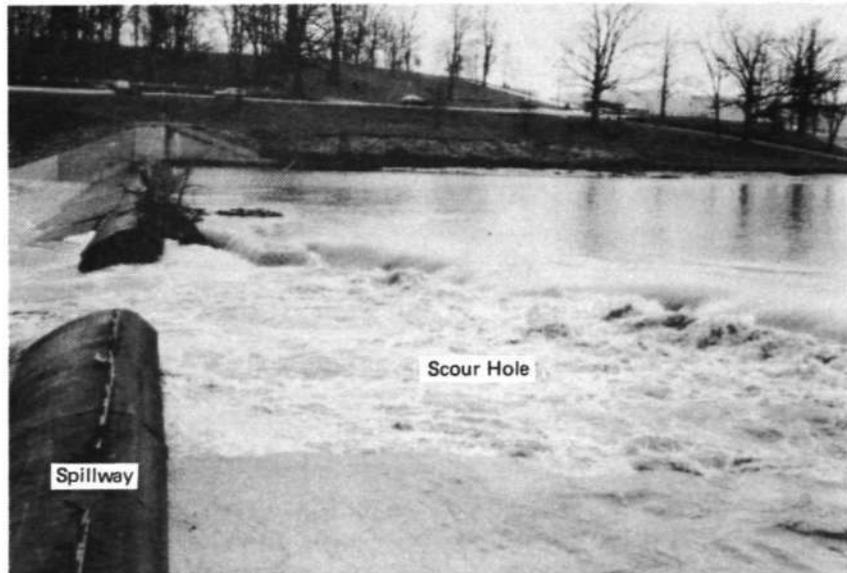
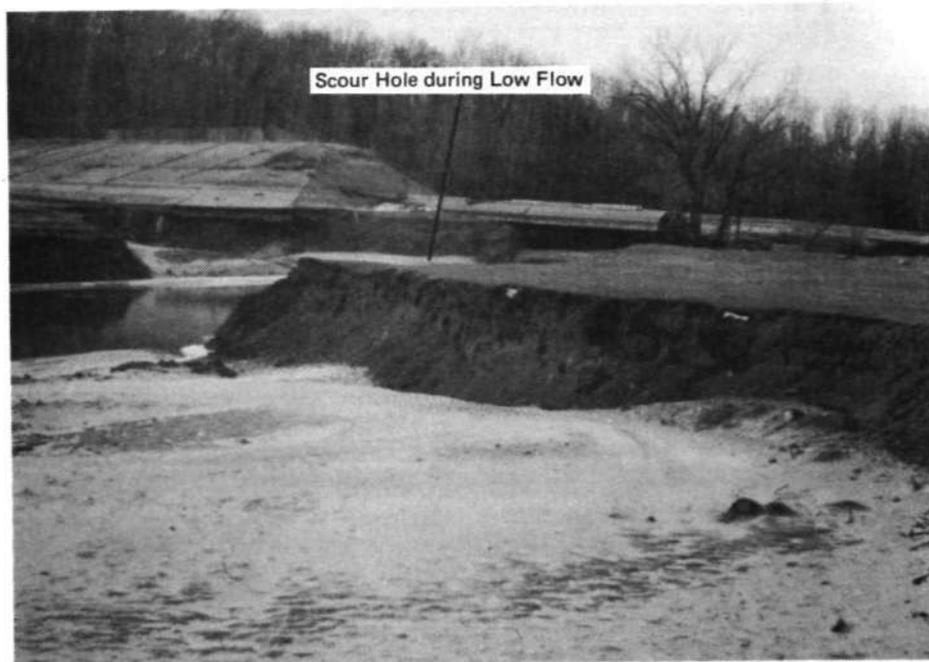
Figure 12. Scour hole just upstream of Lake Charleston spillway after its failure

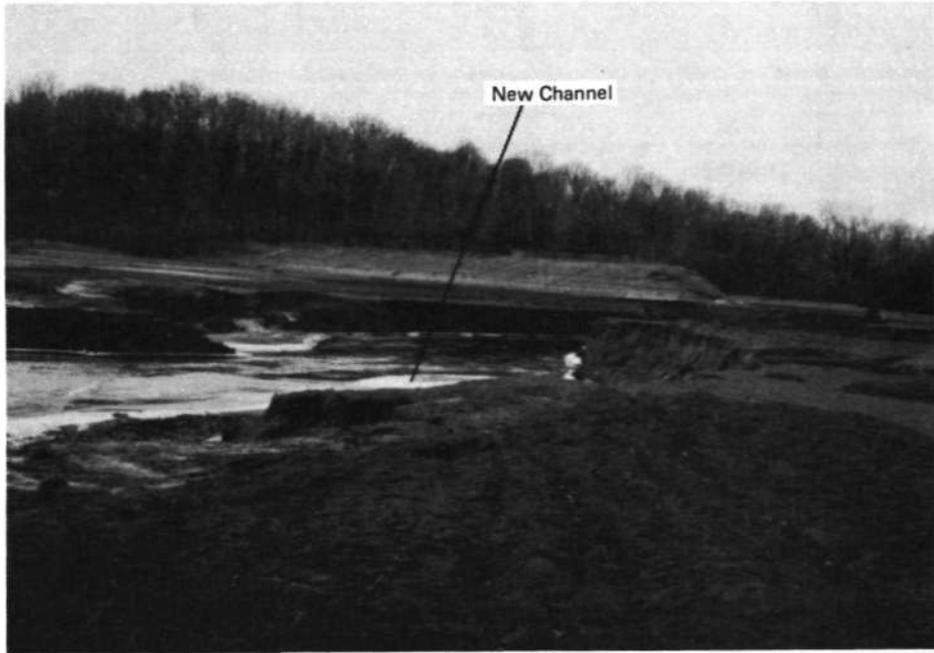
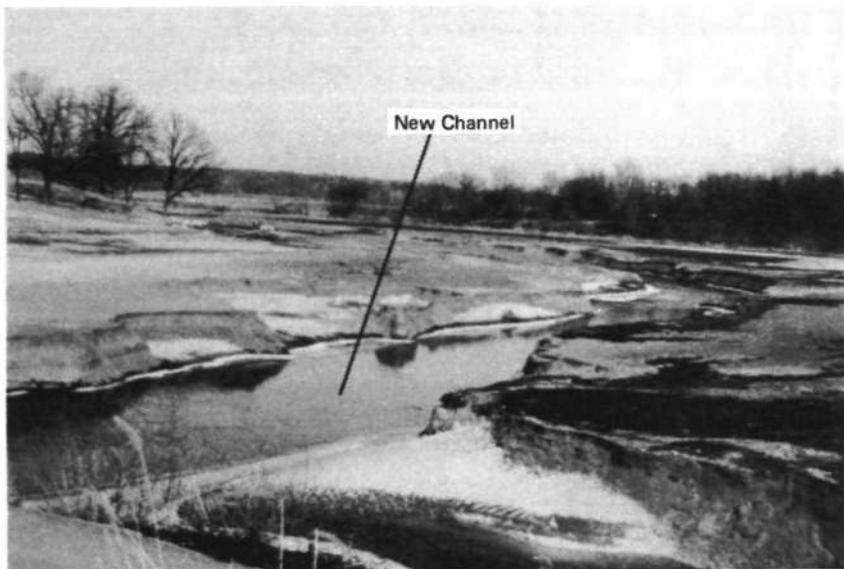
Figure 13. New stream channel which developed after the spillway failure at Lake Charleston

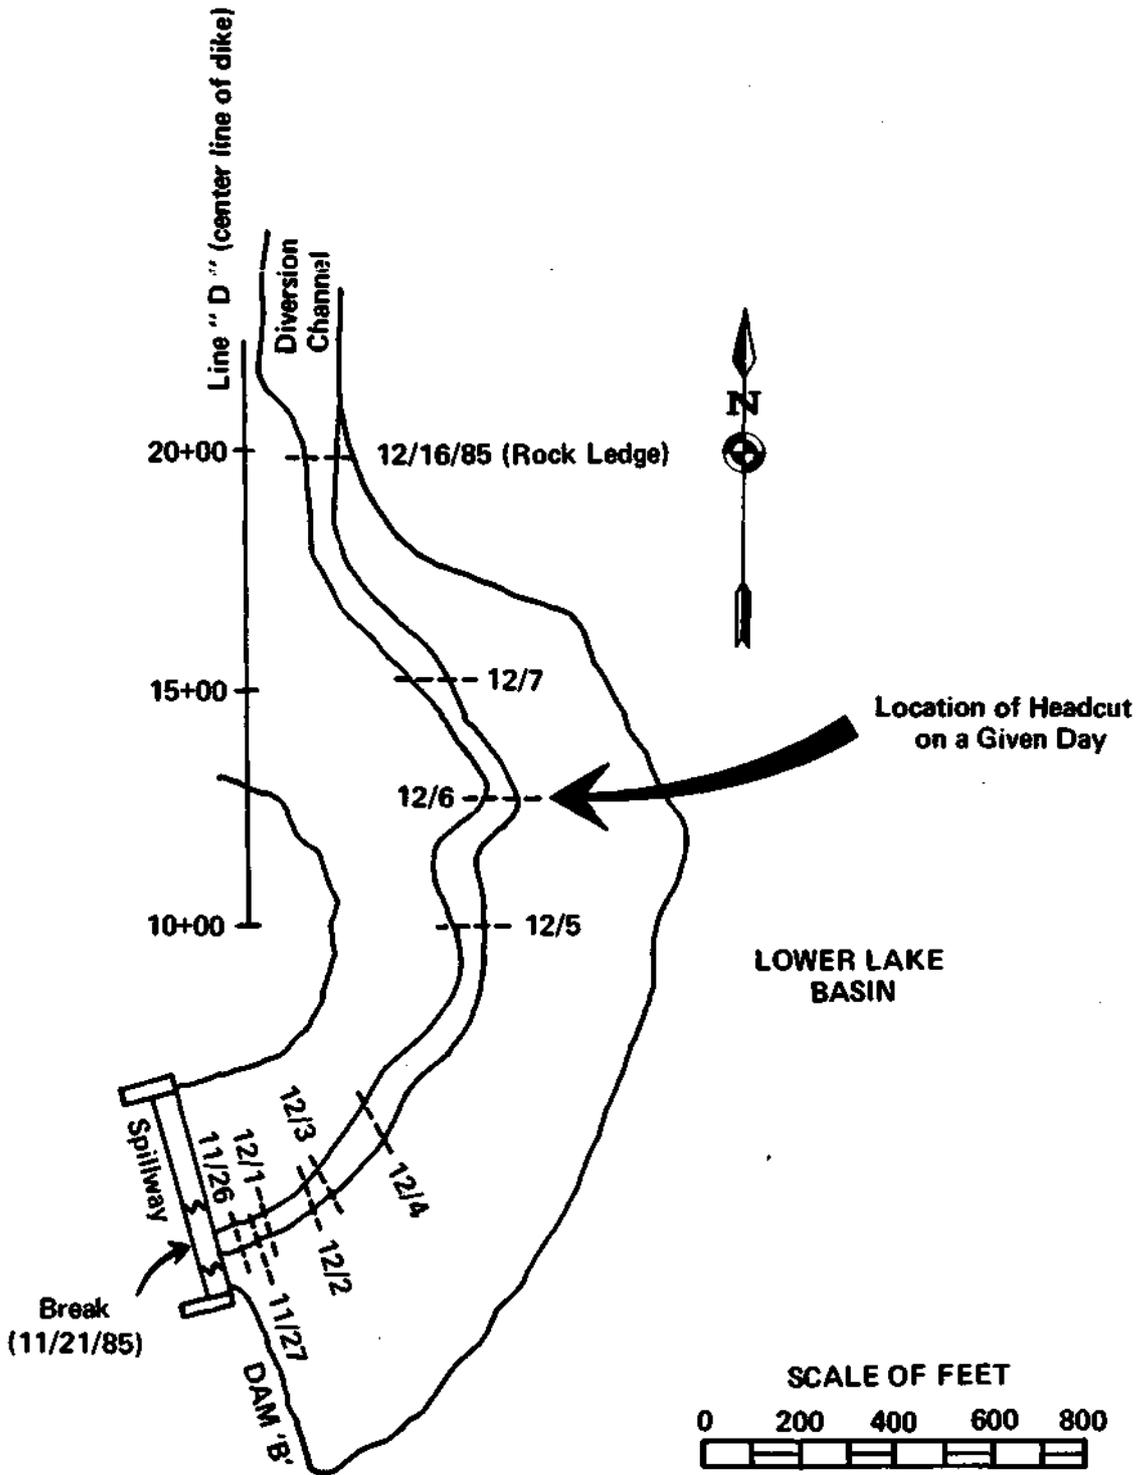
A detailed record of the spillway failure, the development of the "sinkhole," and the upstream migration of the scour channel was kept by Dan England, Assistant City Engineer, City of Charleston. The record is presented below in its entirety. To assist in the interpretation of the record, figure 14 was prepared to indicate the location of the headcut at different times (shown by dates on the figure). The headcut is the upstream extent of the scour channel as it migrated from the spillway towards the diversion channel.

Figure 14. Location of headcut upstream of Lake Charleston spillway at different times

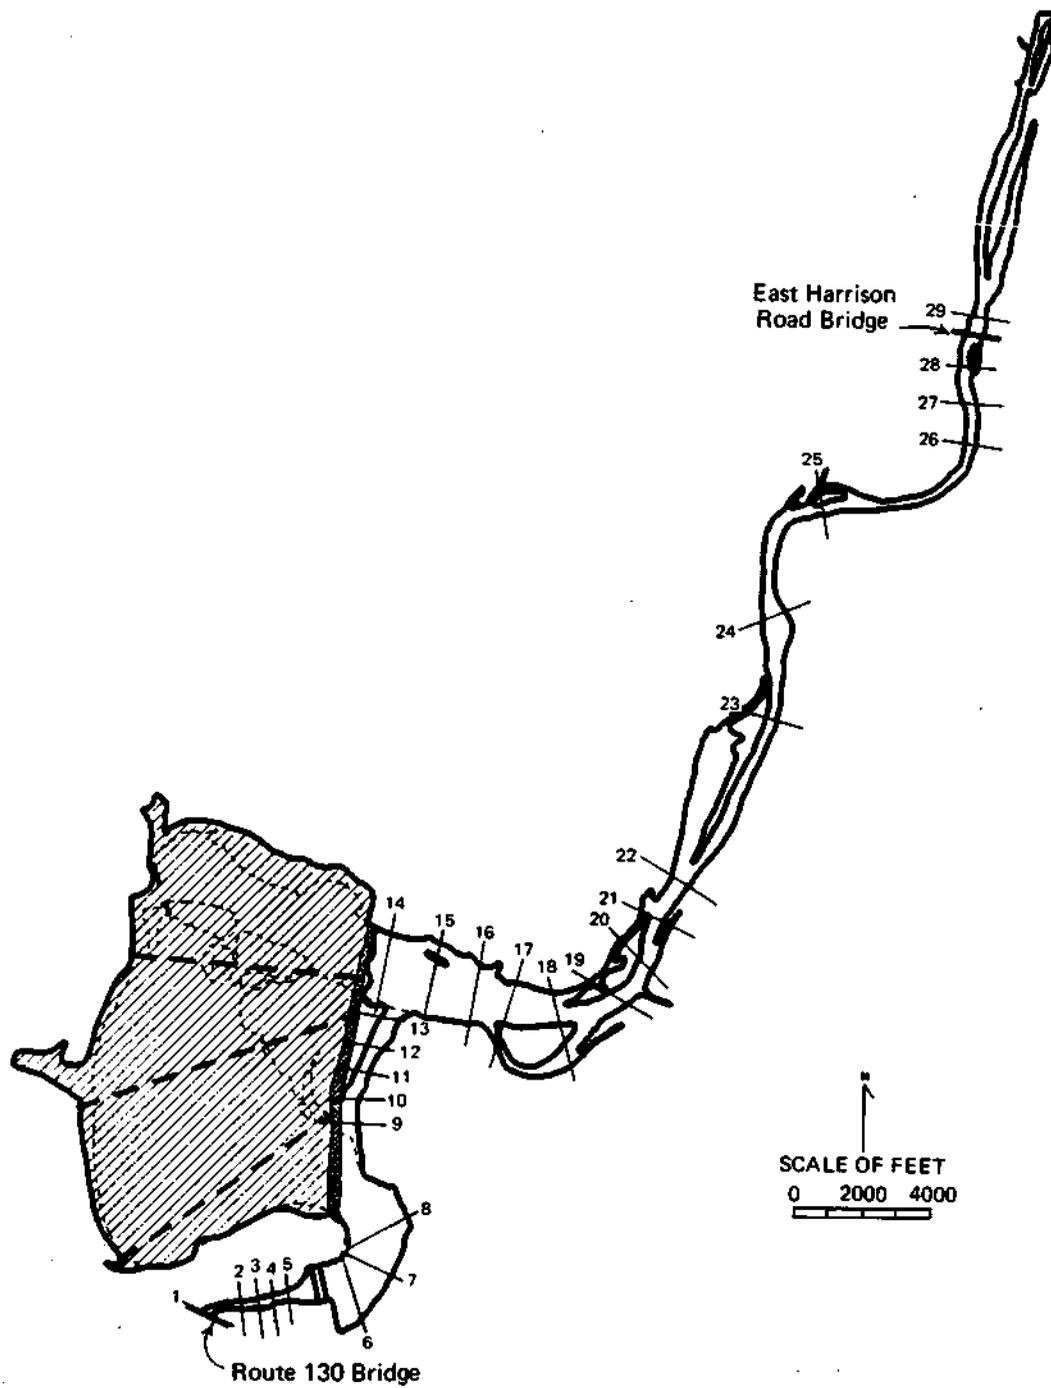
The 15 cross sections used to repeat the 1962 DOWR Flood Control survey were relocated by eye in the field by using base maps prepared at the time of the survey. These cross sections were roughly located at the time of the 1986 survey by a stadia survey.

The five cross sections within the diversion channel (cross sections 9 to 13) were surveyed by re-establishing the construction baseline of the side channel dike. Cross sections were surveyed between stations 22+00 and

Figure 15. Locations of 1986 survey cross sections along the Embarras River

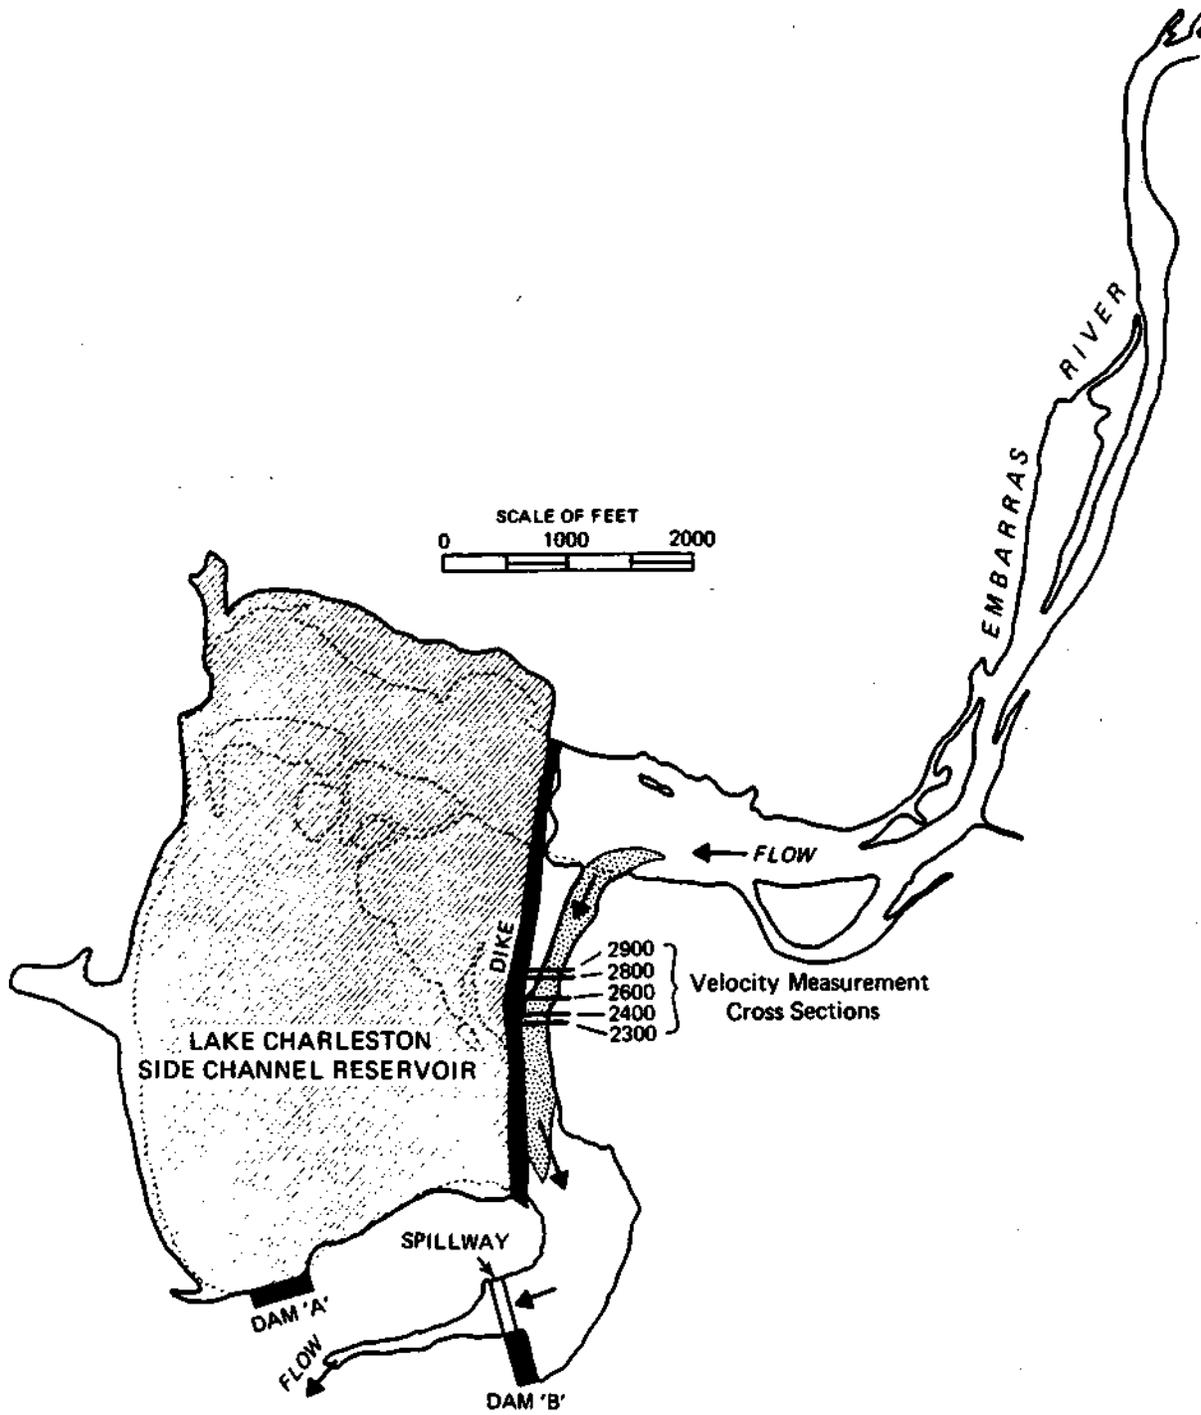
Figure 16. Locations of cross sections where velocity measurements were made in 1986

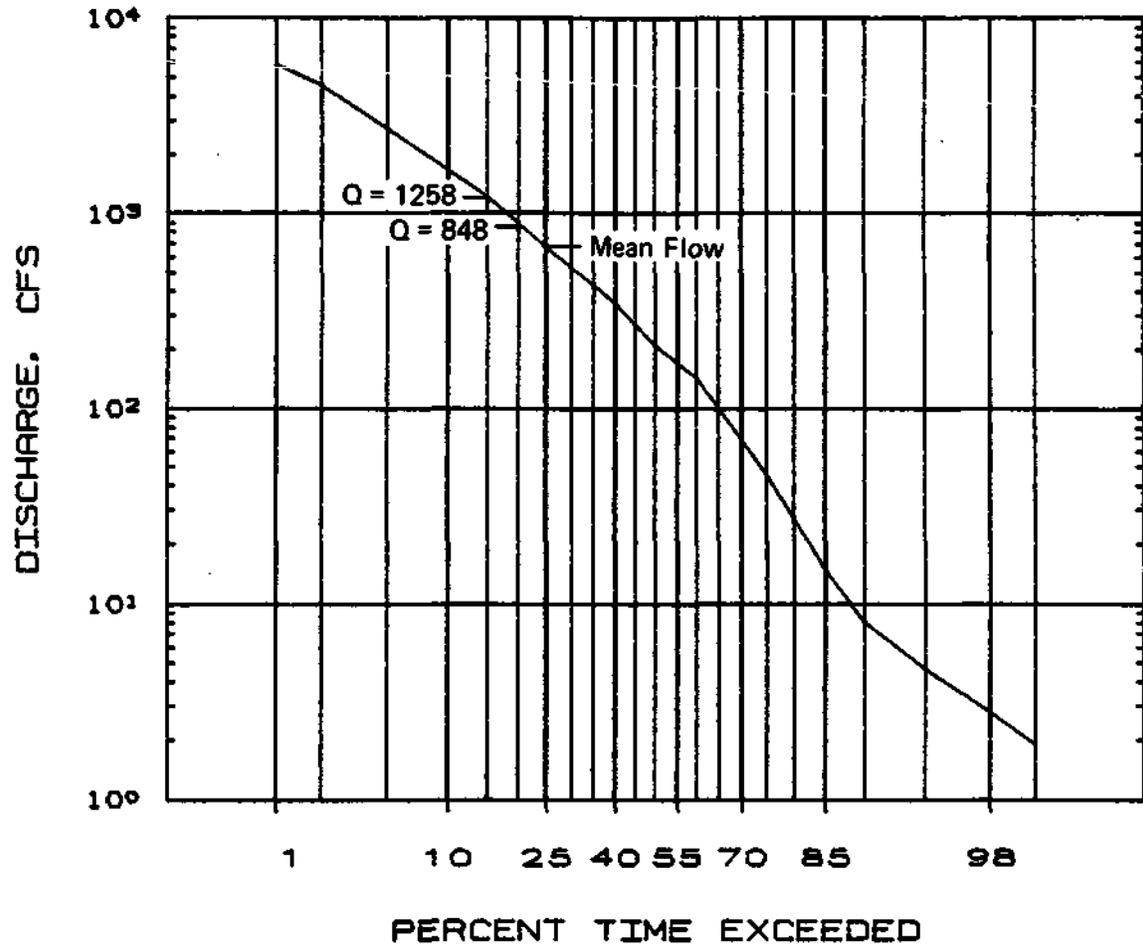
Figure 17. Flow duration curve for Embarras River at Lake Charleston

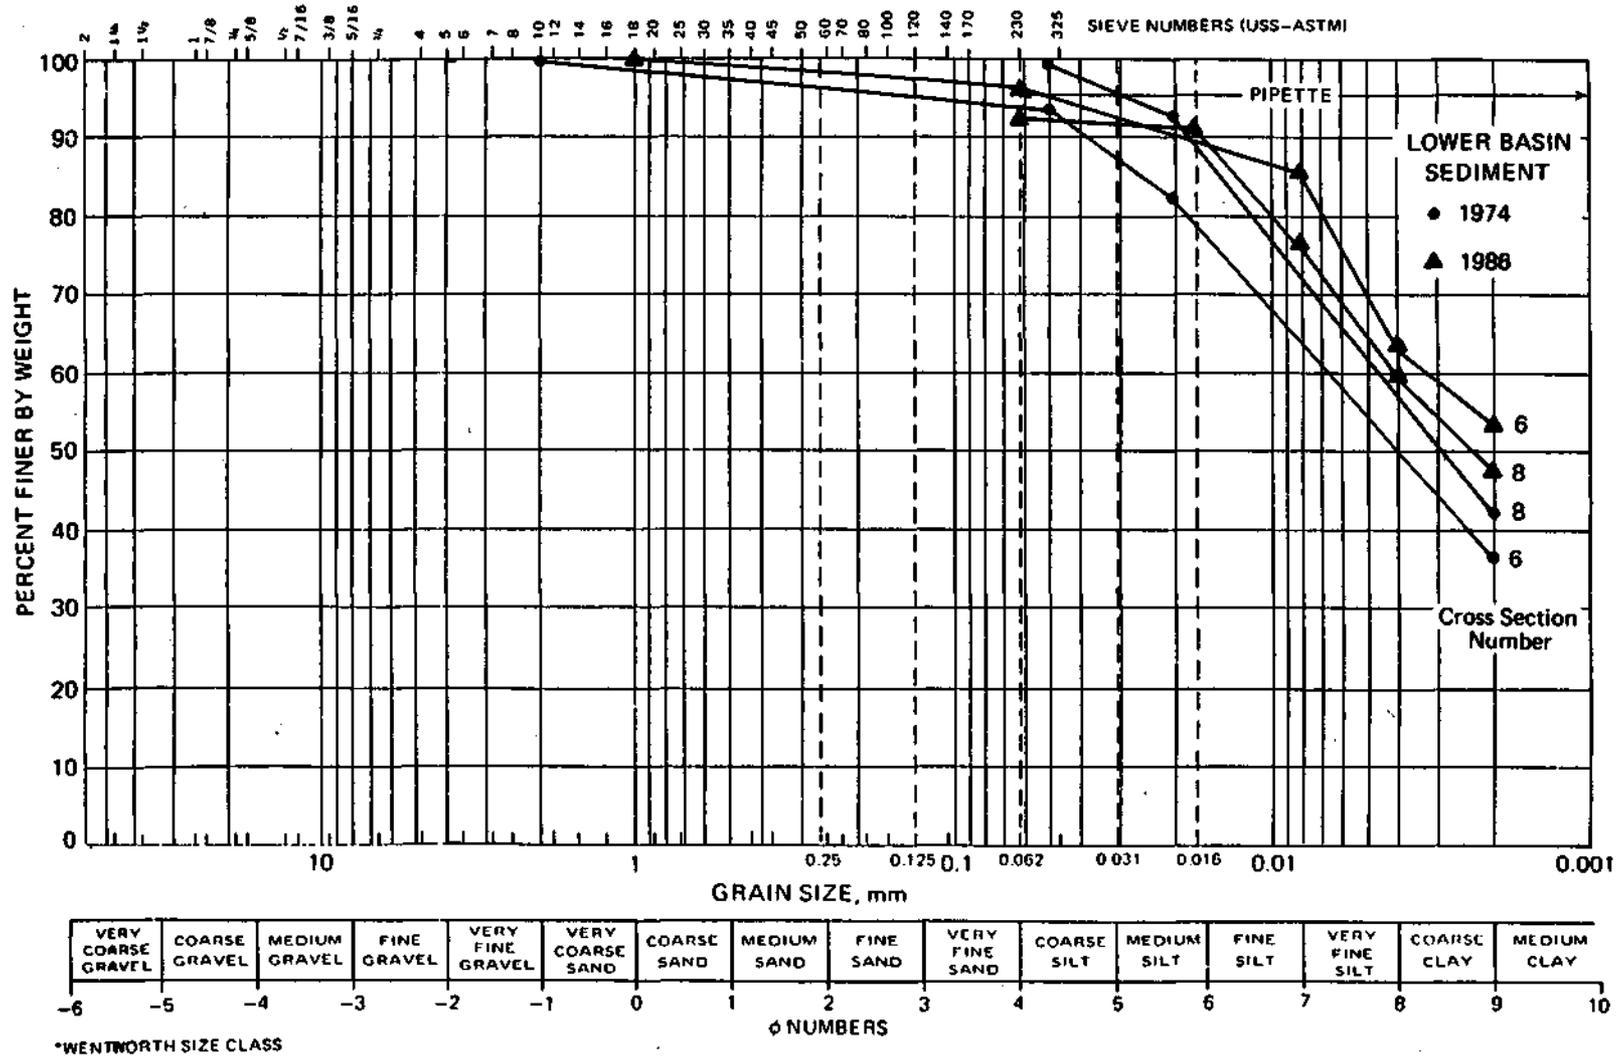
The lake sediment particle size comparison for the lower lake basin is shown in figure 27. Figure 27 shows the comparison between two sample

Figure 27. Particle size distribution of 1974 and 1986 samples in lower reaches of Lake Charleston

sets, one from cross section 6 and the other from cross section 8, from the lower basin. These analyses indicate a fairly good correlation between the 1974 and 1986 samples, with the 1986 samples representing generally finer particle sizes. These results support the hypothesis that significant erosion has occurred beyond the limits of the scour channel. Sediments in the lower end of a reservoir generally accumulate sediments with coarser materials on top of finer materials due to loss of trap efficiency in the upper end of the reservoir with time. Thus the finer sediments collected during the 1986 sampling were most likely deposited prior to the 1974 survey, with later sediment deposits having been scoured after the spillway failure. Because of the change in reservoir hydraulics in 1982, it cannot be determined from this analysis whether some or all of this sediment was reworked prior to the spillway failure.

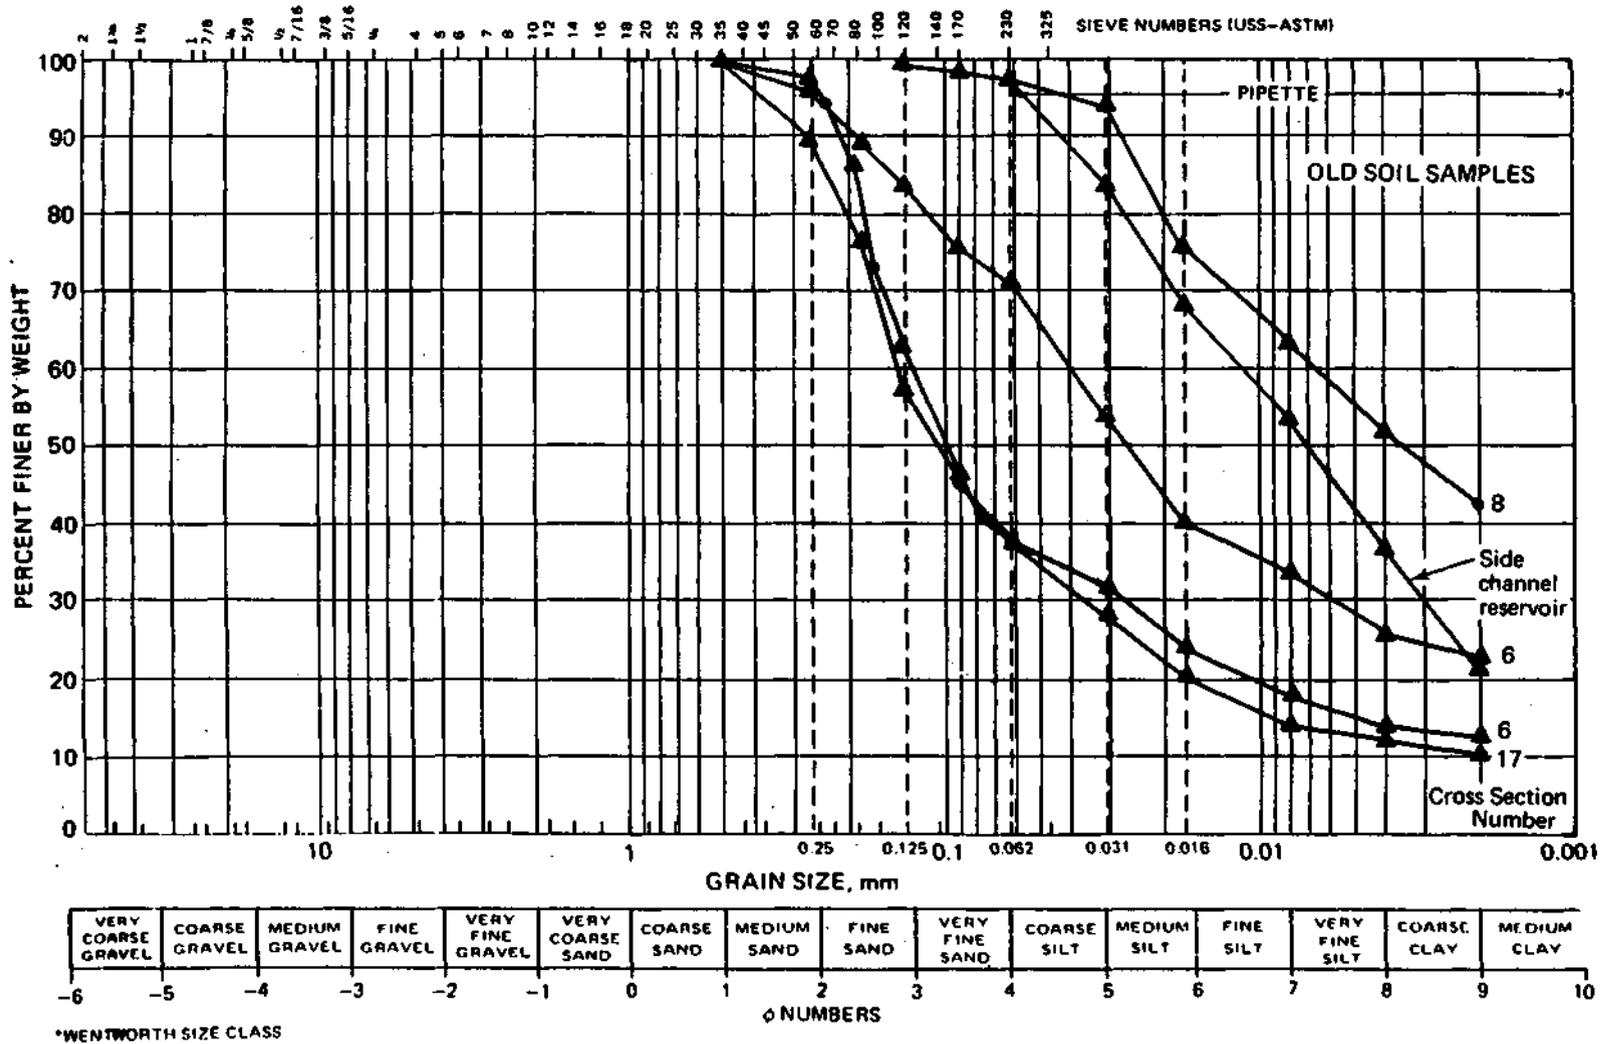
Figure 28. Particle size distribution of native soil scoured by the formation of the new channel
