# Illinois State Water Survey Division

SWS Contract Report 409

## CHANNEL SCOUR INDUCED BY SPILLWAY FAILURE AT LAKE CHARLESTON, ILLINOIS

Champaign, Illinois  
November 1986

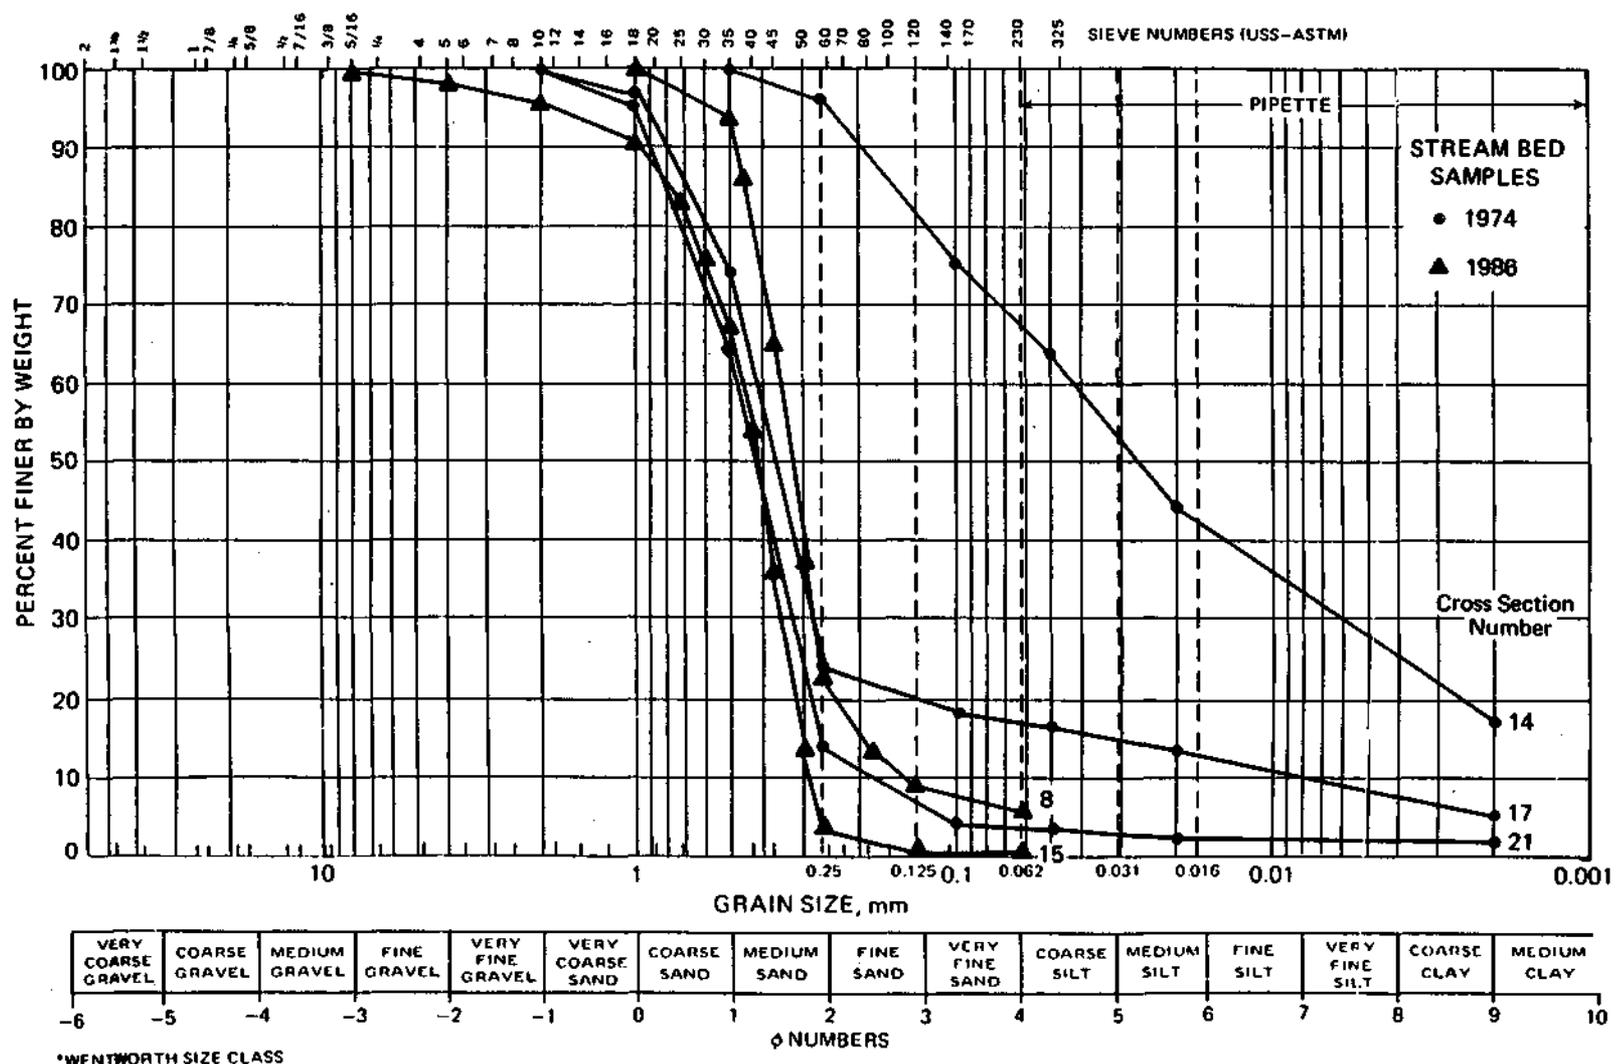
Figure 29. Particle size distribution of stream bed material samples in Embarras River at Lake Charleston

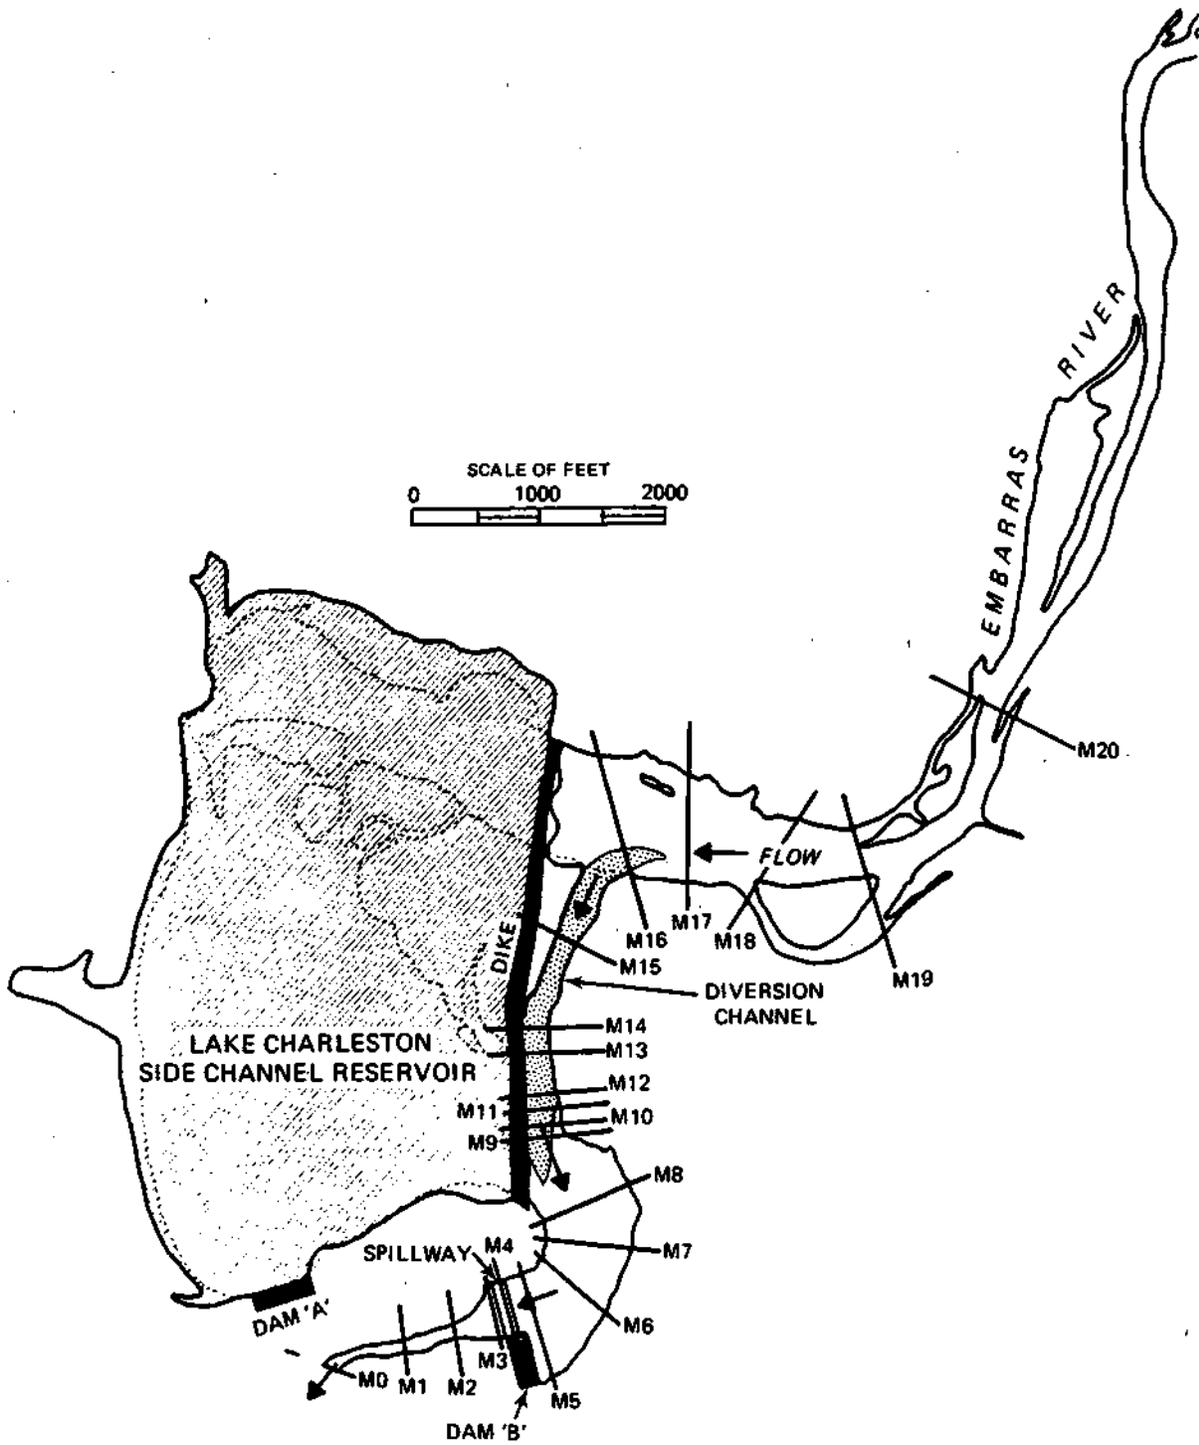
Figure 30. Locations of cross sections used in the HEC-6 model

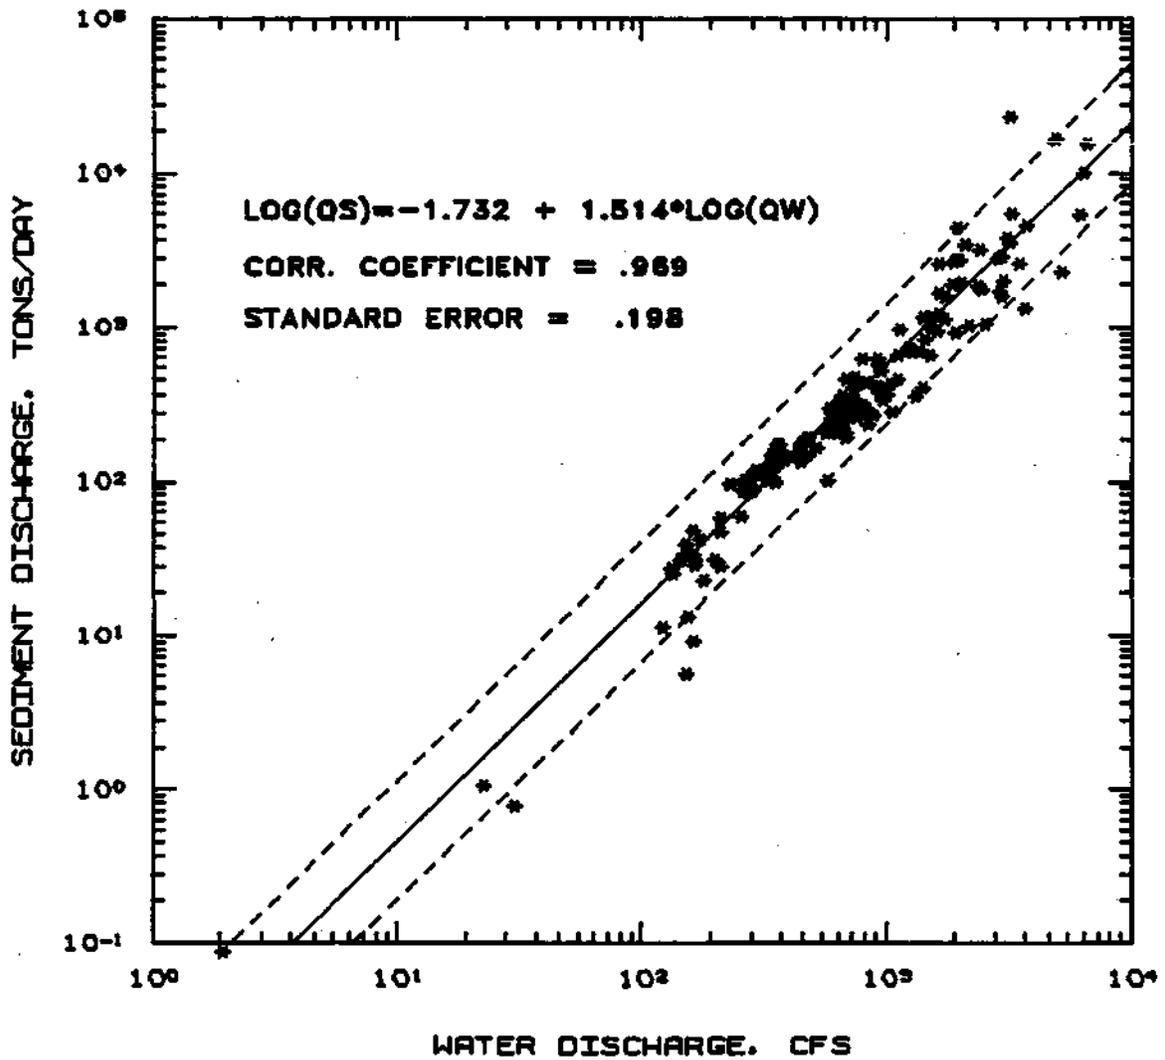
Figure 31. Suspended sediment rating curve for the Embarras River near Diona, IL

$$Q_s = 0.022 Q_w^{1.51} \quad (5)$$

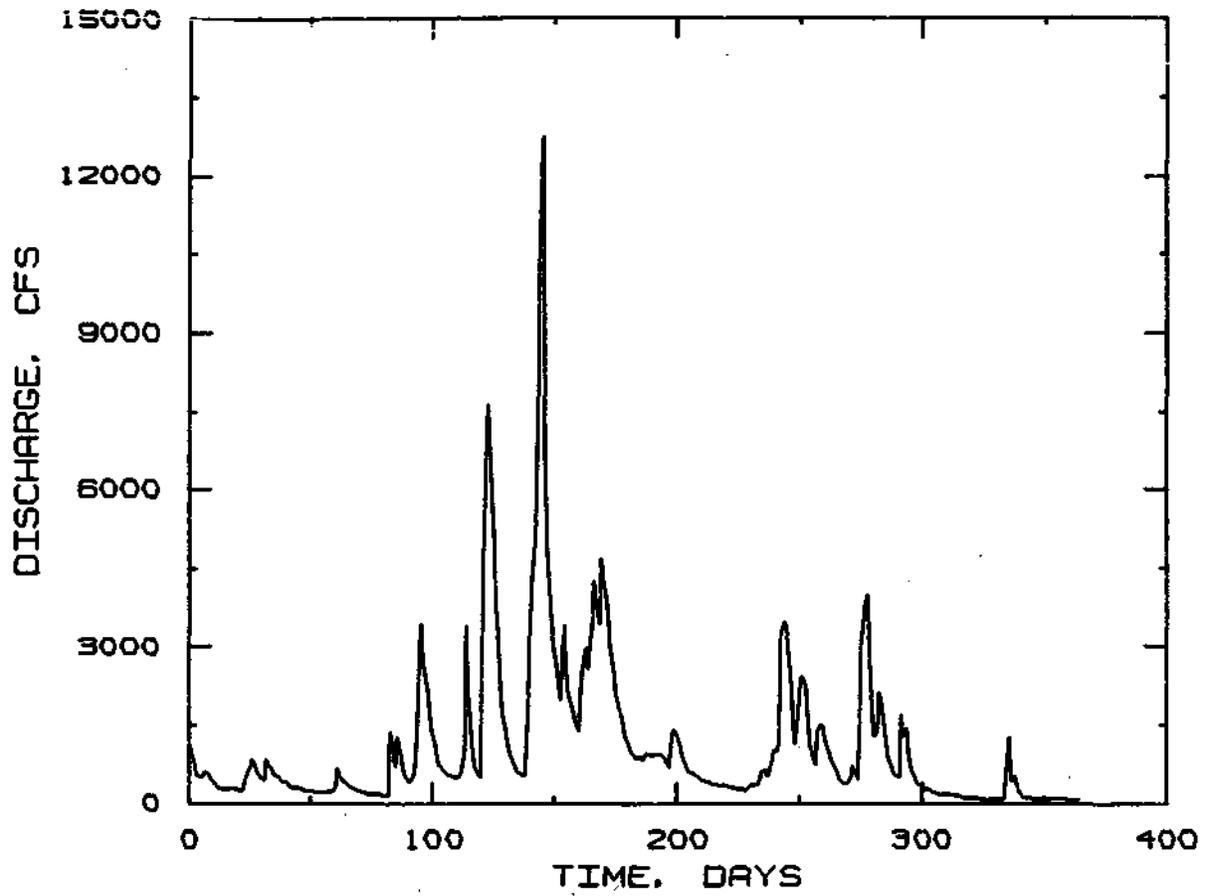
Figure 32. Input hydrograph used in HEC-6 simulations

Diona. For simulation purposes and qualitative evaluation of the model, the 1982 hydrograph at Diona, which is the latest hydrograph available at that station, provides sufficient variation and similar flow conditions to those experienced during the spillway failure. The flows represented by this hydrograph were routed through the river twice to simulate the flow and sediment transport before the spillway failure, and once to simulate conditions after the spillway failure.

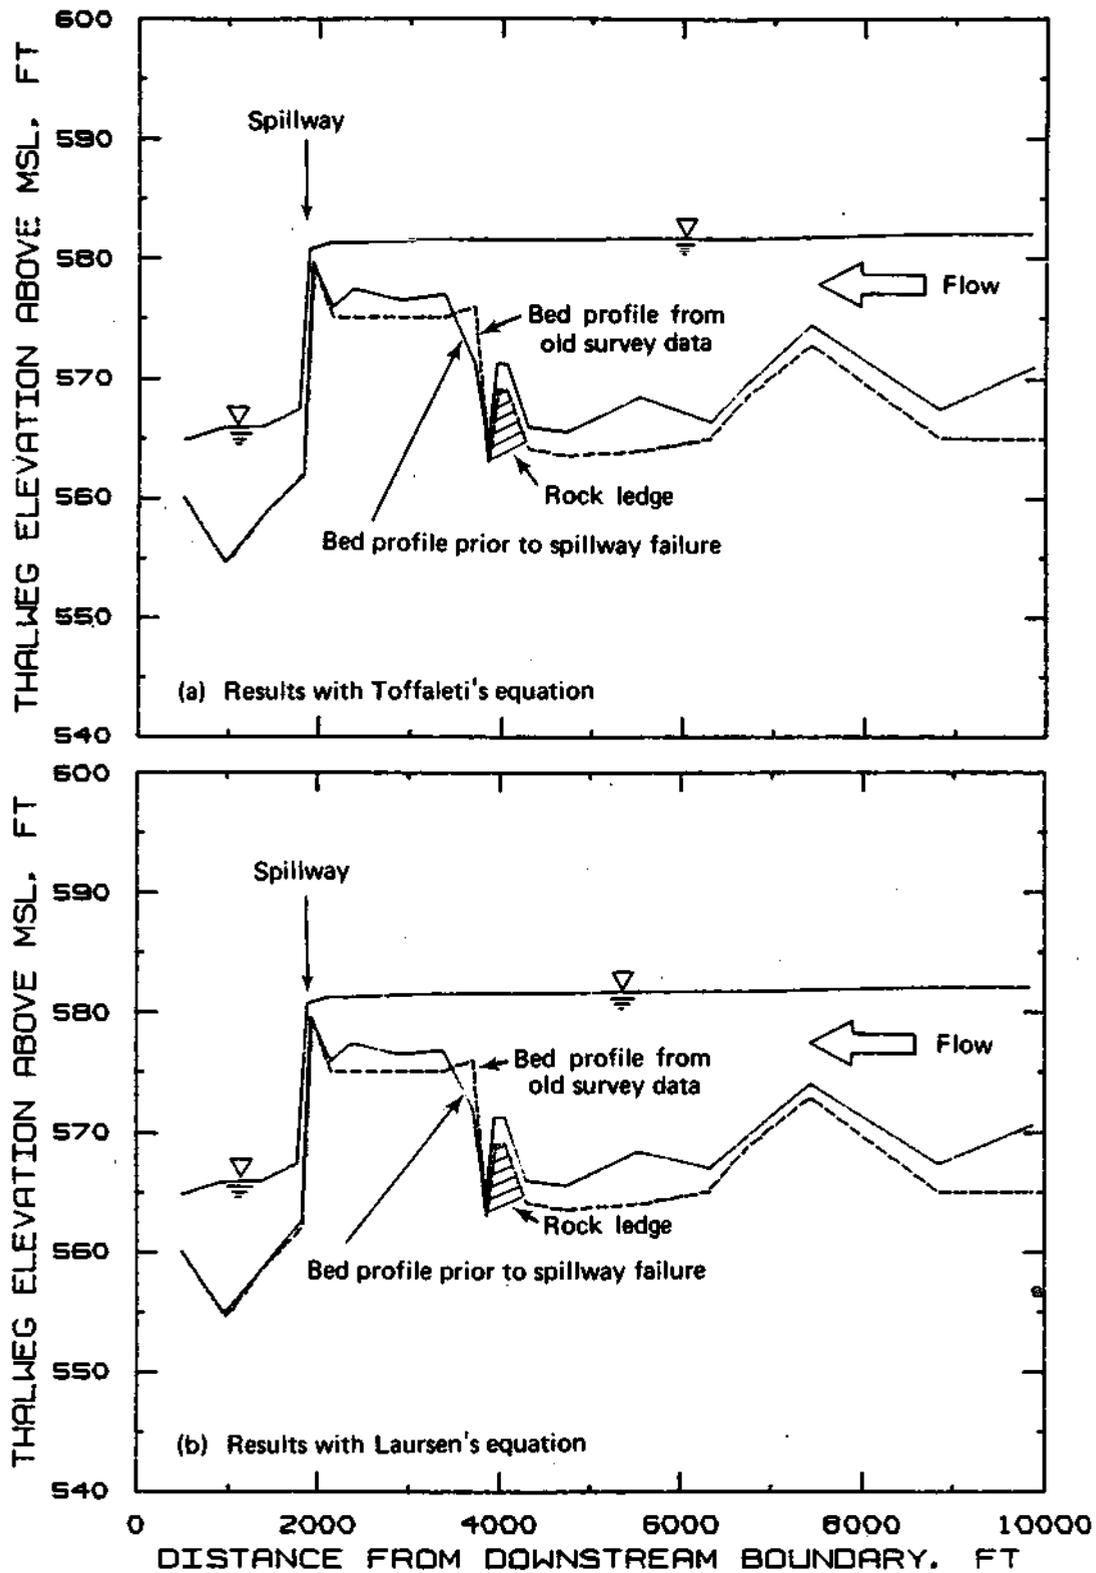
As discussed earlier, the HEC-6 was run under the pre-spillway failure conditions to estimate the lake geometry just prior to failure. Both Toffaleti's and Laursen's sediment transport equations were used in the simulation runs to check whether there were any significant differences in the model outputs depending on the equation used. The bed profiles resulting from such simulations are shown in figure 33. The two sets of results are very similar, and both show sediment deposition for much of the study reach except for the area just downstream of the rock ledge where there is some scour. For the area immediately upstream of the spillway, the results show some sediment deposition above the 1974 sedimentation survey cross-sectional profiles. Most of the sediment deposition, however, is in the upper reaches of the old lake.

Figure 33. HEC-6 simulation results for conditions prior to spillway failure

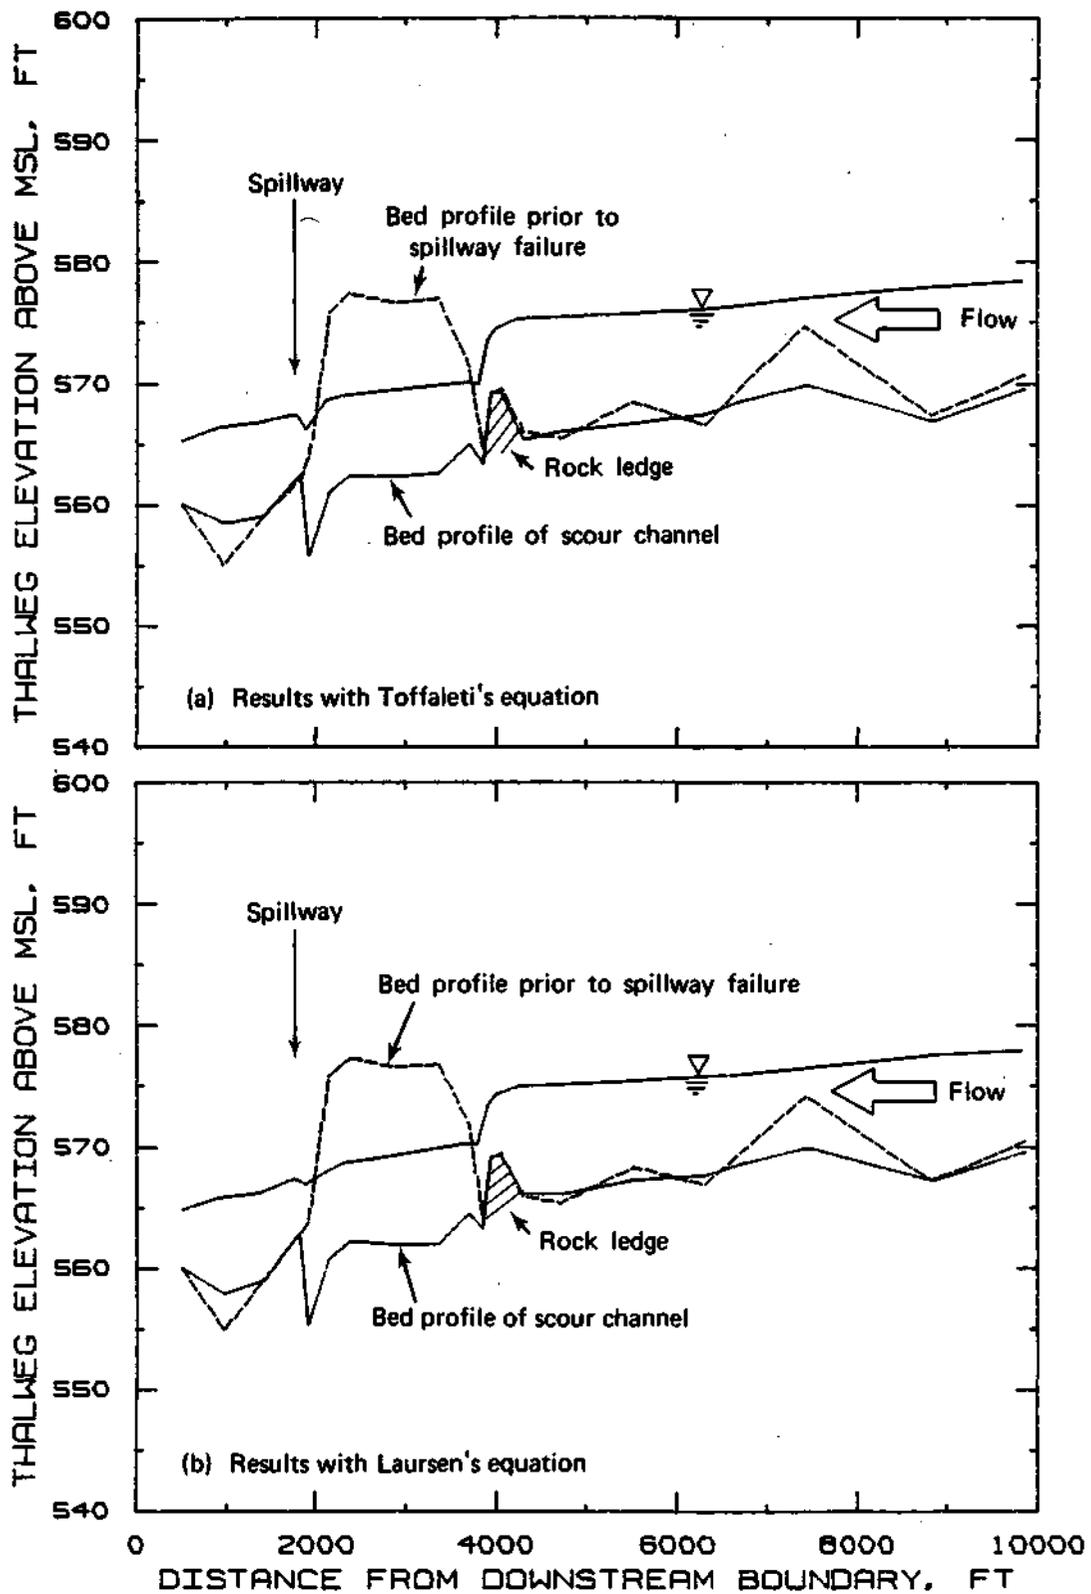
The channel geometry outputs of the pre-failure runs were then used as input data to the HEC-6 simulation of the scour after spillway failure. Both Toffaleti's and Laursen's equations were used. The profiles of the scour channel generated by the HEC-6 as compared to the pre-failure profile are shown in figure 34 for both equations. There was no significant difference in the profiles generated by the two sediment transport equations, even though Laursen's equation gives slightly more scour (figure 34b).

Figure 34. HEC-6 simulation results after spillway failure

As shown in figure 34, the HEC-6 simulation results show over 15 feet of scour for the reach just upstream of the spillway. Most of the extreme scour was confined between the spillway and the rock ledge, which is about 2,000 feet upstream. There is also an area of scour further upstream, just beyond the diversion channel.

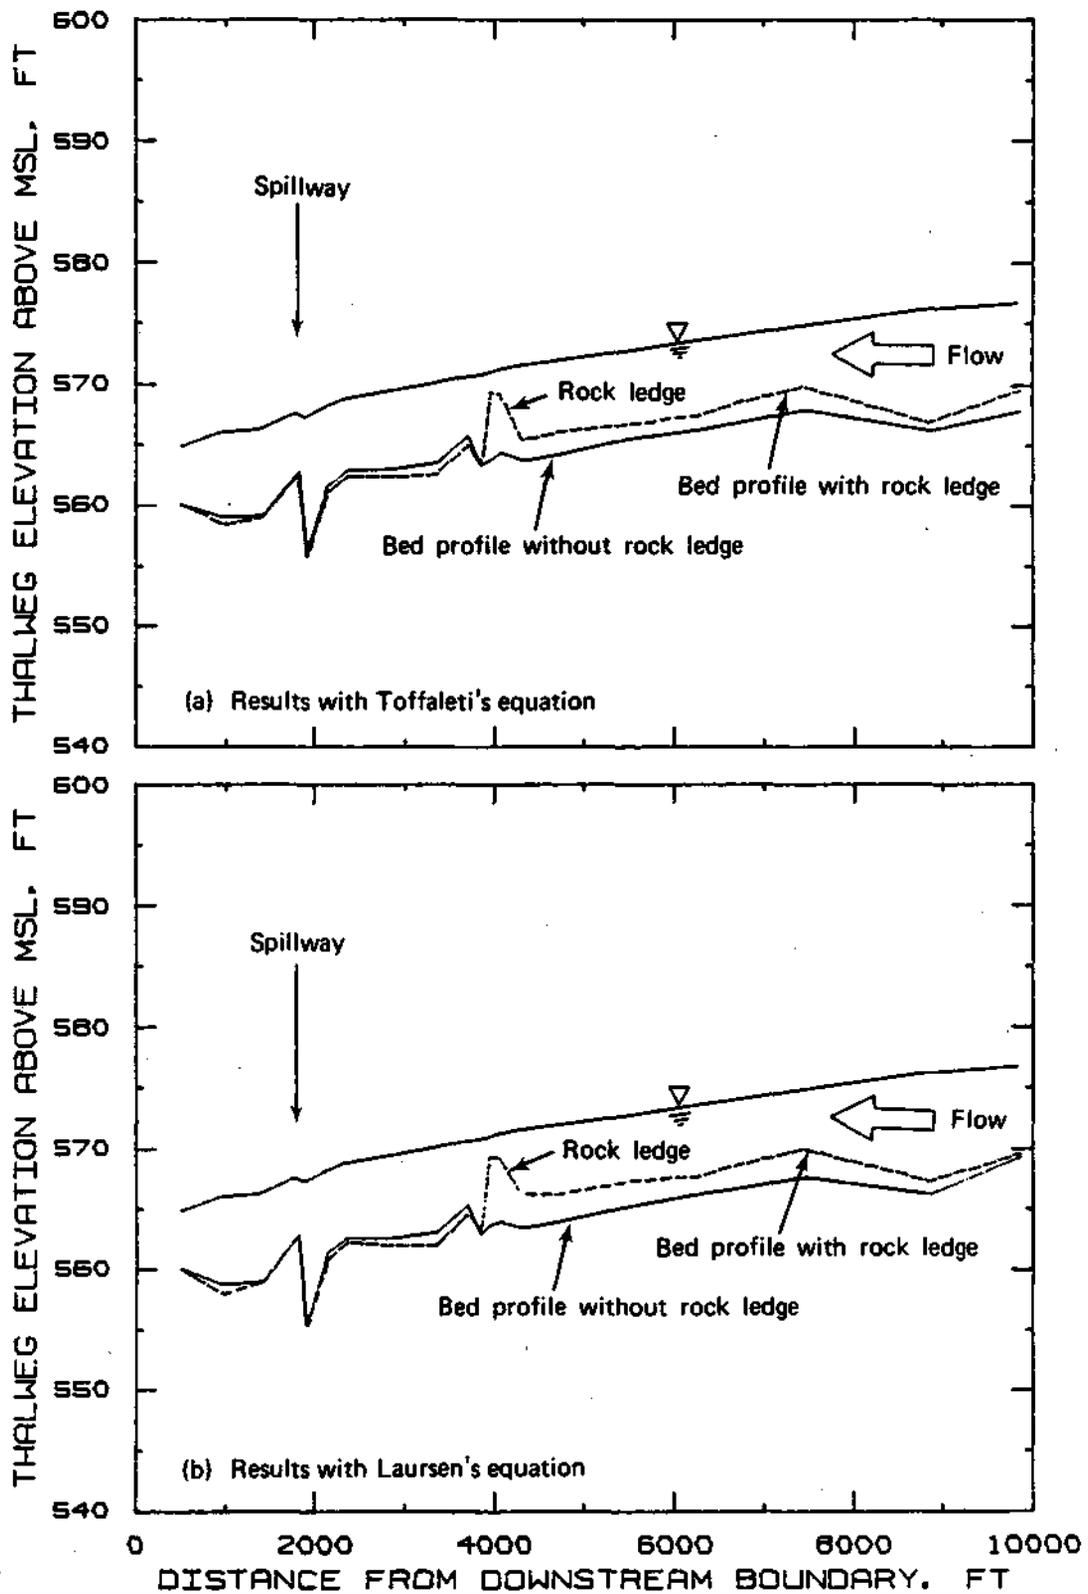
One of the significant observations in the field is the influence of the rock ledge in stopping the upstream migration of the scour channel. It was also observed that the rock ledge, which is primarily shale, is being scoured slowly, especially during high flows. Thus it was judged important to investigate how much more scour might have taken place if the rock ledge had not been present, or how much scour might occur in the future if the rock ledge is gradually eroded away. The result of such an analysis using the HEC-6 is shown in figure 35, in which the bed elevations of the scour channel with and without the rock ledge are compared. Both Toffaleti's and Laursen's equations were used. As shown in the figures, the scouring would have progressed much further upstream if the rock ledge had not been present. The development of the channel downstream of the rock ledge would have been similar either with or without the presence of the rock ledge. The channel upstream of the rock ledge, however, would have been about 2 feet deeper without the rock ledge than it is with the rock ledge.

Figure 35. HEC-6 simulation results with and without rock ledge in the diversion channel

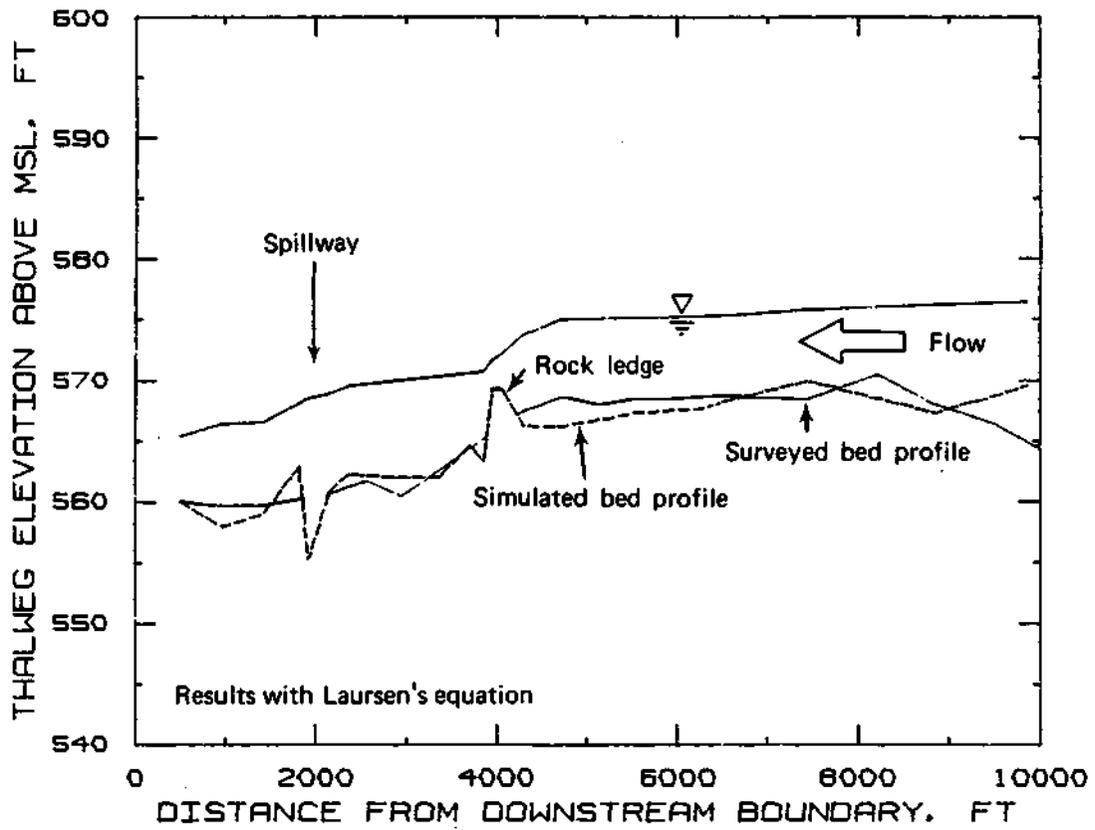
In figure 36, the simulation results from the HEC-6 are compared with the field survey data for the profile of the scour channel. In general, the agreement between the simulated profile and that based on the field data is very good except for the areas just upstream of the rock ledge and just downstream of the spillway. In the area of major scour, upstream of the spillway and downstream of the rock ledge, the agreement between the two is very good.

In the areas where the simulation results do not match very well with the survey data, it is possible that prior sedimentation and channel armoring had taken place. Since there are only limited data on the bed material characteristics from those areas, refinement of the bed material data to improve model performance was not attempted.

Figure 36. Comparison of field-measured and simulated channel profiles
