**THE STORM OF JULY 8, 1951  
IN NORTH CENTRAL ILLINOIS**

A Cooperative Study by  
Illinois State Water Survey Division,  
Geological Survey United States Department  
of the Interior, Soil Conservation Service  
United States Department of Agriculture

**STATE WATER SURVEY DIVISION**

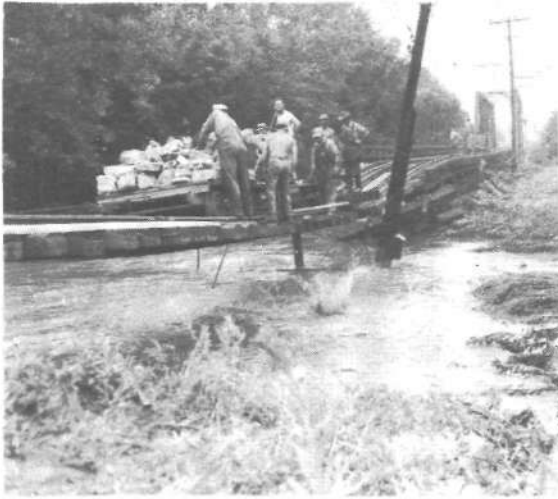
**FIG. 2. AN 80 FOOT WASHOUT ON THE ILLINOIS TERMINAL RAILROAD NEAR ITS MACKINAW RIVER BRIDGE WEST OF MACKINAW.**

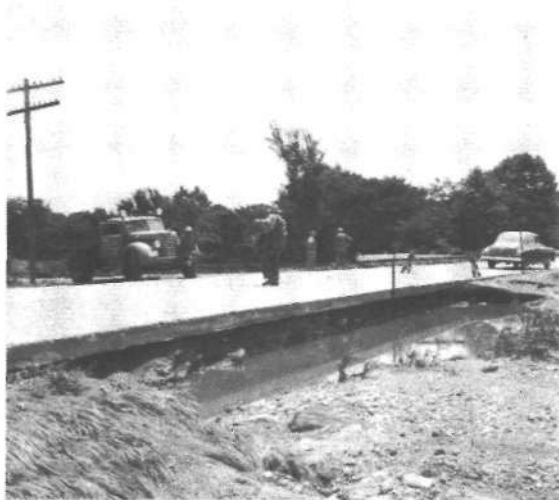
FIG. 4. AN UNDERCUT SLAB ON ROUTE 150 WEST OF MACKINAW DELLS BRIDGE.

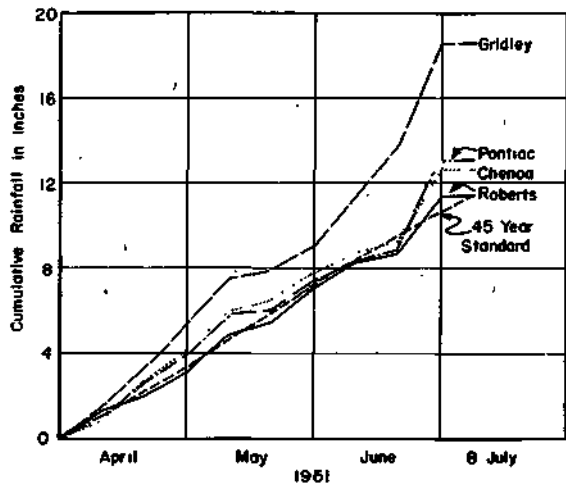
FIG. 6. CUMULATIVE RAINFALL AT SELECTED STATIONS ANTECEDENT TO STORM OF JULY 8, 1951.

An examination of antecedent rainfall conditions at four selected stations located in the region of heavy rainfall for the storm of July 8, 1951, Figure 6, indicates that in the interval from April 1 to June 20 the rainfall was nearly normal at these stations (except Gridley) as compared with the 45-year standard rainfall for Chenoa, Gridley and Pontiac, as computed by the U. S. Weather Bureau.

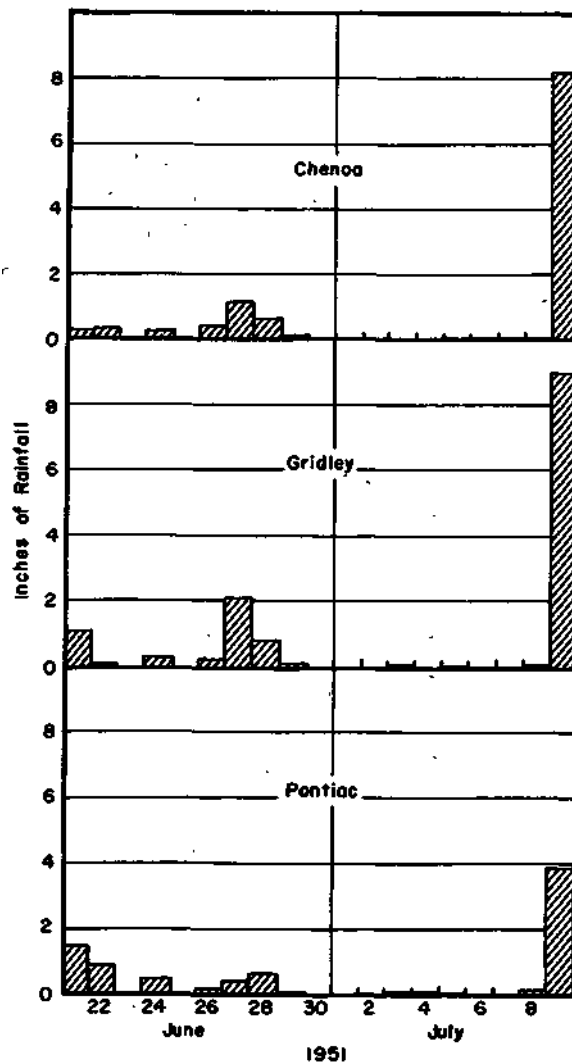
FIG. 7. DAILY RAINFALL AMOUNTS. JUNE 21-JULY 9, 1951.

A more detailed analysis of rainfall for the above-normal interval of June 21 to July 8, 1951, Figure 7, reveals that heavy rainfall occurred during the June 21 -29 interval, but almost no rain was recorded for the 10-day interval immediately prior to the intense storm of July 8. The small amounts of rainfall in this pre-storm interval indicate that the top-soil had a relatively high infiltration capacity when the July 8 rainfall occurred.

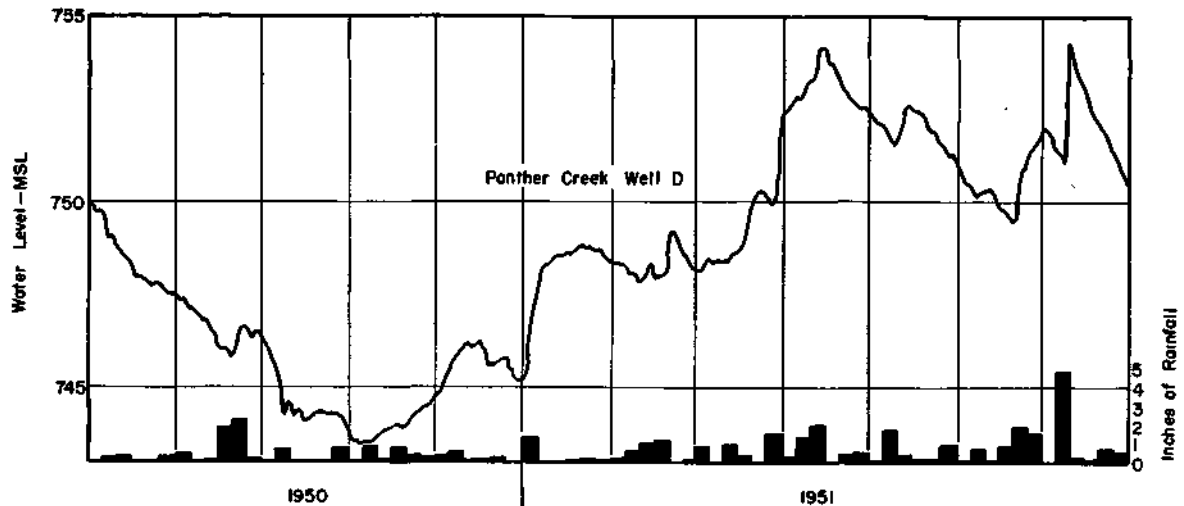
FIG. 8 HYDROGRAPH OF PANTHER CREEK OBSERVATION WELL AUGUST 1, 1950 TO JULY 31, 1951.

In order to obtain some concept of the moisture condition of the sub-soil, a hydrograph of Panther Creek observation Well D (Well location shown in Figures 23, 24, and 25) is included for the interval of August 1, 1950 to July 31, 1951. An analysis of this well hydrograph, Figure 8, indicates that the groundwater level was relatively high at the time of the July 8 storm.

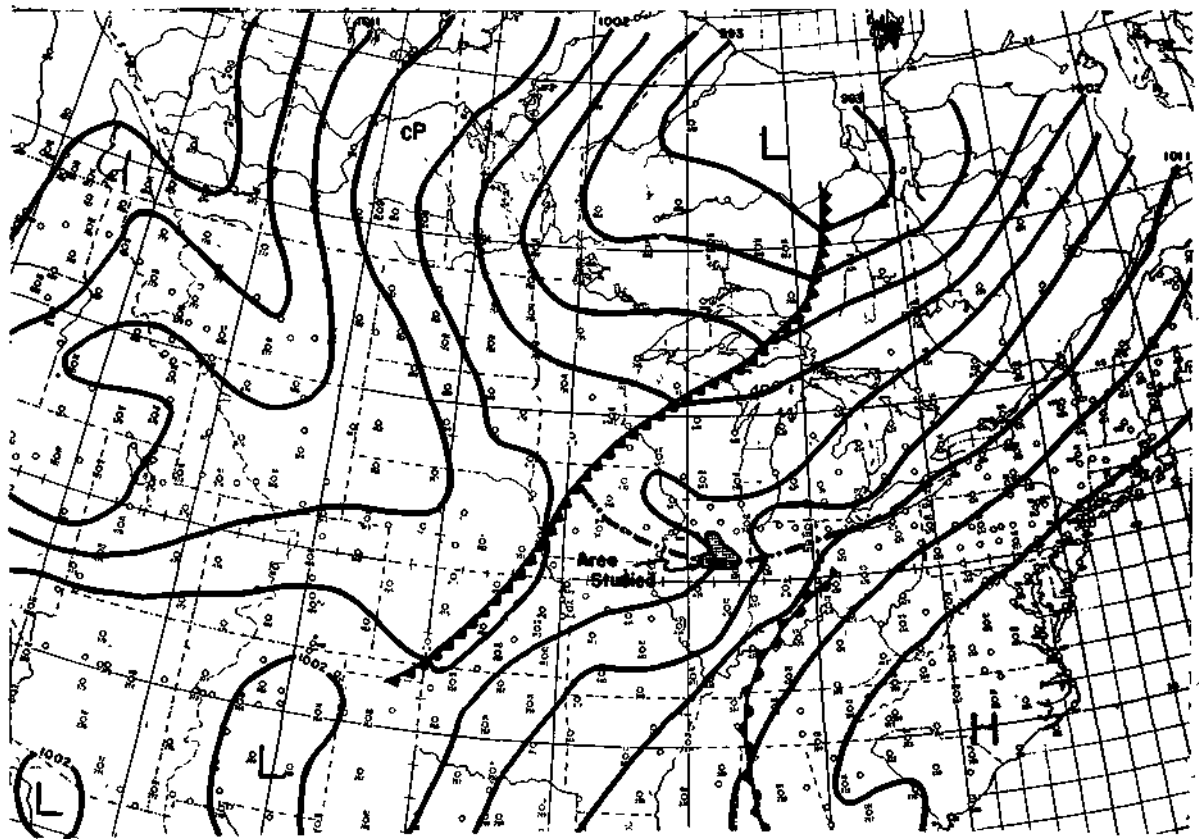
FIG. 11. SURFACE WEATHER MAP FOR 1830 CST, 8 JULY 1951.

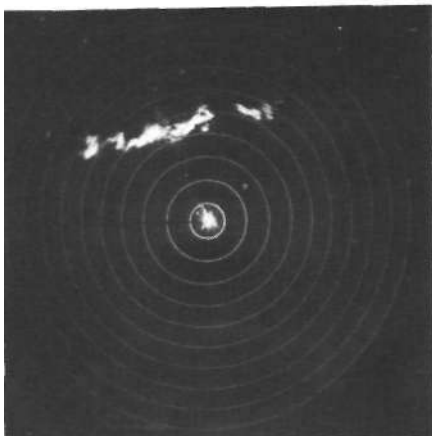
1906 CST

FIG. 12. PLAN-POSITION-INDICATOR RADAR SCOPE (APS-15) OPERATED AT THE UNIVERSITY OF ILLINOIS AIRPORT NEAR CHAMPAIGN SHOWING THE SECOND SQUALL LINE ON 8 JULY 1951, (100 mile radius).

Analysis of the radar data for the storm of July 8, 1951 utilized photographs of the APS-15 radar scope operated by the State Water Survey at the University of Illinois Airport on Route 45 south of Champaign. Figure 12 shows the Plan-Position-Indicator (PPI) scope, which presents a map or picture of the region around the radar station located at the center of the scope; distance between range lines is 10 nautical miles. Raindrops reflect radar signals so that rain showers appear as bright "echoes" (white spots) on the radar scope. (The bright area in the center of the scope is ground return from objects in the immediate vicinity of the radar station.)

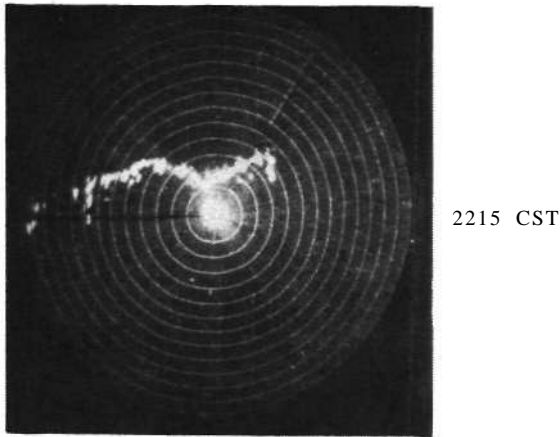
FIG. 13. PLAN-POSITION-INDICATOR SCOPE FOR 8 JULY 1951; SECOND SQUALL LINE APPROACHING CHAMPAIGN, (140 mile radius).

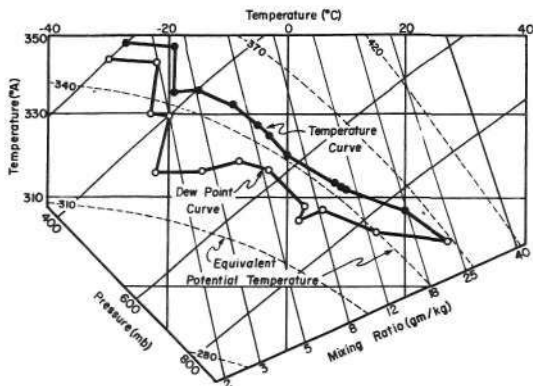
FIG. 15. TEPHIGRAM, (Chanute Field); SOUNDING AT 2100 CST, 8 JULY 1951.

The upper air sounding, (RAOB), taken at 2100 at Chanute Field (RAN), Figure 15, shows that there was about 2.11 inches of precipitable water in the atmosphere of the storm region at that time, indicating that excessive convergence and vertical motion were present in the atmosphere.

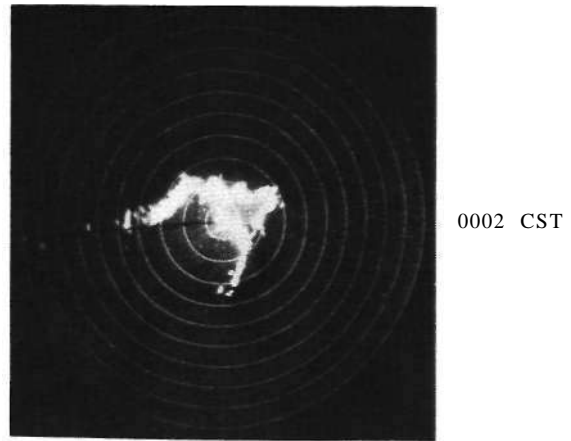
FIG. 14. PLAN-POSITION-INDICATOR SCOPE FOR 9 JULY 1951, (100 mile radius).

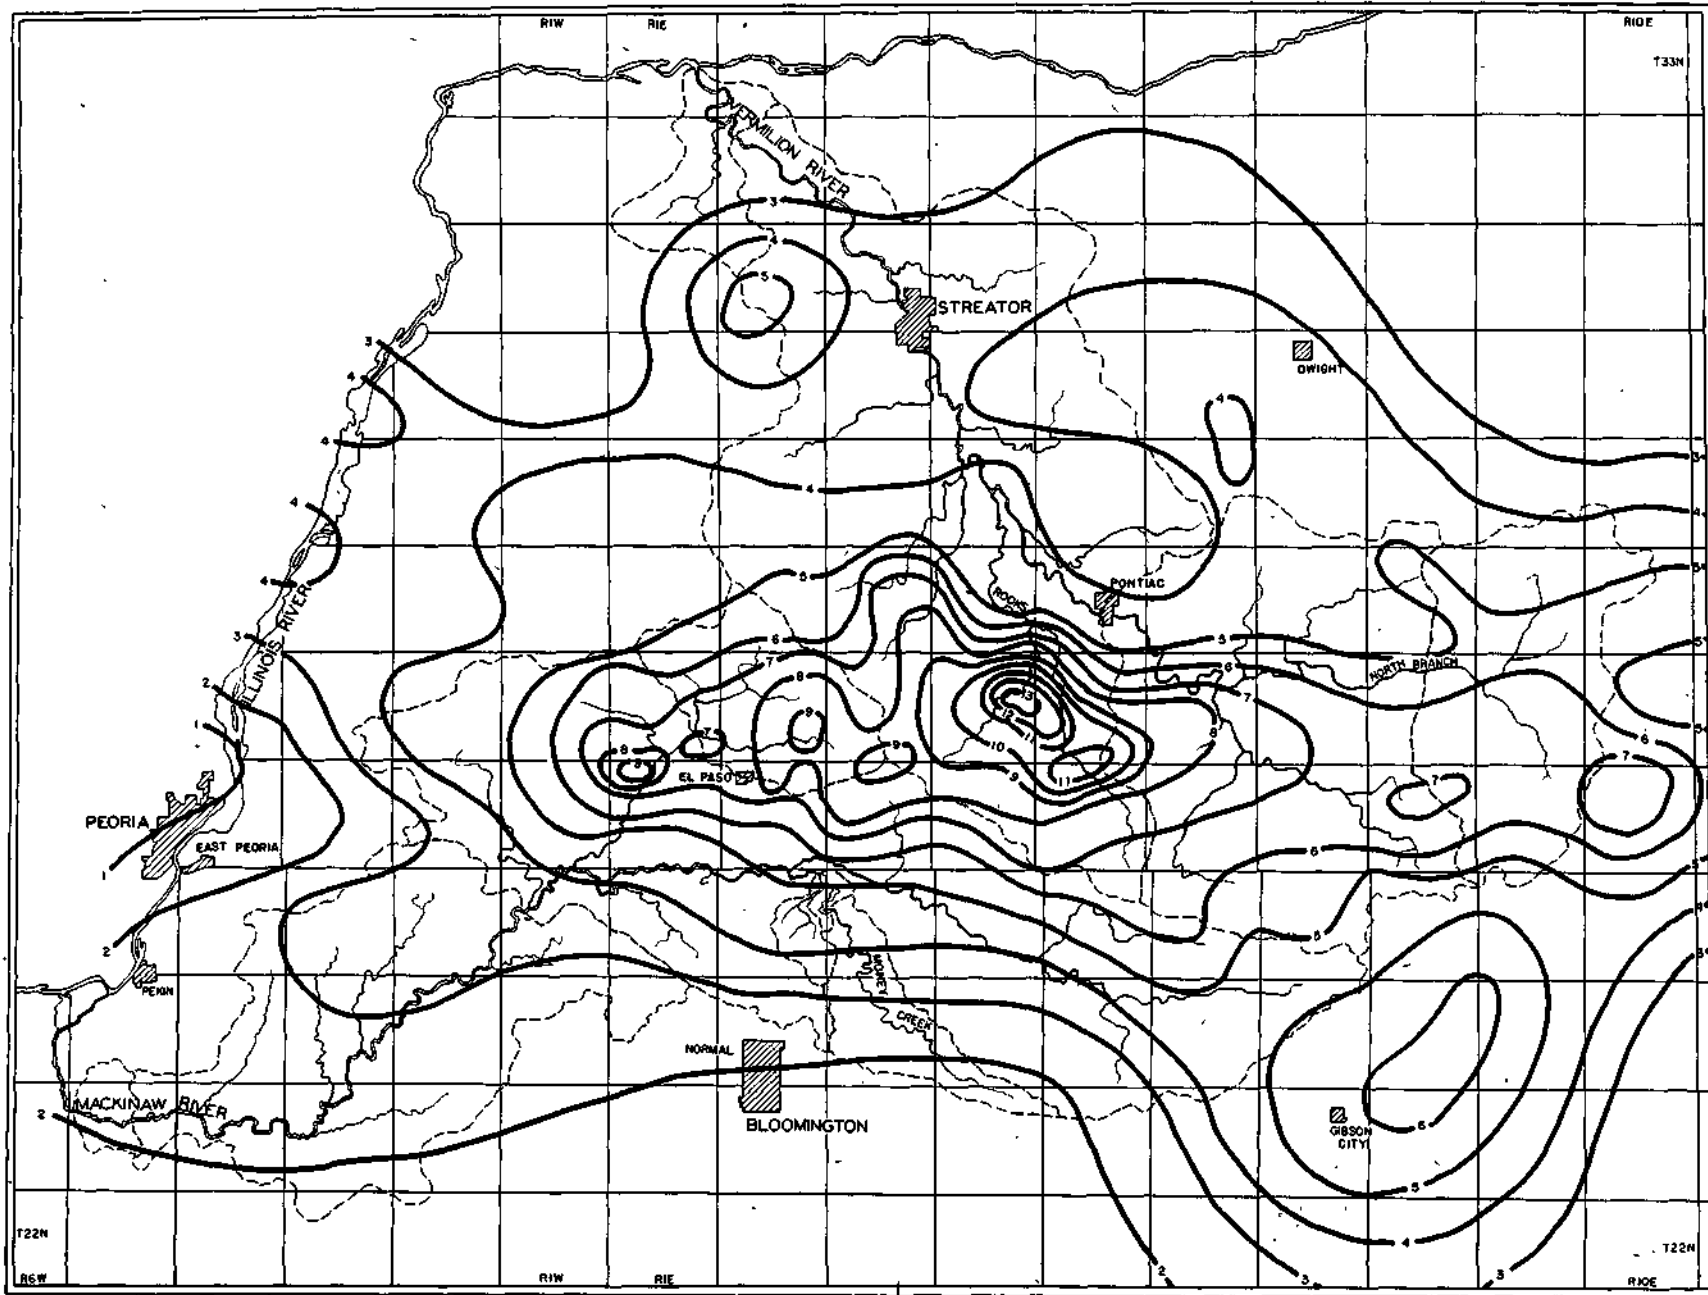
FIG. 18. ISOHYETAL PATTERN FOR THE TOTAL STORM RAINFALL.

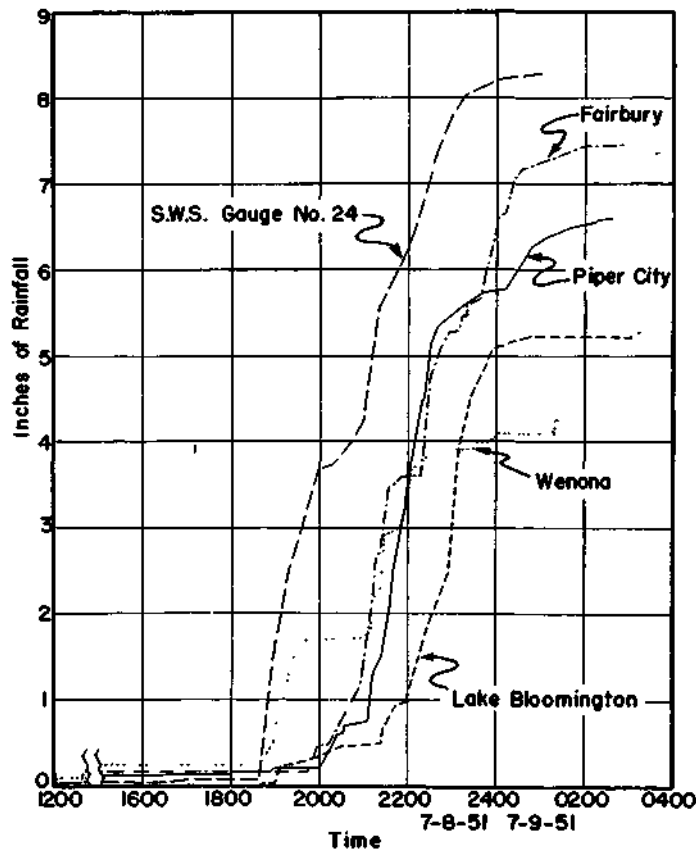
FIG. 19. MASS CURVES OF RAINFALL FROM SELECTED STATIONS.

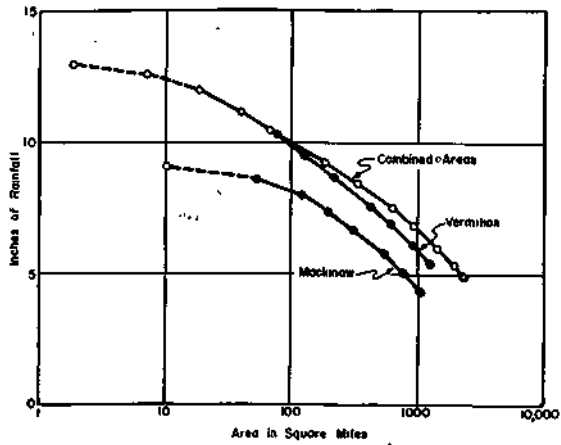
FIG. 10 AREA-DEPTH CURVES, TOTAL STORM RAINFALL.

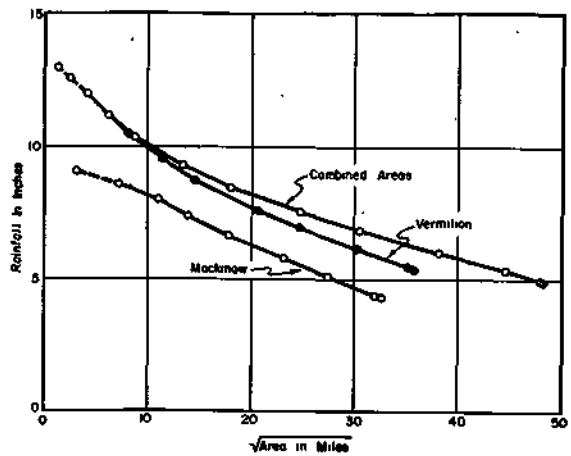
FIG. 21. AREA-DEPTH CURVES, TOTAL STORM RAINFALL.

tionable since the position of these isohyets is determined by a small number of observations. In addition, the portions of the curves corresponding to large areas are somewhat unrepresentative, since the isohyets do not close within the area studied. The 6-hour average depths of rainfall for the individual as well as the combined basins is presented in Table 2 for areas of 10, 20, 50, 200, 500, 1,000 and 2,000 square miles.

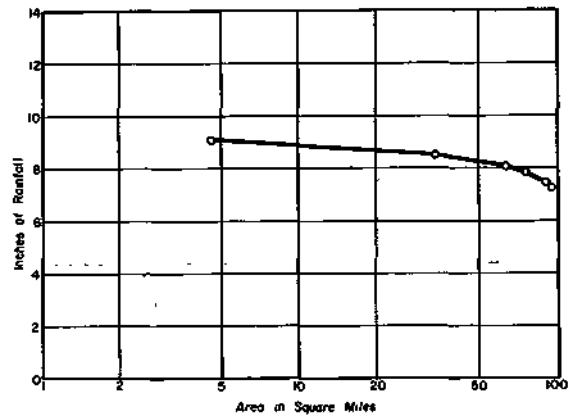
FIG. 22. PANTHER CREEK AREA-DEPTH CURVE.

An area-depth curve for the Panther Creek watershed, Figure 22 was also prepared. The curve is not considered to be fully representative, since only a few isohyets close within this relatively small basin area.

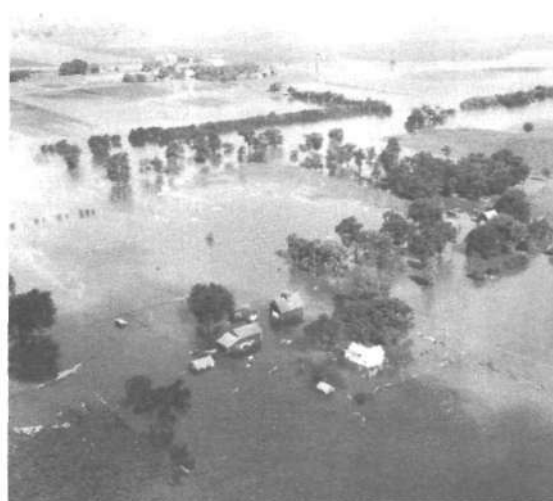
FIG. 30. AN ISOLATED FARM NEAR OCOYA SHOWING THE OVERLAND FLOW FROM ROOKS CREEK BASIN (left center) TO TURTLE CREEK BASIN, (lower right).

by special methods (slope-area reach or contracted-opening site) was found. Flood marks showed that the creek and its tributaries were practically long narrow lakes during the flood, out of the high-water banks and spread across the flat fields for hundreds of feet and in some cases for half a mile or more. Every road bridge in the basin was under water by 1 to 4 feet, and low approaches to some of the bridges had even deeper water over them. All the flow of Rooks Creek passed under the Illinois Central Railroad bridge about 6 miles west of Pontiac, but channel conditions above and below were such that no computation of any accuracy could be made. East of Ocoya School, in the headwaters of Rooks Creek, the flood was so high that water flowed over a low saddle into the adjoining basin of Turtle Creek, (Figure 30).

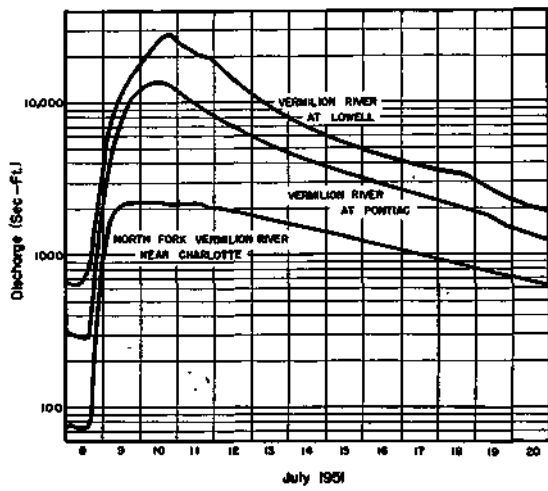
FIG. 31 HYDROGRAPHS - VERMILION RIVER BASIN.

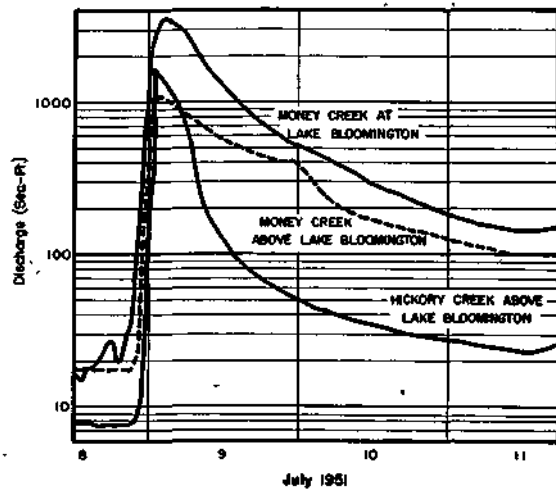
FIG. 33. HYDROGRAPHS - MACKINAW RIVER BASIN.

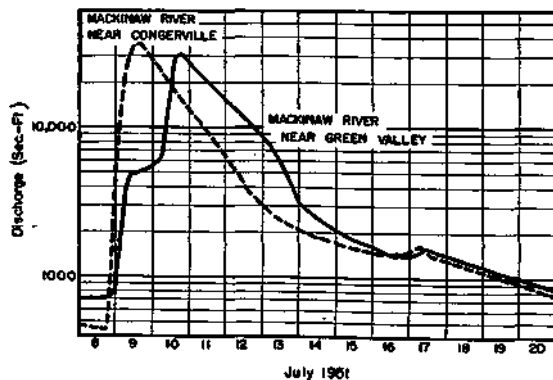
FIG. 32. HYDROGRAPHS - MACKINAW RIVER BASIN.

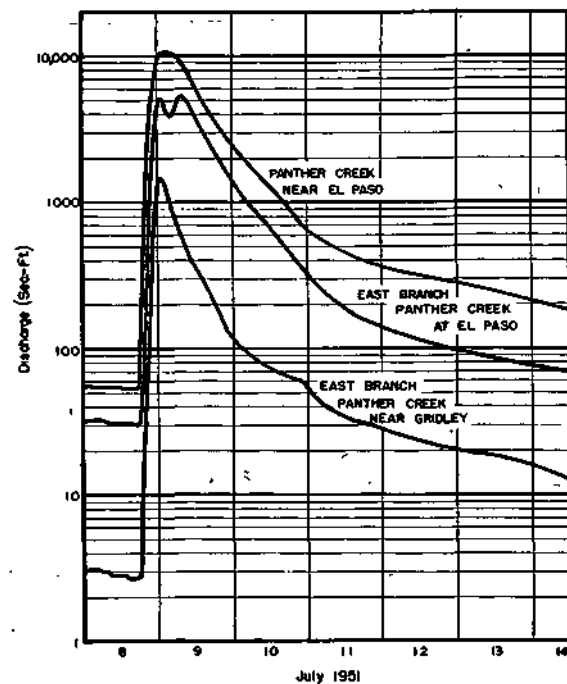
FIG. 34 HYDROGRAPHS - MACKINAW RIVER BASIN.

distinct peaks, the first at 1 a.m. on July 9 and the second at 7:30 a.m., (Figure 34). The first peak agrees well in timing with the peak at the other two stations in the basin, but the reason for the second peak, which was 0.04 feet higher and which followed a drop of 0.9 foot from the initial peak, is unknown. There was no burst of rain above the gage to which the rise can be attributed. Various conjectures have been made as to the cause, as follows:

1. A jam of logs or debris downstream caused the first peak and then washed out. This would eliminate the first peak so far as the discharge record is concerned and would leave the timing of the peak discharge out of harmony with the other stations and out of line with past experience on smaller floods within the basin. There is no evidence or knowledge of any jamming at the Illinois Central Railroad bridge downstream, the most likely spot for such to happen.

2. A jam downstream caused the second peak. If so, the discharge for the first peak would be much greater than computed. In view of the lack of evidence of jamming this is considered unlikely.

3. A jam upstream gave way and produced the second peak by release of water ponded behind the jam. There is no evidence at hand to

support or disprove this idea. The second peak does not show up at the Panther Creek station downstream as a secondary peak or as a noticeable flattening off of the recession curve. Whether the second peak could be so flattened by effects of valley storage that it would not be discernible at the Panther Creek station is not known, but such a condition is not impossible.

4. The second peak resulted from delayed runoff from drain tiles. It is known that large areas of farm land above El Paso are heavily drained by tiles, and it has been suggested that the tiling has such an effect as to produce the second peak. The idea is interesting, but data are inadequate to warrant any conclusions.

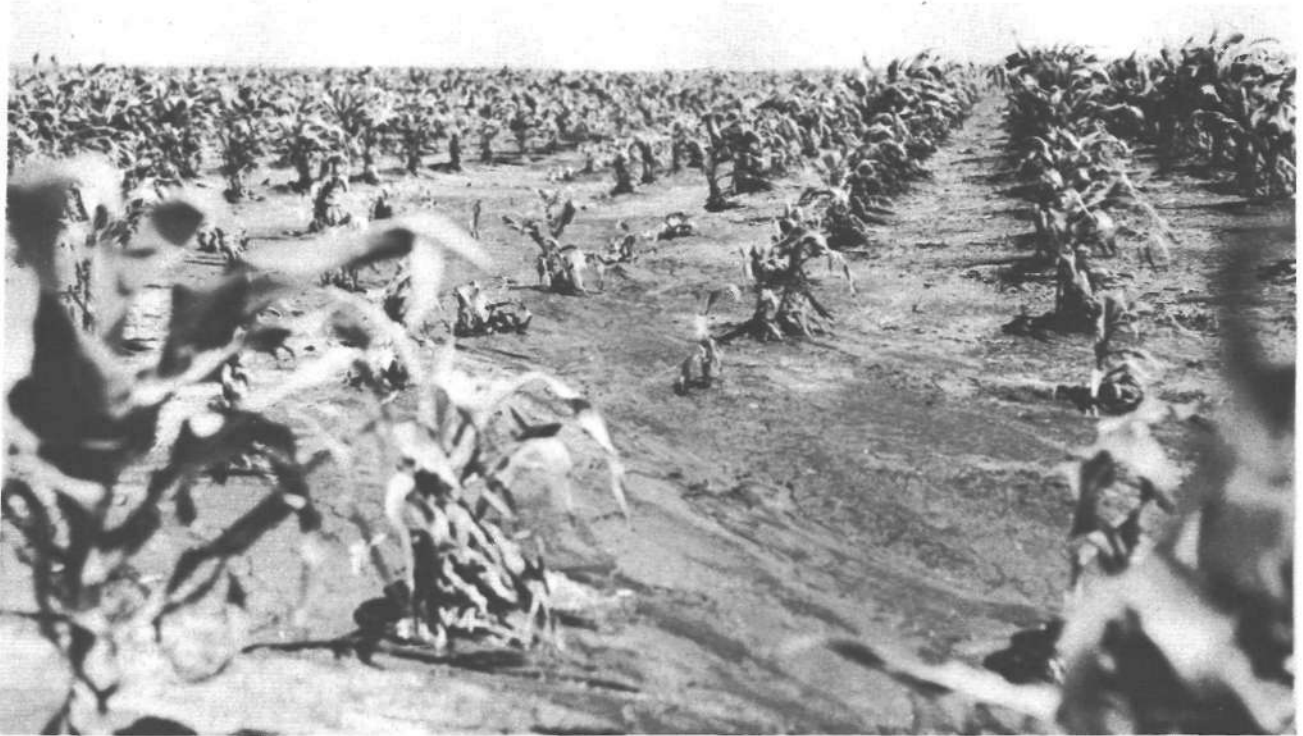
**FIG. 35. A CORN FIELD IN McLEAN COUNTY AFTER A 7-INCH RAIN. THE LONG GENTLE SLOPES ARE ESPECIALLY VULNERABLE TO EROSION DAMAGE.**

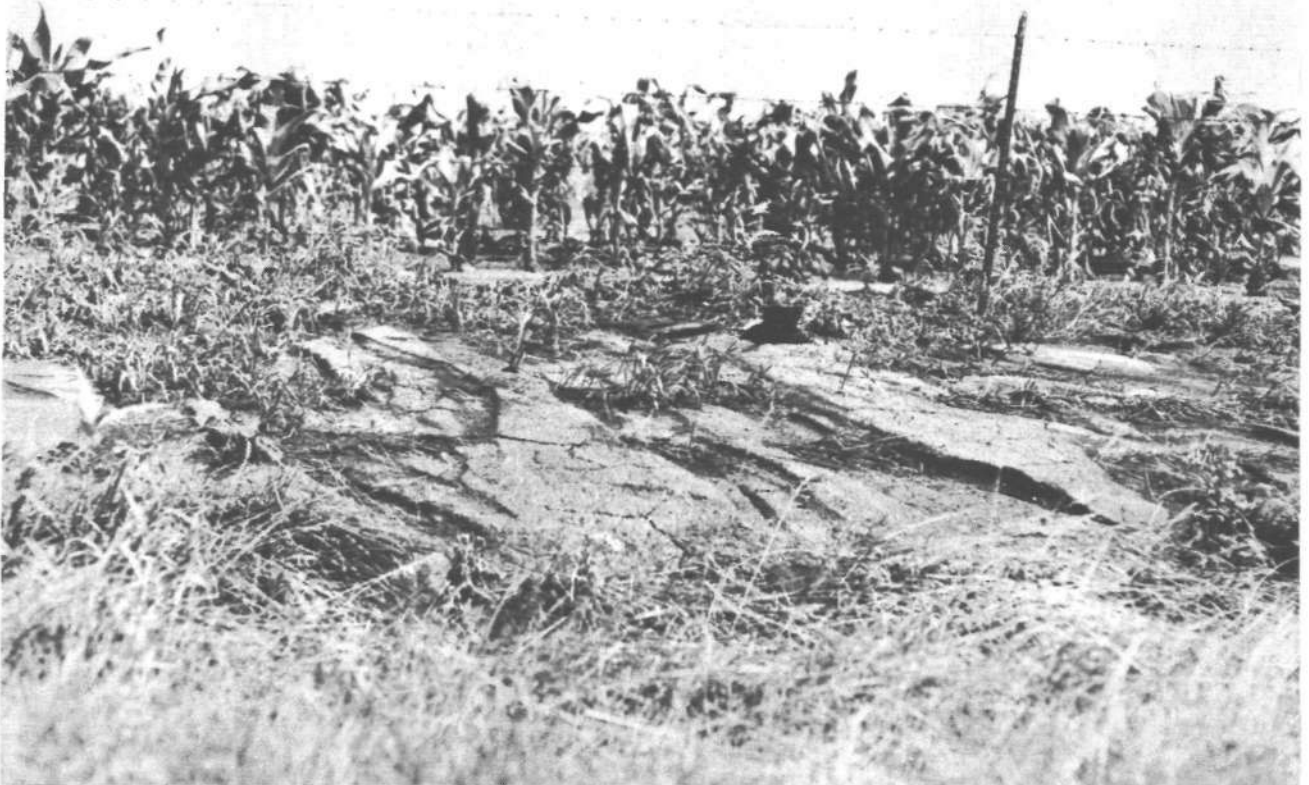
**FIG. 36. TONS OF SOIL WERE DEPOSITED IN THE GRASS AS RUNOFF FROM THE CORN FIELD SHOWN IN FIG. 35 FILTERED THROUGH THIS SOD.**

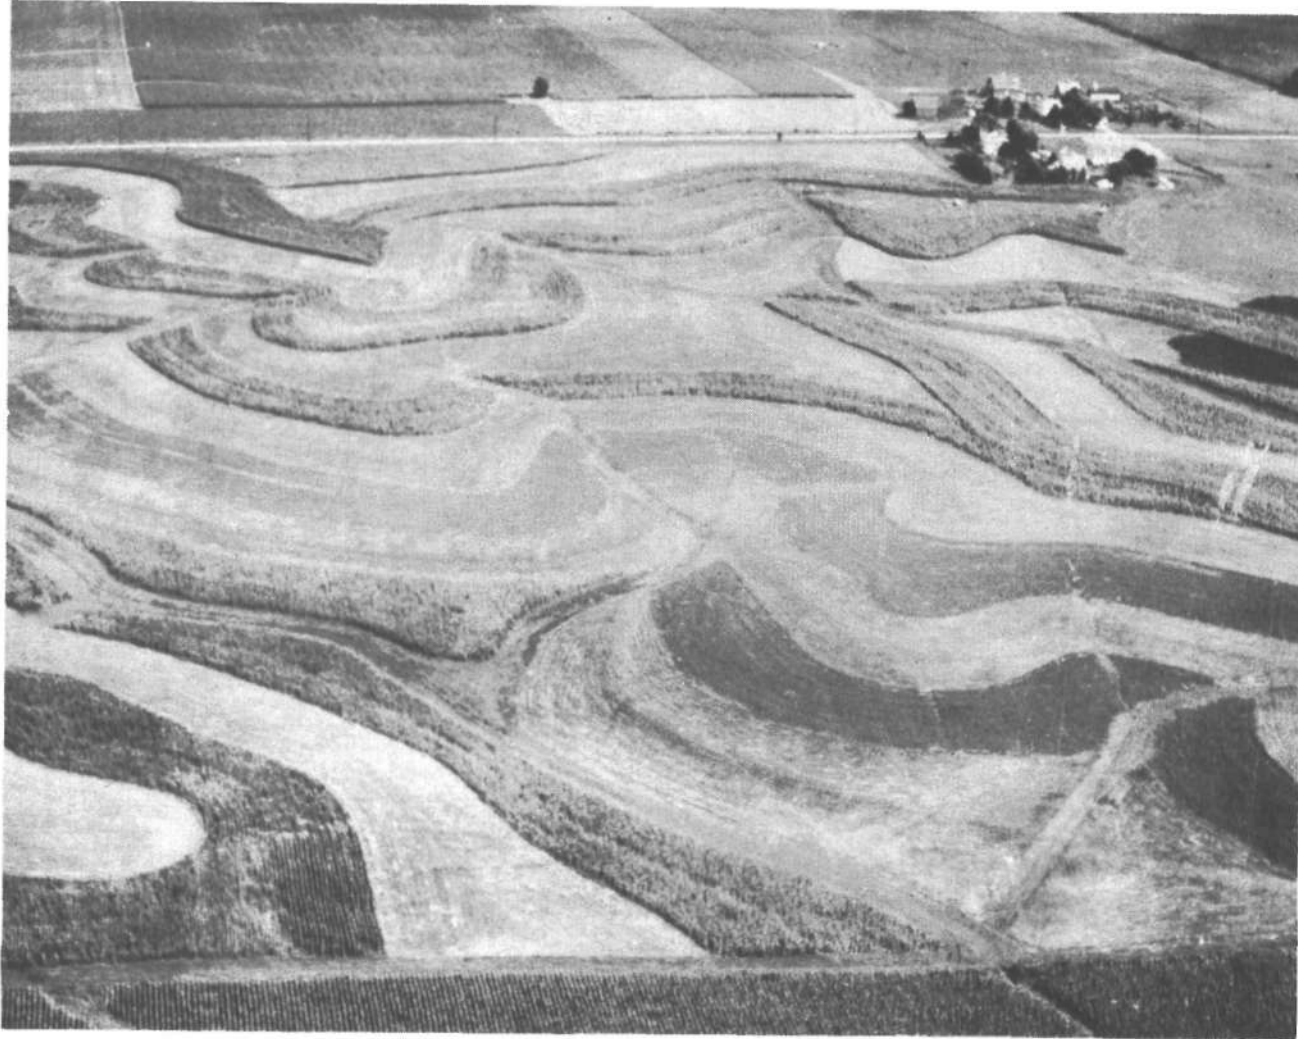
FIG. 37 CONSERVATION PRACTICES, (1 mile north of Eureka), WHICH SUCCESSFULLY WITHSTOOD 4 INCHES OF RAIN IN 6 HOURS
