Senachwine Creek Watershed Assessment Report

**Illinois Department
of Natural Resources
Office of Resource
Conservation**

**United States Army
Corps of Engineers**

2008

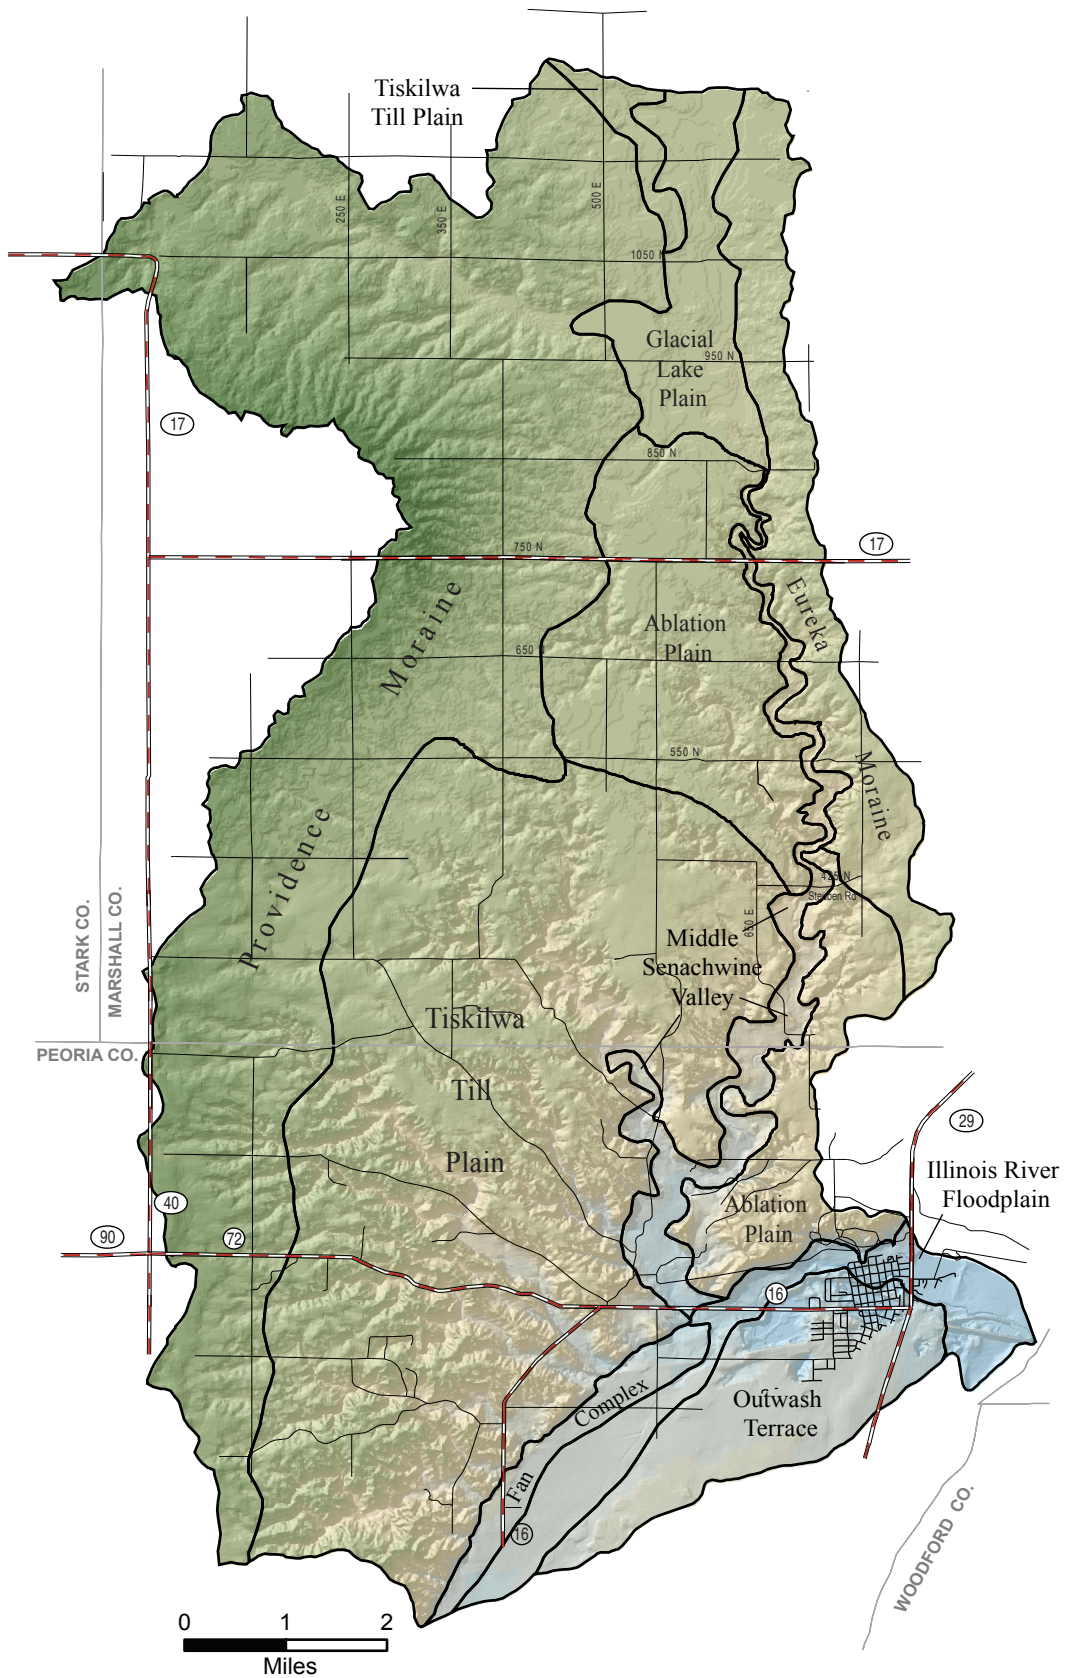
Figure 5. Landscape of Senachwine Creek watershed

The Senachwine Creek watershed developed in a valley between two glacial moraines deposited during the most recent glaciation (Figure 5). The glacier flowed over the Illinois River valley from the east, scraping pre-existing sedimentary cover down to bedrock and leaving subglacial and proglacial deposits upon retreat. This was followed by deposition of a blanket of wind-blown dust (loess) over the region, and erosion and re-sedimentation of existing deposits as the drainage network continued to develop. Prairie grasses and forests became established over lower and steeper slopes, respectively. Thus, the upper portion of the watershed is a composite of deposits from downwasting ice, till, debris flow, and stratified sediments (Ablation Plain), outwash streams (stratified sediments along Senachwine Creek valley) and ice-marginal lakes (Glacial Lake Plain). The lowermost part of the valley cuts through the Illinois River bluff and flows over a terrace left from outwash deposits of the last glaciation. Tributaries to Senachwine Creek mainstem are mainly incised into the till plain.

The Middle Senachwine valley begins where the stream exits the Glacial Lake Plain and flows through the Ablation Plain (Figure 5) formed by downwasting of ice that created the Providence Moraine and by meltwater streams flowing off the glacier terminus at the Eureka Moraine. The present channel along this reach moderately meanders and increases in sinuosity downstream. The valley slope is ~13% within 1000 feet of the channel, steepens abruptly where the stream cuts through Illinois River bluffs, then shallows to ~3% below the confluence of Little Senachwine Creek (Figure 6; note that the valley slopes differ from the channel slopes, discussed below). The Middle Senachwine valley thus includes the lower portion of HUC 401, all of HUC 402, and the upper portion of HUC 403.

In the lower reach on the Ancient Mississippi floodplain, the channel again gently meanders and has significant modified subreaches (Figure 5). The gentle valley slope drops only 20 feet over 3 miles (~0.1%) down to the Illinois River (Figure 6). East of Illinois Route 29, the channel has been straightened and maintained since before 1939. The Woerman maps of 1902-1904 were produced by the USACE and show the river and floodplain during low water after diversion from Lake Michigan began in 1900 (Woerman, J. W. 1902-1904). The Woerman maps show two outlets for Senachwine Creek: Spring Branch and the present outlet (Bhowmik et al., 1993). By 1939, Spring Branch no longer received flow and appeared to be cut off or abandoned. There is no distinct delta at the stream mouth, because either the Illinois River either transports sediment rapidly downstream or partly deposits it in streamwise-oriented sediment bars, islands, or both. Channel constriction and navigation channel and bridge maintenance activities also may influence morphology at the stream mouth.

The moraines, which border the Senachwine Creek watershed, were formed by the Wisconsin Episode glacier (Figure 5). The Providence Moraine, which comprises the western watershed divide, was deposited about 20,000 radiocarbon years ago (Hansel and Johnson, 1996). The Eureka Moraine, which comprises the eastern watershed divide, was deposited between about 15,500 and 18,500 radiocarbon years ago.

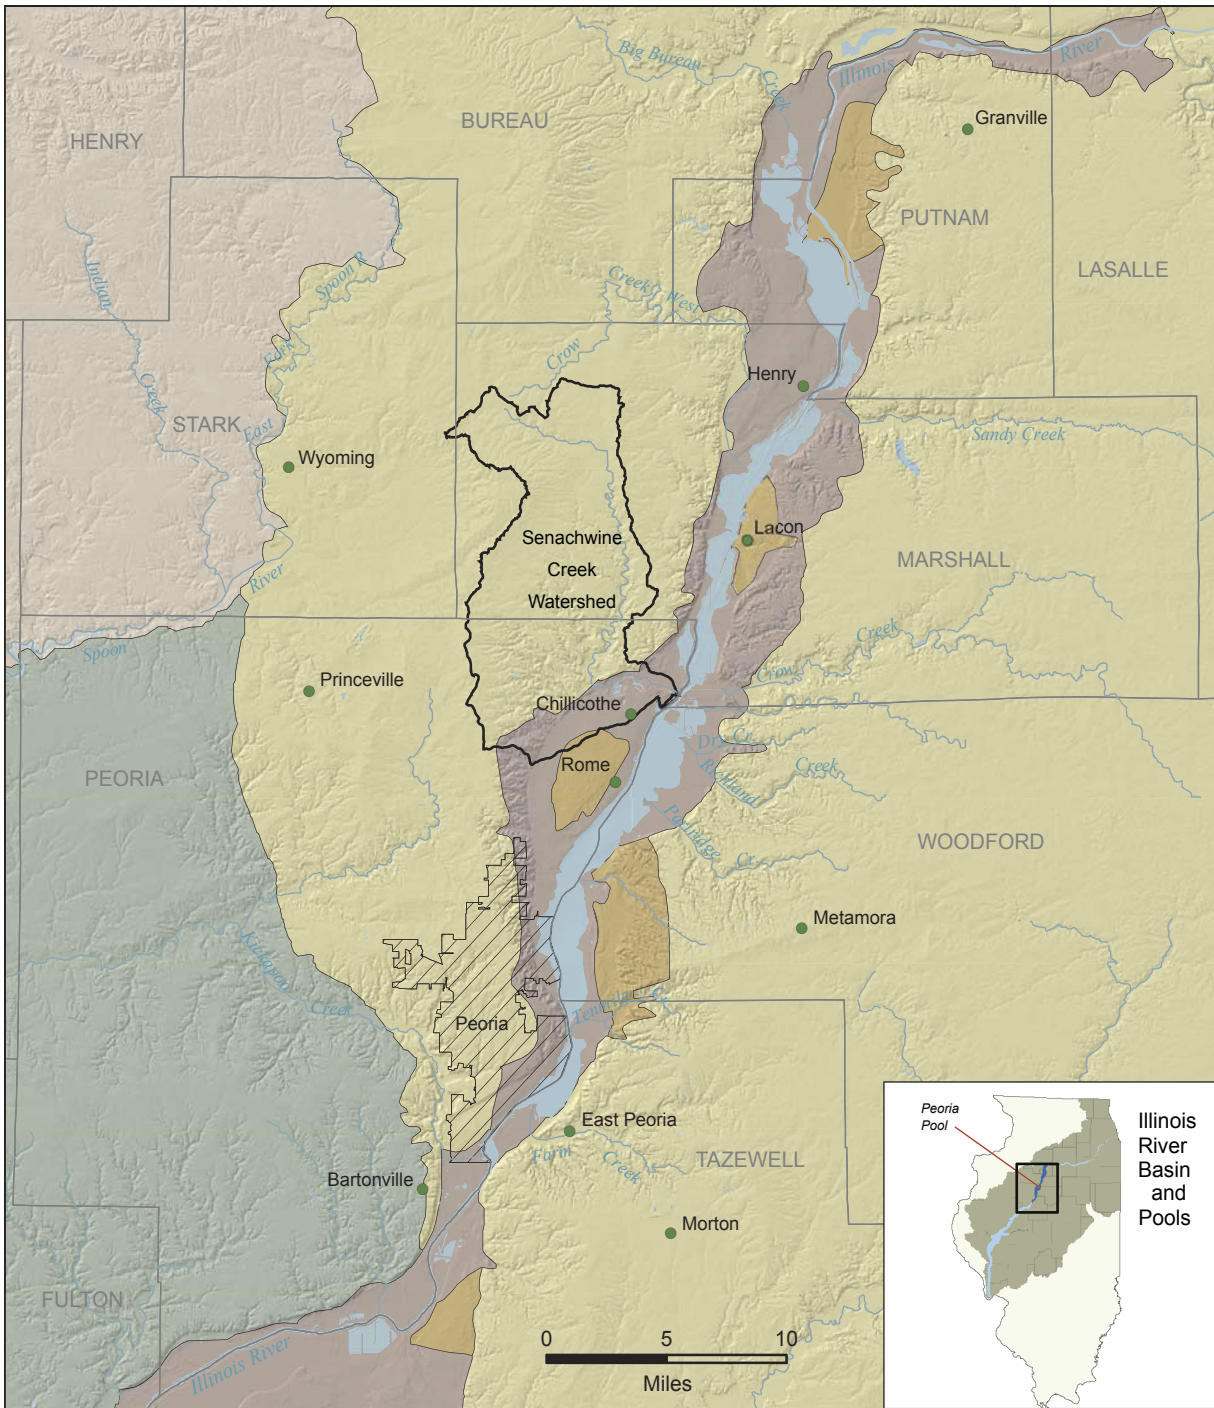
Natural Divisions of Illinois

Settlers of the Senachwine Creek watershed found a landscape characterized by a mix of oak woodlands and prairie in the early 1800s (Suloway et al., 1996). Schwegman (1973) classed natural environments and biotic communities in Illinois based primarily on topography, soils, bedrock, glacial history, and distribution of plants and animals (Figure 7). The Senachwine Creek watershed is located primarily in the Grand Prairie Section of the Grand Prairie Division but also includes the Illinois River Section of the Upper Mississippi River and Illinois River Bottomlands Division, and a very small area in the Illinois River and Mississippi River Sand Areas Division. The

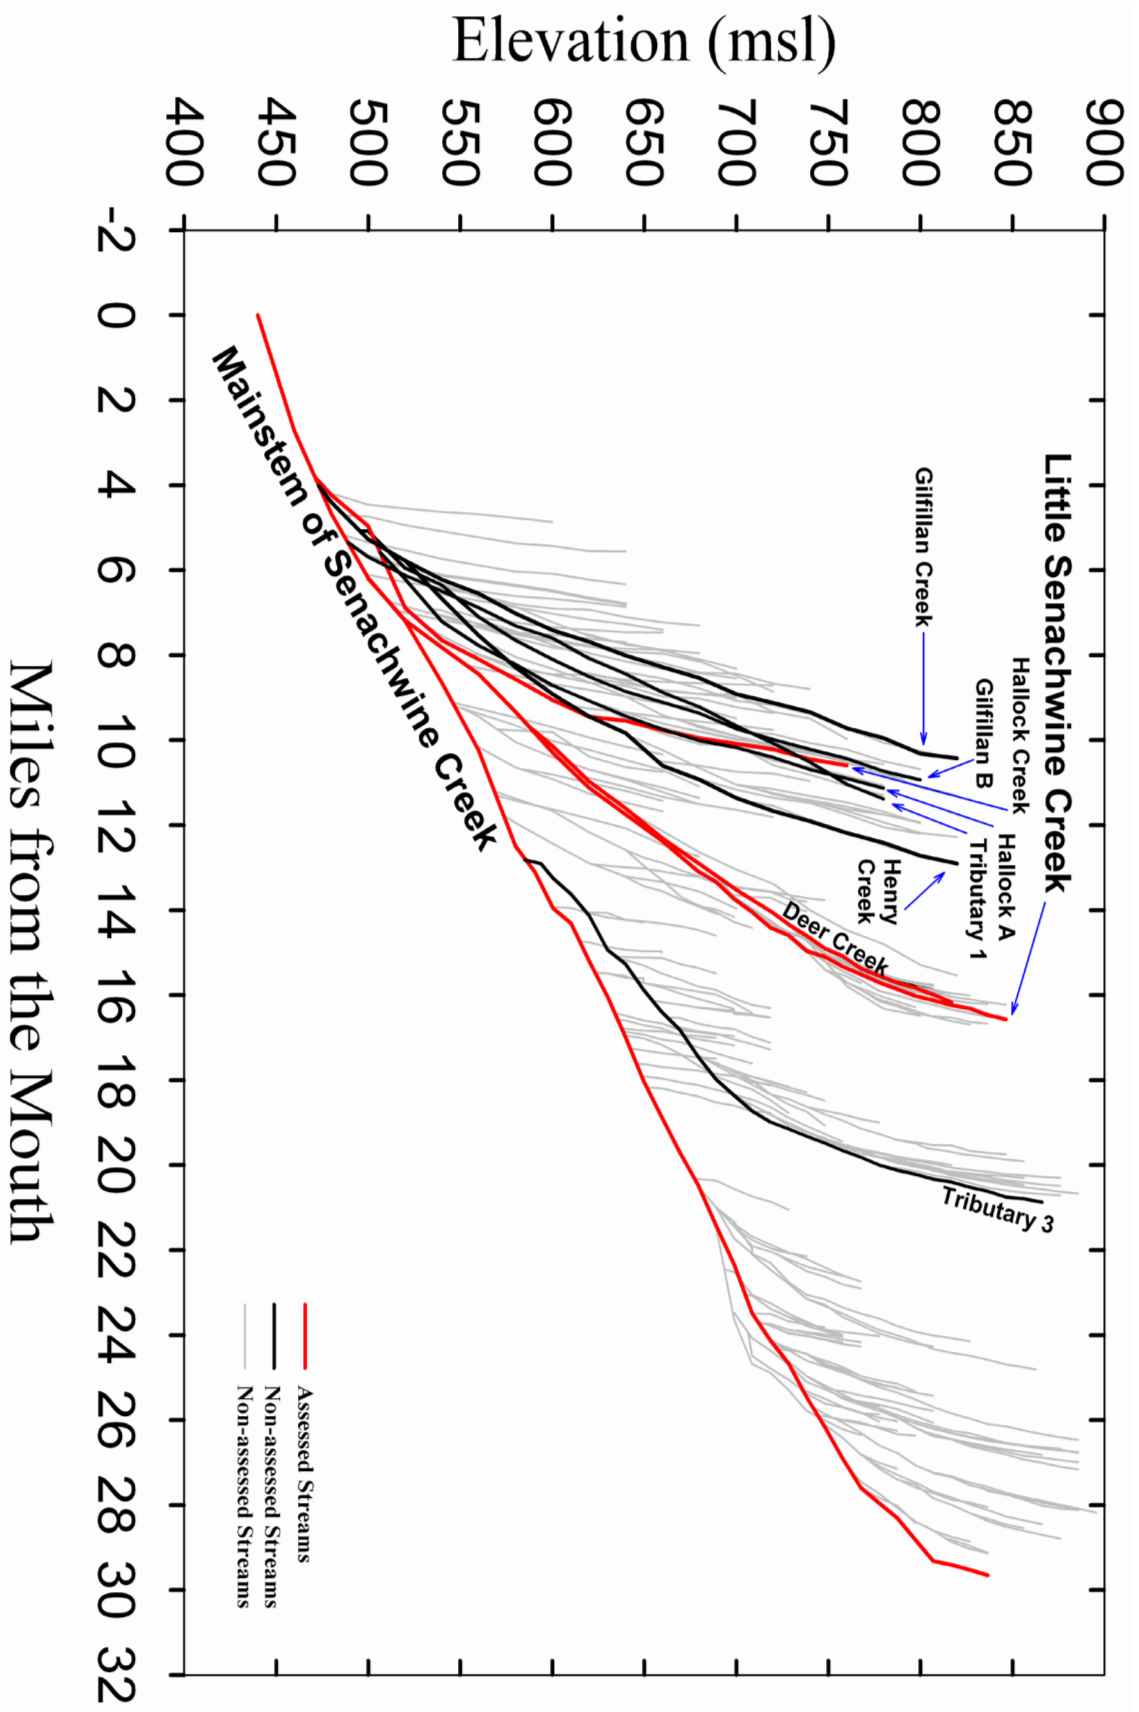
Figure 23. Gradients of Senachwine Creek and its tributaries.

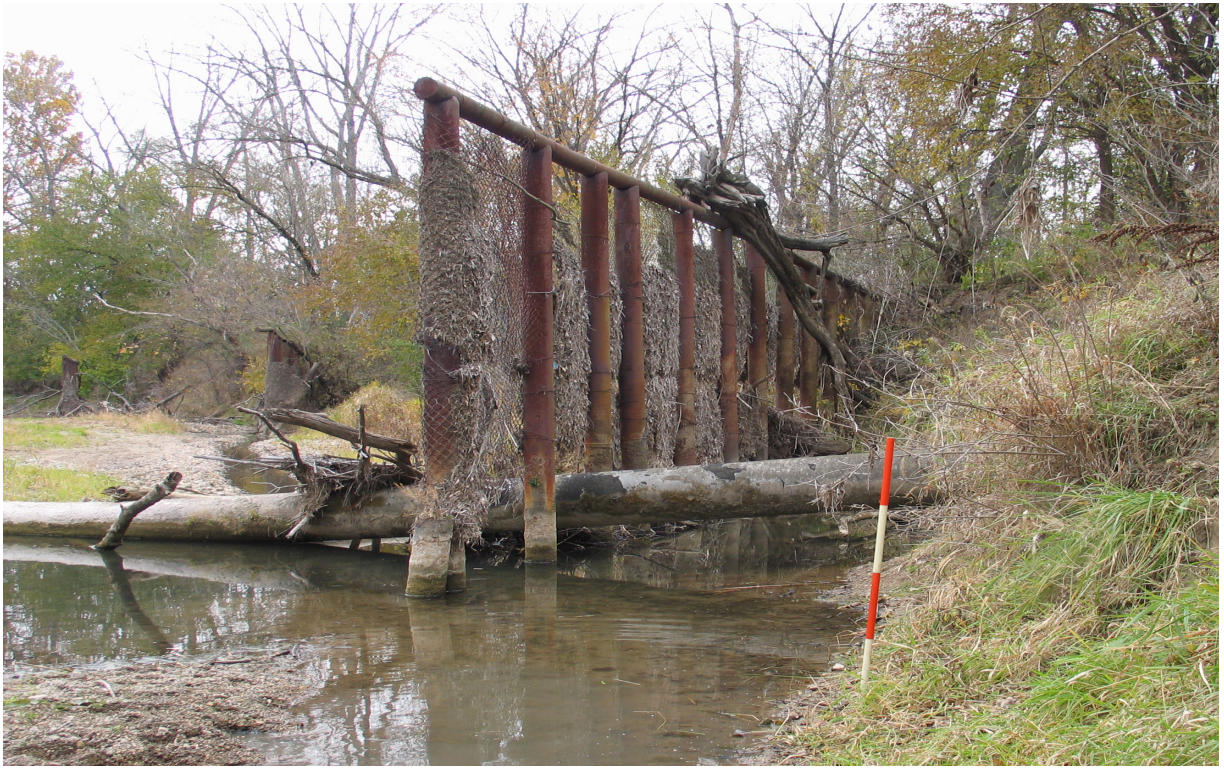
Photo 1. Exposed active gas pipeline with pipe protection along lower Senachwine Creek (Pipelines are data for interpretation of channel incision or migration)

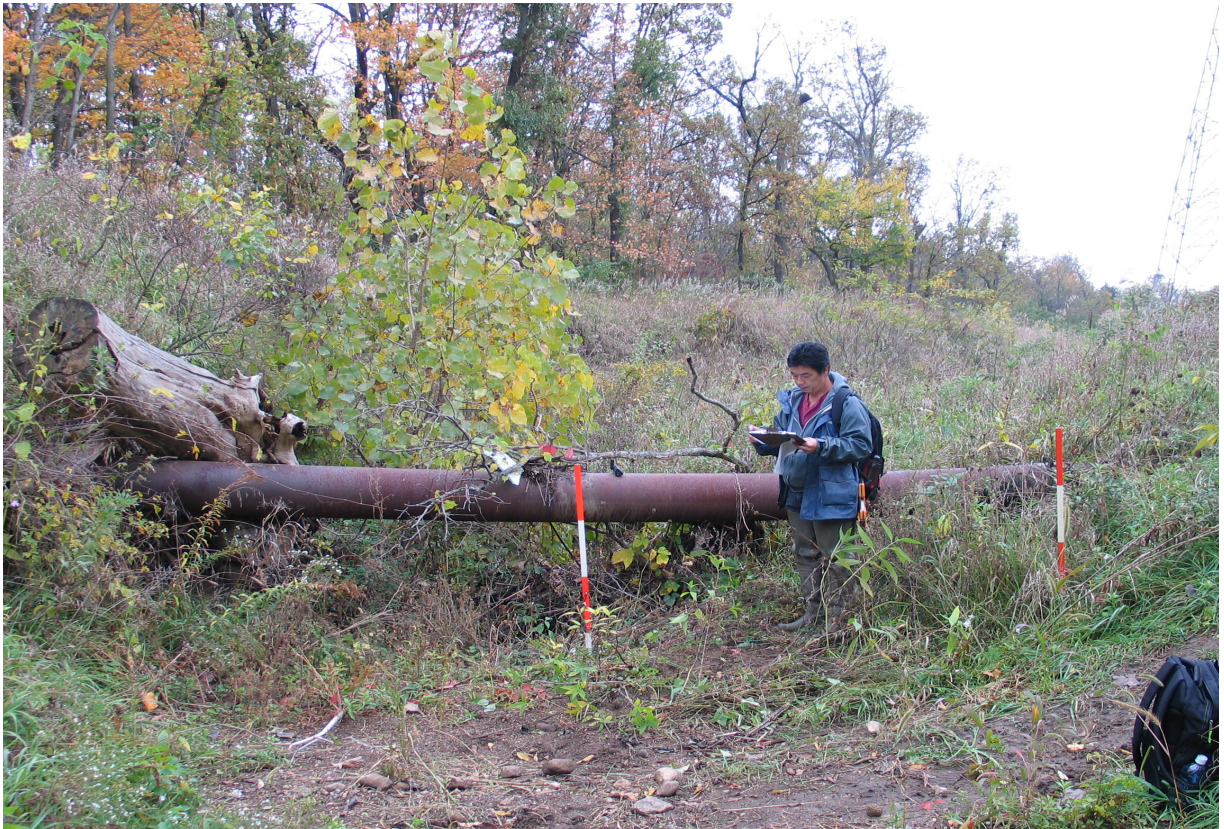
Photo 2. Exposed abandoned gas pipeline along Hallock Creek

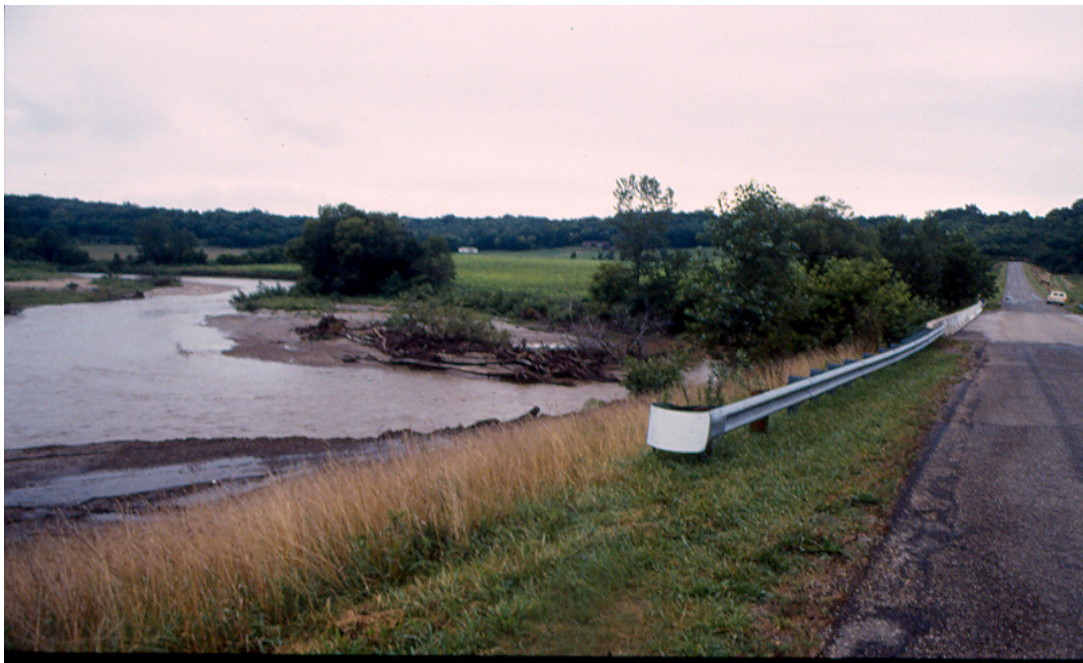
Photo 3. Picture of Benedict Bridge

In a previous study, the ISWS collected 275 water samples, 32 stage samples, and made 90 discharge measurements at Benedict Bridge (Photo 3) from October 1988 to November 1990 (Bhowmik et al., 1993). As an example of flow variability, Bhowmik et al., 1993 reported that the creek was completely dry for five of the first 12 months of that project period, and average water discharge was about 6 times lower in 1989 than 1990. During the early dry period, Senachwine Creek received some flow from snowmelt over frozen ground, but no significant flow until a storm in early June 1989, after which the creekbed was dry again two weeks later. Recorded stages showed extreme variability in spring 1989. Field measurements showed that the streambed was absorbing streamflow. Senachwine Creek was again dry for an extended period during fall 1988 and summer 1989. Following recovery from that prolonged drought period, the creek was very flashy during storm periods, rising 10 feet or

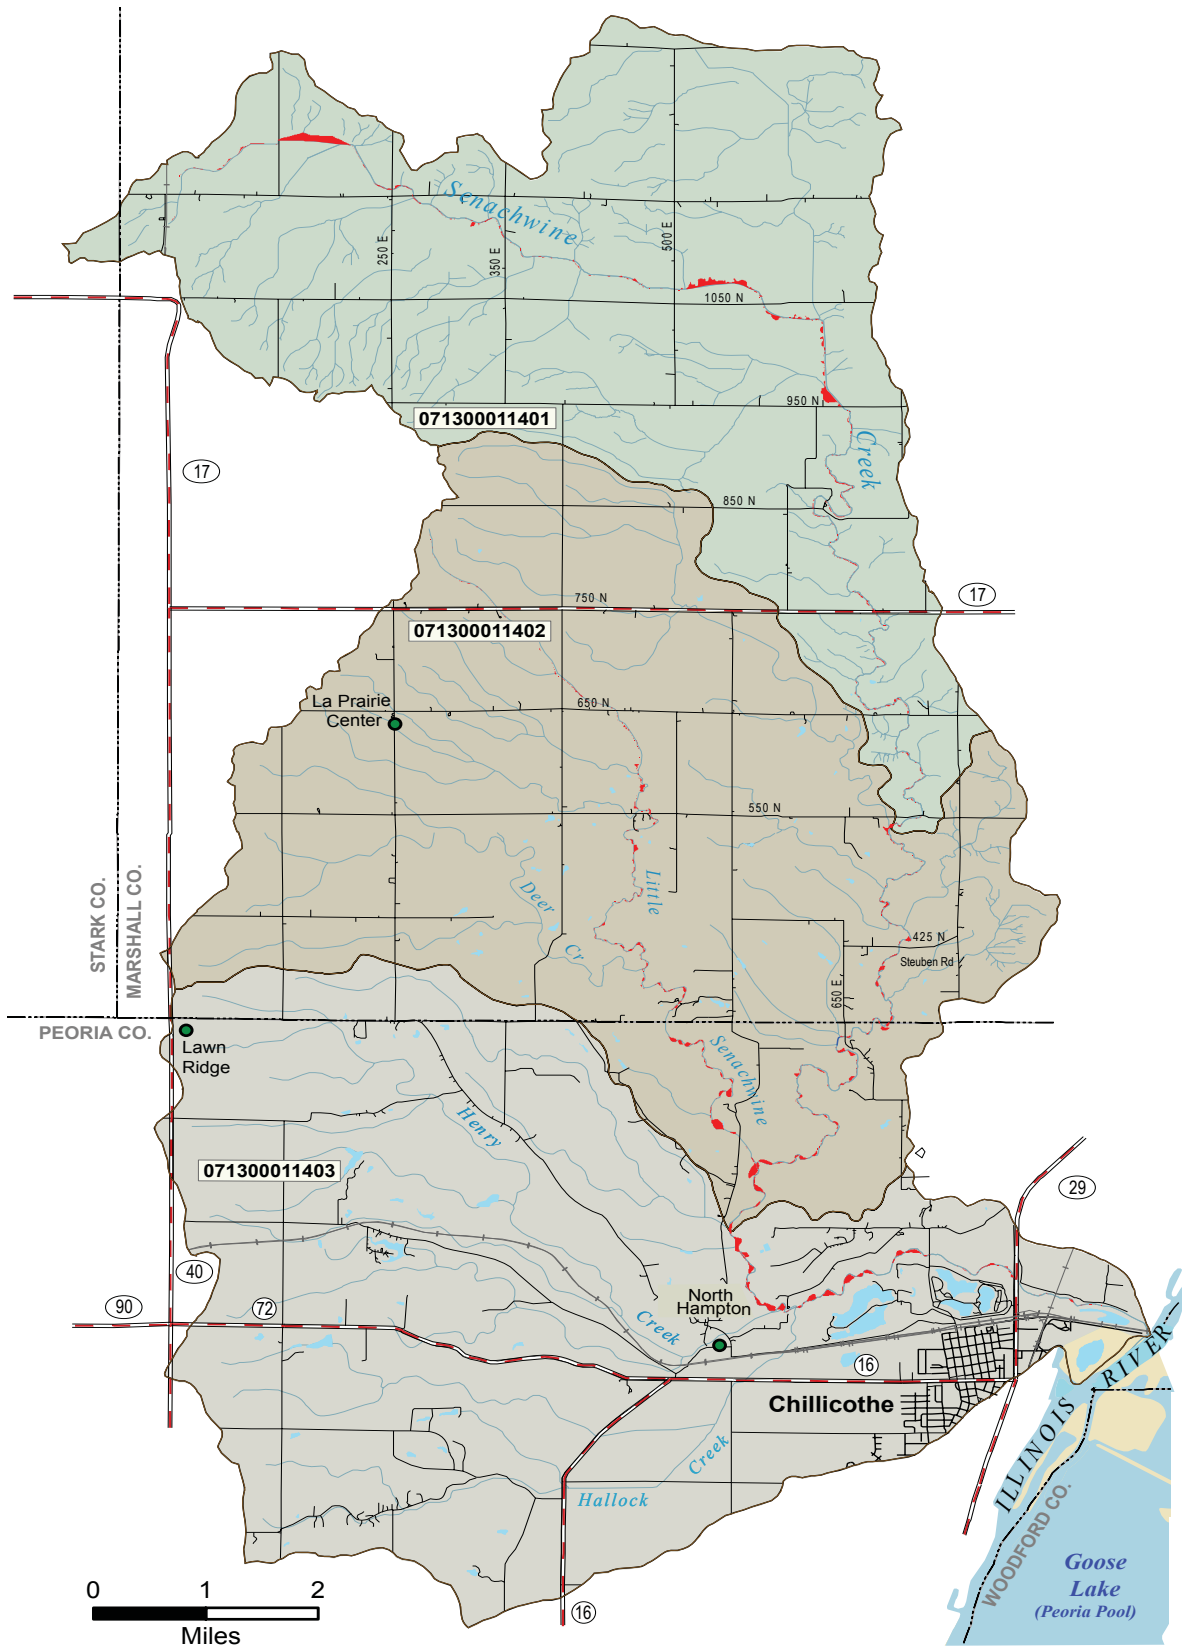
Figure 29. Reaches in red showing significant differences in planform position between 1939 and 1998

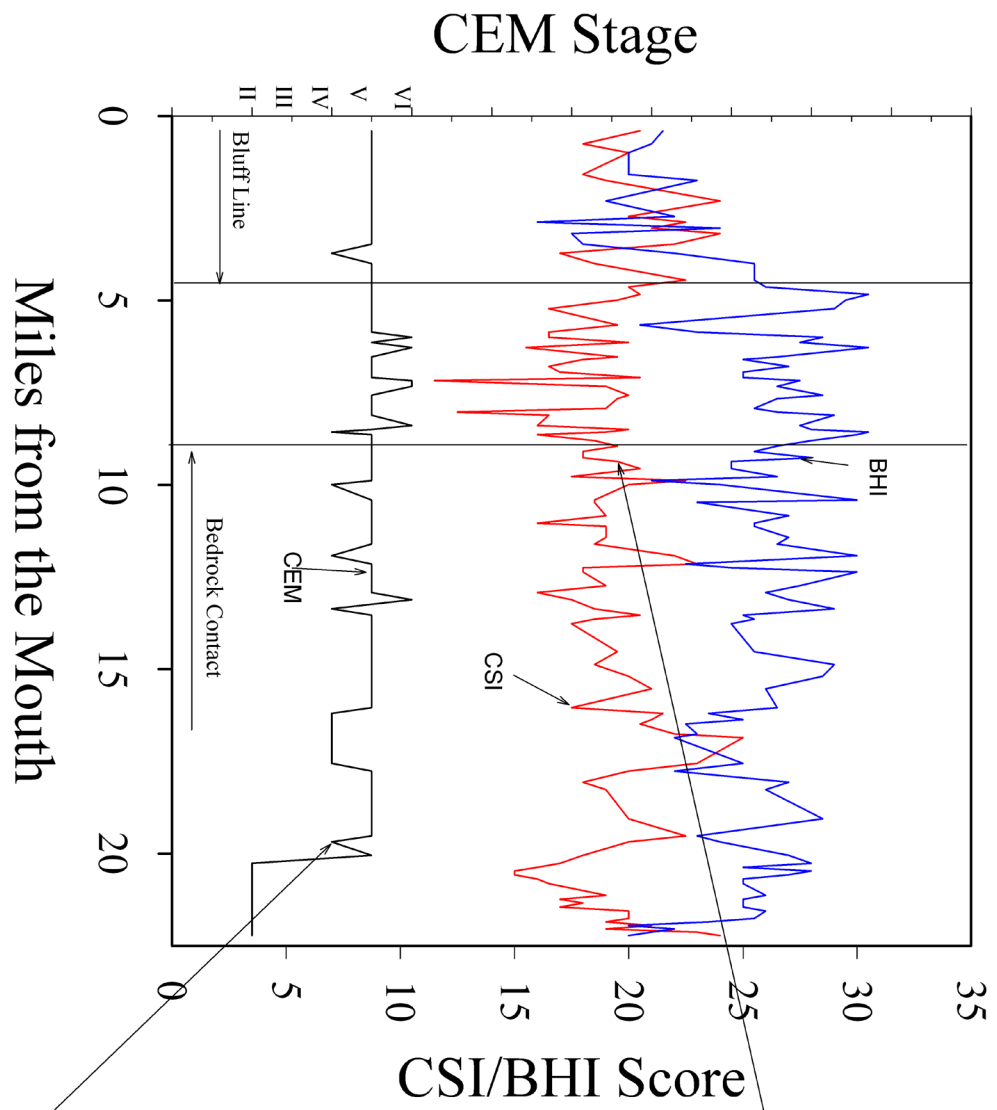
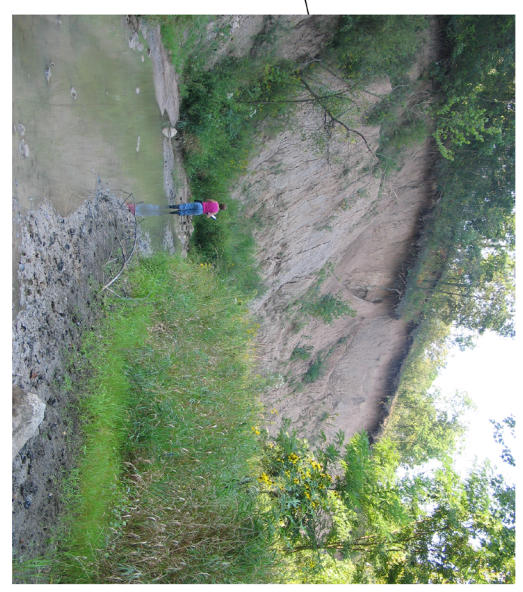
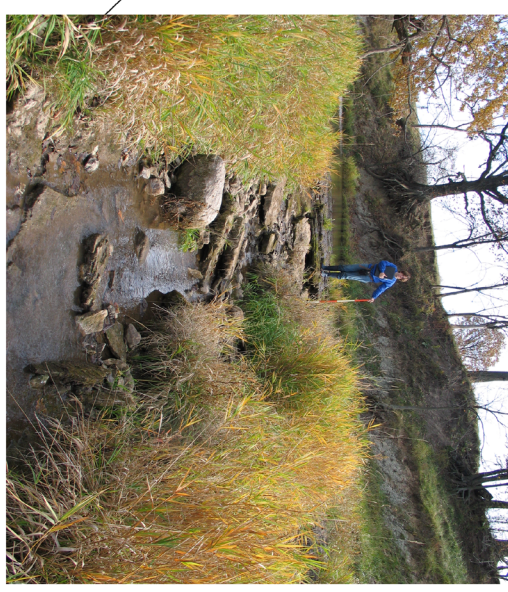
Figure 33. CEM stages as they rank with channel satbility and biological habitat indices
