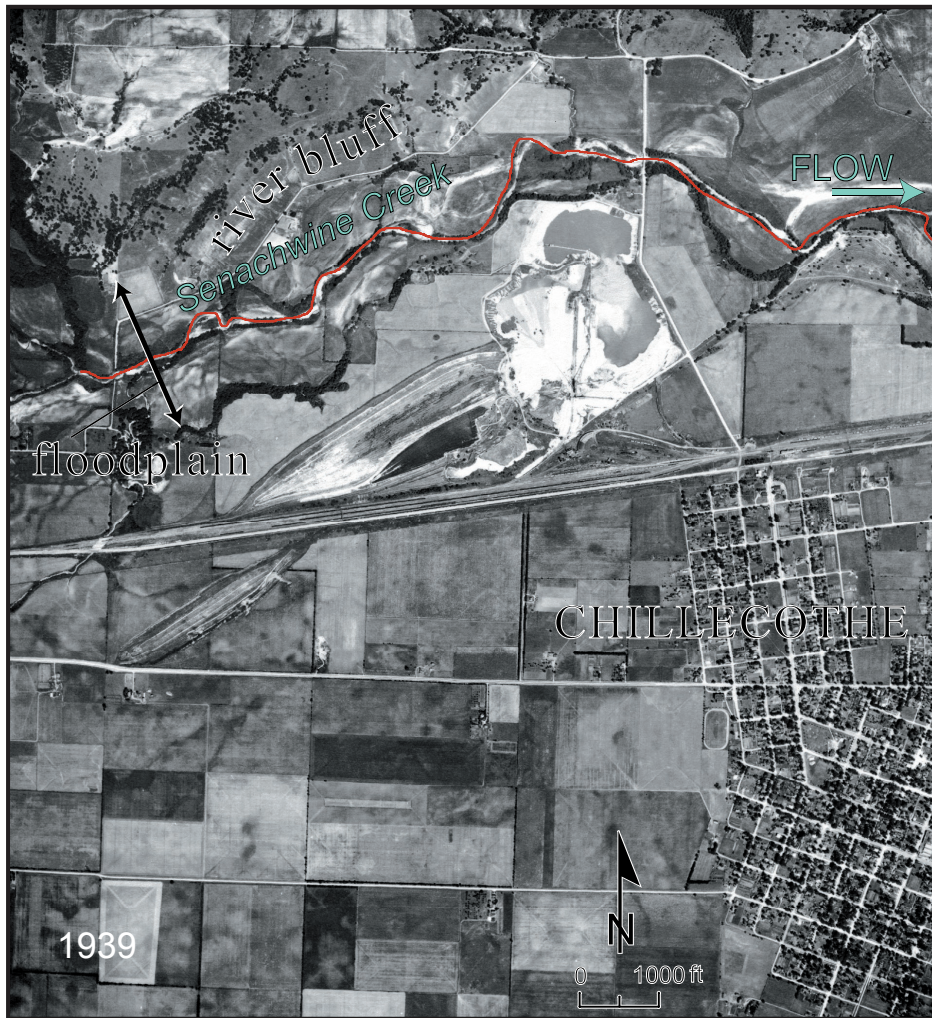
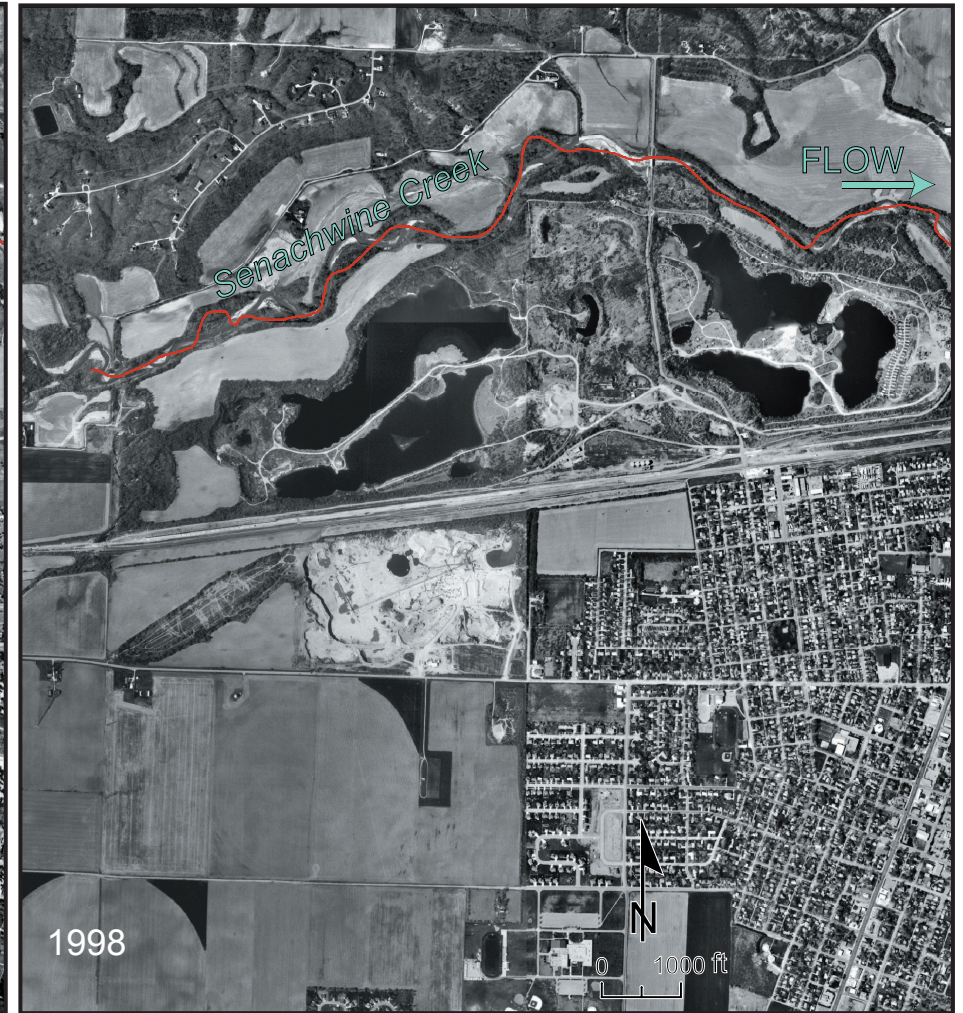
A ~1.5 mile reach of lower Senachewine Creek near Chillicothe in 1939 (left) and 1998 (right). Comparison of the 1939 channel center-line (in red) to the 1998 channel shows that the channel developed several meanders and existing meanders migrated about 50 m downstream over that period. Crevasses, evidence of overbank flooding, are prominent in the 1939 image but not in 1998, which may indicate changes in flood height, channel incision, or may be an effect of time lapse since the previous flood. Floodplain sediments are dominantly sandy. Note expansion of the aggregate mine in the floodplain south of the creek, conversion of land on river bluffs and riparian zone from row crop agriculture to forest, and growth of the town. Flow is from left to right.
