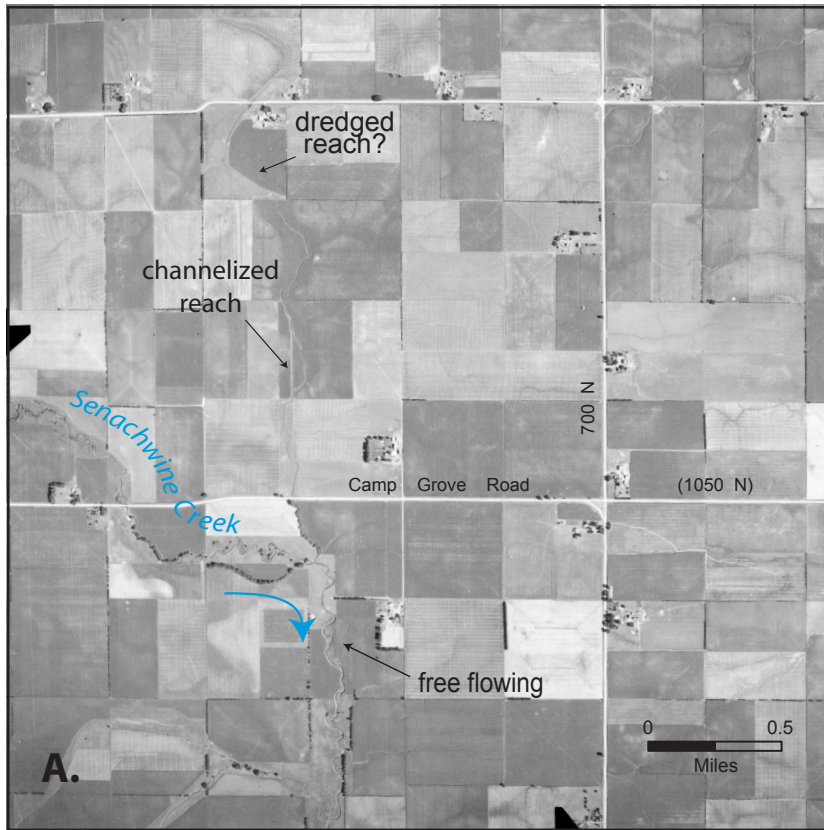
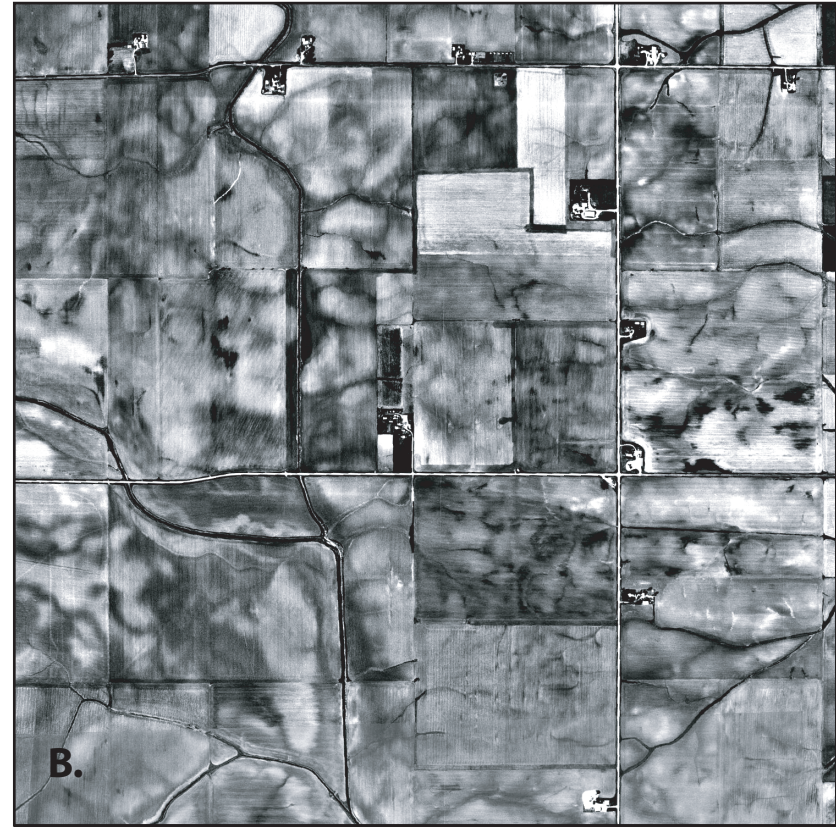
Figure W2. (A) Portion of July 30, 1939 airphoto of confluence of Senachwine Creek and northern tributary in glacial lake plain. Some reaches showed signs of alteration, but the mainstem was free flowing. Image obtained from ISGS Historical Airphoto Archive. (B) The same area in 1998. Senachwine Creek was completely altered by this time. Image is a USGS DOQ.
