SWS Contract Report 517

**INSTALLATION AND OPERATION OF A DENSE RANGAGE NETWORK
TO IMPROVE PRECIPITATION MEASUREMENTS
FOR LAKE MICHIGAN DIVERSION ACCOUNTING: WATER YEAR 1990**

Prepared for the
U.S. Army Corps of Engineers, Chicago District

FINAL REPORT

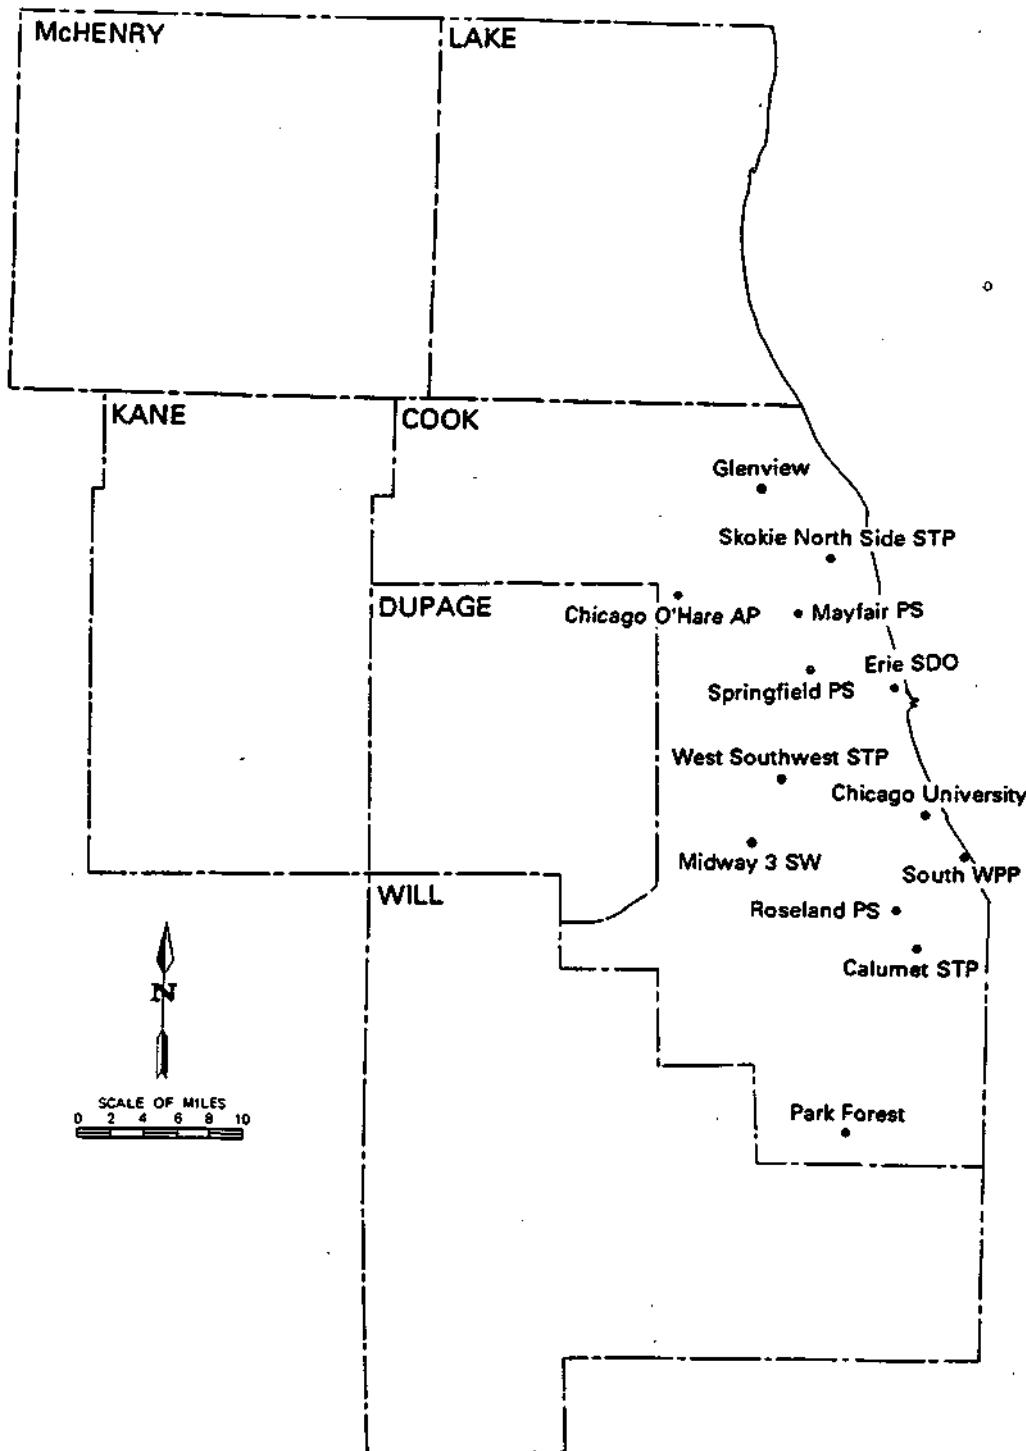
Figure 1. For Lake Michigan diversion accounting purposes, 13 raingage sites were used prior to Water Year 1990. Chicago O'Hare AP, Midway 3 SW, Chicago University, and Park Forest are National Weather Service sites; Mayfair PS, Springfield PS, South WPP, and Roseland PS are City of Chicago sites; Glenview, Skokie North Side STP, Erie SDO, West Southwest STP, and Calumet STP are Metropolitan Water Reclamation District of Greater Chicago sites. Abbreviations are as follows: AP = Airport; SDO = Sanitary District Office; SW = Southwest; WPP = Water Purification Plant; PS = Pumping Station; and STP = Sewage Treatment Plant.

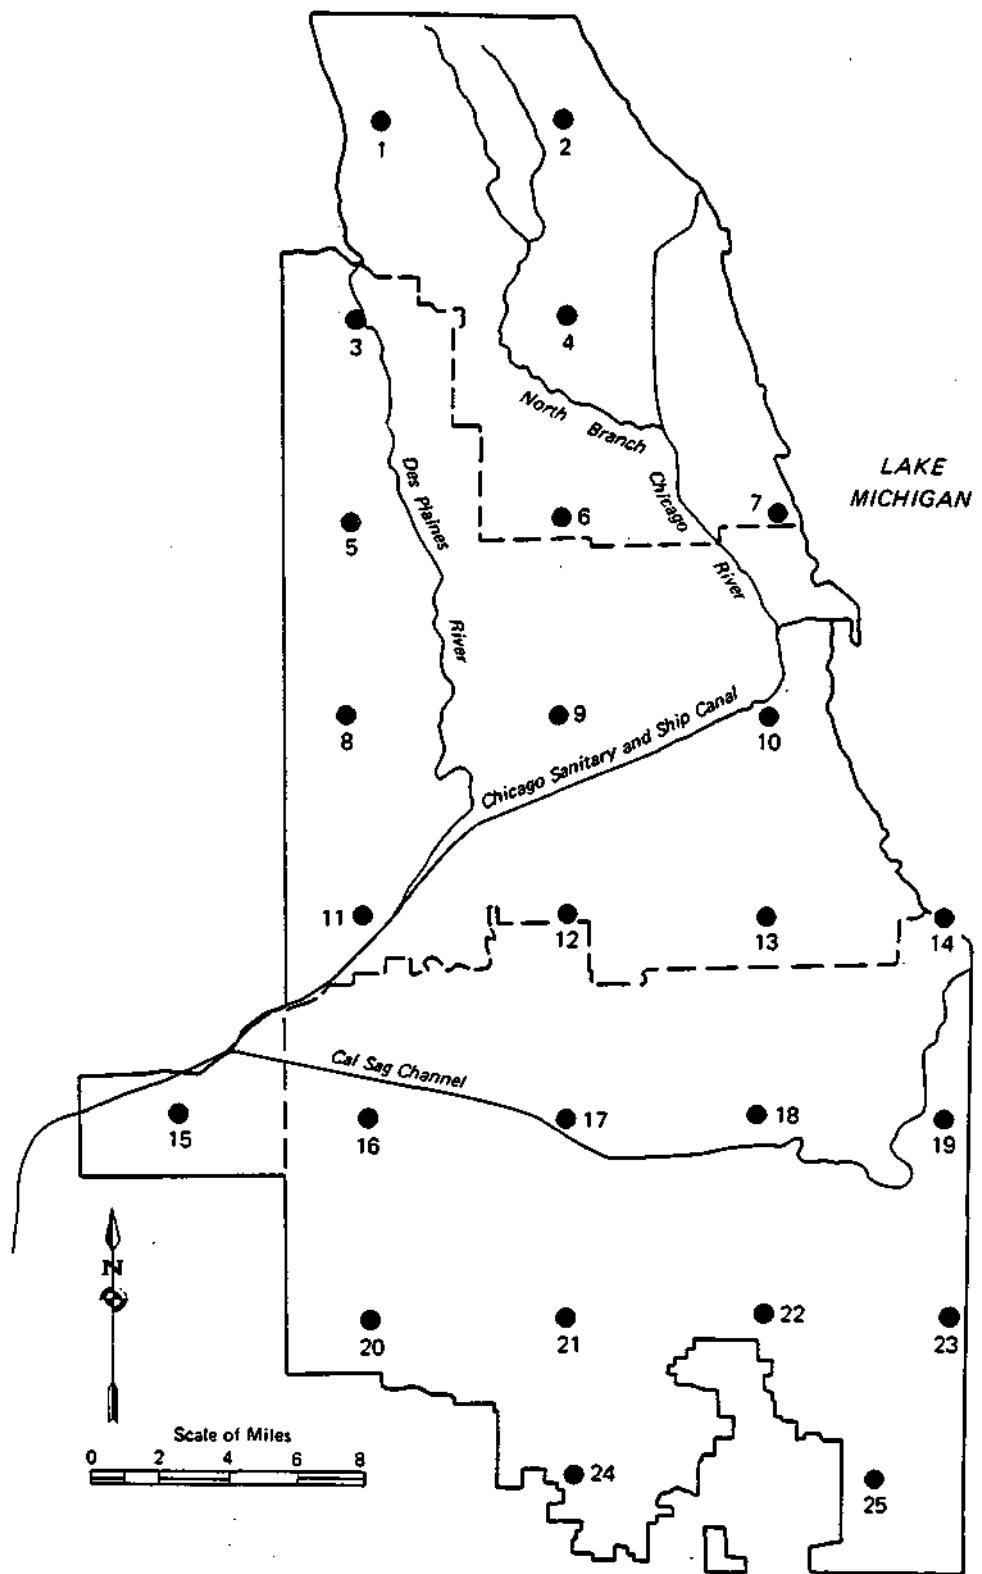
Figure 2. Original 25-site grid of the proposed raingage network.

Using the idealized grid, topographic maps of the Cook County region were used to approximate the location of each of the 25 sites and fine-tune their placement to best position the sites with respect to residential areas, industrial facilities, or municipal grounds. Since terrain effects are fairly minimal in northeastern Illinois, gridding was possible.

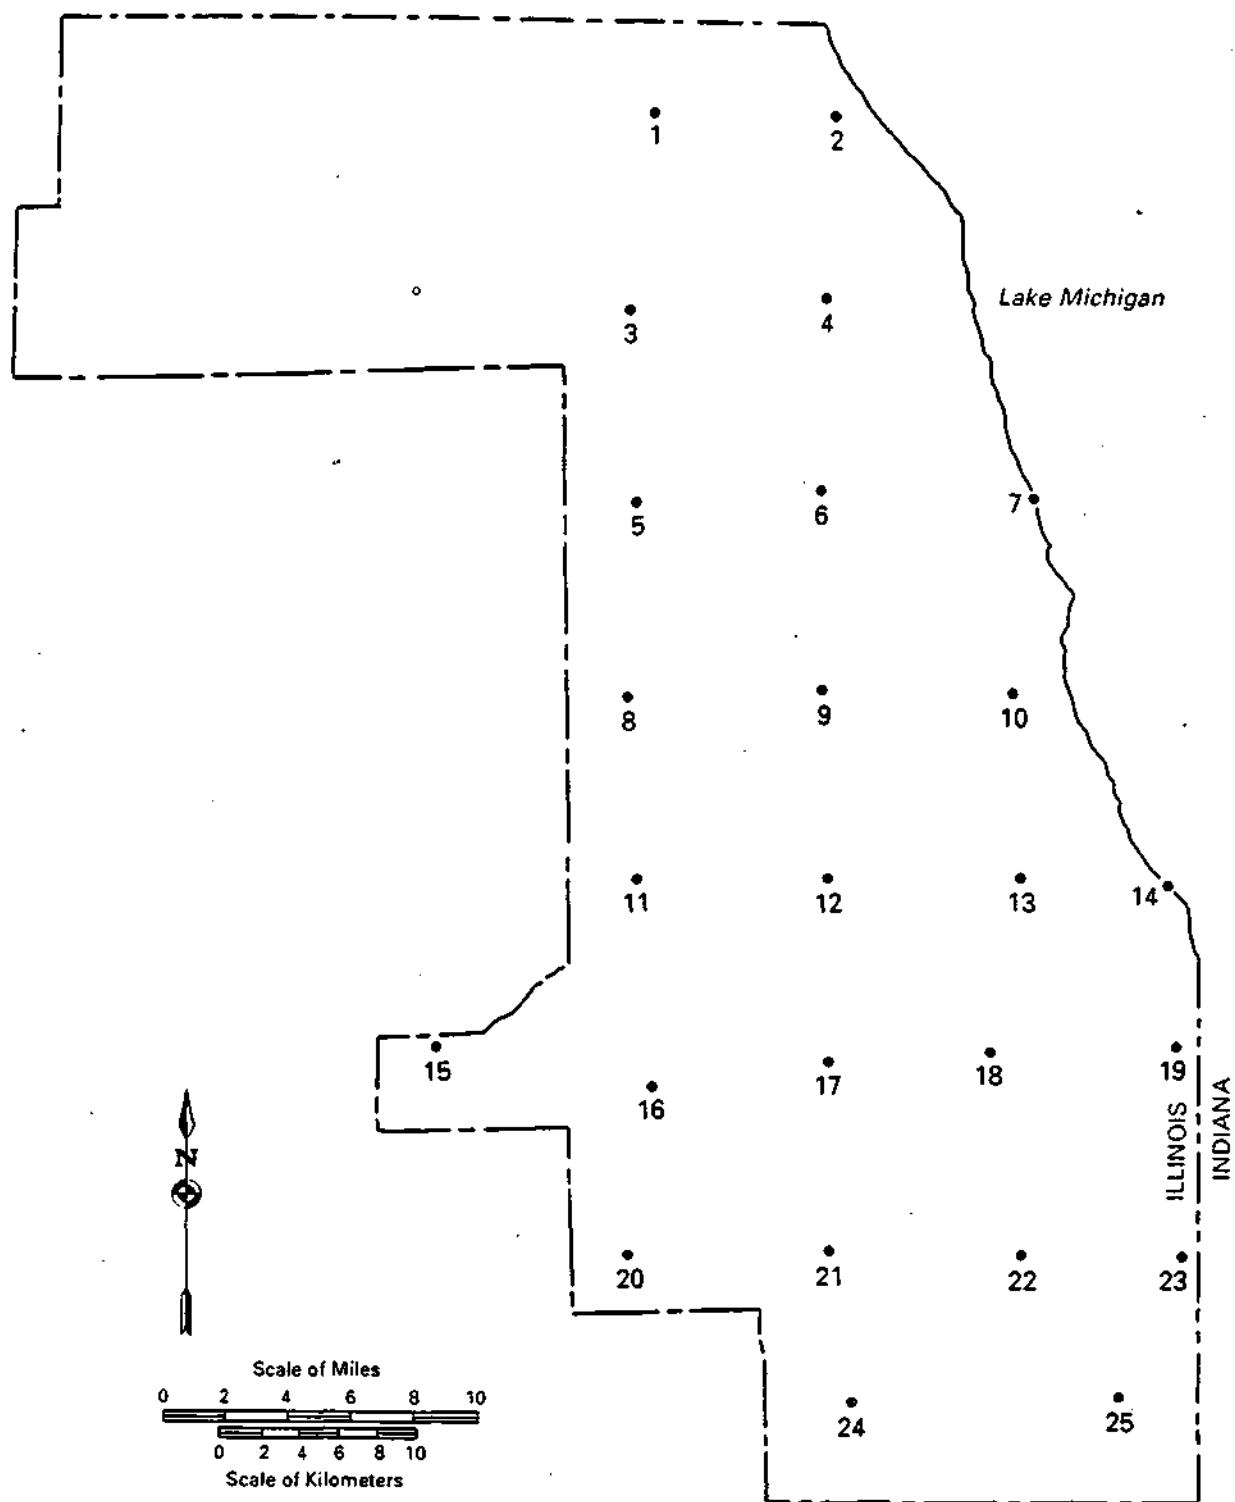
Figure 3. Current configuration of the 25-site raingage network.

In late September and early October 1989, the entire 25-gage network was installed. The Belfort weighing-bucket raingage was used throughout the network, and each fitted each with a battery-powered electric chart drive for more consistent and reliable operation. The Water Survey donated all raingages needed from its inventory. Figure 3 shows the current configuration of the network (as of July 1991), while Table 1 gives further information for

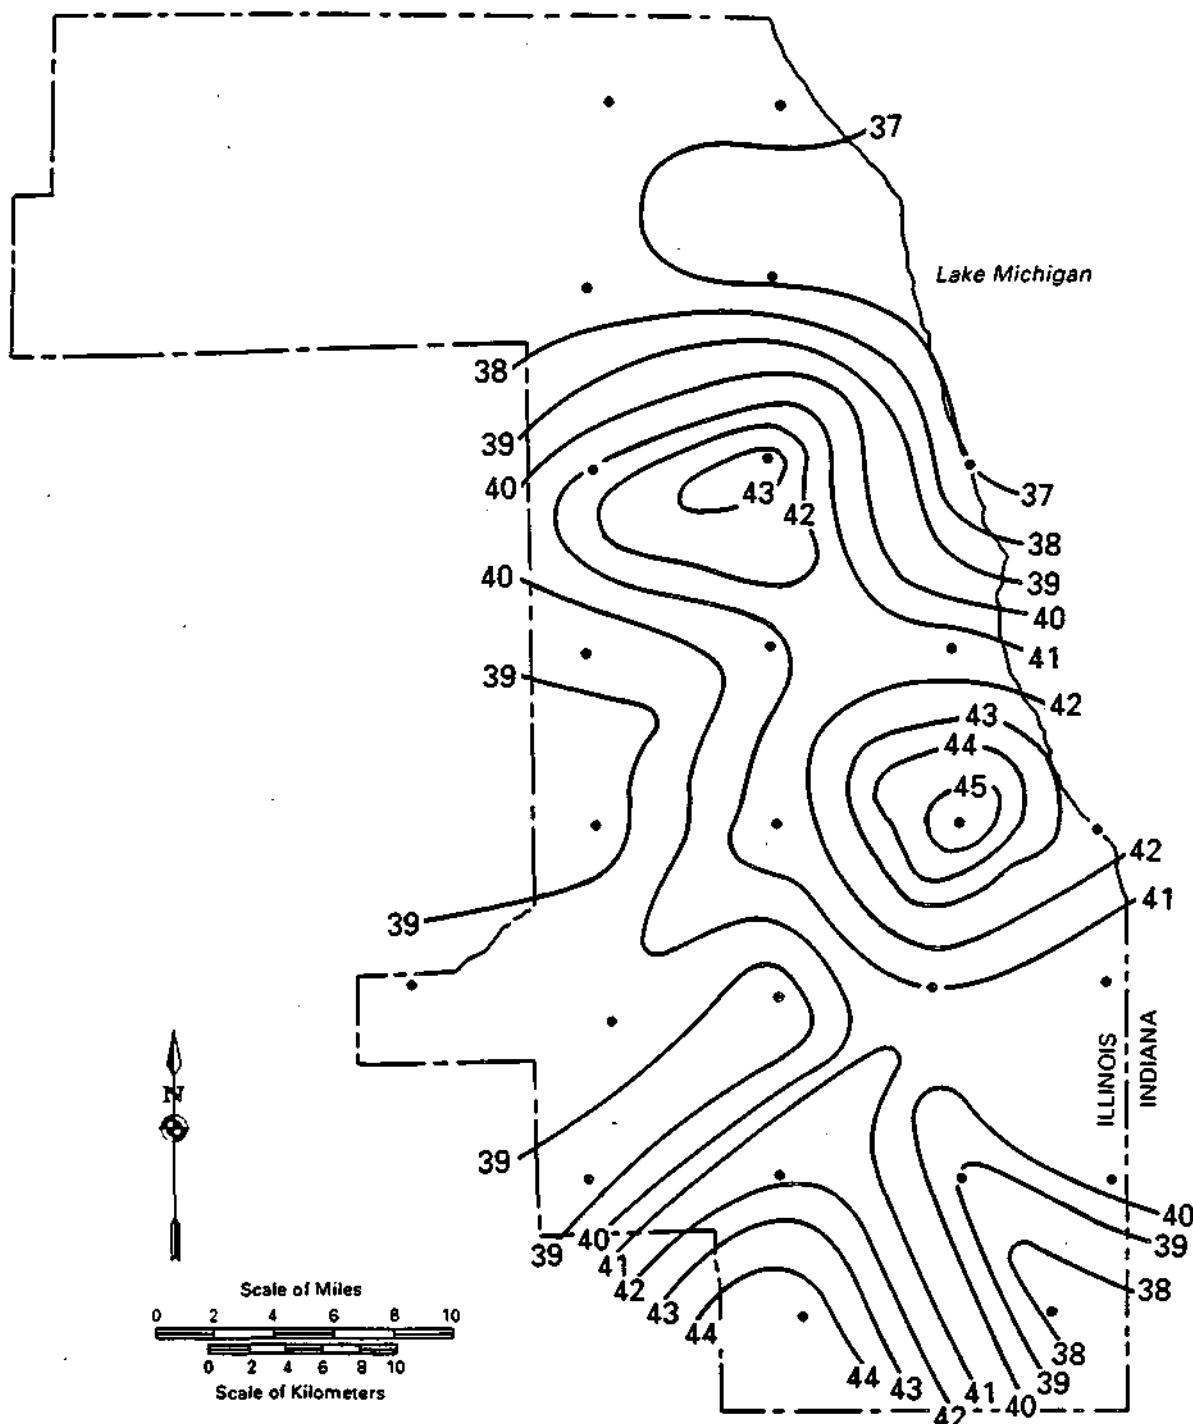
Figure 4. Precipitation pattern (inches) for Water Year 1990. Dots indicate network sites.

Figure 4 contains the Water Year 1990 analysis. Isopleths are drawn to every inch. The figure reveals precipitation highs in the north central, east central, and extreme southwestern portions of Cook County encompassed by the network, centered on Sites #6, #13, and #24, respectively. Areas of lower precipitation were located in the extreme northern, northeastern, west central, southwestern, and southeastern portions of the region, centered on Sites #4, #7, #11, #17, and #25, respectively. The maximum at Site #6 seems to coincide with an urban high noted by Huff and Vogel (1976) from data for 1949-1974 ("north central high") and from data for other water years in the 1980s (e.g., Peppier, 1991). The minima in the extreme north and northeast may be associated with the stabilizing effect exerted by Lake Michigan on convective rainfall, as noted in data by Huff and Vogel (1976).

The minimum in the west central region appears similar to adjusted ones found in Water Years 1988 and 1989 (Peppier, 1991), while the maximum in the east central region extending toward the Indiana border also resembles those 1988 and 1989 patterns (Peppier, 1991). Thus, the Water Year 1990 pattern, as collected by the raingages in the new network, displays characteristics found in previous established data. It generally disagrees with the unusual anomalies associated with the collection of raingages from the NWS, MWRDGC, and CC used to generate precipitation information in Water Years 1984-1989. Therefore, the new network can be considered to have improved collection properties.

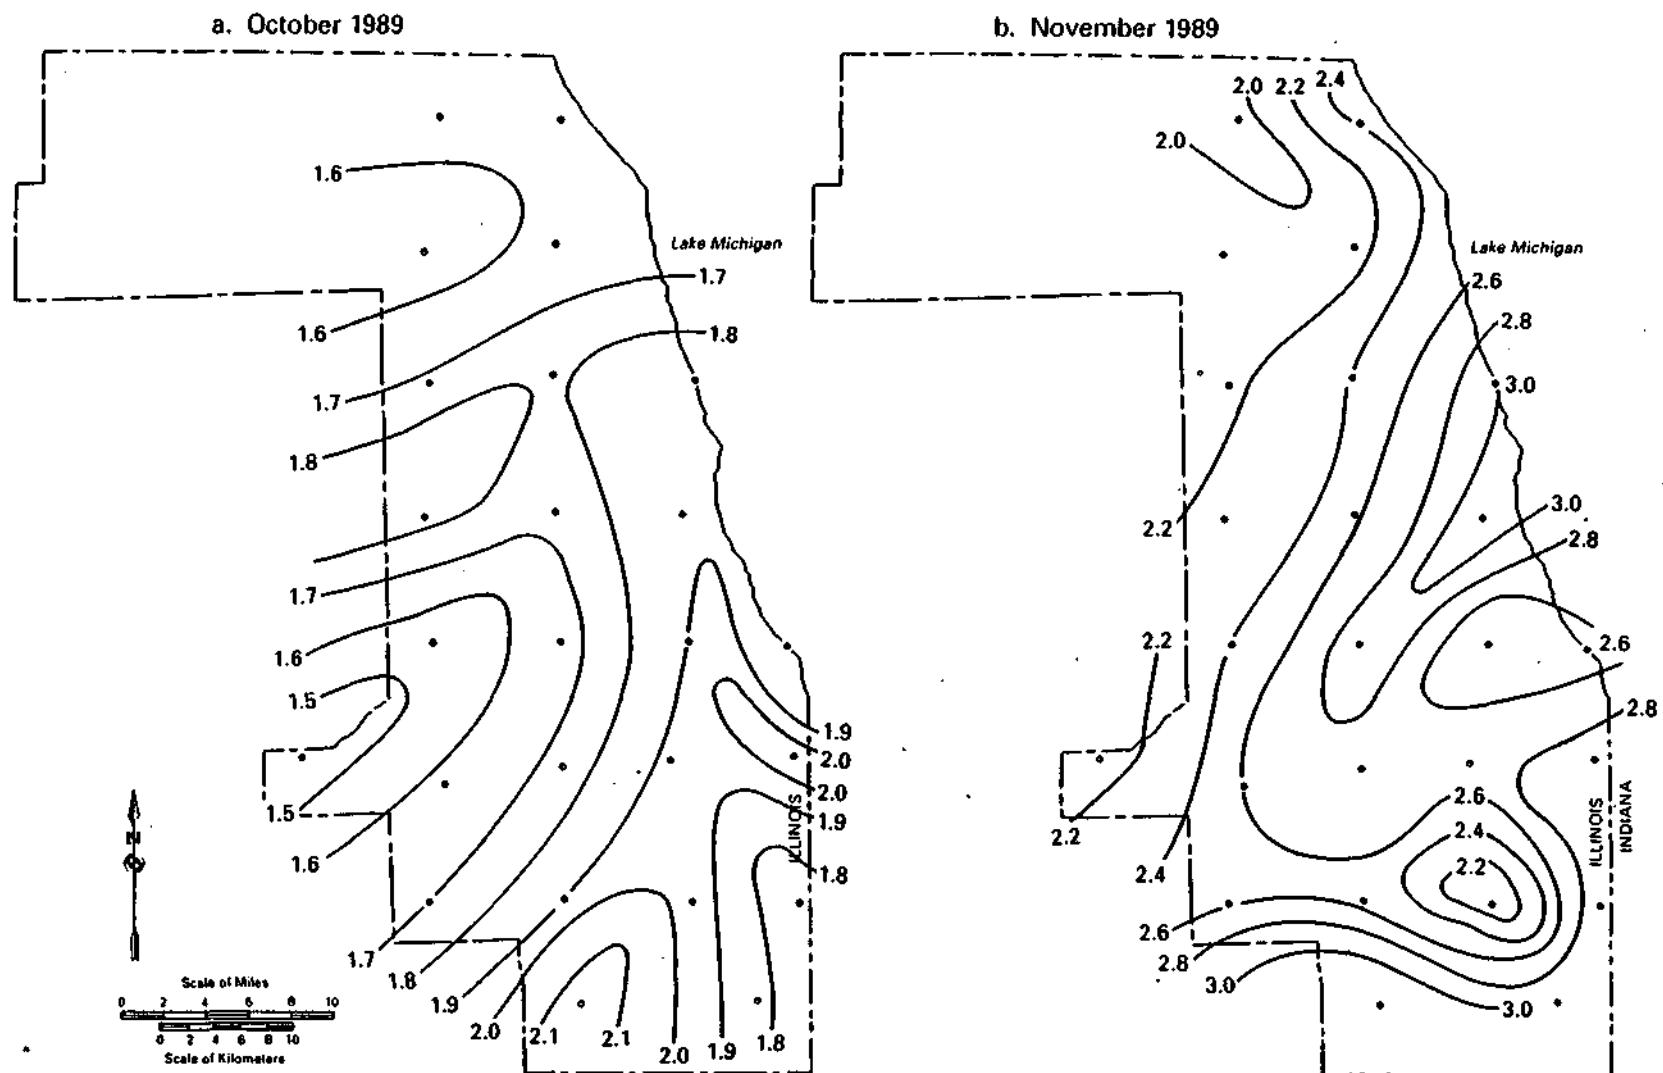
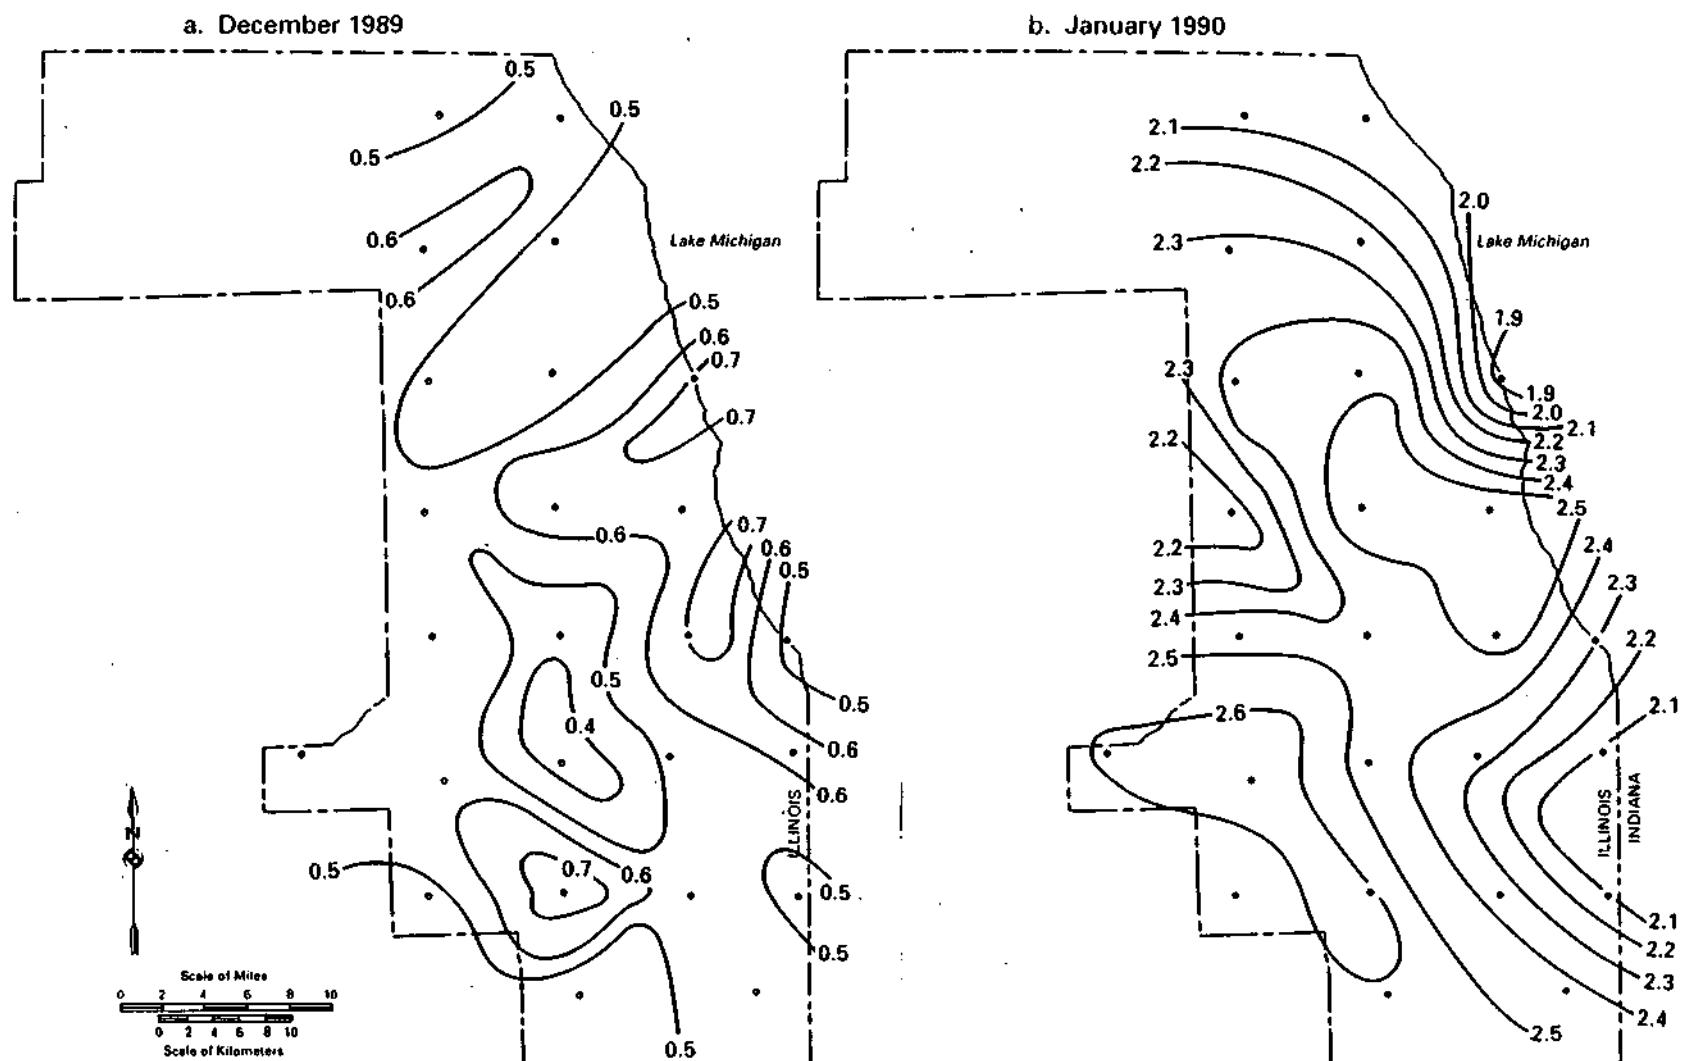
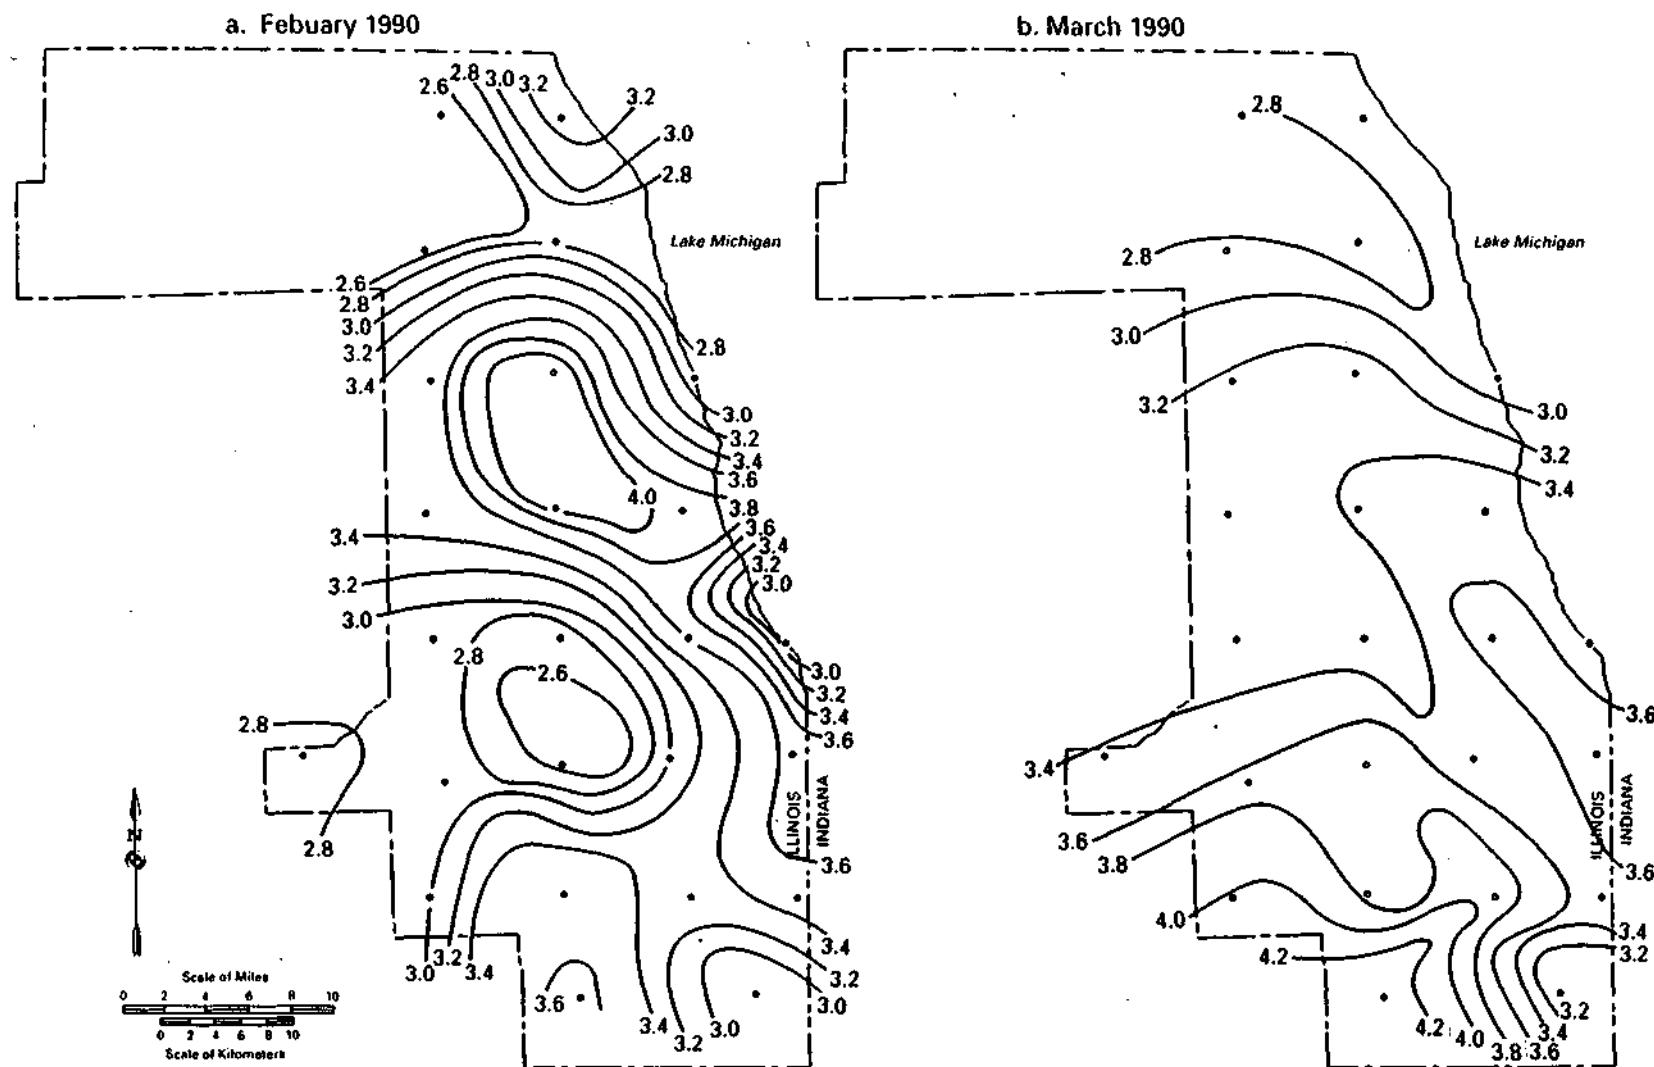
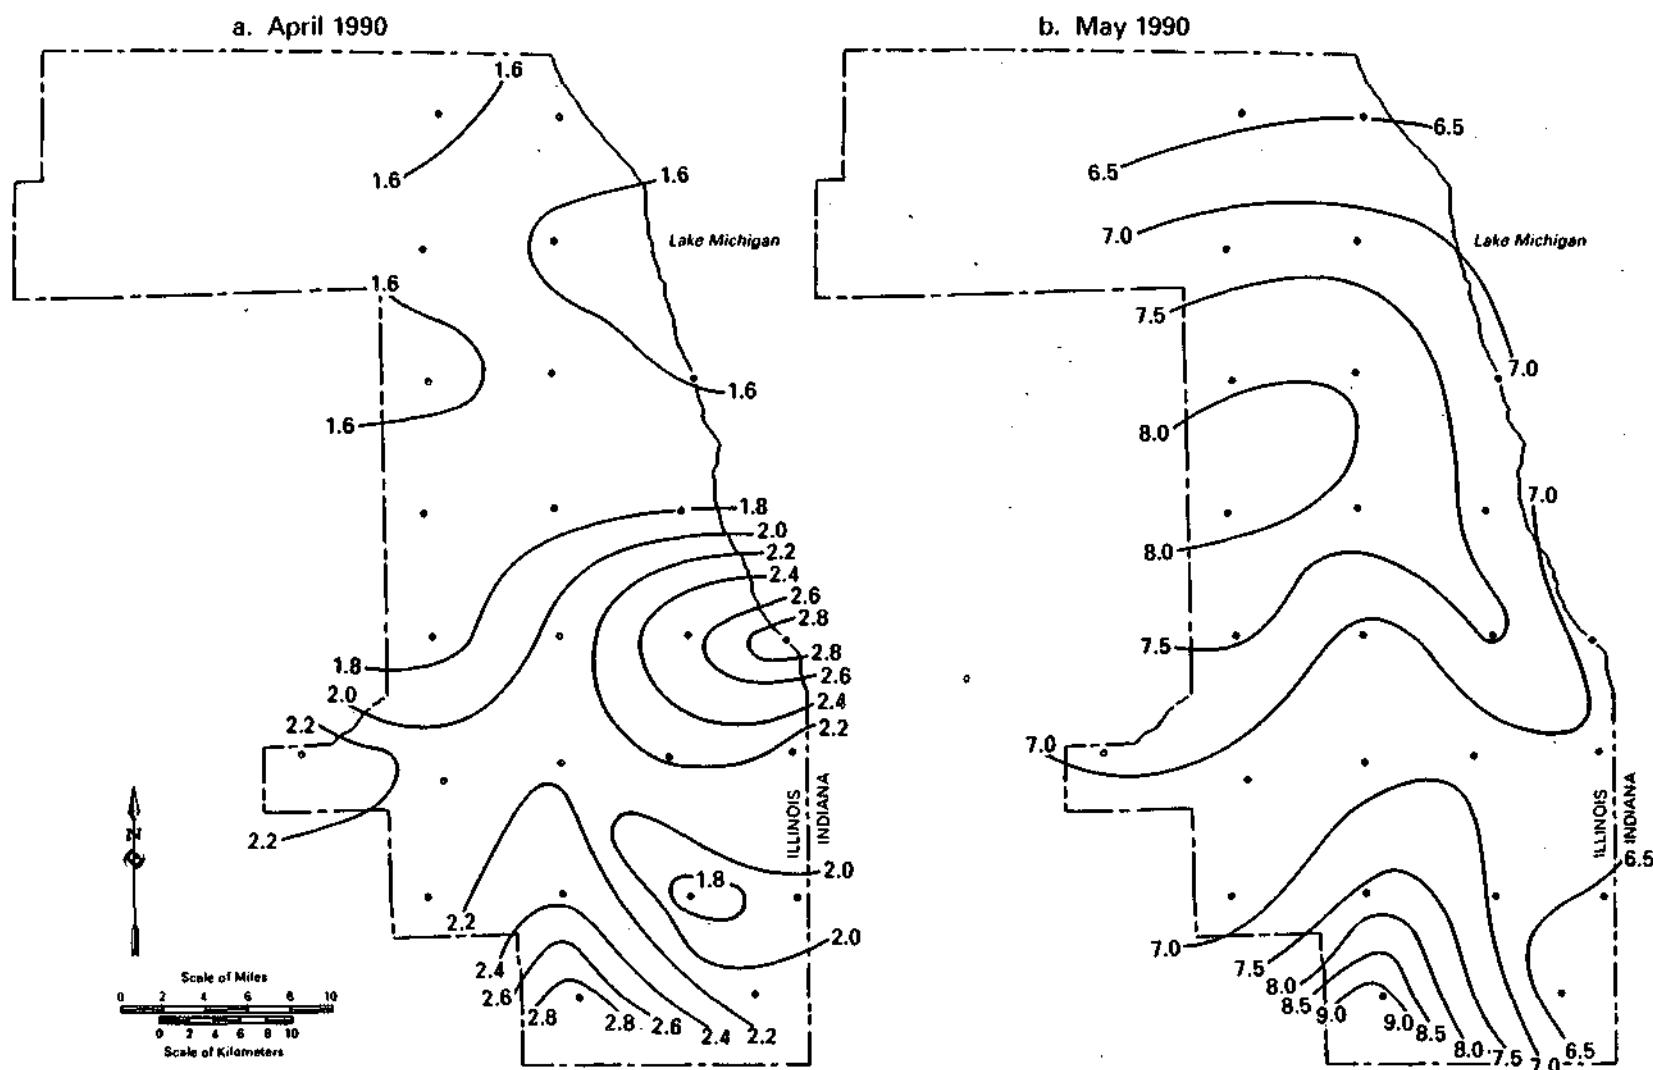
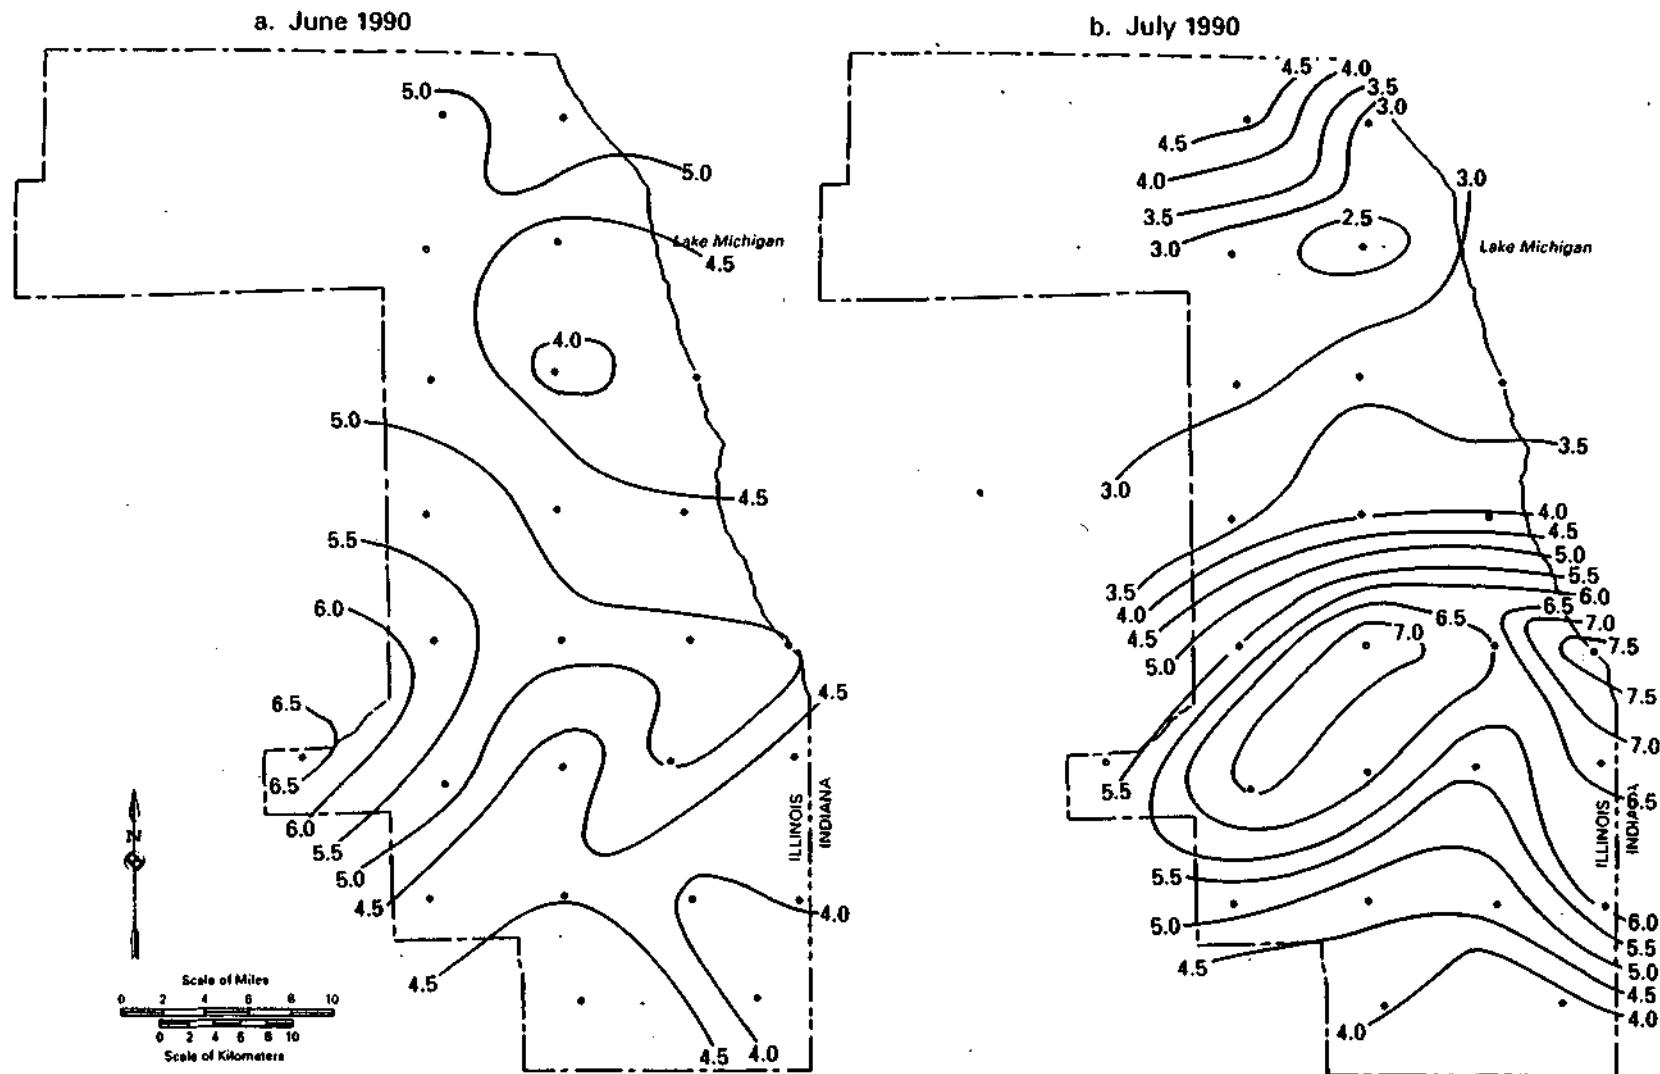
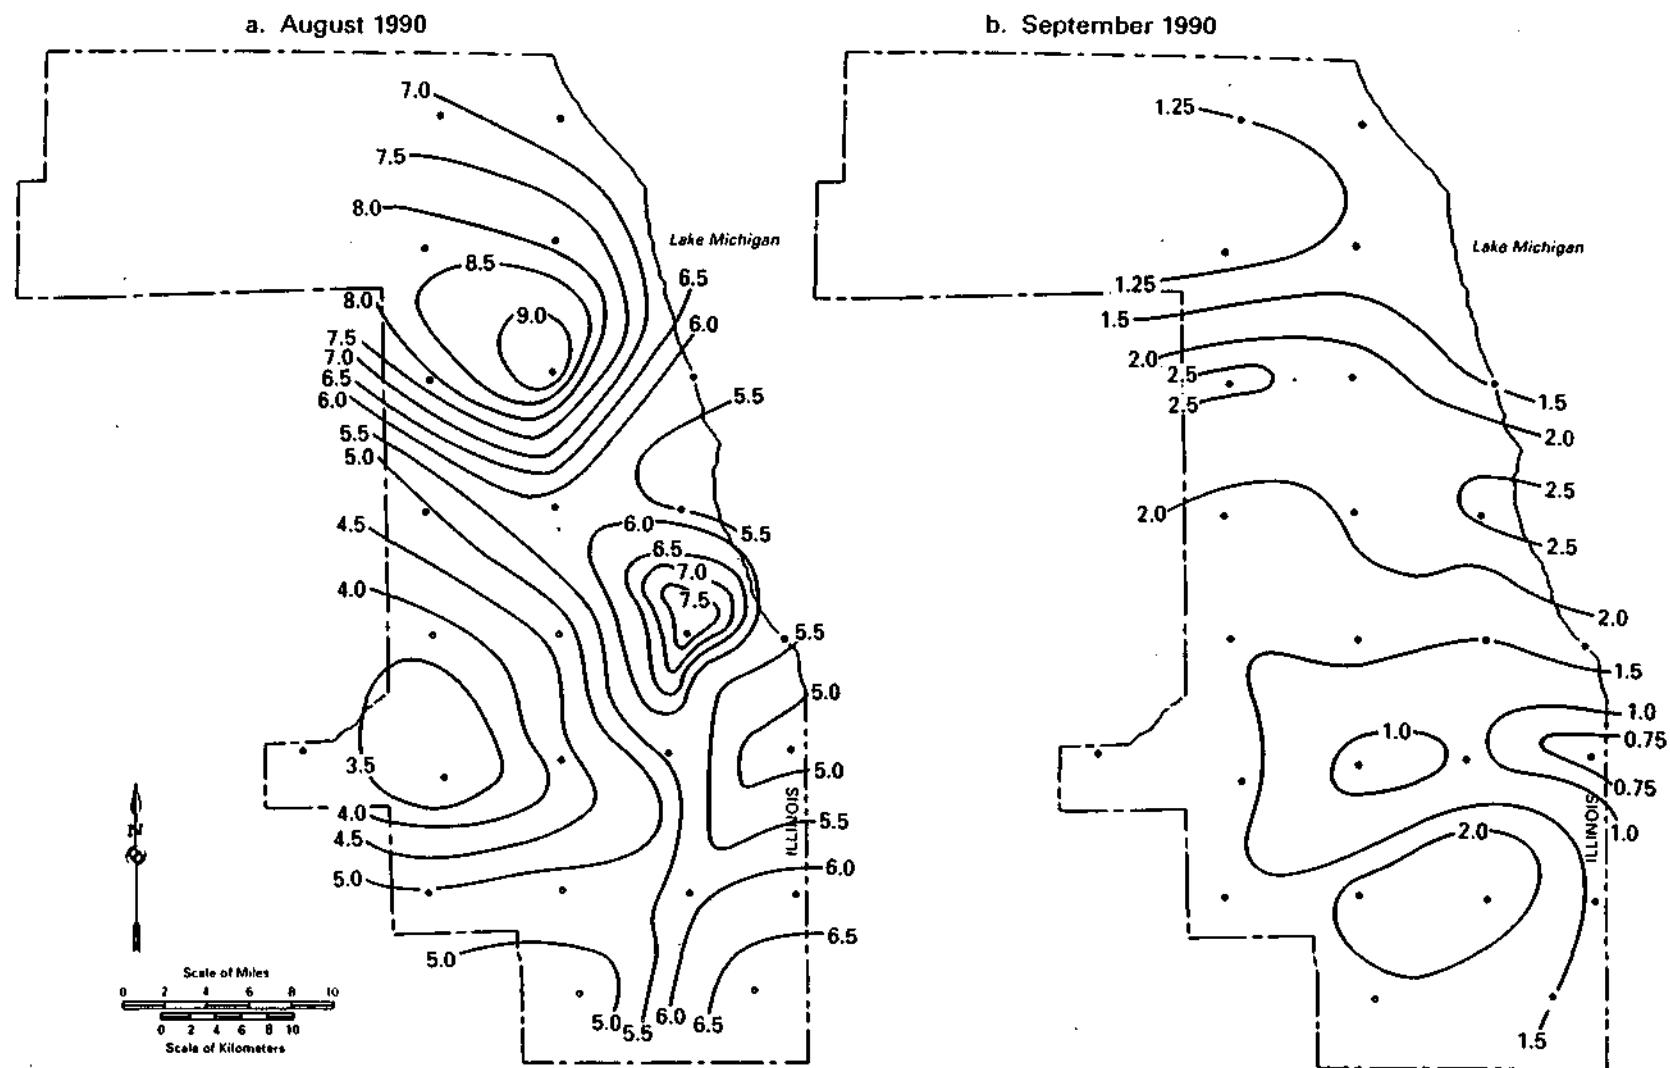
Figure 5. Precipitation patterns (inches) for October 1989 (Panel a) and November 1989 (Panel b). Dots indicate network sites.

Figure 6. Precipitation patterns (inches) for December 1989 (Panel a) and January 1990 (Panel b). Dots indicate network sites.

Figure 7. Precipitation patterns (inches) for February 1990 (Panel a) and March 1990 (Panel b). Dots indicate network sites.

Figure 8. Precipitation patterns (inches) for April 1990 (Panel a) and May 1990 (Panel b). Dots indicate network sites.

Figure 9. Precipitation patterns (inches) for June 1990 (Panel a) and July 1990 (Panel b). Dots indicate network sites.

Figure 10. Precipitation patterns (inches) for August 1990 (Panel a) and September 1990 (Panel b). Dots indicate network sites.

Figures 5-10 contain monthly analyses for the water year period. Generally, light precipitation occurred in October, December, which had the lightest precipitation of the water year, April, and September (Figures 5, 6, 8, and 10, respectively). Heavier amounts occurred in May and over parts of the region in July and August (Figures 8-10, respectively). Looking at some of the more interesting cases, December's monthly amounts (Figure 6) ranged from just 0.33 inches at Site #17 to 0.73 inches at both Sites #7 and #21. February particularly showed the increased precipitation region in the north central portion of the area (Figure 7), as did August (Figure 10). Site #6 in August had the highest monthly total recorded during the water year at any site, 9.35 inches. May had high values throughout the entire network (Figure 8), with a maximum of 9.32 inches at Site #24 in the extreme southwestern portion of the grid. Both July and August had the greatest ranges of amounts over the network (Figures 9-10, respectively). In July, monthly totals ranged from only 2.43 inches at Site #4 in the north to 7.84 inches in the southeast at Site #14. A band in the 7-inch range spread from Site #16 in the southwest to Site #14, while values were below 3 inches north of Site #5. In August (Figure 10), values ranged from 3.23 inches at Site #16

to the previously mentioned water year high of 9.35 inches at Site #6 to the north. This month displayed a very cellular pattern of precipitation. In both July and August, most of the rainfall occurred in a few well-defined storm systems: Storm 84 in July and Storms 89, 90, 91, 92, and 94 in August. Some produced serious localized flooding. Storm 84 on July 19-20 was particularly prominent; over 4 inches fell on Sites #12-14, #17, and #19 in the south central and southeast portions of the region. The storm high for the water year, 5.72 inches, occurred at Site #14. Finally, September (Figure 10) included two sites (#17 and #19) that had monthly amounts of less than one inch (0.96 and 0.66 inches, respectively). Appendix IV gives storm totals for all events greater than an annual event (one-year recurrence interval), considering storm periods of one hour to ten days.

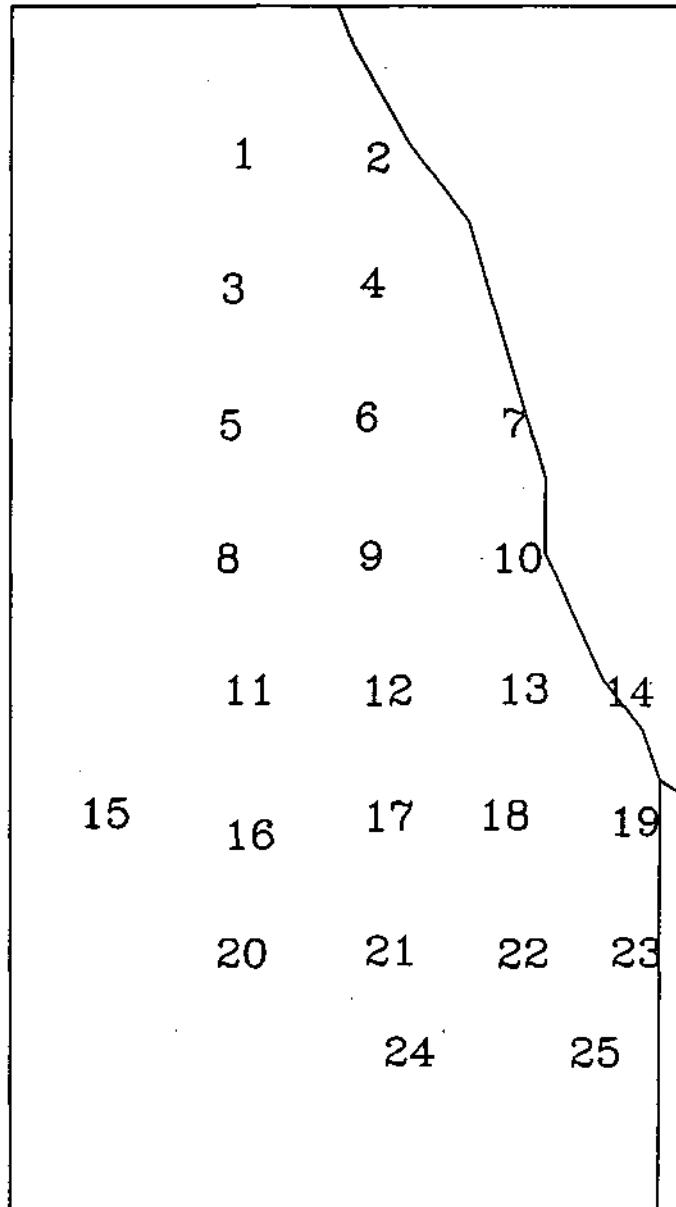
Figure 11. Computer-drawn configuration of current network layout, compatible with Figures 12-14 and Figure 16.
