SWS Contract Report 517

**INSTALLATION AND OPERATION OF A DENSE RANGAGE NETWORK
TO IMPROVE PRECIPITATION MEASUREMENTS
FOR LAKE MICHIGAN DIVERSION ACCOUNTING: WATER YEAR 1990**

Prepared for the
U.S. Army Corps of Engineers, Chicago District

FINAL REPORT

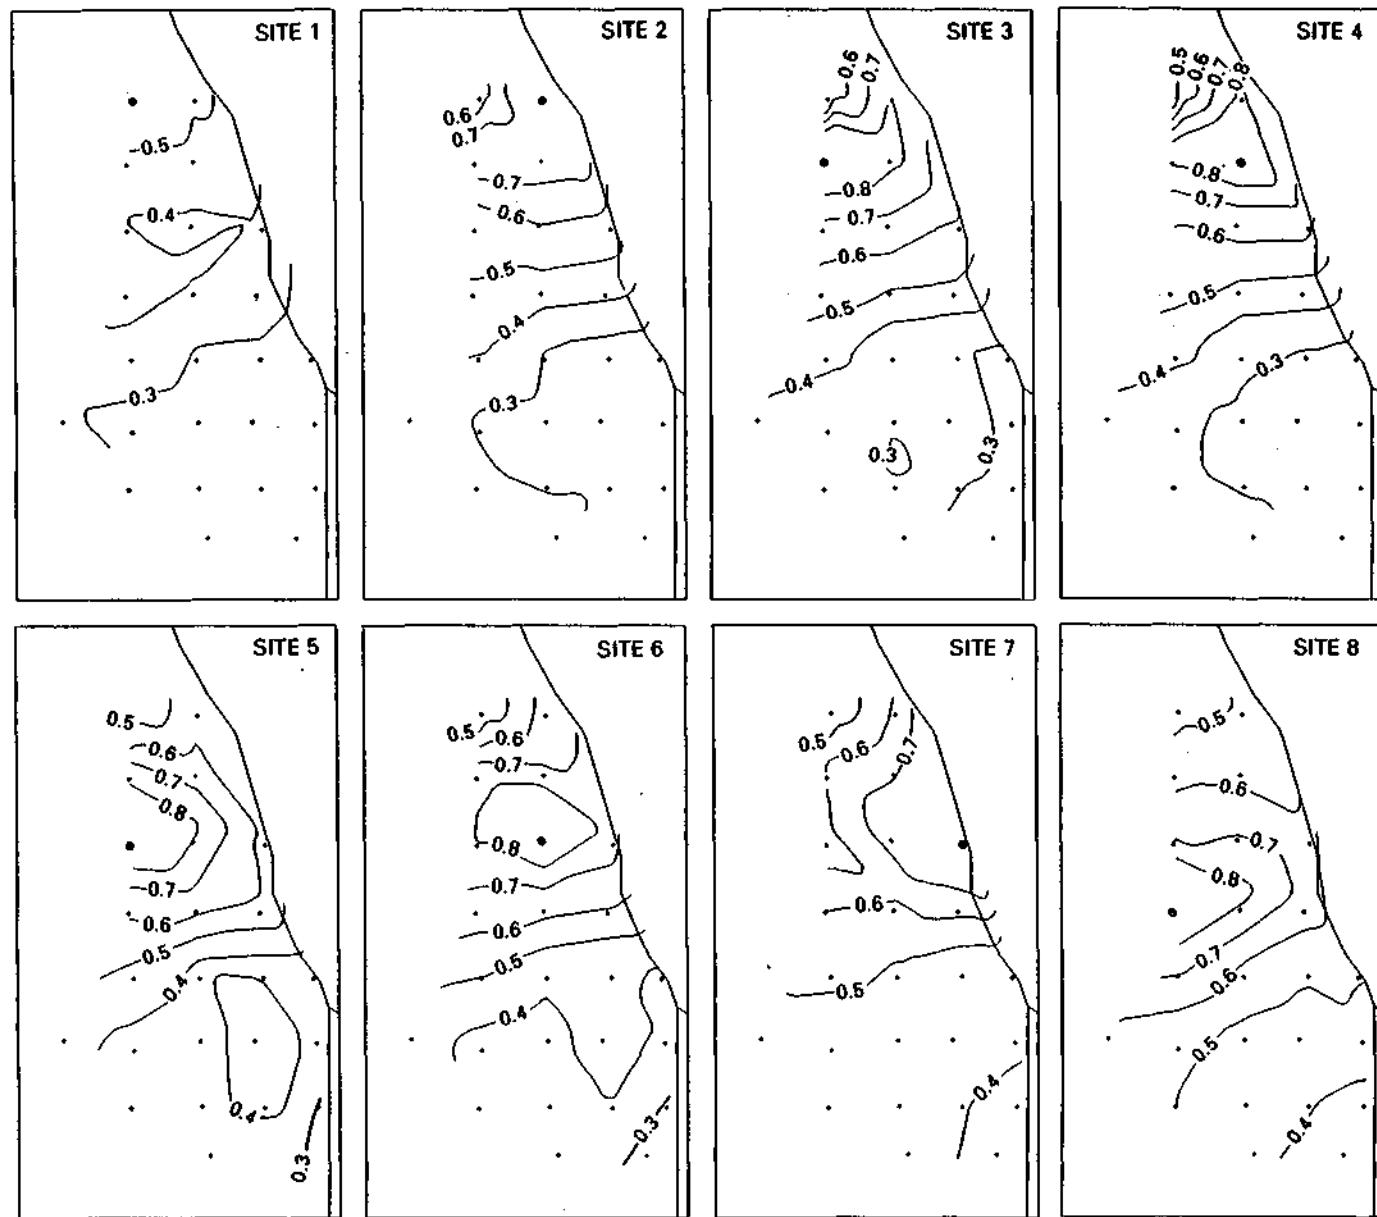
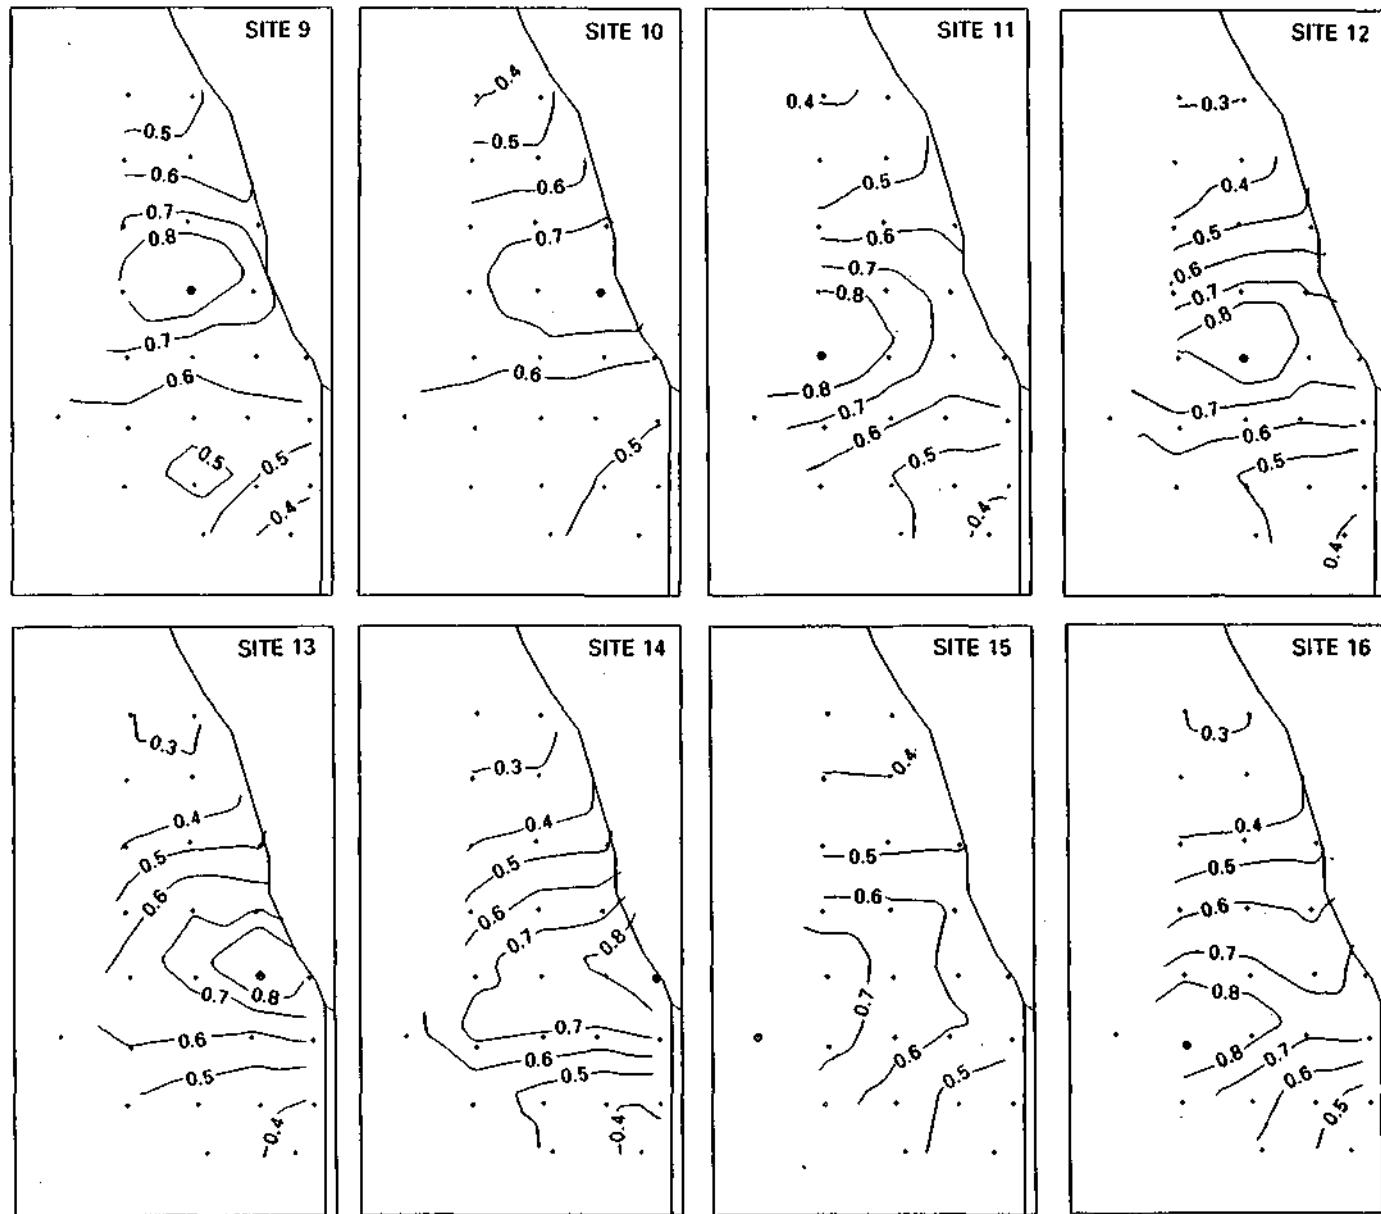
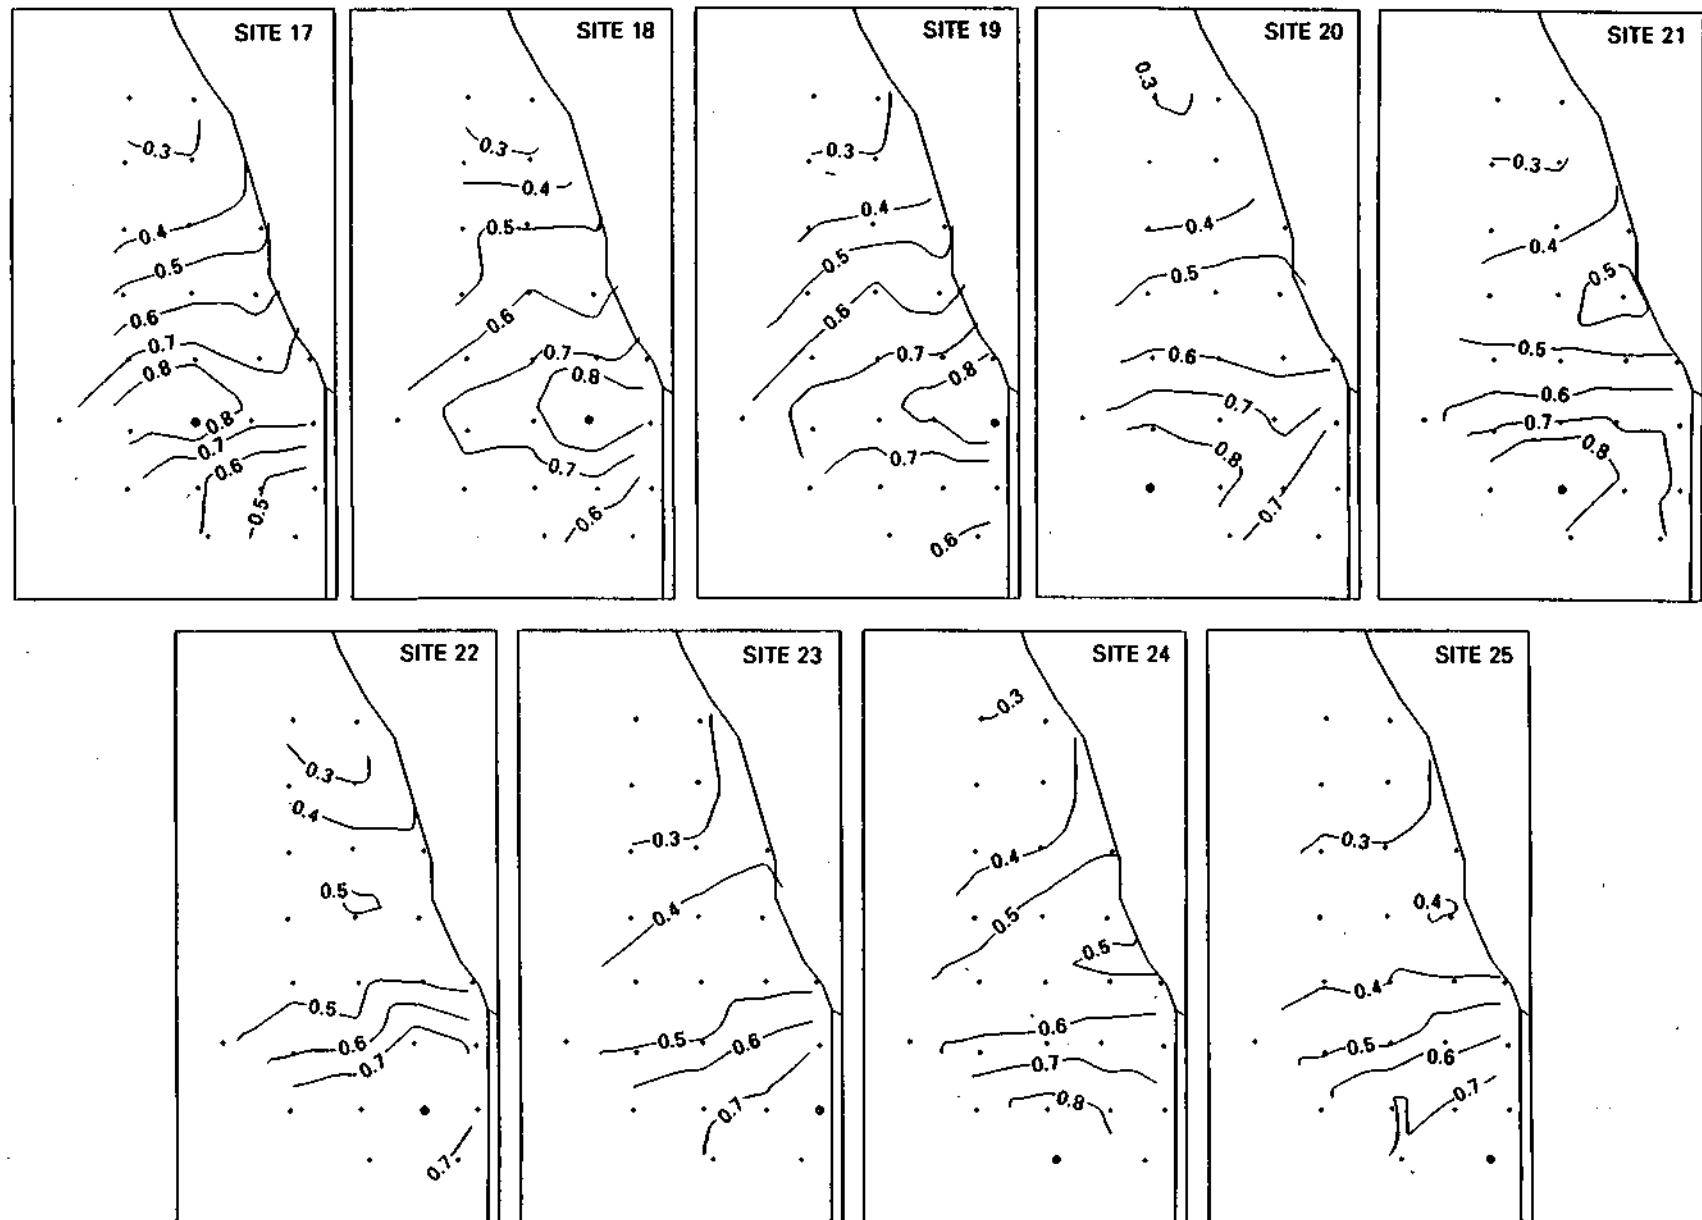
Figure 12. Correlation coefficient patterns for Sites #1-#8. Isopleths (no units) represent linear correlation magnitudes with the labeled site, which is indicated on the map by a large dot. Smaller dots indicate the other sites.

Figure 13. Correlation coefficient patterns for Sites #9-#16. Isopleths (no units) represent linear correlation magnitudes with the labeled site, which is indicated on the map by a large dot. Smaller dots indicate the other sites.

Figure 14. Correlation coefficient patterns for Sites #17-#25. Isopleths (no units) represent linear correlation magnitudes with the labeled site, which is indicated on the map by a large dot. Smaller dots indicate the other sites.

The results of the spatial correlation analysis for the Water Year 1990 period are shown in Figures 12-14. Table 4 gives the magnitudes of the entire matrix of correlations. Figure 11 gives the alignment of the network for the maps produced by this analysis. Linear correlation coefficients range in value from -1.00 to +1.00 and assess the degree of linear relationship between the hourly precipitation values at one site with those of each of the other 24 sites. In general, the maps indicate that each site has a high degree of correlation with one to four of its surrounding neighbors, with correlations dropping rather rapidly with distance away from a site. The two sites most alike in this sense were Sites #16 and #17, with a linear correlation of 0.8766 (Figures 13 and 14), while the site least related to any others in the network was Site #1, which had only a correlation of 0.5418 with Site #2 (Figure 12). As can be seen from the figures, most of the patterns are oval-shaped around the site in question, with a west-east rather than a north-south orientation. It is hypothesized that these orientations will vary by season (e.g., southwest-northeast during

Ten sets of 25 correlation patterns each, similar to the set shown in Figures 12-14, were computed and drawn from the bootstrapped data samples. General results will be discussed, but only those patterns for Site #17 are shown as examples (Figure 16). Overall, the patterns held up very well for most of the sites, the exceptions being in the extreme northern portion of the network (Sites #1-#3), at two of the Lake Michigan proximity locations (Sites #7 and #10), and some sites in the extreme southern part of the network (Sites #20 and #22). In a correlation magnitude sense, the highest inter-site correlations for each site in the bootstrapped samples fell within some range around the highest values found from the actual data, with more values slightly below the actual ones, indicative of a slight inflating effect in the actual data by autocorrelation. Thus, the effect of the bootstrapping, which attempted to randomize the autocorrelation of the time-series, was to not significantly dilute the correlations in the actual data, so it appears that most of the correlation patterns and magnitudes in the actual data are "real". The sites that had the most resilient correlation structures are generally in the central part of the network, including Site #17 (Figure 16). Site #1 seems to have had the poorest correlation structure of any raingage location. The correlation patterns within close proximity of a site were generally elongated from west-to-east, rather than north-to-south, as in the actual data.

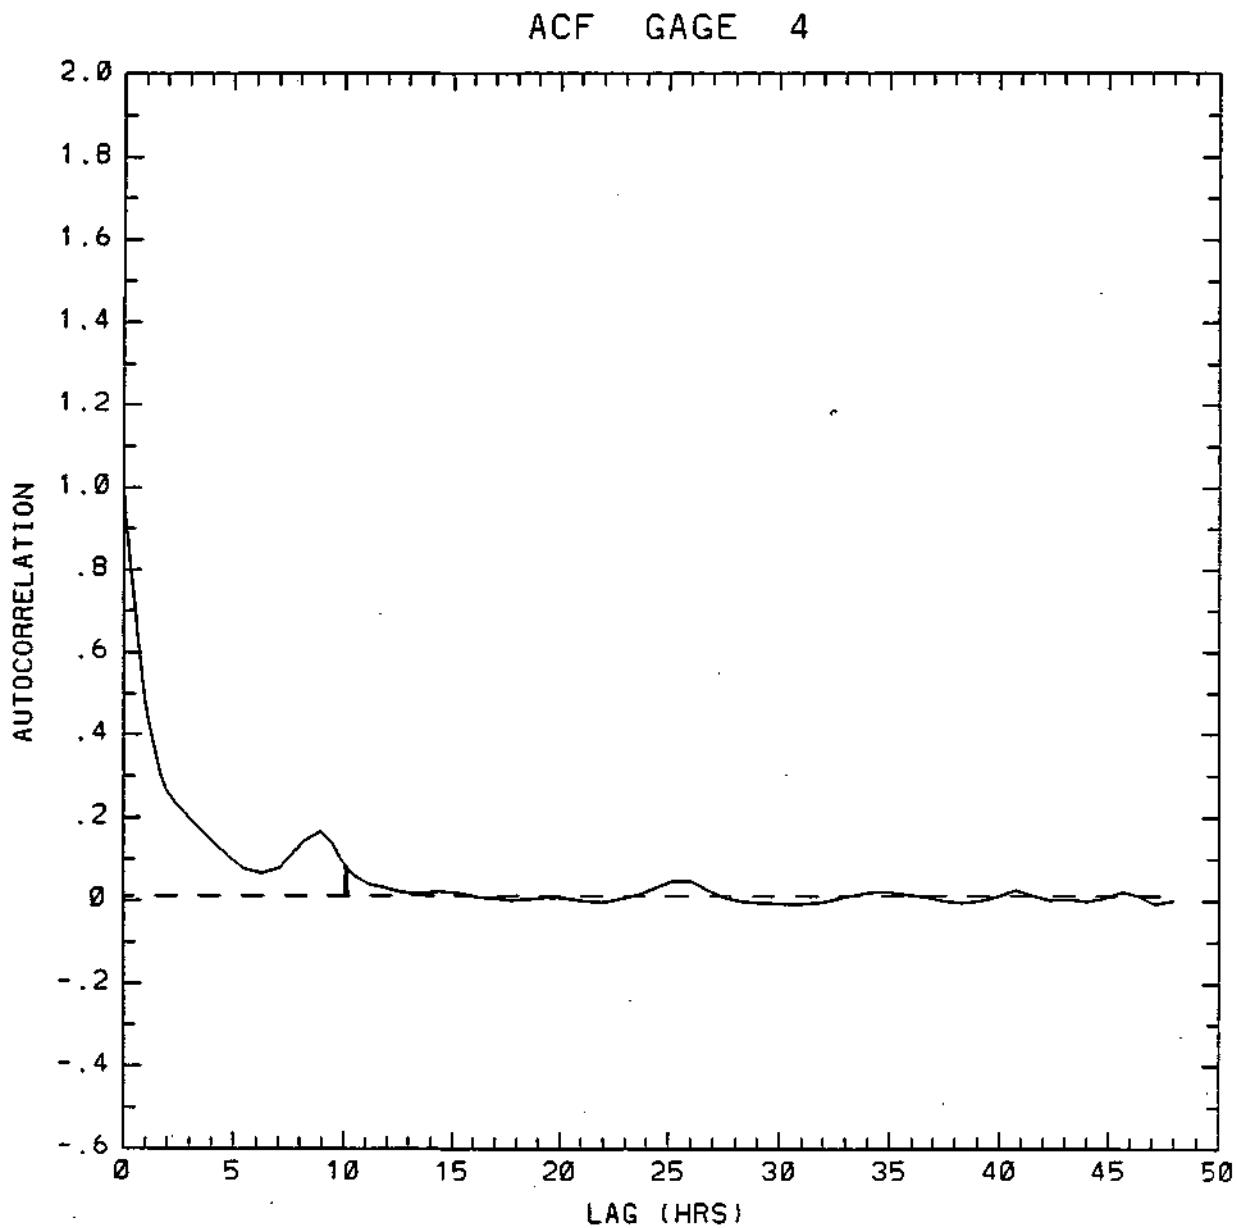
Figure 15. Autocorrelation function for Site #4 (solid curve). Dashed line represents the level of white noise associated with a sample size of 8,760 hourly data values. Vertical line between the autocorrelation function and white-noise line at lag 10 represents the last lag (hour) of autocorrelation greater than the maximum found from a similar function for pseudorandom standard normal variates.

All stations had autocorrelations within their hourly precipitation data ranging from 6 to 12 hours (Table 5). Thus, the effective sample size is about an order of magnitude less than the sample size of 8,760 (8,760 divided by the lag). In other words, the amount of independent information contained in each time-series is much less than the total number of observations would indicate. Within this range of autocorrelation, succeeding values are

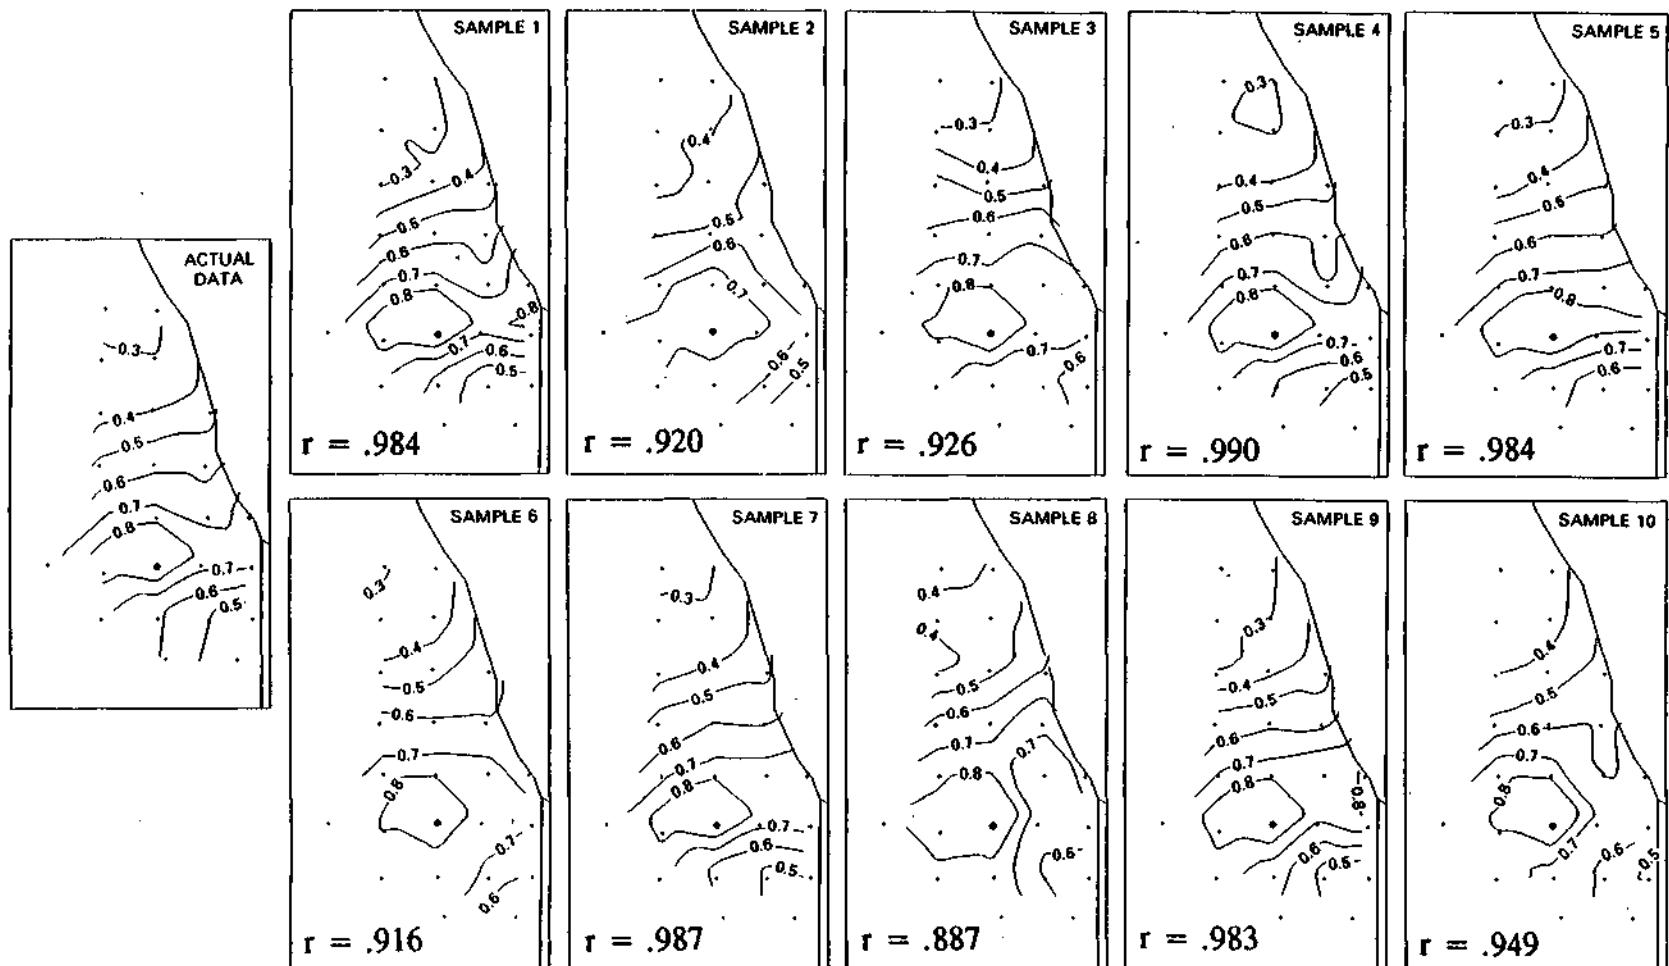
Figure 16. Correlation coefficient patterns for Site #17 from the original data (left panel) and from ten replication samples extracted from the original data. Isopleths (no units) represent linear correlation magnitudes with the labeled site, which is indicated on the map by a large dot. Smaller dots indicate the other sites. Numbers in lower left corners of the sample panels indicate the correlation of that pattern and the actual data.

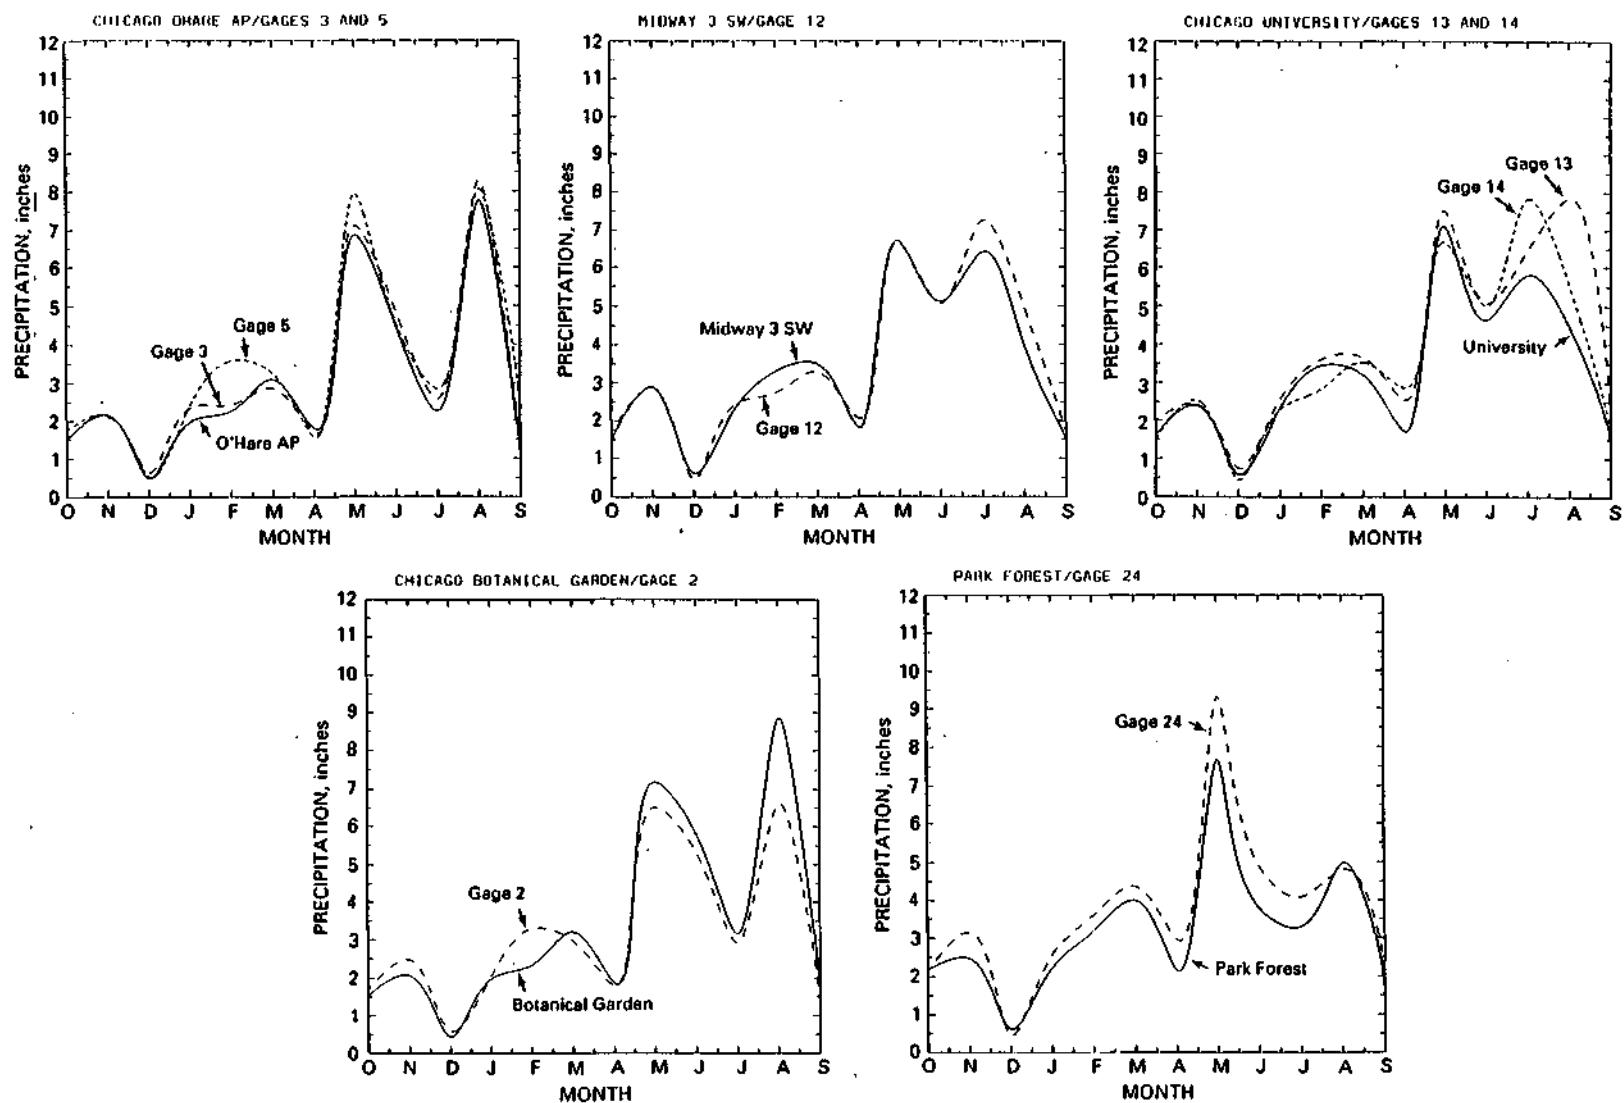
Figure 17. Comparisons of monthly precipitation amounts (inches) between network raingages and nearby NWS raingages, spanning the entire Water Year 1990 period.

With the exception of a few noticeable differences, trends and amounts of NWS and network raingages agreed closely (Figure 17). Discrepancies of note occurred in February 1990 between Chicago O'Hare AP and Sites #3 and #5, in July-September 1990 between Midway 3 SW and Site #12, and during much of the period March-September 1990 between Chicago University and Sites #13 and #14 when Chicago O'Hare AP, Midway 3 SW, and Chicago University, respectively, had less precipitation. Other discrepancies occurred in February 1990 between Chicago Botanical Gardens and Site #2, and in May-

September 1990 when the Botanical Gardens had less and more precipitation, respectively. Finally, the Park Forest NWS site consistently underestimated precipitation throughout the water year in comparison to Site #24. Overall, these comparisons reveal that differences were usually within the natural spatial variability associated with precipitation. In all cases, except for the Chicago Botanical Gardens (39.95 inches), the NWS sites captured less precipitation than did their nearby network counterparts over the water year (Table 3): Chicago O'Hare AP (35.59 inches); Midway 3 SW (39.60 inches); Chicago University (38.73 inches); and Park Forest (approximately 38.50 inches [March 1990 is missing]).

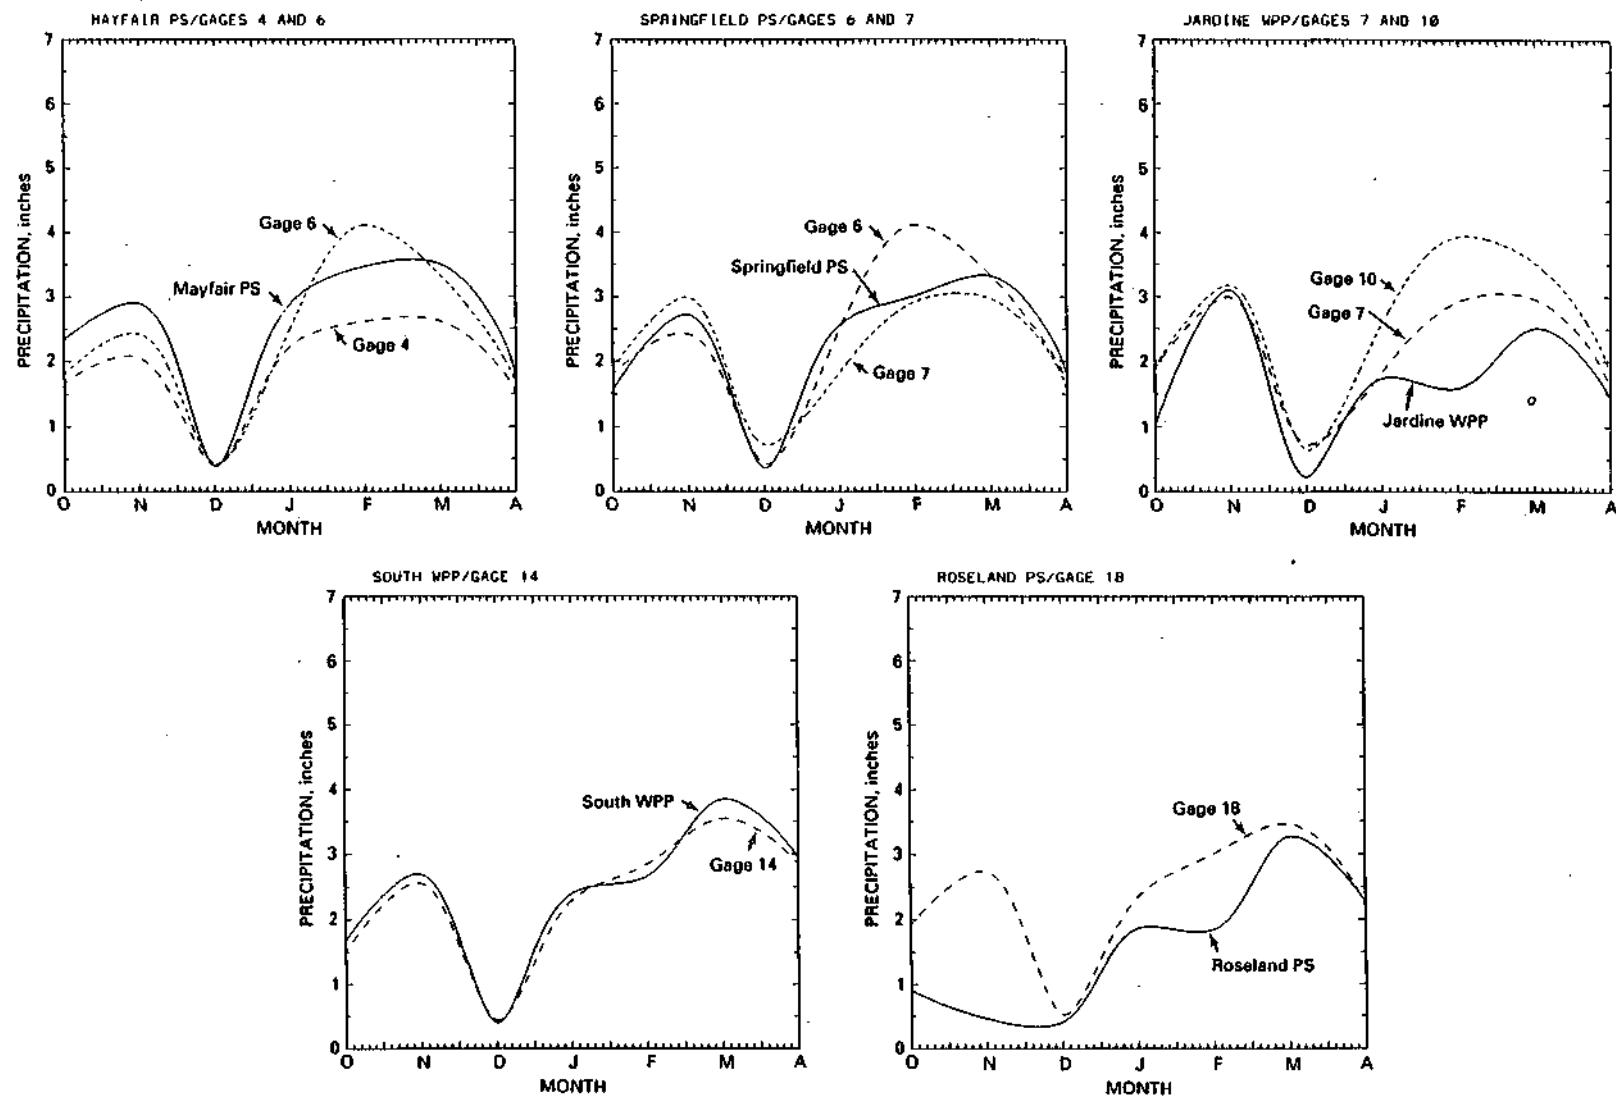
Figure 18. Comparisons of monthly precipitation amounts (inches) between network raingages and nearby CC raingages for the period October 1989-April 1990. Jardine WPP is located just east of Erie SDO (see Figure 1).

Comparisons between network raingages and their CC counterparts (Figure 18) for October 1989-April 1990 were much more variable, as expected. Although trends were generally similar between sites, amounts varied much more than they did for the NWS comparisons. Mayfair PS overestimated precipitation in comparison to network Sites #4 and #6 during October 1989-January 1990; Jardine WPP generally underestimated precipitation in comparison to Sites #7 and #10 throughout the entire October-April period; and Roseland PS greatly underestimated precipitation in comparison to Site #18 over the period. Amounts at Springfield PS tended to vary between amounts at Sites #6 and #7, while Site #14 and South WPP, which are located near each other, showed very good agreement. It had been noted in the adjustment work for other water years (e.g., Peppier, 1991) that some CC sites (and several MWRDGC ones) had consistently underestimated precipitation, due to both poor raingage exposure and to the use of tipping-bucket raingages, which inherently tend to underestimate precipitation. These months indicate that Roseland PS and Jardine WPP particularly underestimated precipitation.

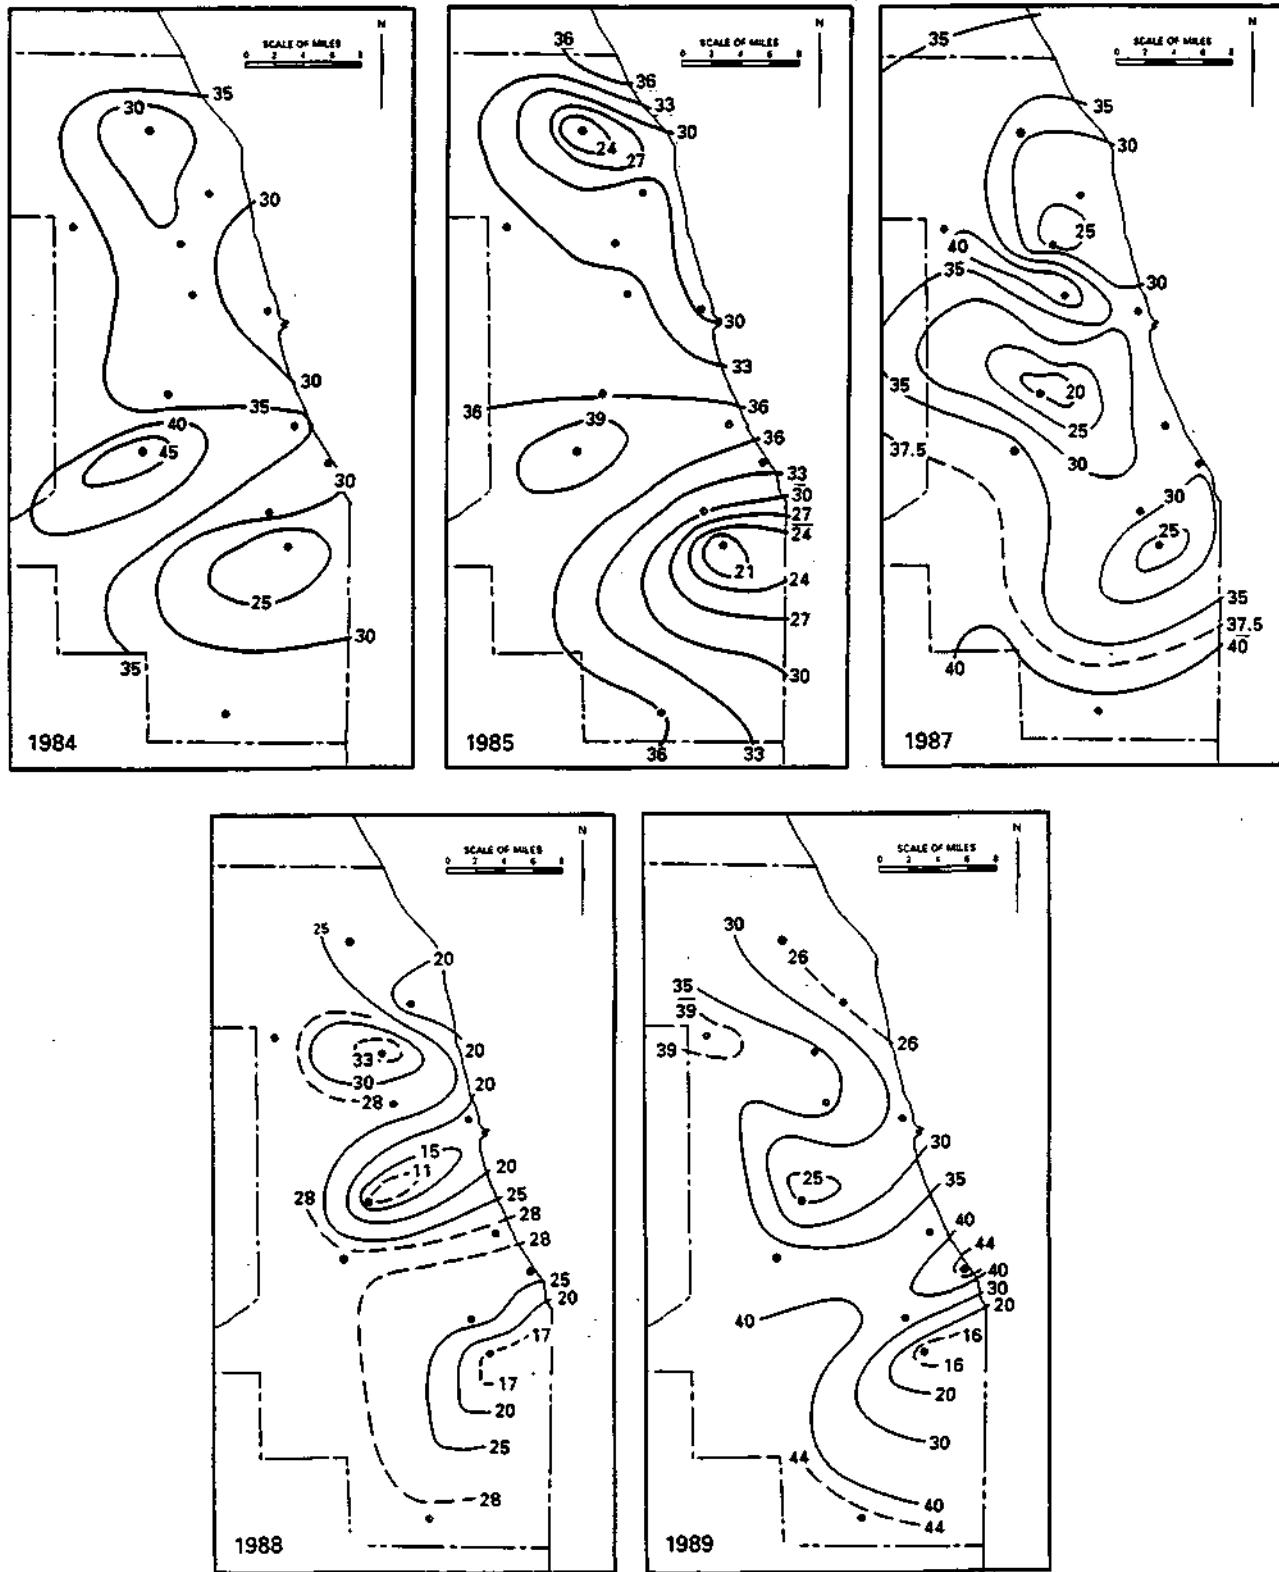
Figure 19. Raw precipitation patterns (inches) for Water Years 1984-1989 from NWS, CC, and MWRDGC raingages. Compare to Figure 4 for patterns from Water Year 1990 network raingages.

One final comparison is made here between the unadjusted data from Water Years 1984, 1985, 1987, 1988, and 1989 (Figure 19) and network totals from Water Year 1990 (Figure 4). Excluding the low values at West Southwest Sewage Treatment Plant (a MWRDGC site in the center of the region - Figure 1) which had many missing observations during Water Years 1987-1989, the network pattern for 1990 does not show the unusual patterns found in the other water years from the NWS, CC, and MWRDGC gages that necessitated the adjustment of those data. In this sense alone, the new network is sampling the precipitation of the Cook County region much more consistently than the previously used gages did in the 1980s, and the data it provides are a great improvement over data collected prior to October 1989.
