The 1993 Flood on the Mississippi River in Illinois

Illinois State Water Survey
Miscellaneous Publication 151

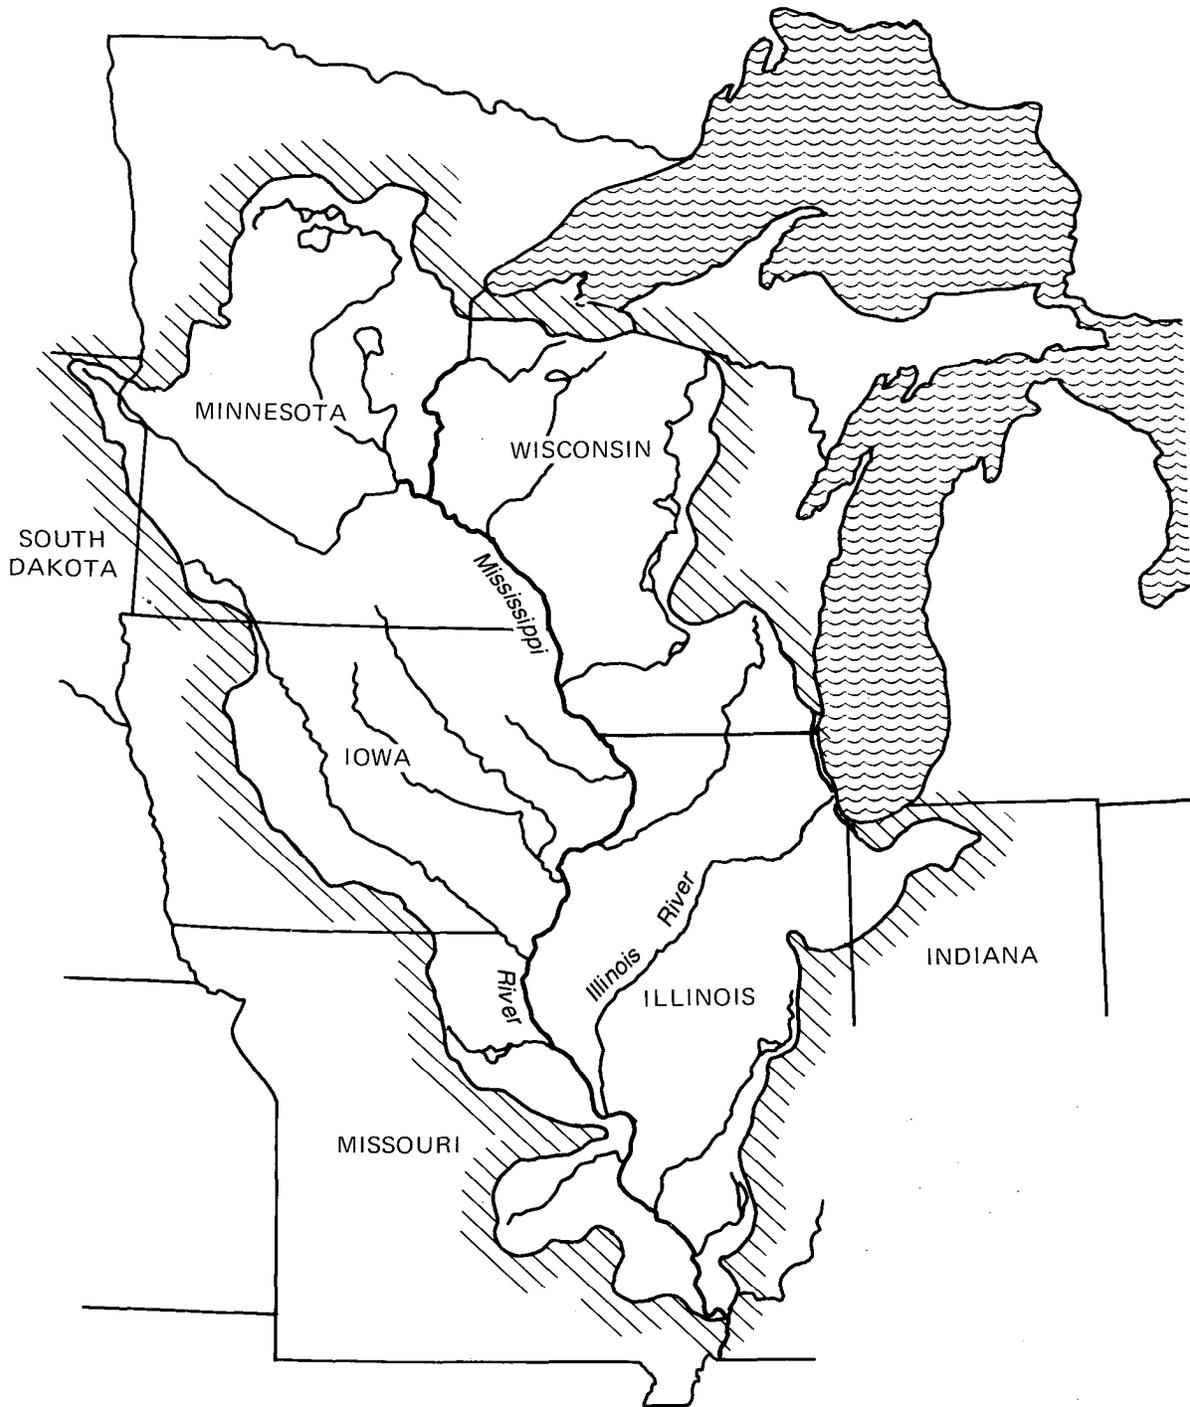
Figure 2.1 The Upper Mississippi River system
(after UMRBC, 1981)

The UMR basin is elongated in shape, lying on a north-northwest to south-southeast axis between latitudes 37° and 48° and longitudes 86° and 97°. It is approximately 550 miles wide by 750 miles long. This region is largely within the Central Lowland physiographic province, except in

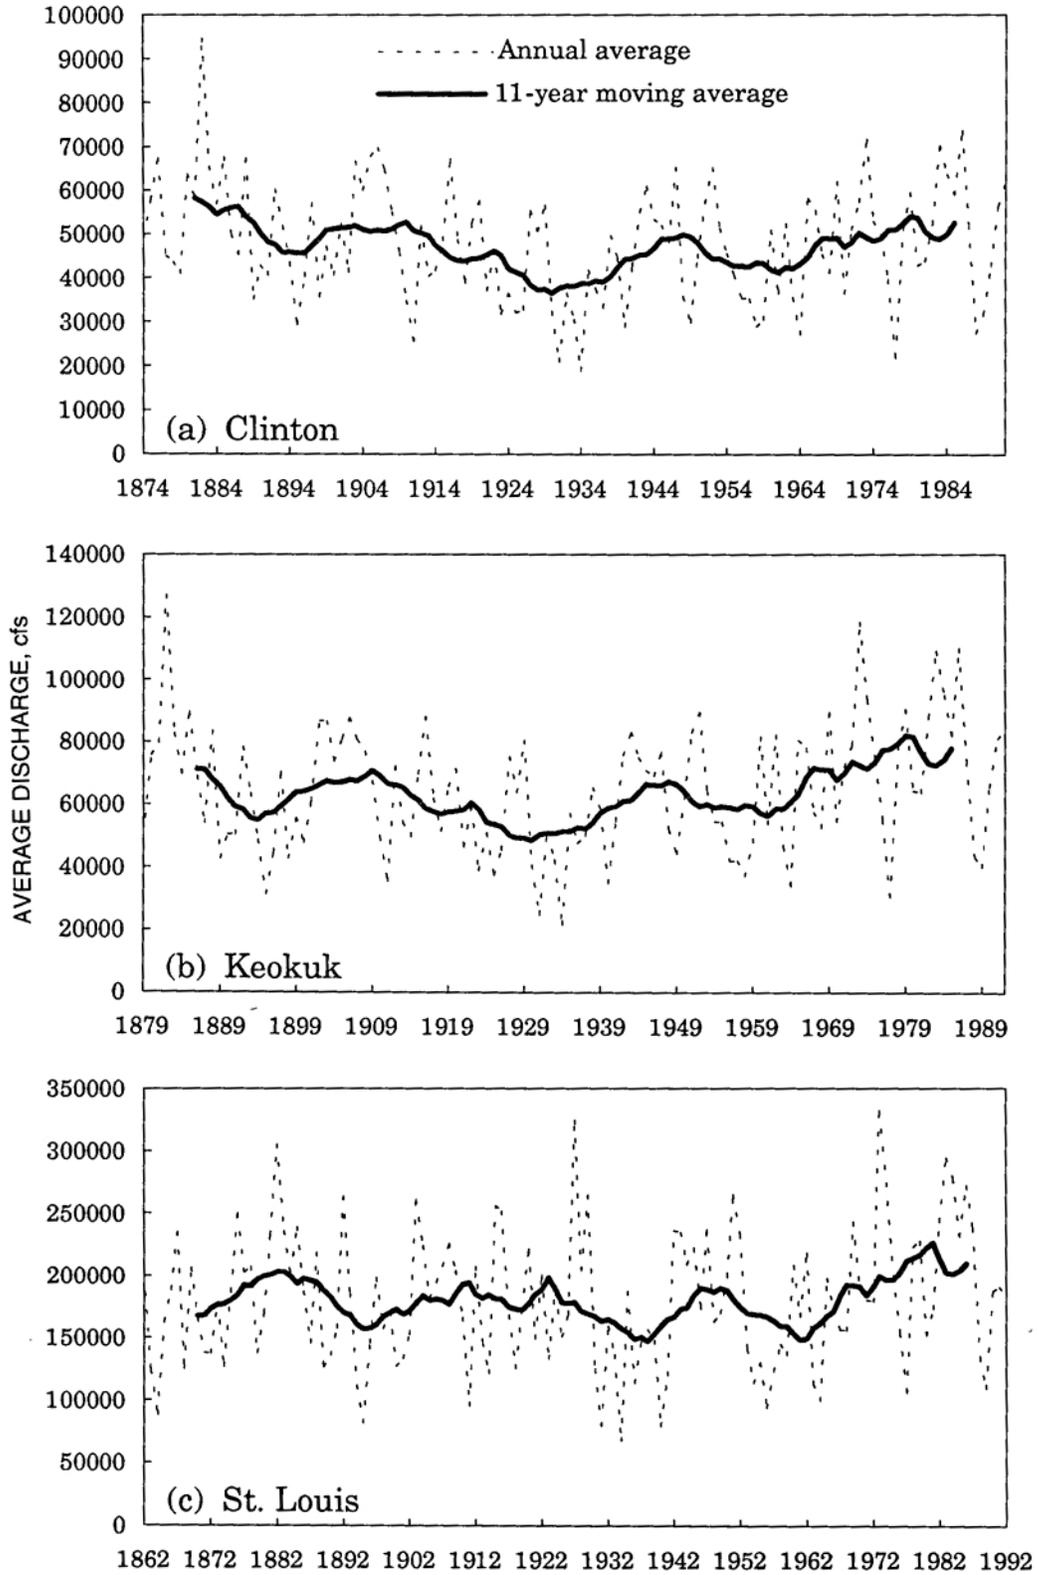
Figure 2.8. Average annual flows and the 11-year moving average flow on the Mississippi River at Clinton (a), Keokuk (b), and St. Louis (c)

The average flow in the Upper Mississippi River varies over time, not just annually, but over decades and multiple decades. Table 2.2 shows the changes in average flow as measured at three long-term gaging stations on the Upper Mississippi River, and figure 2.7 shows the locations of the gaging and stage recording stations in Illinois. The change in average flow over time is also illustrated for the Clinton, Keokuk, and St. Louis gages in figure 2.8, along with the 11-year moving average of the annual values. As illustrated, the average flow has changed over time, and occasionally the 11-year average flow has differed from the long-term average by more than 15 percent. For most locations along the Mississippi River, the 28-year period since 1965 has witnessed the highest average conditions on record. Despite the periodic differences in average streamflow, the long-term average flow has remained remarkably consistent over time. Figure 2.9 shows the cumulative streamflows at Clinton; Keokuk, Iowa; and St. Louis over the respective periods of record.

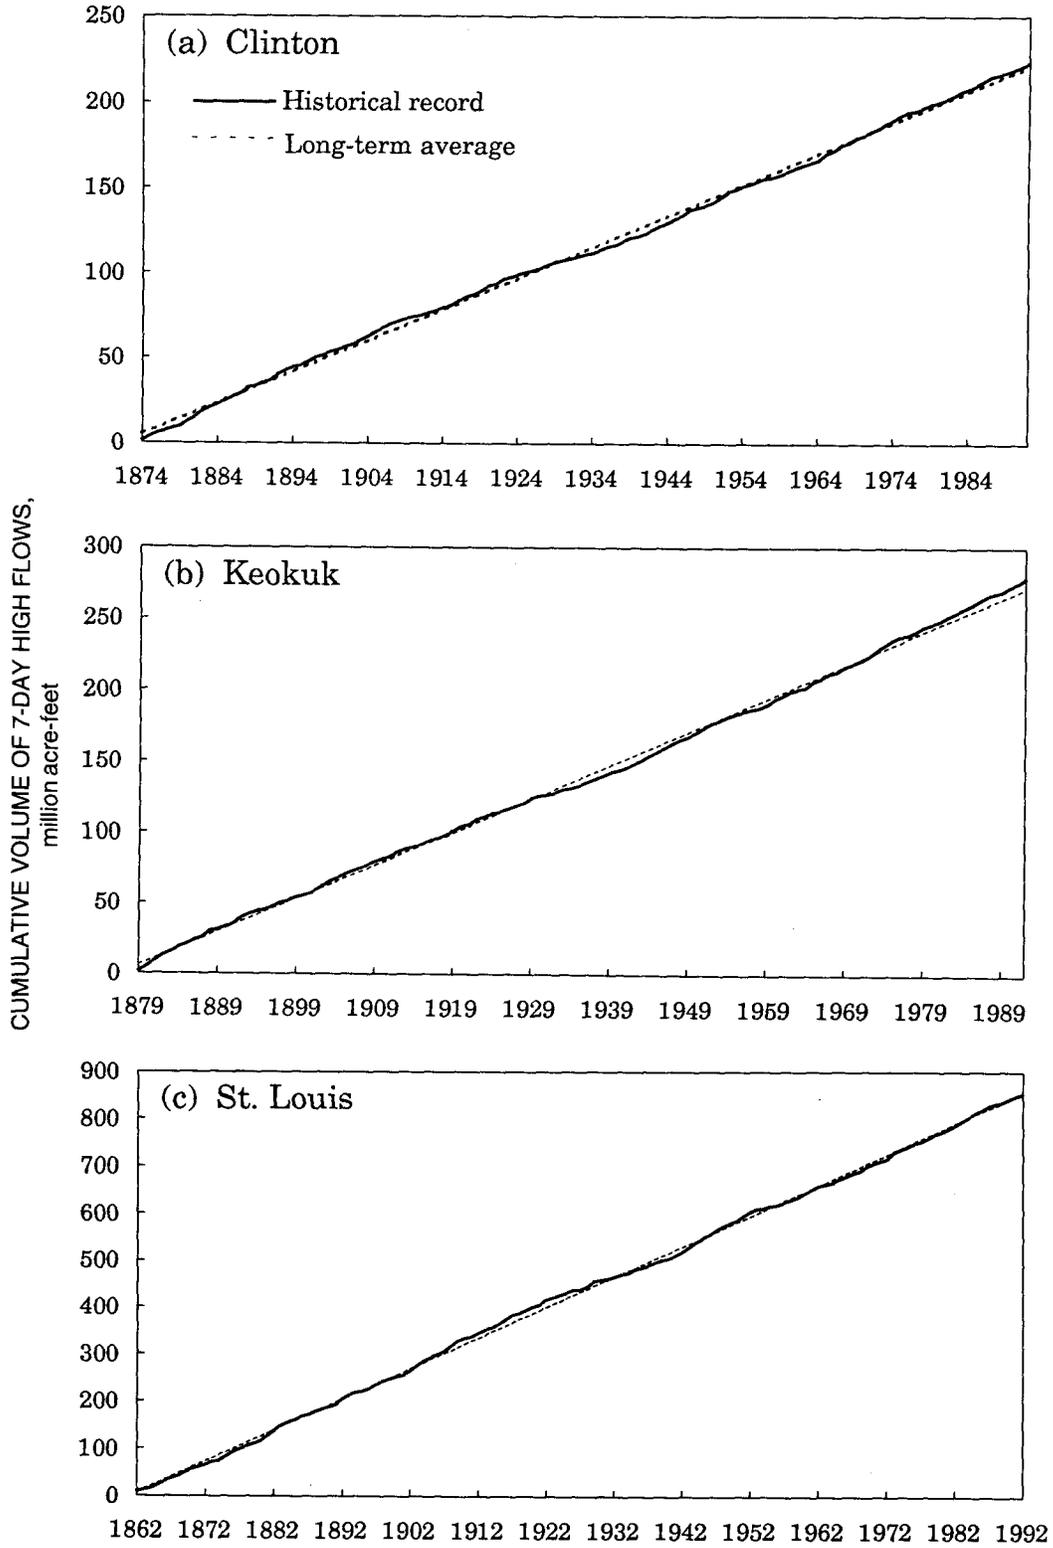
Figure 2.11. Cumulative volume of annual 7-day high flows at Clinton (a), Keokuk (b), and St. Louis (c)

Figure 2.11 shows the cumulative volumes associated with annual high flows along the Mississippi River at Clinton, Keokuk, and St. Louis. During the last 20 years, the 7-day high flows experienced at Keokuk have been, on average, 15 percent greater than the long-term average high flows. This change shows in figure 2.11b as a moderate divergence between the cumulative volume (solid line) and the long-term average (broken line). At both Clinton and St. Louis, the deviation of high flows from the long-term average is insignificant. But the increase in high flows shown by the Keokuk record is not consistent with observed trends in high flows on the tributaries to the Mississippi. Although the Illinois River has shown increases in its high flows (Ramamurthy et al., 1989), none of the other major tributaries in the vicinity of Keokuk shows such increases. The Des Moines and Iowa Rivers have experienced decreases in high flows, likely from the impact of flood control reservoirs.

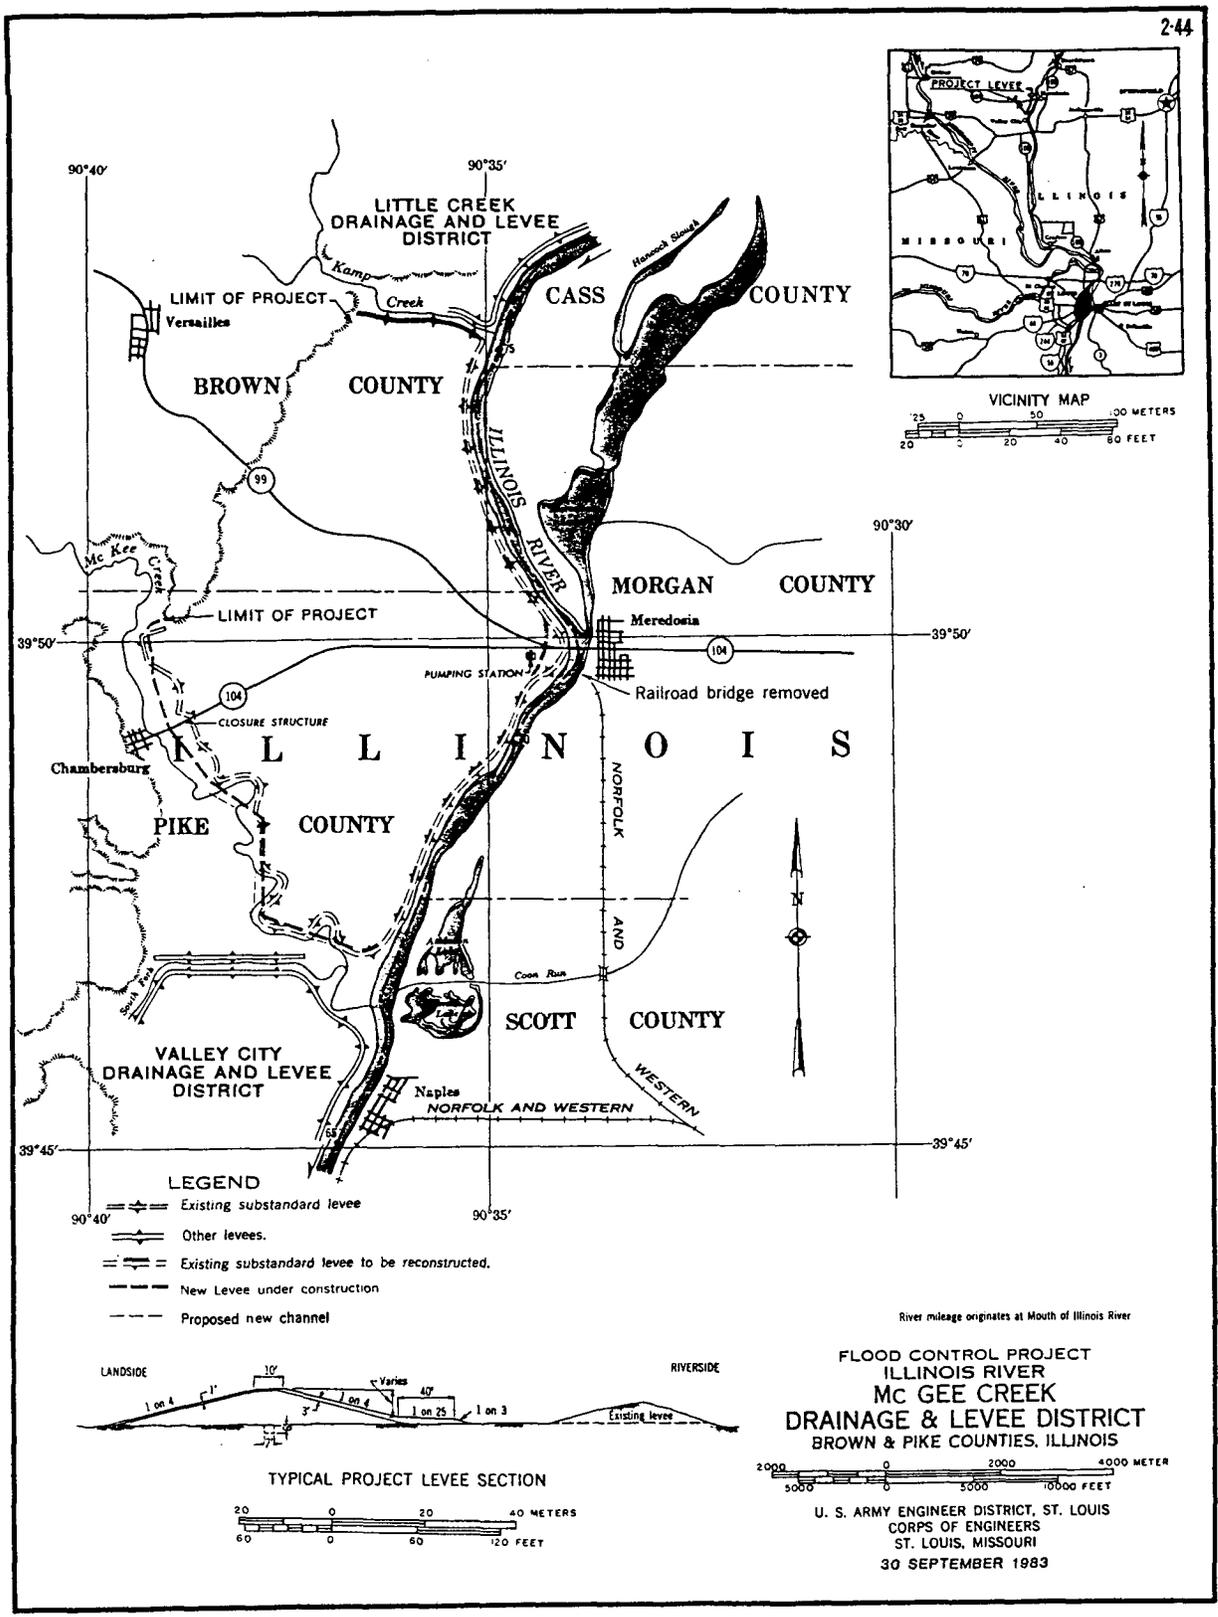
Figure 2.14. McGee Creek Levee and Drainage District along the Illinois River (after USACOE, 1980)

Width at the levee top should be 10 to 20 feet or more, so that major levees can support a crushed stone road to facilitate levee maintenance and repair. Figure 2.14 shows a typical cross

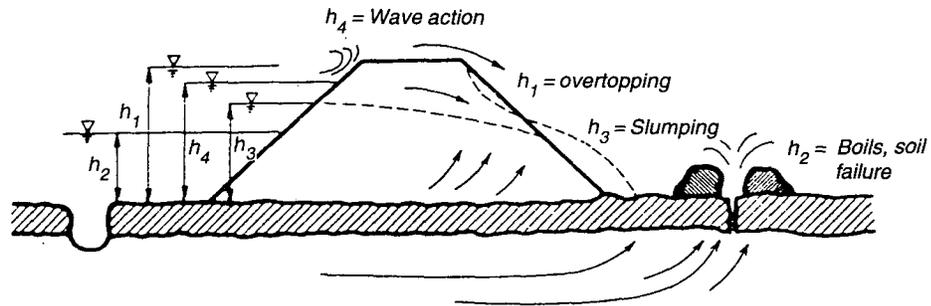
Figure 2.16. Conceptual levee failure mechanisms (after Bogardi and Mathe, 1968)

Failure of a levee by overtopping can occur regardless of any foundation problems. As the floodwaters start flowing over the levee crown toward the land side, soil erosion begins. This is

progressively aggravated by several factors: increasing water depths and velocities, rapid erosion of the levee crown, and erosion of the land-side face of the levee. When levee failure or breach eventually occurs, it is typically limited to a few weak and somewhat lower sections (probably because of settling) of the levee.

In the Upper Mississippi and Lower Illinois River floodplains, alluvial deposits are covered by one or more layers of relatively pervious material or by layers of less permeable silty sands and slightly permeable clays. In many cases, conditions favor sand boils, the relatively fast passage of flood waters through pervious layers under the levee base to the area protected by the levee. This in turn leads to the phenomenon of piping.

Bogardi and Mathe (1968) have considered various phenomena leading to levee failure (figure 2.16), including: 1) overtopping, 2) sand boils and hydraulic soil failure, 3) saturation and

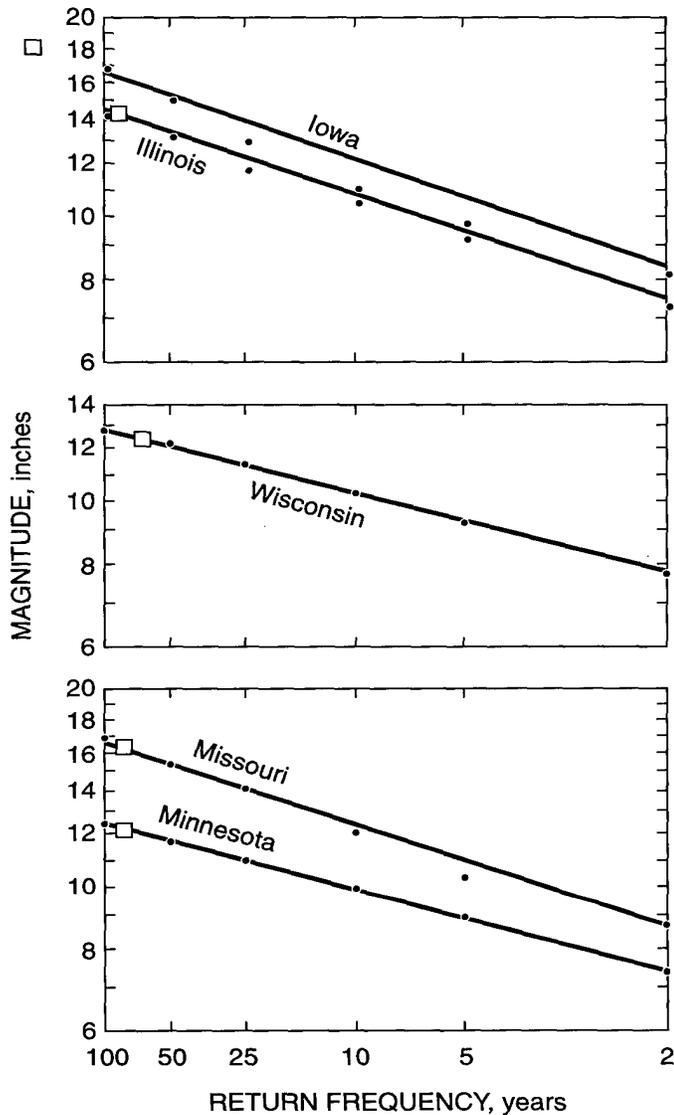
Figure 3.5. Magnitudes of June and July precipitation for various return frequencies (1993 is indicated by the open boxes)

The June-July precipitation for the Mississippi River basin upstream of Quincy, Illinois, totaled 14.24 inches. This represents about twice the 30-year average (normal) and the greatest two-month precipitation over the basin since records began in 1895. Table 3.6 presents the ten greatest

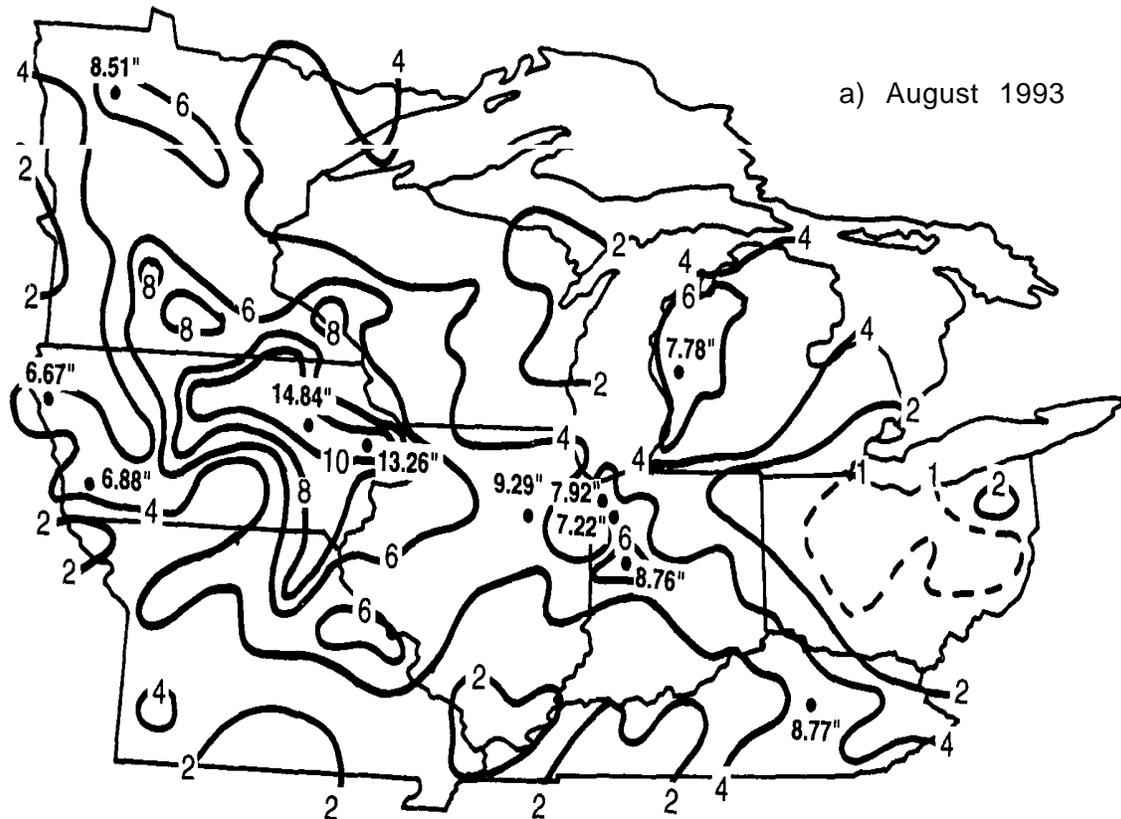
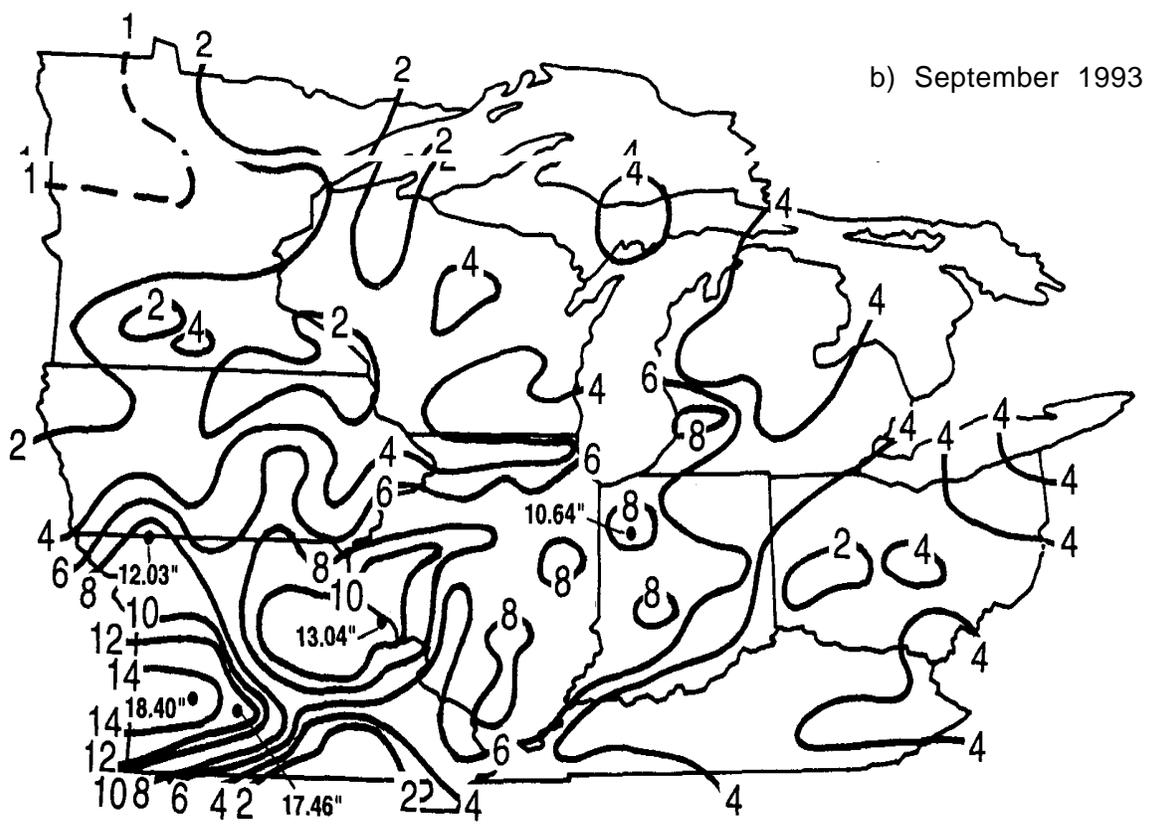
Figure 3.6. Total precipitation for August (a) and September (b) 1993

Precipitation from September 1992 through August 1993 over the same watershed was the greatest of any 12-month period since 1895. In fact, the 12-month total of 49.2 inches is fully 7 inches above the previous record set from June 1972 to July 1973 (also a major flood year). Precipitation for June 1993 was the fifth greatest of any single month, and that from July 1993 was the tenth wettest month, again, since 1895.

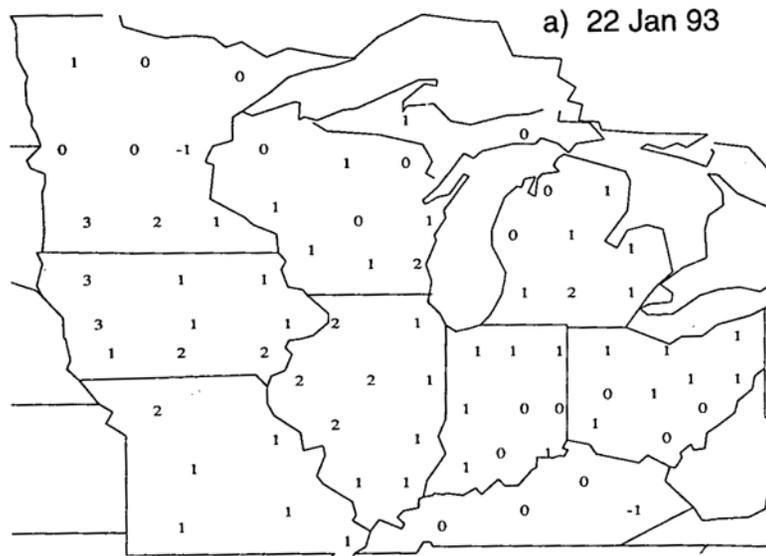
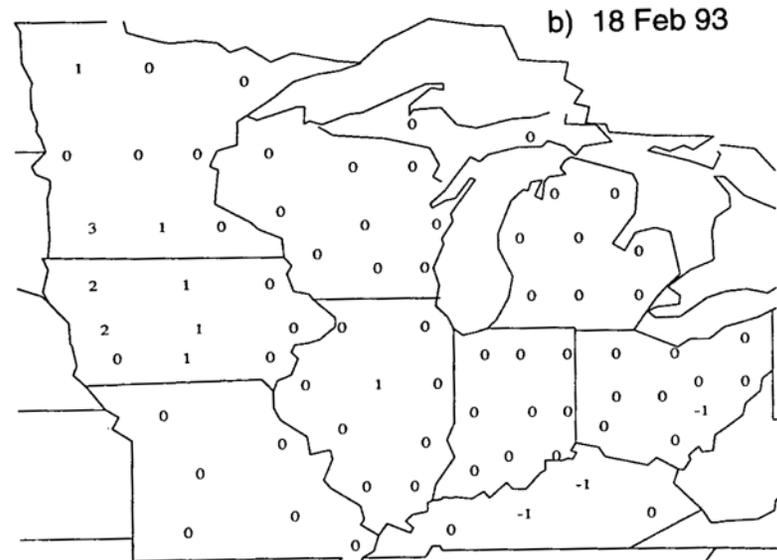
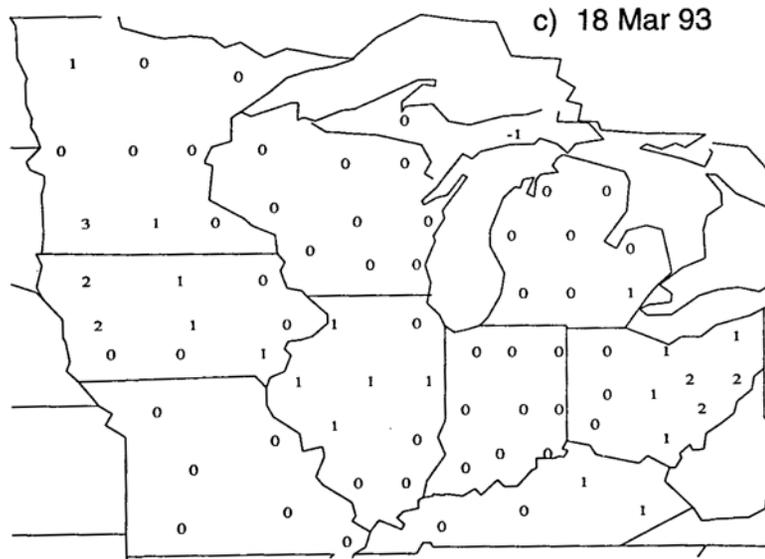
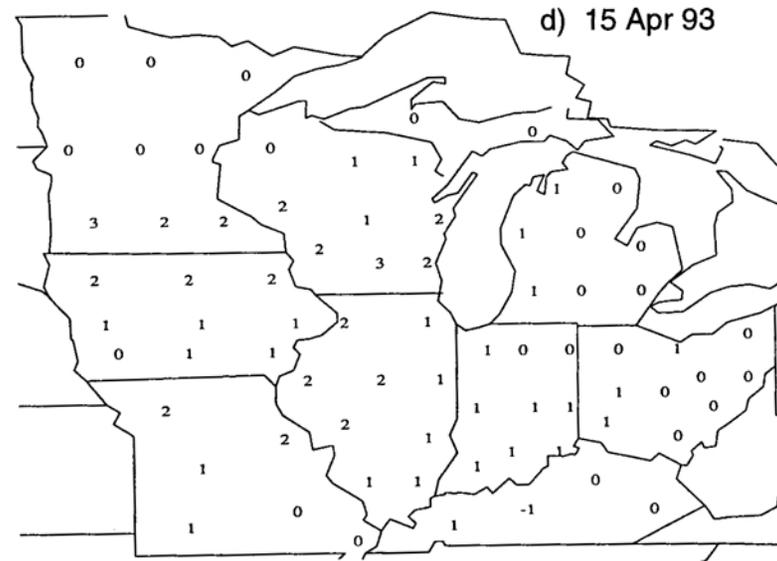
Figure 3.7. Soil moisture deviations from average for January (a), February (b), March (c), and April (d) 1993

Four weeks later, soil moisture had declined by about one inch to near the average of 10 to 12 inches over Missouri, Illinois, Indiana, and Ohio, and to slightly less than the average of 10 to 12 inches in Kentucky (figure 3.7b). As of March 18, with little precipitation in northern sectors and a bit more than average in the south, soil moisture was essentially unchanged, although it increased slightly in Ohio and Kentucky (figure 3.7c).

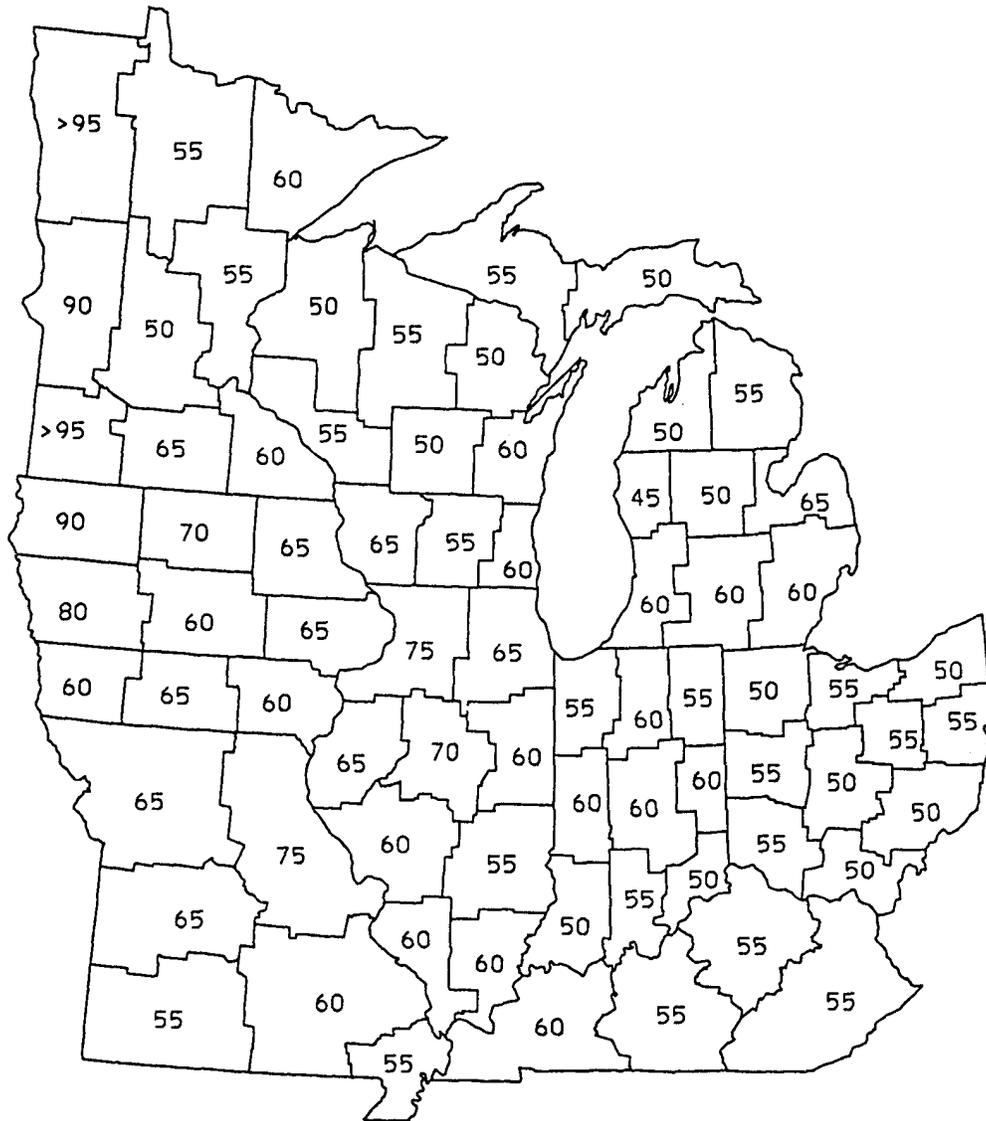
Figure 3.9. Percentage of probability of above-average soil moisture on March 1, 1994

Figure 3.9 shows the probability that soil moisture levels will be above normal on March 1, 1994, the meteorological beginning of spring. The probabilities are greater than 60 percent throughout the western half of the Corn Belt. In western Minnesota and northwestern Iowa, probabilities are 90 percent or greater. Therefore, it is highly likely that spring runoff will be greater than normal and that the soil will have a very limited ability to absorb spring rains or snowmelt. The size of the

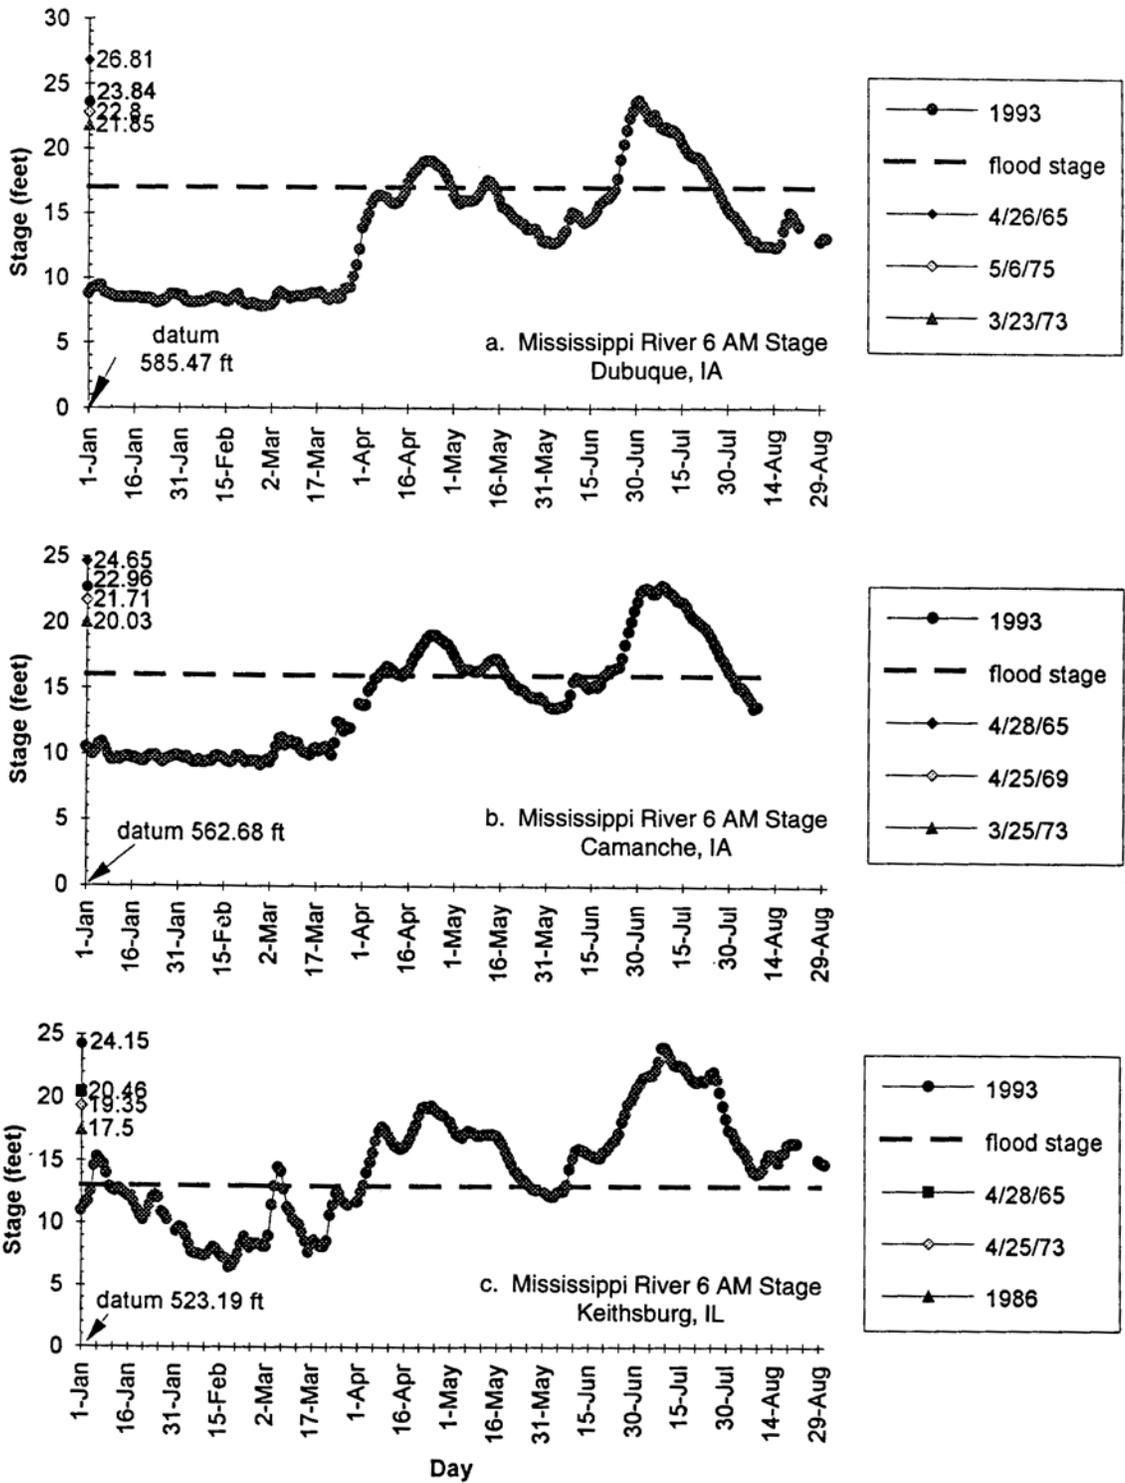
Figure 3.10. Mississippi River stages from January 1 through August 29, 1993, at Dubuque (a), Camanche, IA (b), and Keithsburg (c)

The record-setting peak stages in July and August along the Mississippi were preceded by several months of high flows with stages repeatedly exceeding flood stage. The Dubuque and Camanche station data (figures 3.10a and 3.10b) clearly show the two major flood waves, the first rise occurring in mid-April. The pattern of the stages recorded at these two stations differs from the pattern recorded at stations downstream, where flood stage was exceeded in March. Several major tributaries join the Mississippi between Camanche and Keithsburg, the next station downstream (figure 3.10c): the Rock and Edwards Rivers enter from the east; and the Maquoketa, Wasipinicon, and Iowa Rivers from the west. The contribution of these tributaries is indicated by the elevated river stages in early March at the stations downstream of Camanche (figures 3.10c and 3.11). Between the Keithsburg and St. Louis stations, the Missouri and Illinois Rivers join the Mississippi. The impact of flow contributions from these major tributaries can be seen in the undulations in the stage data, i.e., multiple peaks superimposed on the flood wave, in the plots for St. Louis (figure 3.12a) and stations farther downstream.

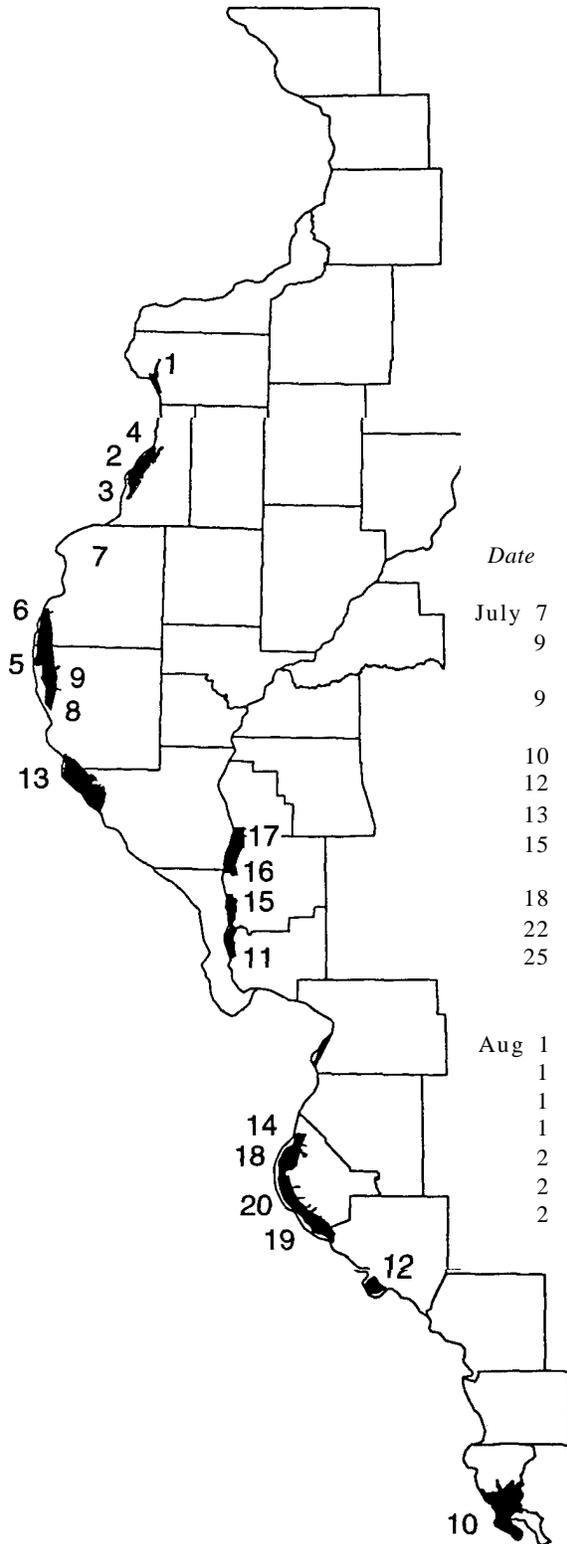
Figure 3.18. Failed levees in Illinois

The first Illinois levee was breached on July 7 at Pope Creek near Keithsburg, which protected 1,260 acres. The levee of the Lima Lake Drainage District, near the small town of Meyer, failed two days later (July 9). This break also caused flooding at the Hunt Levee and Drainage District, where 28,600 acres were inundated. The three levees in Henderson County near Gulfport failed the same day, flooding an additional 15,000 acres. The flooding of Niota on July 10-11 and the subsequent oil spill raised the fear of floodwaters contaminated with hazardous materials.

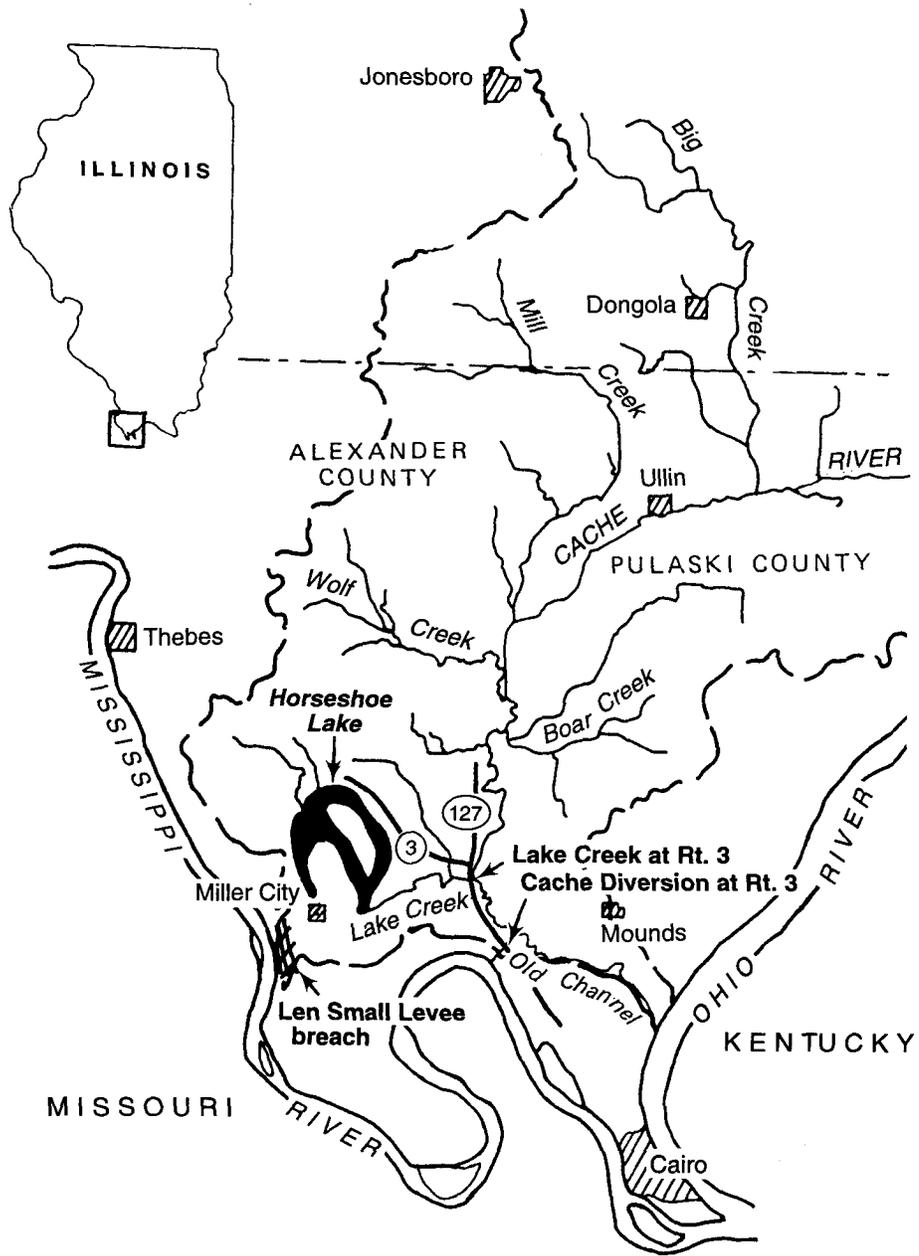
Figure 3.19. The Len Small Levee breach area on the Mississippi River, including the locations of the stage measuring stations

Water elevations were measured at these stations as well as at the Thebes station on the Mississippi (figures 3.20 and 3.21). The data were plotted according to measurements made around 7:00 a.m. each day, and missing data points were interpolated. As the levee breach widened, water levels rose at the temporary stations. By the beginning of August, the water-level fluctuations on Lake Creek and at the Cache River diversion were mimicking the fluctuations in stage of the Mississippi River recorded at Thebes.

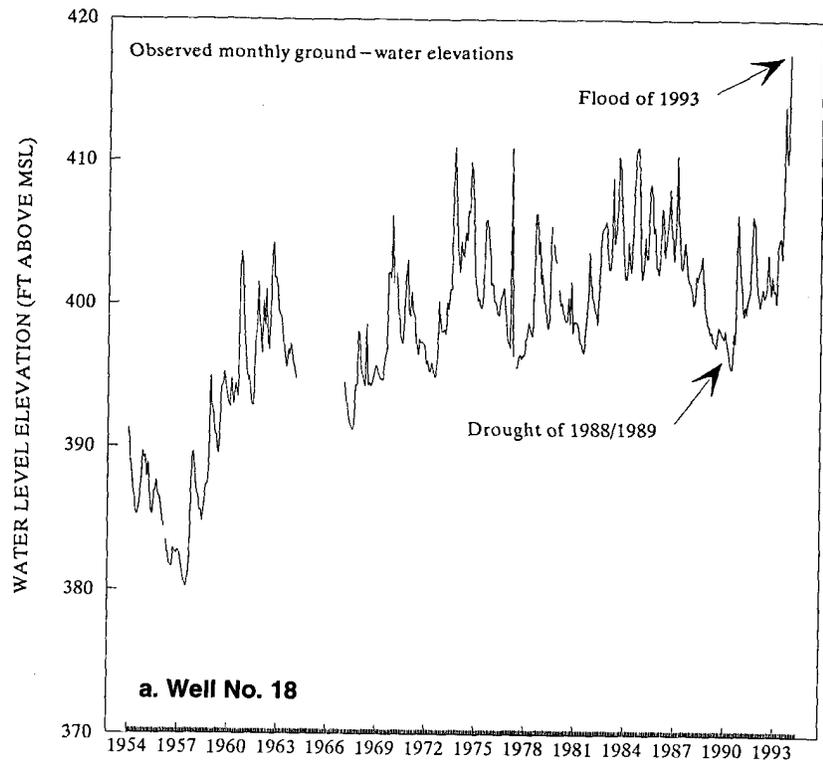
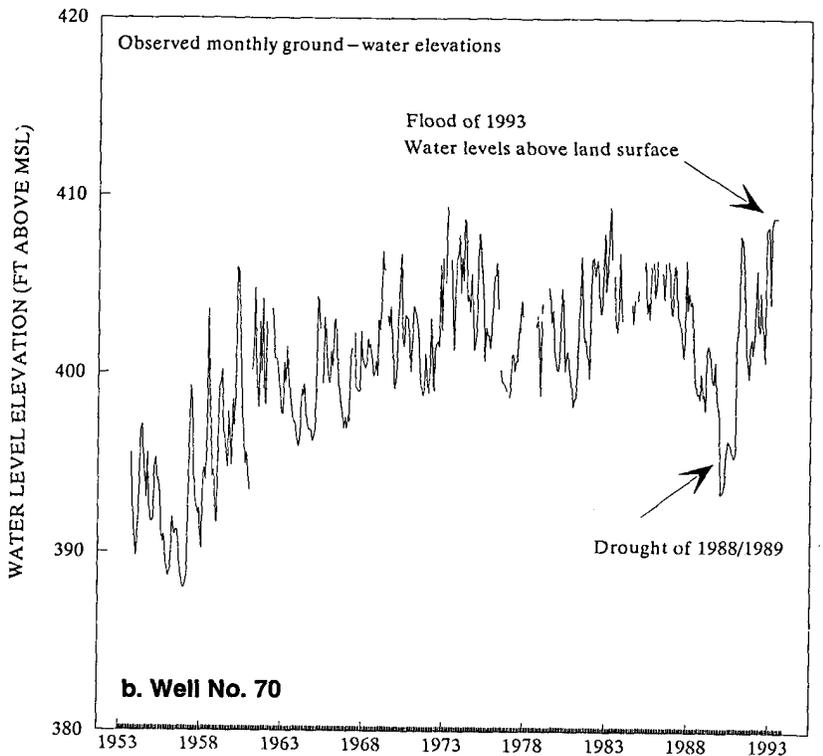
Figure 4.4. Ground-water levels in USACOE relief wells 18 (a) and 70 (b) along the Chain of Rocks Canal near Granite City

Granite City, Cahokia, Venice, and East St. Louis are a few cities now experiencing problems with sewer failure. Granite City has reportedly experienced 16 such sewer failures to date. Some of these breaks have occurred on major sanitary sewer lines, leaving residents without this vital public utility. Fluctuations seen in the hydrograph for U.S. Army Corps of Engineers relief wells 18 and 70 (figures 4.4a and b) located along the Chain of Rocks Canal near Granite City, Illinois, show ground-water levels at all-time highs since the Illinois State Water Survey started collecting data from them in the early 1950s. These ground-water levels correlate closely to Mississippi River stages because of the hydraulic connection between the river and the sand-and-gravel aquifer. The hydrograph for LaClede Steel Company Well No. 1 near Granite City (figure 4.5) shows that at the end of August 1993, the second highest ground-water level ever was recorded at this well. Continued high ground-water levels in the Mississippi River bottomland regions may persist well after river stages have receded.

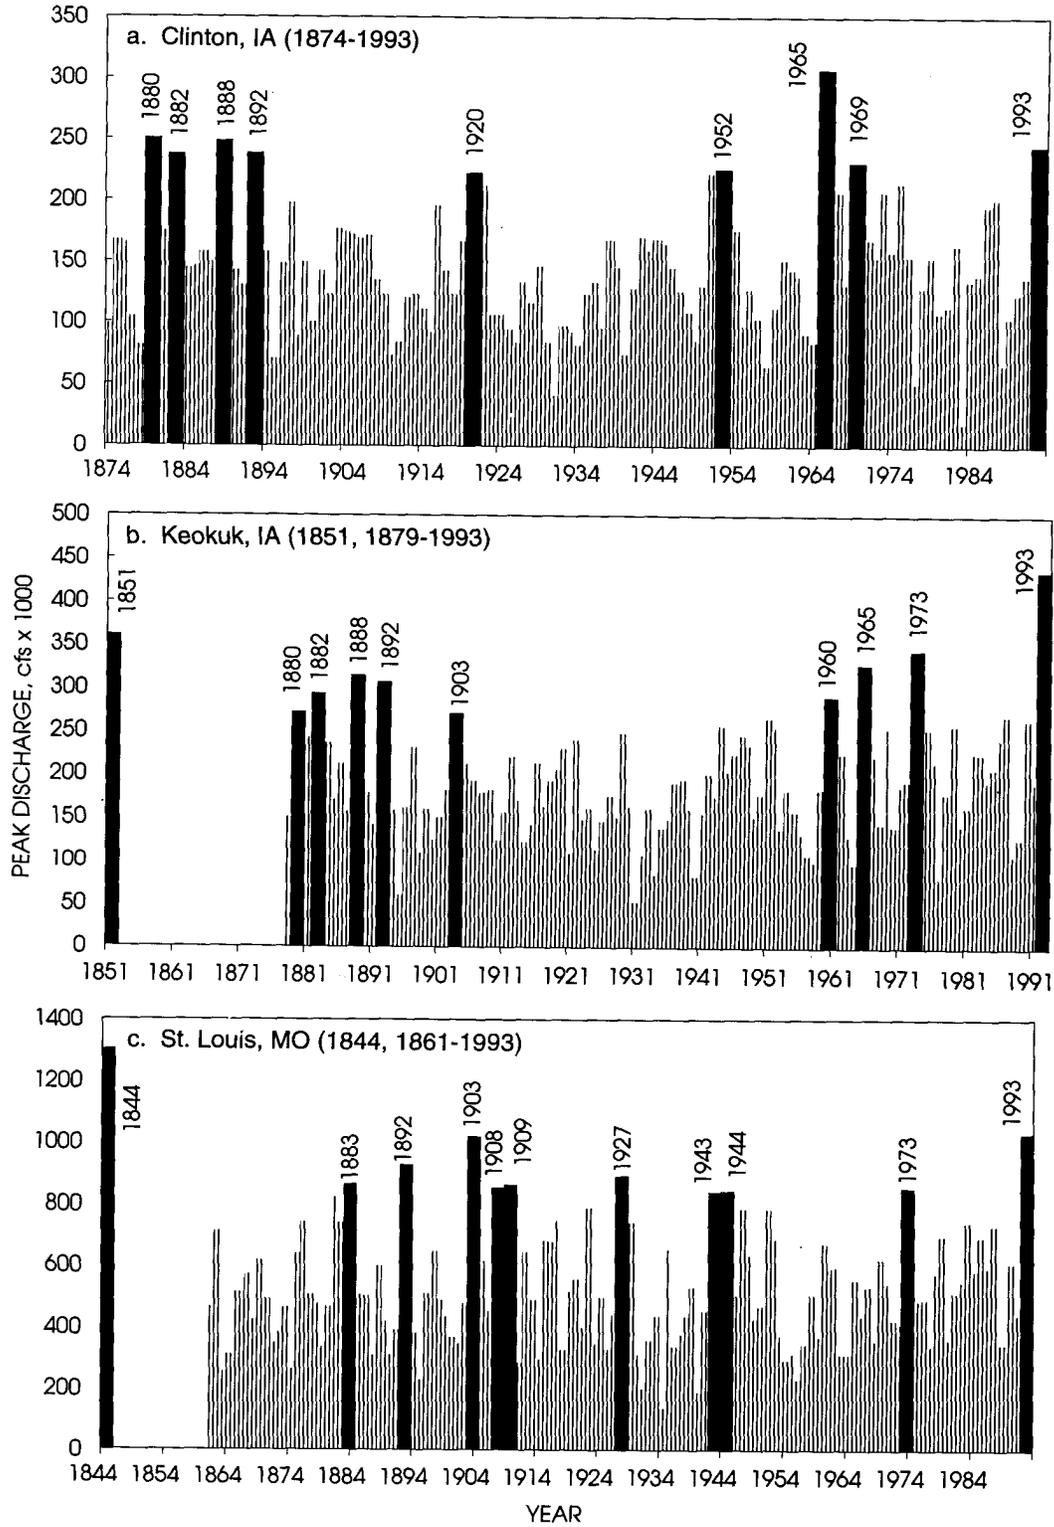
Figure 6. Annual peak discharges at Clinton, IA (a), Keokuk, IA (b), and St. Louis, MO (c) (major flood events highlighted in black)

Peak discharges and high flows at the Keokuk gage are somewhat higher over the last 25 years, and are closely correlated to the higher amount of precipitation and average streamflow that has also occurred over that period. Expected high flow values were estimated for the Mississippi River gages using long-term precipitation as the independent variable. For the Clinton and Keokuk records, the differences between the expected and observed high flows have no trend. Therefore, all observed changes in high flows and peak discharges at these two stations appear to be related to climate variability.

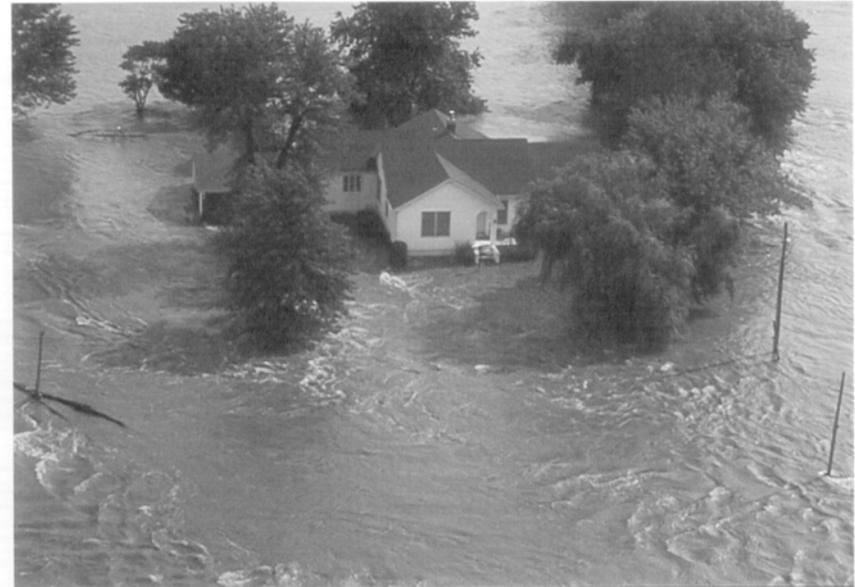
Len Small Levee breach causing severe damages (photo courtesy of U.S. Army Corps of Engineers)
