The 1993 Flood on the Mississippi River in Illinois

Illinois State Water Survey
Miscellaneous Publication 151

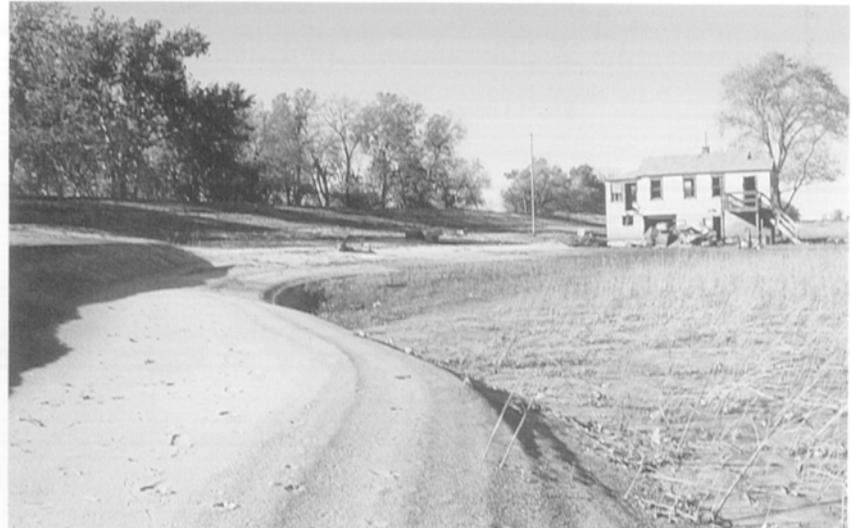
Sand deposit behind a failed levee district north of Quincy

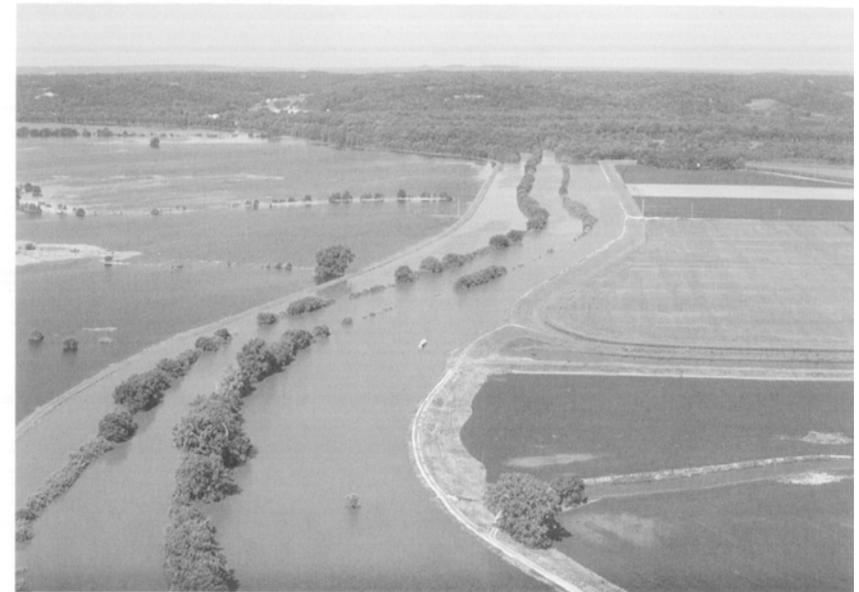
Failed levee (left) and intact levee (right) on the Illinois River

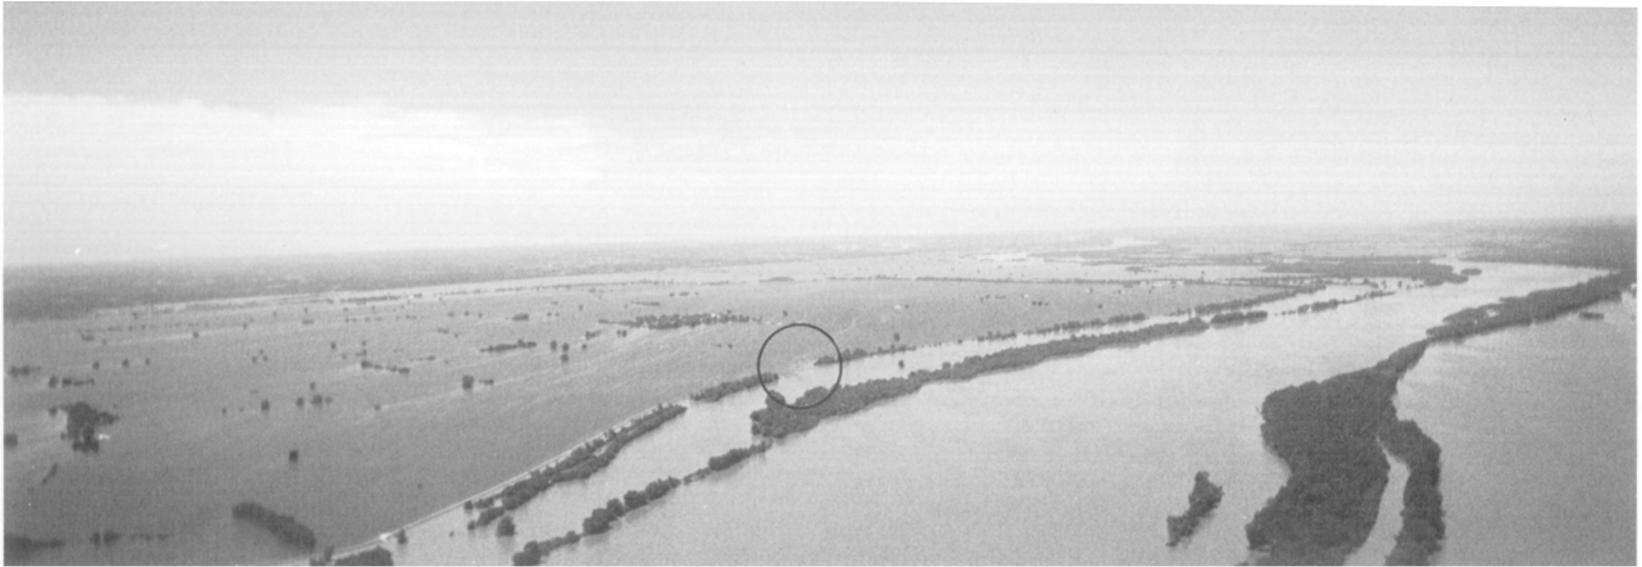
Kaskaskia Island looking north. Circled area shows broken levee.

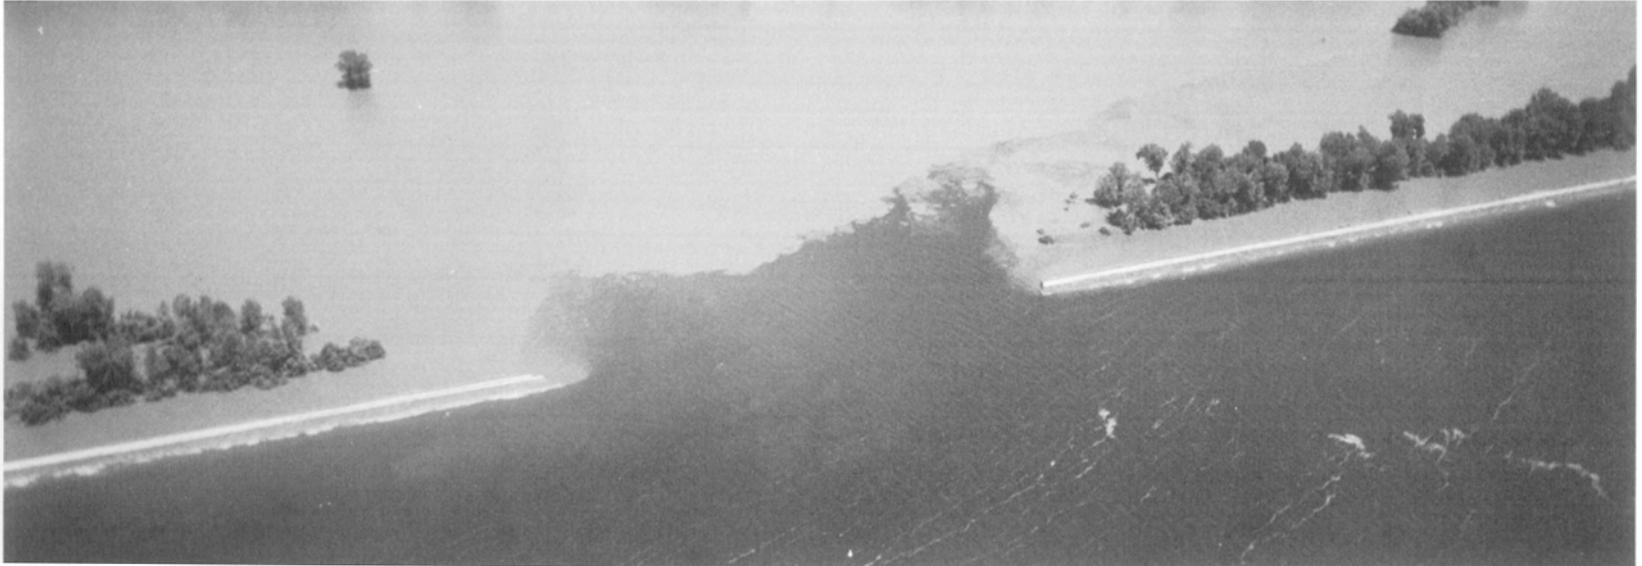
Broken levee at Kaskaskia Island
