Contract Report 2000-03

Kankakee River Basin in Illinois: Hydraulics, Hydrology, River Geometry, and Sand Bars

Interim Report

Illinois State Water Survey
Watershed Science Section
Champaign, Illinois

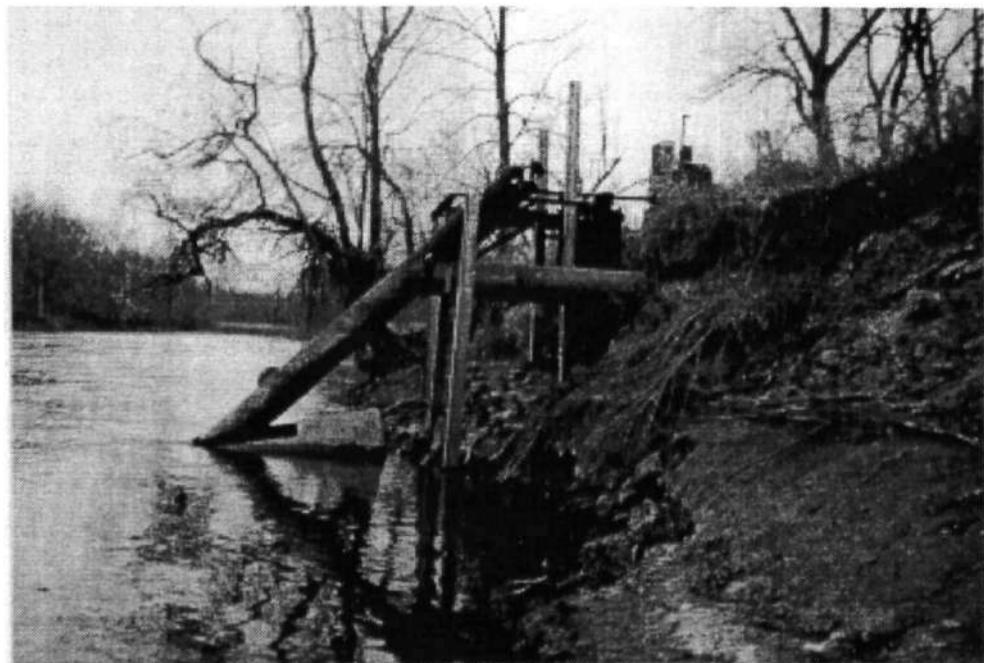
Figure 9b. An example of a rural pump station and bank erosion conditions along the Kankakee River in Indiana

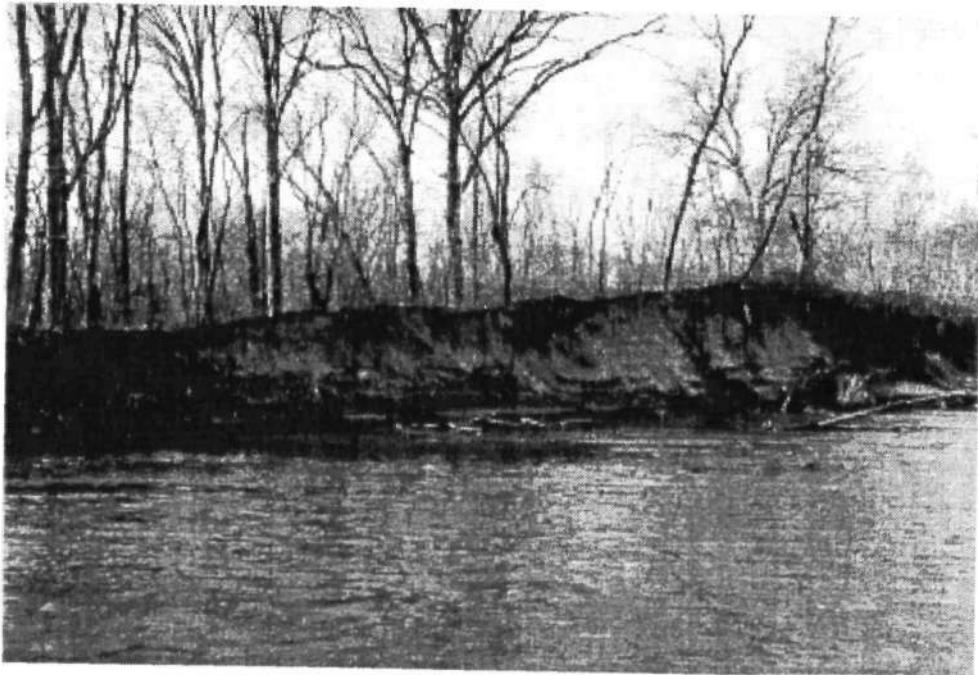
Figure 10a. An example of mass wasting along the Kankakee River in Indiana
