Contract Report 643

Sedimentation Survey of Lake Vermilion, Vermilion County, Illinois

Prepared for the
Consumers Illinois Water Company

May 1999

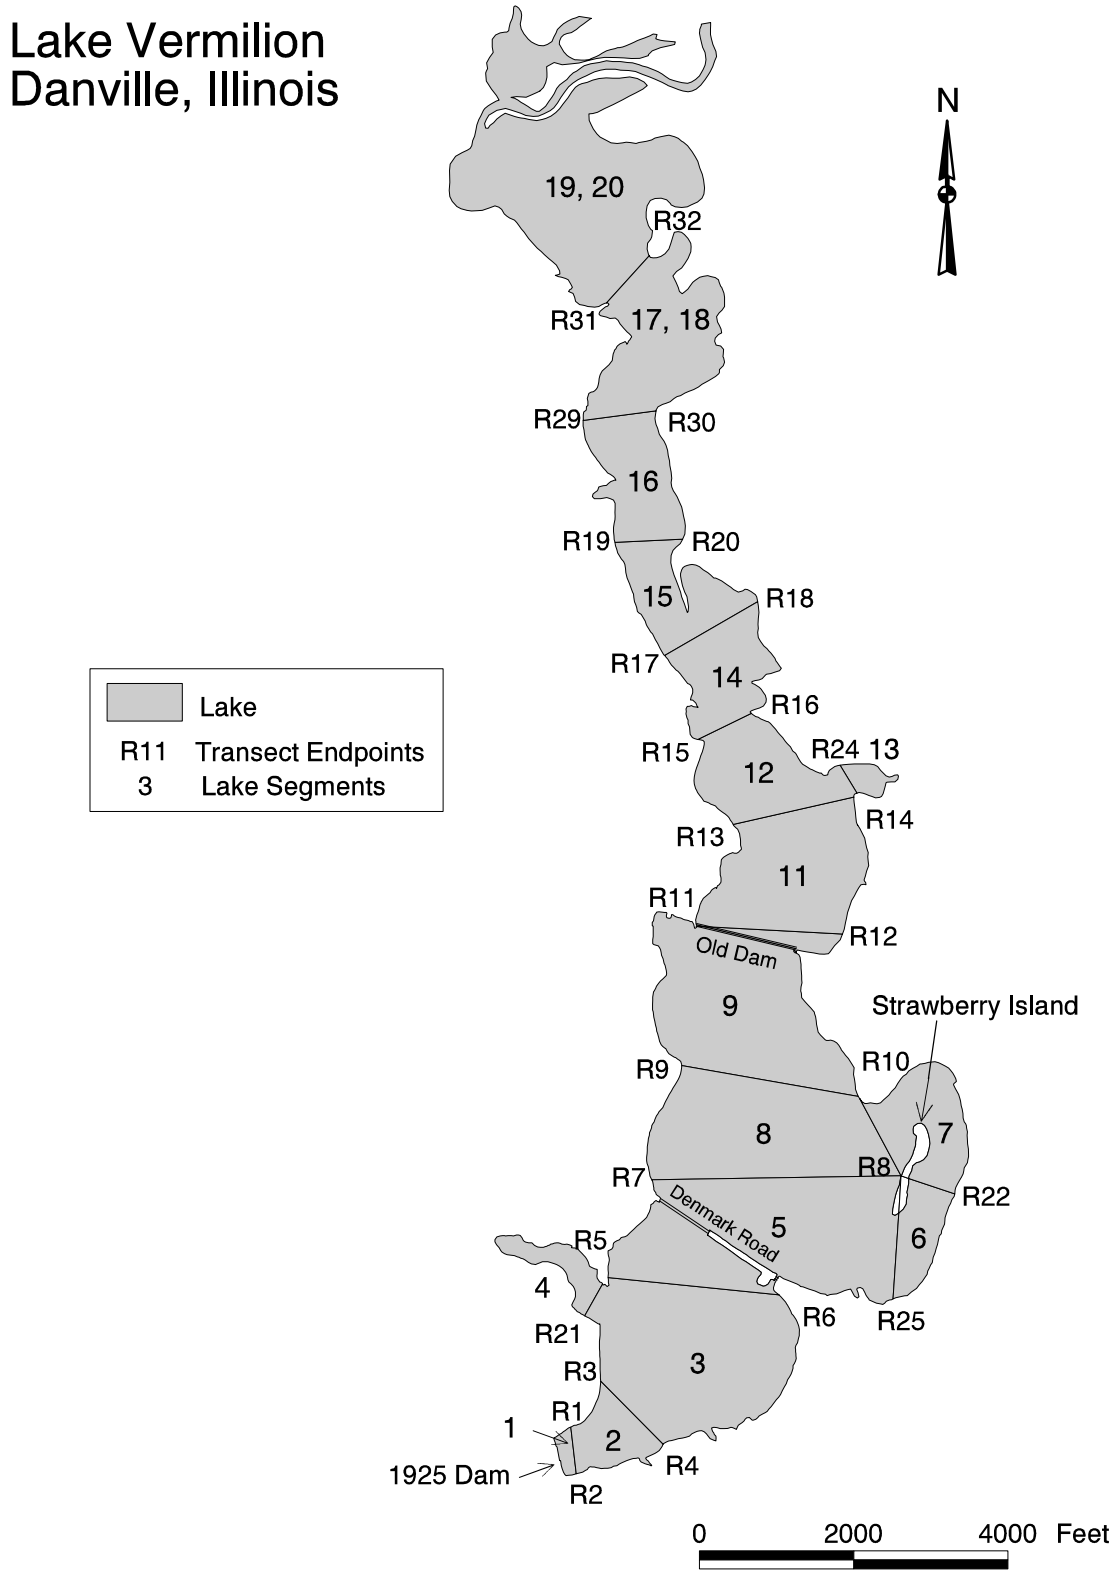
Figure 2. Survey plan for Lake Vermilion, 1998

The ISWS conducted sedimentation surveys of Lake Vermilion in 1963 (Neibel and Stall, 1964) and 1976 (Bogner and Gibb, 1977). The 1998 sedimentation survey of Lake Vermilion (figure 2) repeated as closely as possible a series of survey lines established during the 1963 survey. In 1963, cross sections were laid out at 18 lines across the lake, surveyed, and monumented by installing 4-inch by 4-inch concrete posts to mark the transect ends. During the 1976 and 1998 surveys, these survey lines were resurveyed to define temporal changes in lakebed topography.

as shown in figure 2. Sediment thickness ranges from 2.3 to 9.3 feet. The most significant accumulation by either measure, depth or mass, is in the segments north of Denmark Road and north beyond the old dam.

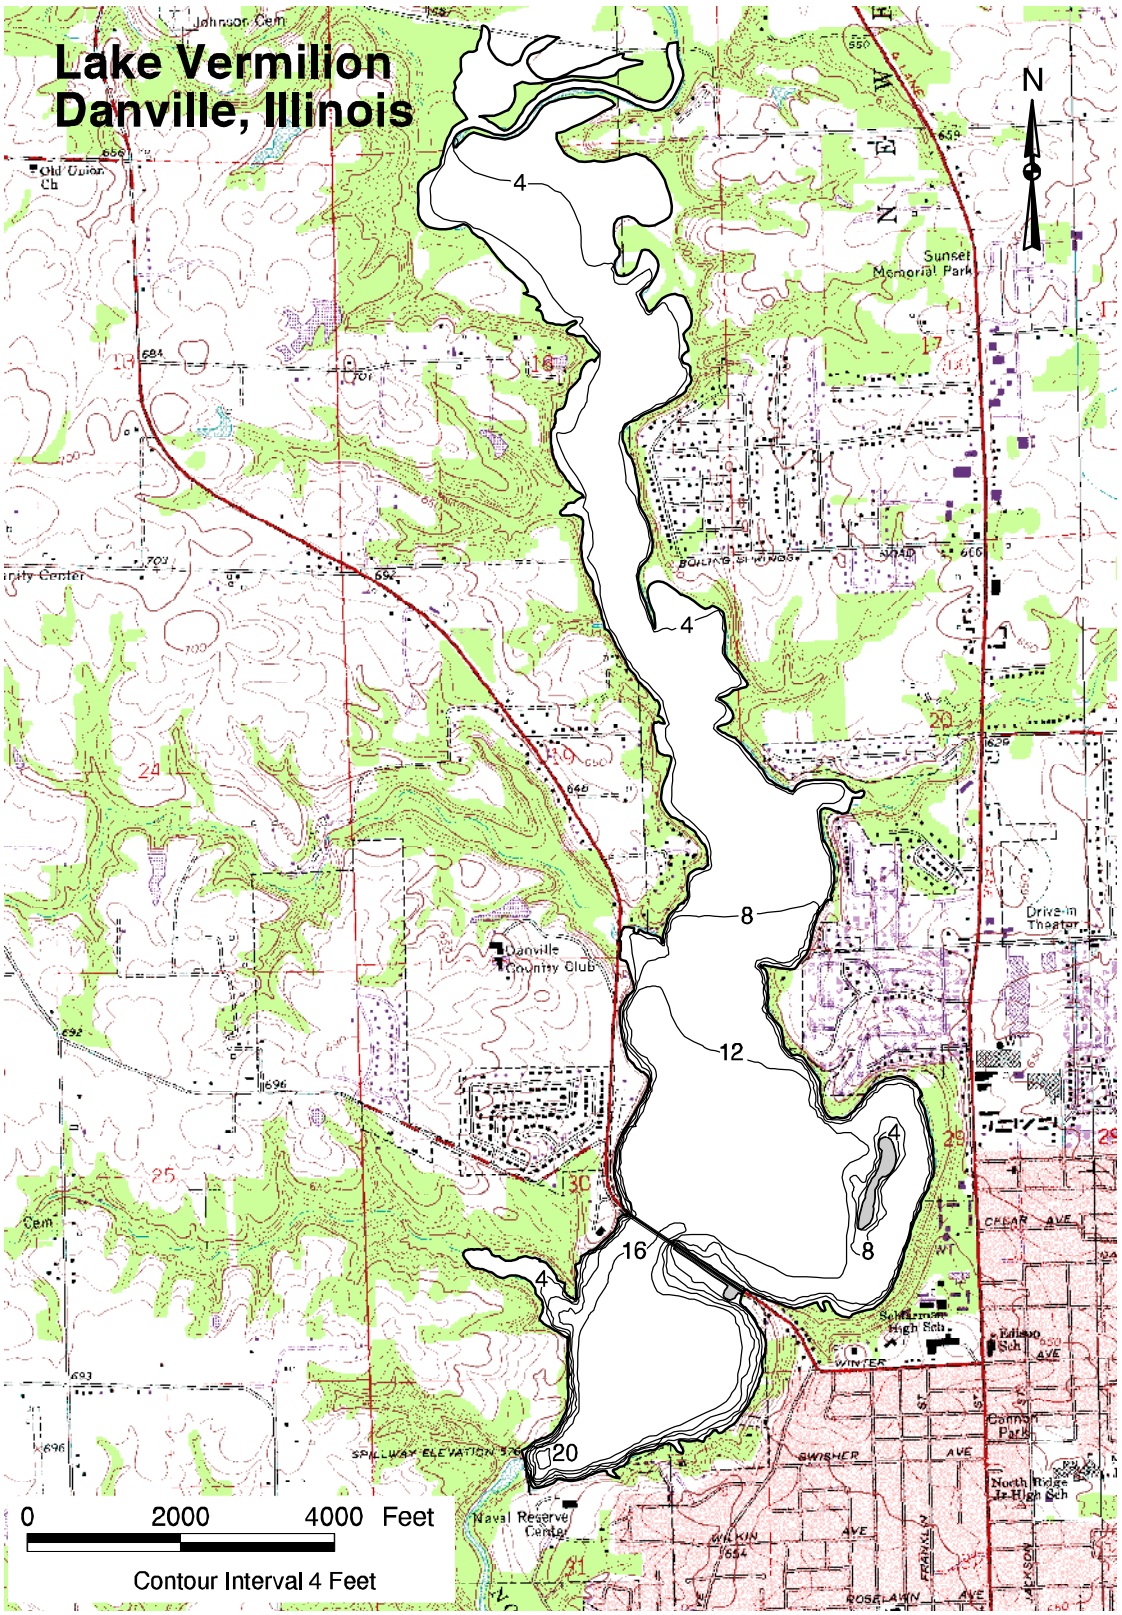
Figure 3. Bathymetric map of Lake Vermilion

The 1998 water depths for the lake were used to generate the bathymetric map in figure 3 and the volume distribution curve data in figure 4. Figure 4 can be used to determine the capacity of the reservoir below a given stage elevation. For example, the water volume below the 4-foot depth contour (shown by the dashed line in figure 4) is 4,543 ac-ft. With time and continued sedimentation, the relationships shown in figure 4 will become obsolete. Alteration of the spillway elevation, or the implementation of a dredging program would likewise alter these relationships.

During the 1998 survey, much of the area flooded because the 1991 spillway level increase was found to have a depth of 4 to 5 feet. Much of the inundated area had been part of the original lake. Earlier sedimentation surveys found that 165 acres of the original surface area of the lake had become terrestrial. Analyses of aerial photography verify that, in 1936 11 years after construction of the present dam and 23 years after construction of the old dam) the lake covered an area approximately equal to the present extent of the lake. By 1976, sediment had filled most of this 165-acre area and had formed exposed land above the then existing lake pool level.

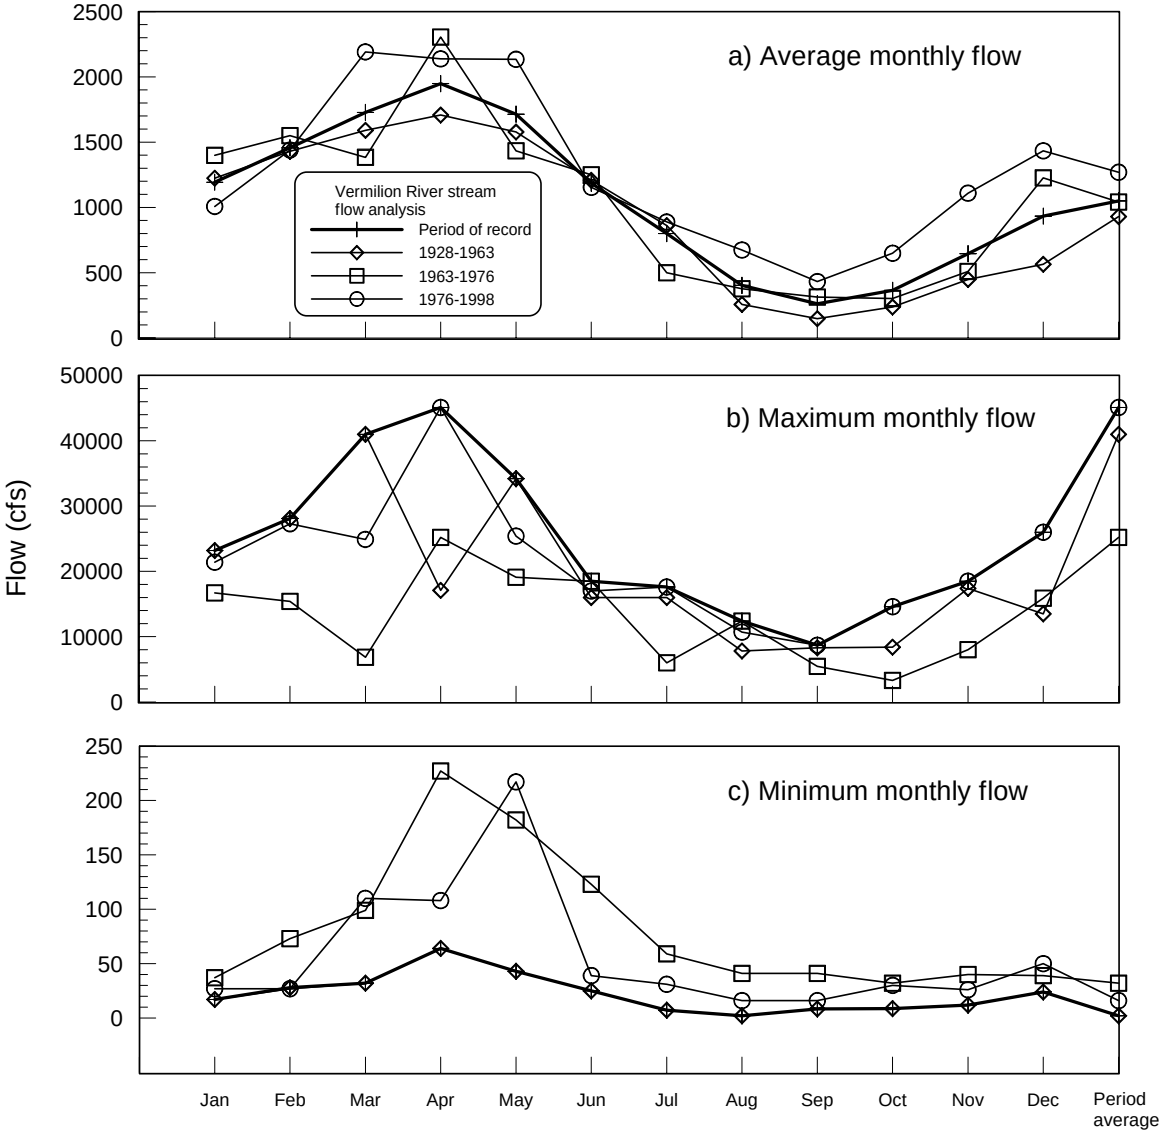
Figure 5. Comparison of a) average monthly flow, b) maximum monthly flow, c) minimum monthly flow for the Vermilion River near Danville for the three sedimentation periods (1928-1963, 1963-1976, and 1976-1998) and the full record of the station

sedimentation are the maximum flows and the average flows. High sediment transport rates are closely related to peak water discharge periods (Demissie et al., 1983; Bhowmik et al., 1993). The plots in figure 5 indicate that average flows for most months have been higher during the most recent (1976-1998) sedimentation study period for Lake Vermilion. This observation is consistent with statistical analyses of streamflow records presented in IDNR (1999), which indicate that average streamflow since 1965 has been 20 percent higher than in previous years. This increase in flow was observed to coincide with an increase in annual precipitation. This suggests that sediment delivery to the lake should be somewhat higher during the latter two survey periods. Instead, the latter two survey periods show lower sedimentation relative to the 1925-1963 period. This suggests that other watershed conditions have been larger factors in determining Lake Vermilion sedimentation rates.

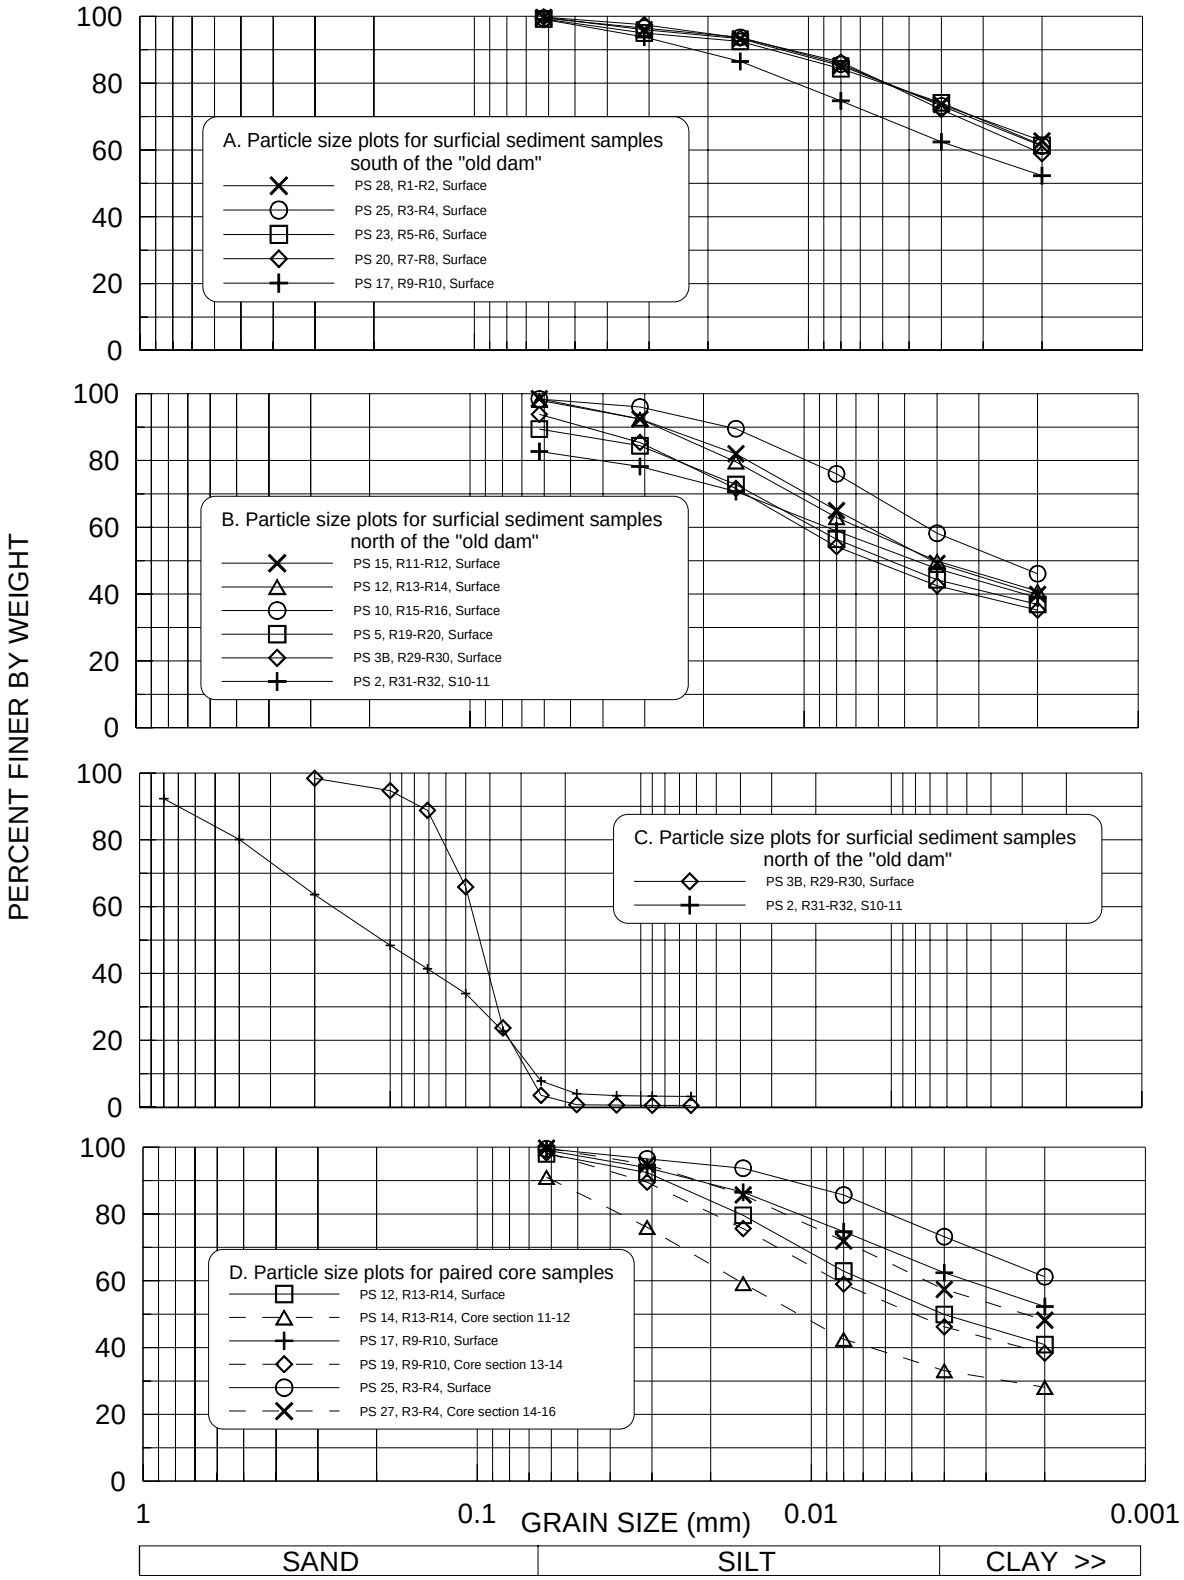
A total of 16 lakebed sediment samples were collected for particle size distribution analysis. The laboratory analyses for these samples are presented in figure 6. The analyses shown in figure 6a and 6b are particle size distribution plots for samples collected from the top surface of the accumulated sediments. These samples show extremely uniform characteristics south of the old dam area (figure 6a). Surface sediment samples collected north of the old dam show a tendency to become slightly finer from upstream to downstream. This reduction in deposited sediment particle sizes is consistent with all other Illinois impoundment lakes for which particle size distribution data are available. This trend in particle-size distribution is a result of the natural sorting of suspended sediments in the lake environment. Coarser sediments are deposited as the inflowing stream water is first slowed upon entering the lake. As water moves through the lake, the suspended sediments become finer as the coarser-sized fractions fall out of suspension. At the dam, the suspended sediments are predominantly composed of colloidal and organic materials.

Field examination of two samples indicated sand size material (figure 6c). Both samples were collected in the near-channel areas of the north end of the lake. All other samples were composed of clay and fine silt size sediment materials. This would be consistent with general observations concerning sediment distribution in Illinois lakes (Fitzpatrick et al., 1987; Bogner, 1986). These and other sources indicate that the occurrences of sand exceeding 10 percent are unusual for samples collected from lake sediments. In this case the sand was associated with the redevelopment of the stream channel since 1991.

Three sets of samples (figure 6d) were collected to analyze vertical variations in particle size distribution. These samples show a temporal trend toward finer sediments in the surface layer at each sample site. This observation is counter to the usual trend in lake sediments. Surficial sediment, the most recently deposited sediment, tends to be coarser with time at a given point. This is due to the downlake shift in the initial depositional environment of the lake due to the loss of trap efficiency of the upper end of the lake. With time, the initial depositional zone in the lake will move further down the lake because of water volume loss to sedimentation. For Lake Vermilion, this tendency was interrupted by the 1991 spillway increase, which re-established upstream sediment storage capacity.

Figure 6. Particle size (ps) distributions for Lake Vermilion sediment samples
