Bank Erosion Survey of the Illinois River Volume 1

by
Nani Bhowmik and David Soong

December 2000

Illinois State Water Survey
Watershed Science Section
Champaign, Illinois

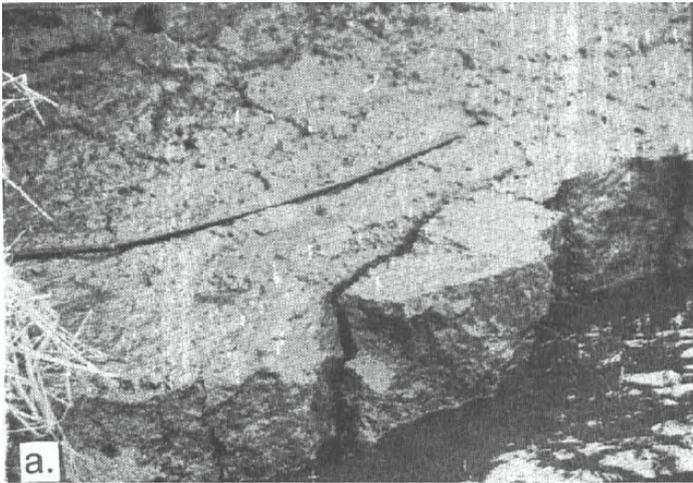
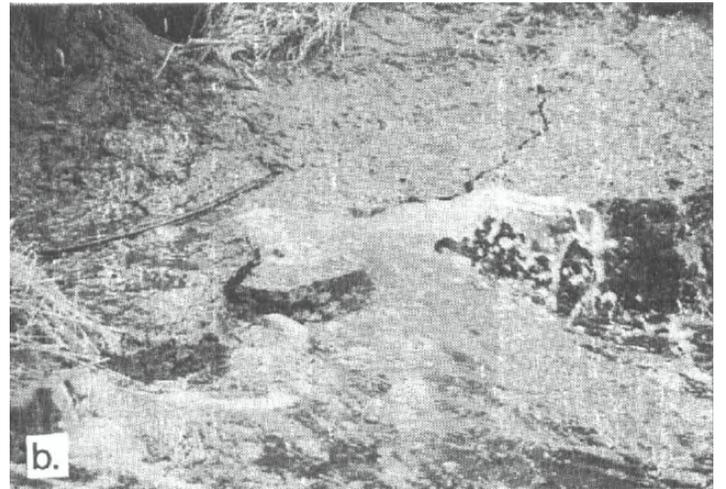
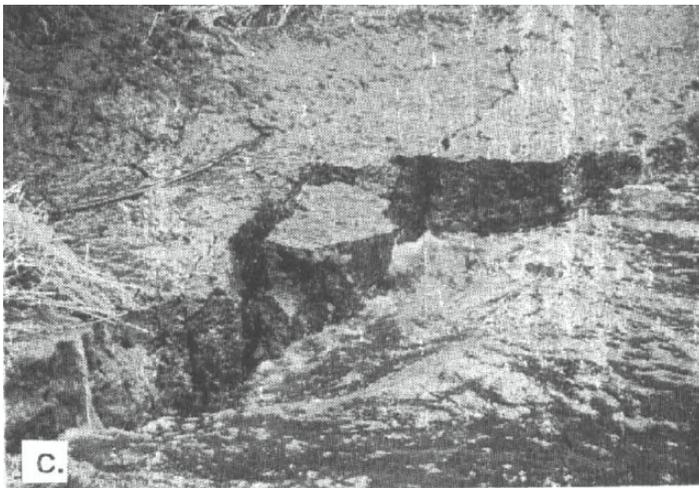
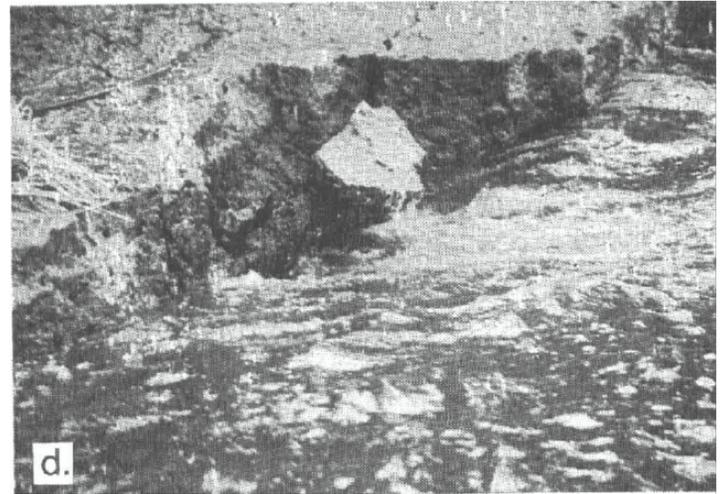
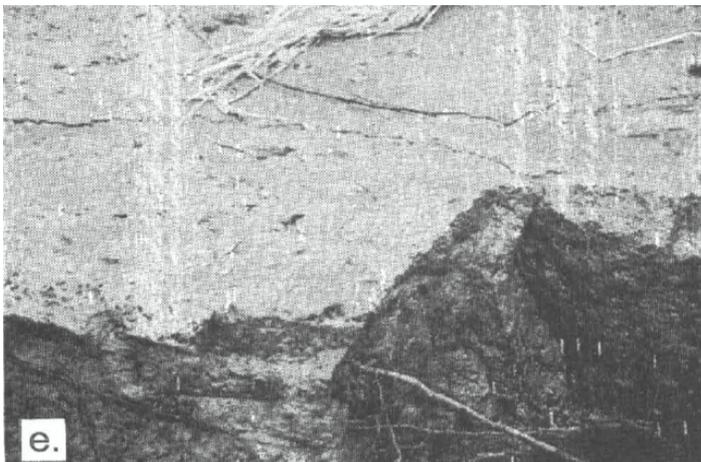
Figure 12 shows another theoretical erosion pattern at and below the extremely high watermark in a free flowing system. This type of block failure was observed at several locations on the open river portion of the Upper Mississippi River (UMR) shown by two sets of photographs in figures 13 and 14 for two water levels. Figure 13 shows a set of five photographs at RM 605, tip of the Sweezy Island on the UMR, taken when the water level was quite high and the bank eroded by waves overtopping. Figure 14 shows a riverbank at RM 52.3, site 42 on the UMR where bank failure occurred due to failure of a sandy layer. Similar failure mechanisms were observed on the Illinois River. Again, riverbank failure and erosion can be interrelated with the dominant erosional process and have been categorized in following these concepts. The following sections describe exactly what was done for the Illinois River.

Figure 13. Bank erosion due to overtopping, RM 605, UMR

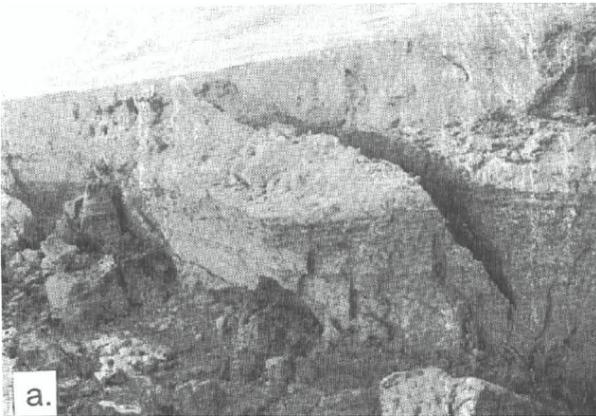
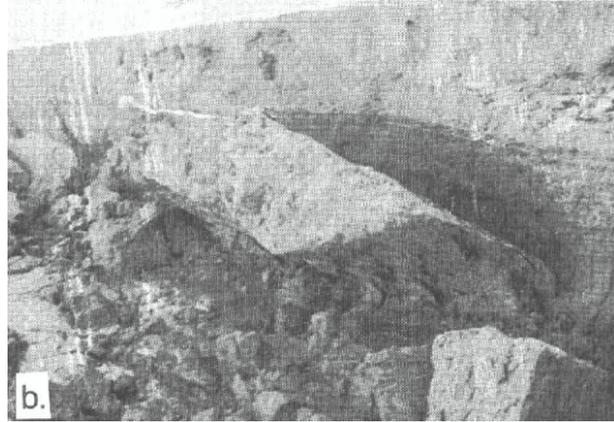
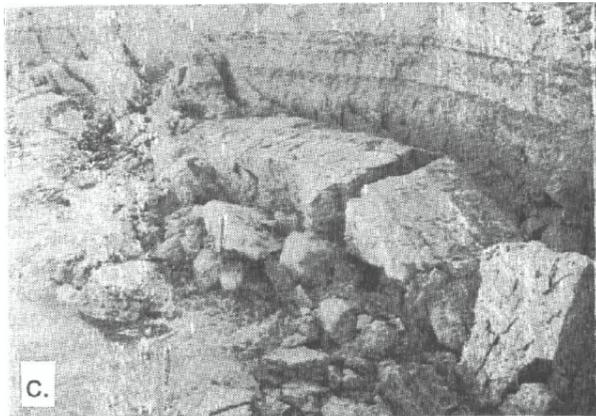
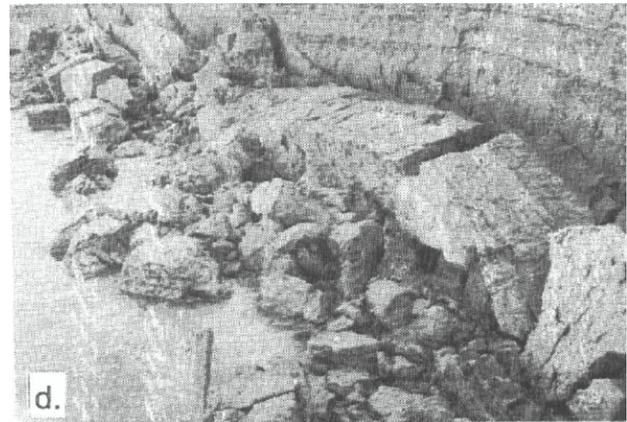
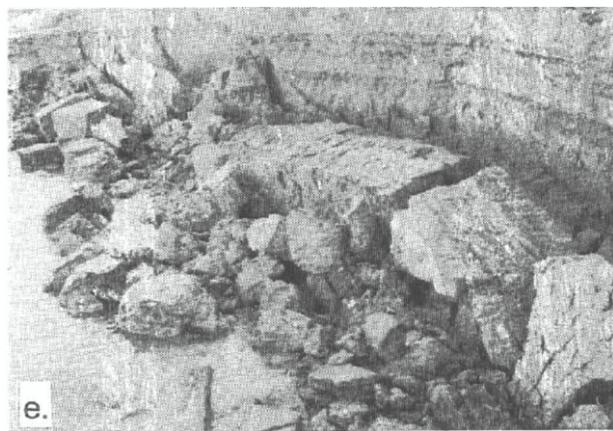
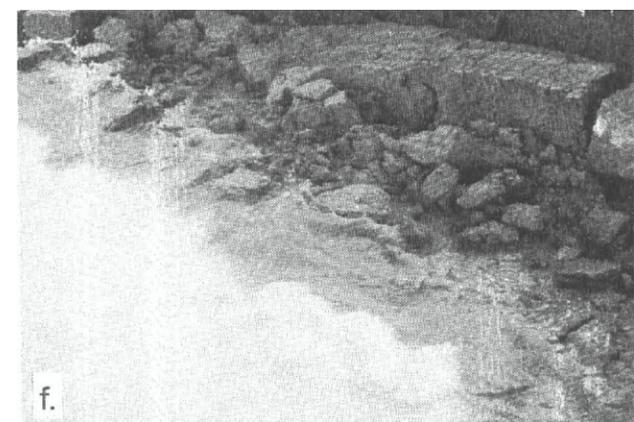
Figure 14. Bank erosion due to undercutting, RM 52.3, UMR

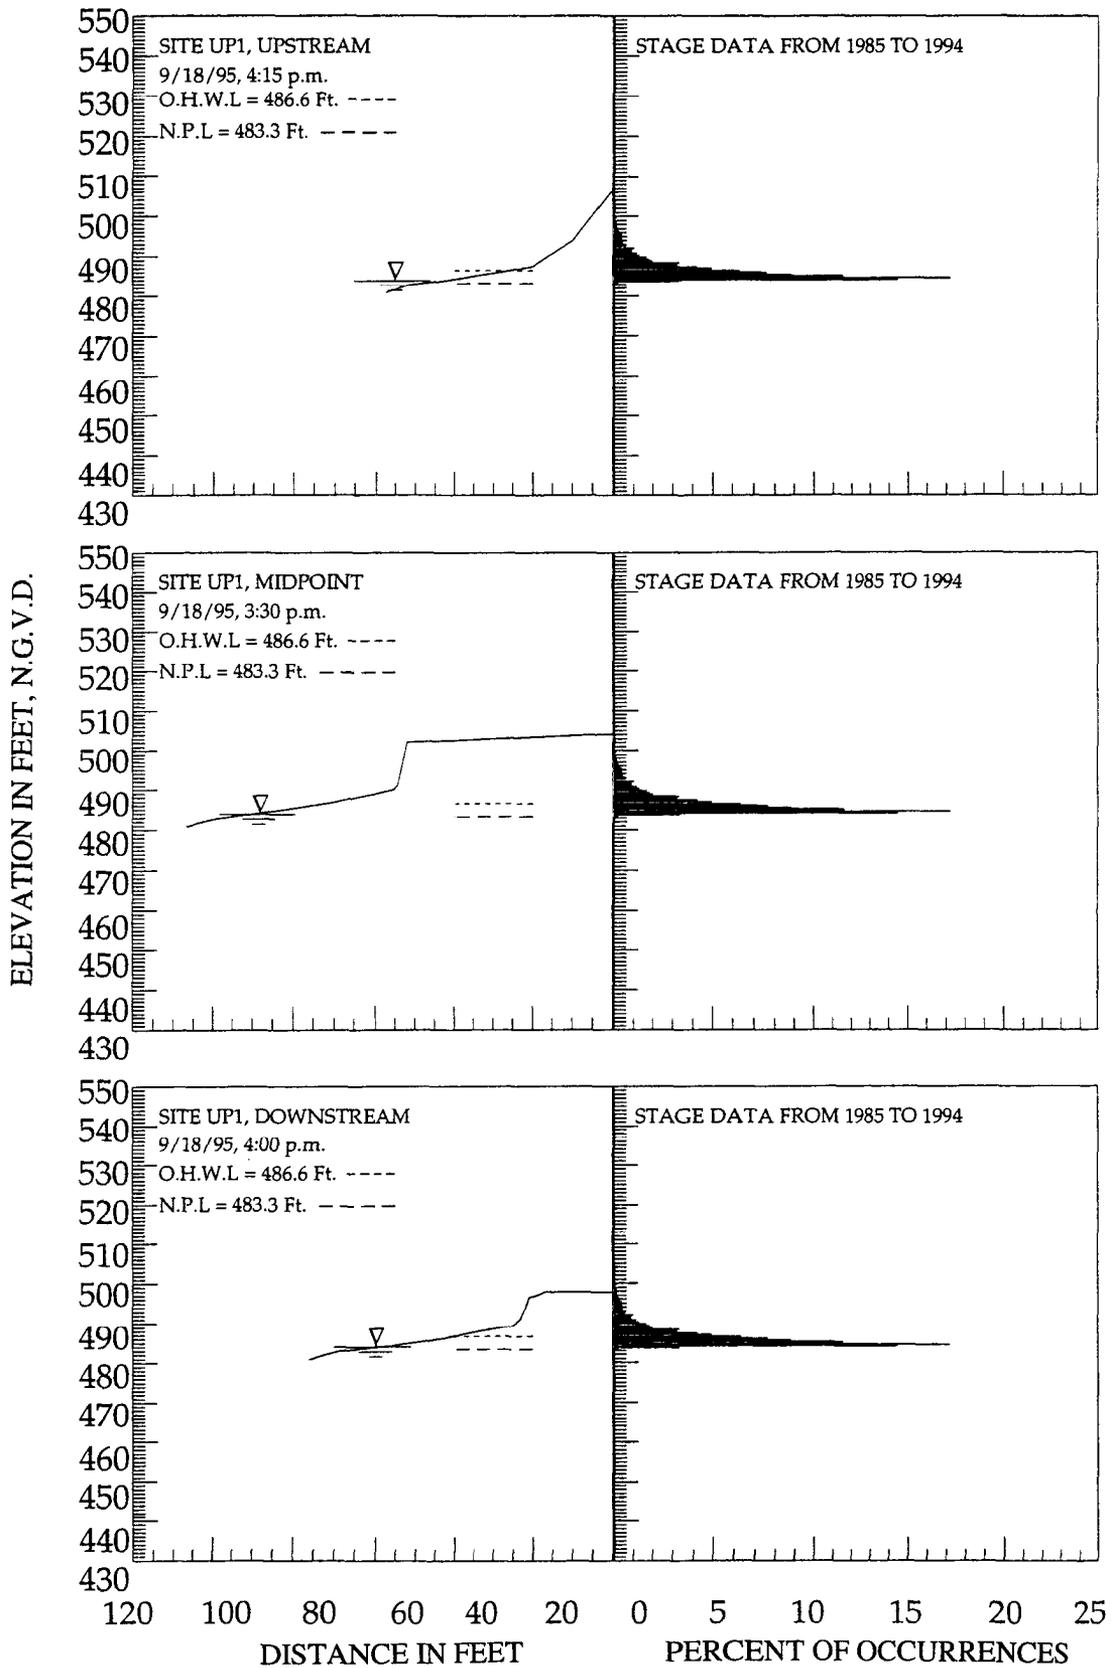
Figure 15. Bank profile at site UP1 in Marseilles Pool of the Illinois River, RM 270.8, RBD stage histogram at tail gage of Dresden Island Pool, RM 271.5

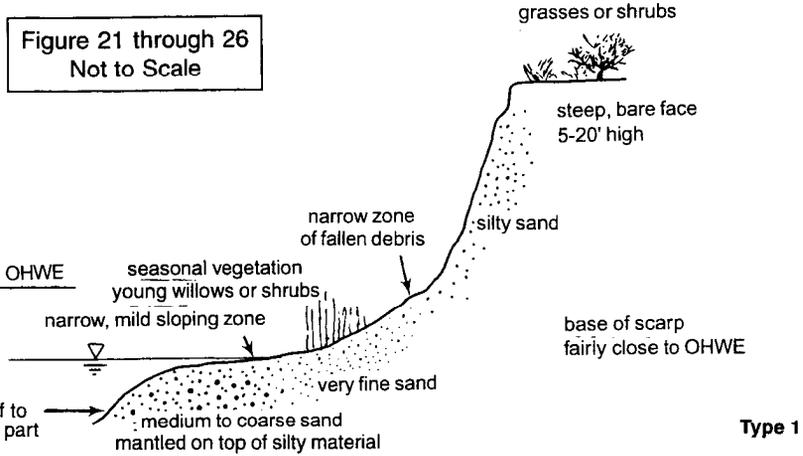
Figure 21. Type 1 bank on the Illinois River: steep bank with high bare face (ordinary high water elevation is low as compared to the bank elevation)

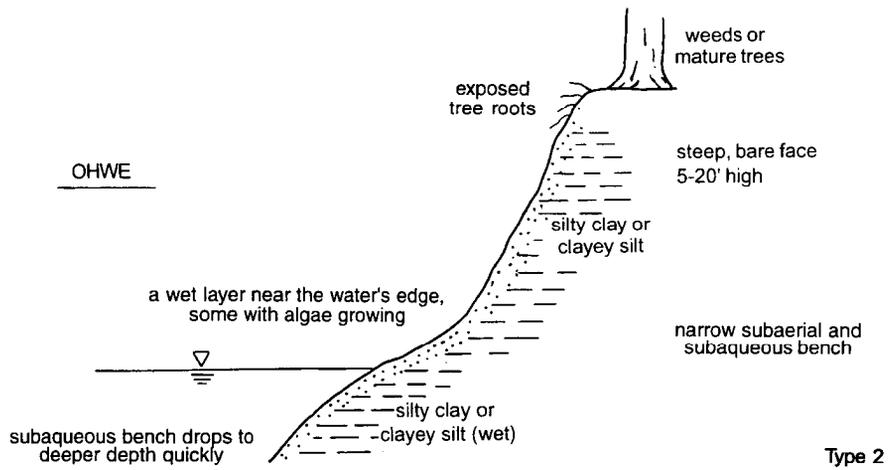
Figure 22. Type 2 bank on the Illinois River: steep bank with high bare face (ordinary high water elevation is comparable to the elevation at top of the bank)

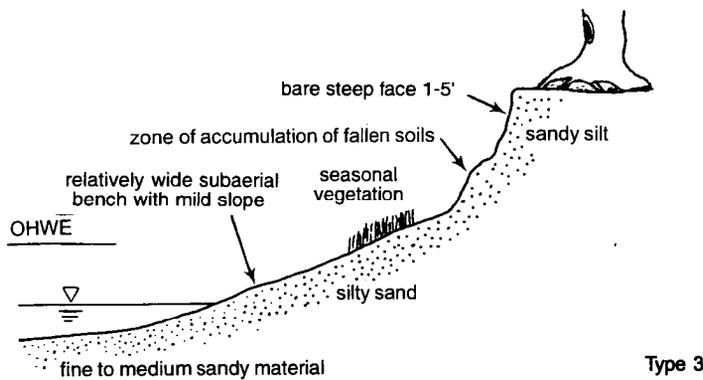
Figure 23. Type 3 bank on the Illinois River: short scarp face and fairly long bench (ordinary high water elevation is low as compared to the bank elevation)

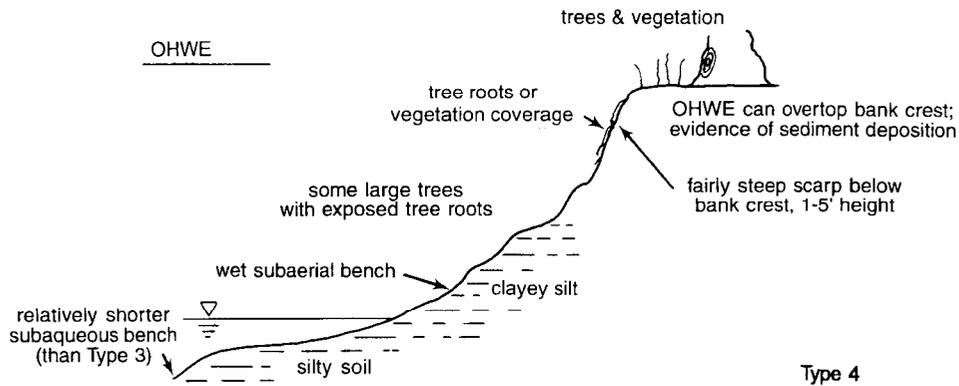
Figure 24. Type 4 bank on the Illinois River: small scarp face with bare bank (ordinary high water elevation can overtop bank crest or reach the face of scarp)

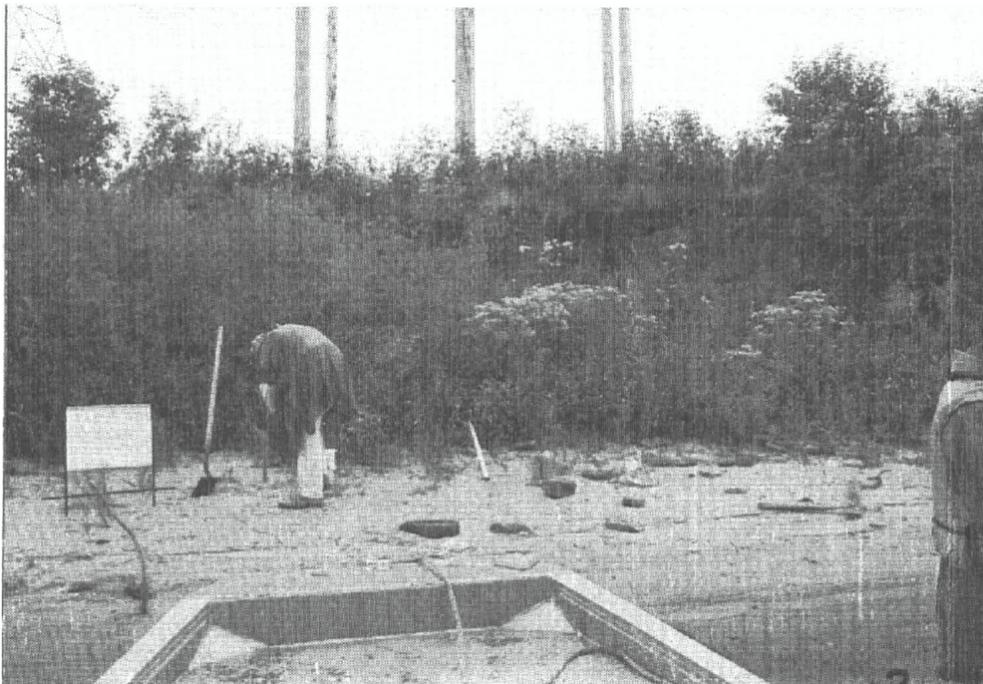
Figure 37. Site UP1 on the Illinois River

An almost vertical failure face approximately 15-20 feet high is present at this site. Recession of the bank line is close to the support of a nearby powerline frame. One of the four legs of a nearby powerline support was only 3 feet from the bank face.

The bench slope varied from 1V:6.8H to 1V:9.H. The bank at this site can be classified as a combination of types 1 and 3 (figure 21 and 23 and table 9). Floods and high water stages could be the major cause of bank erosion. There was a collapsed bank section. Failure could be due to erosional oversteeping. Several holes were observed on the bank face, indicating that piping could also be a factor in bank failure.

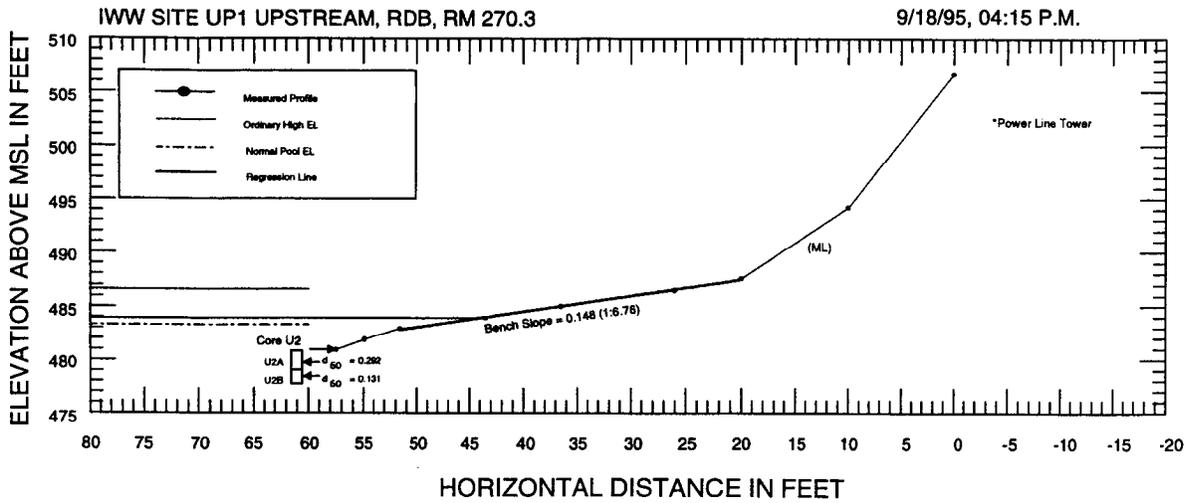
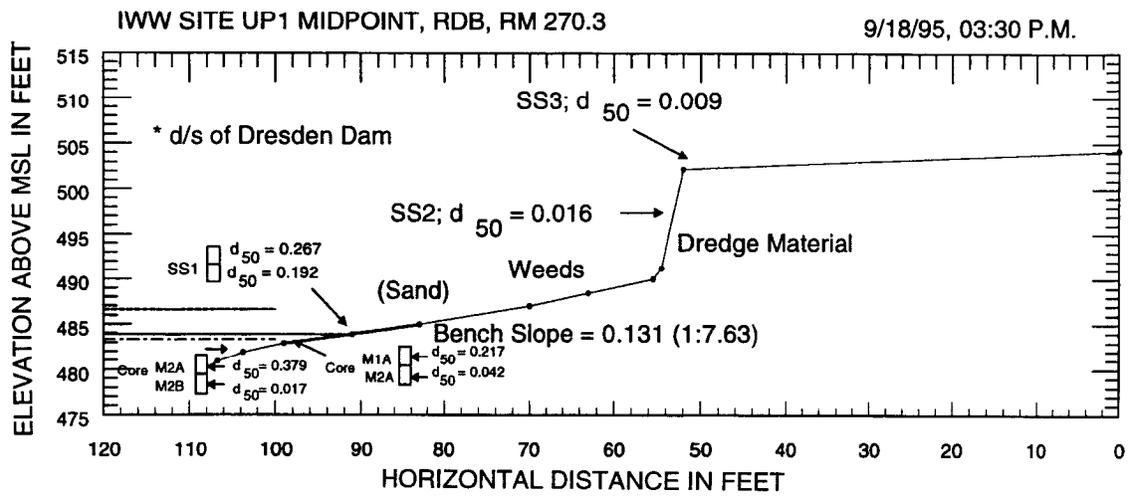
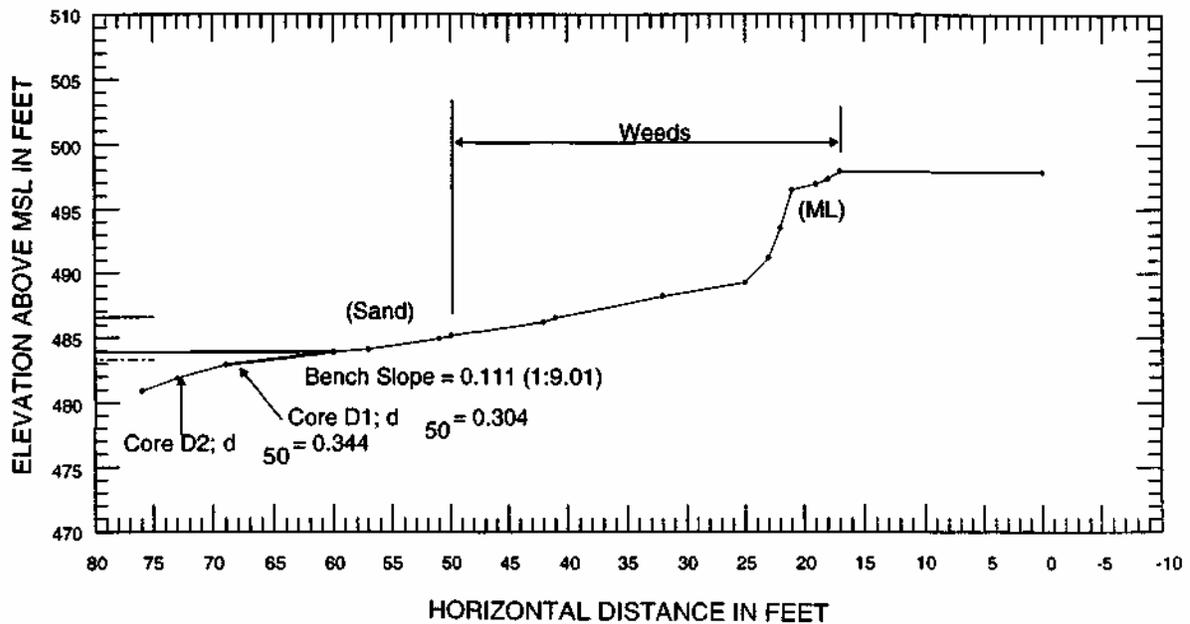
Figure 38. Bank sections at site UP1

Only one river cross section was measured at this site, and the detailed cross section and coordinates are shown in appendix D. Three bank sections were measured at this site, as given in figure 38 with the computed values of bench slopes and median diameters of the bank soils. For site UP1, the OHWE is at 486.6 and NP is at 483.3 feet above mean sea level (ft-msl), respectively. The NP elevation corresponds to a break in the subaqueous bench slope. There were weeds growing on the bench near the base of the scarp. The bank above the OHWE line is relatively high as compared to local stage fluctuations. According to 10-year stage data (see table 11), the OHWE reaches the base of the scarp and only high stages (less than 10 percent exceedence frequency, or approximately at 489.9 feet) can reach the existing scarp face. Otherwise, normal stage fluctuations (the range between OHWE and NP) occur mostly on the bench area.

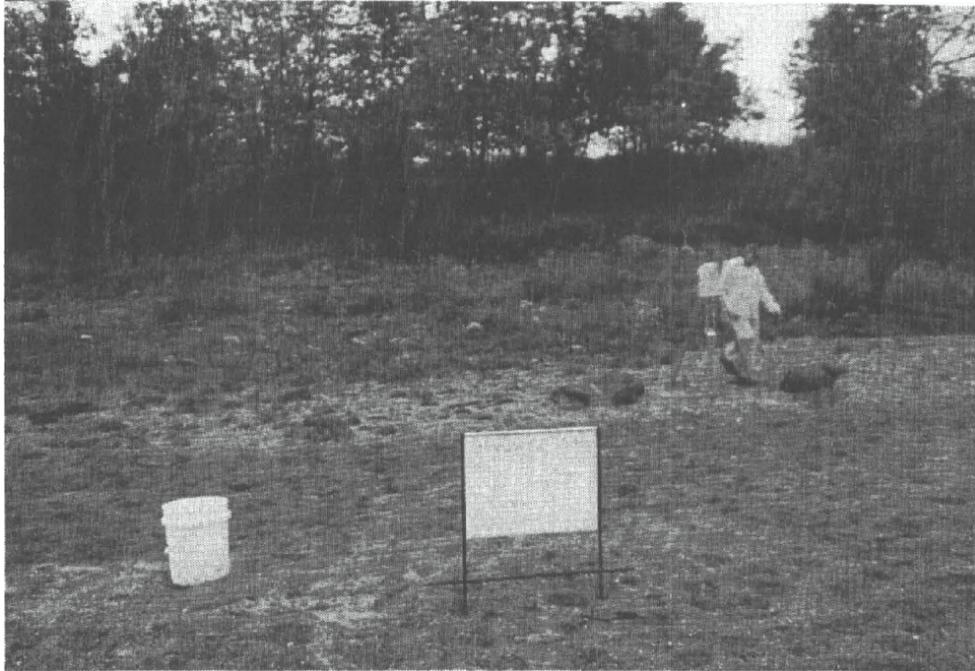
Figure 39. Site UP2 on the Illinois River

The site is about 280 feet from the sailing line, and no major tributary enters the river at this location. In Bhowmik and Schicht's (1980) note, this side was marked as a dredge material displacement site. Trees and grass covered an obvious scarp approximately 3 feet in height and 100 feet from the water's edge. The bench was composed of coarse sand, gravel, and boulders. More boulders were encountered between the scarp face and the bench.

The bench slope was 1V:11H, and the bench was covered with noncohesive sandy soil. This site can be classified as type 5 (see figure 25 and table 9). The scarp was above OHWE stage. Erosion could have occurred during flood stages. The base of the scarp showed sand deposits indicating that seepage at the base could weaken the bank. Waves and currents could remove/transport failed soils that mantle the bench.

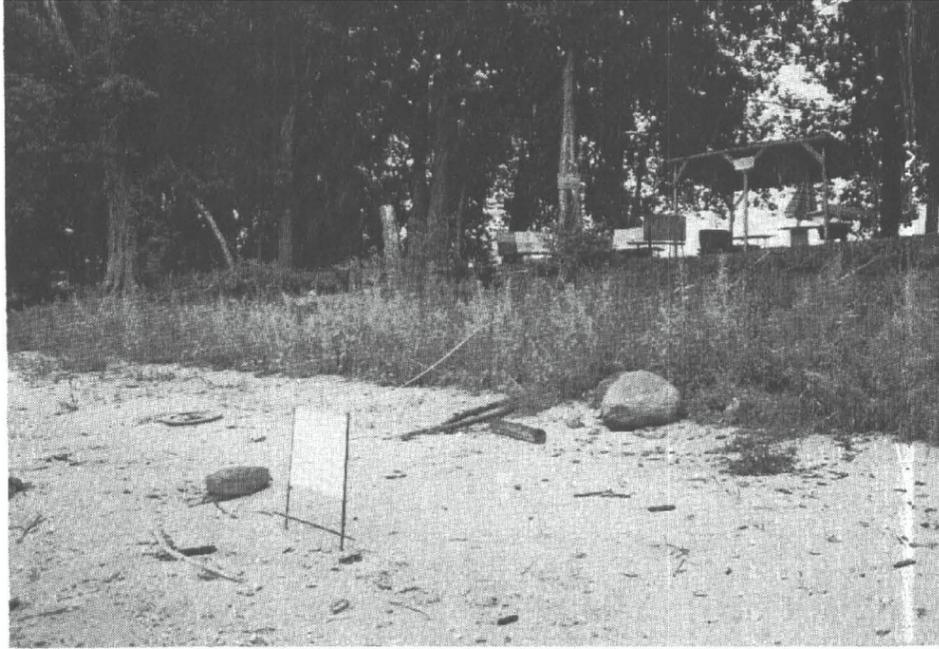
Figure 42. Site UP3 on the Illinois River

An obvious scarp approximately 5-10 feet high was at this site. Erosion of the bench area, if not retreat of the bank line, could be described as significant when compared with a 1988 photo. Figure 43 shows the three measured bank sections and a reduced cross section. At all subsequent figures, w.e. indicates water surface elevation. At the downstream section, a concave bank face was observed. The OHWE is 485.7 feet and NP is 483.3 ft-msl. The NP elevation corresponds to a break in the subaqueous bench slope. The OHWE reaches to the upper part of the bench and corresponded well with the lower end of the weed zone. The bank top is relatively high and only high, stages exceeding the 10 percent occurrence frequency (at 488 feet, see table 13) can reach the berm or the scarp.

Bench slopes varied only slightly from 1V:21.7H, and the bench was covered with noncohesive sandy materials. This site can be classified as type 3 (see figure 23 and table 9). Erosional undercutting, rework, and transport by waves and currents at high stages or during floods could be major causes of erosion at this site. After a flood recedes, the bank soil may slip and fall as blocks, as shown in the downstream section. Land use as a trailer park can be a factor at this site too. Seepage at the recession stage of a flood also could play a significant role in bank failure. Waves and disturbances created by local boating activities can cause entrainment of recently deposited sediments from bench areas.

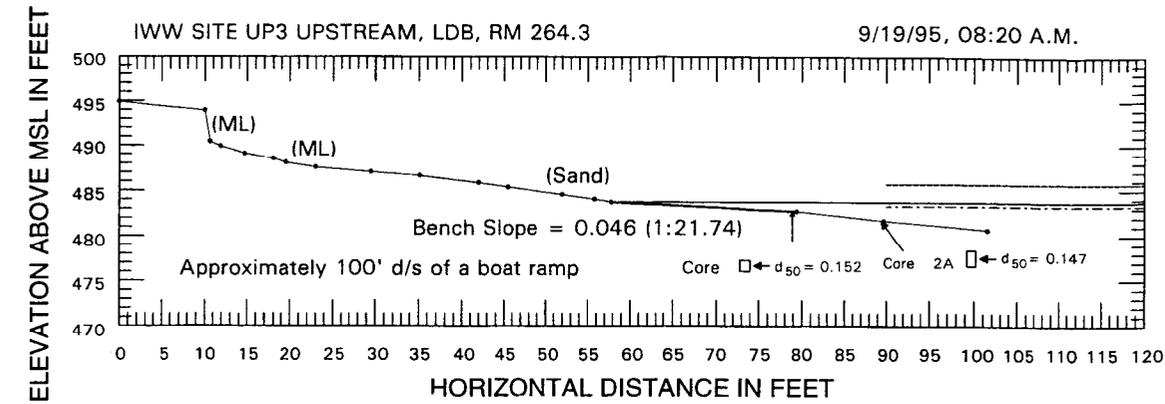
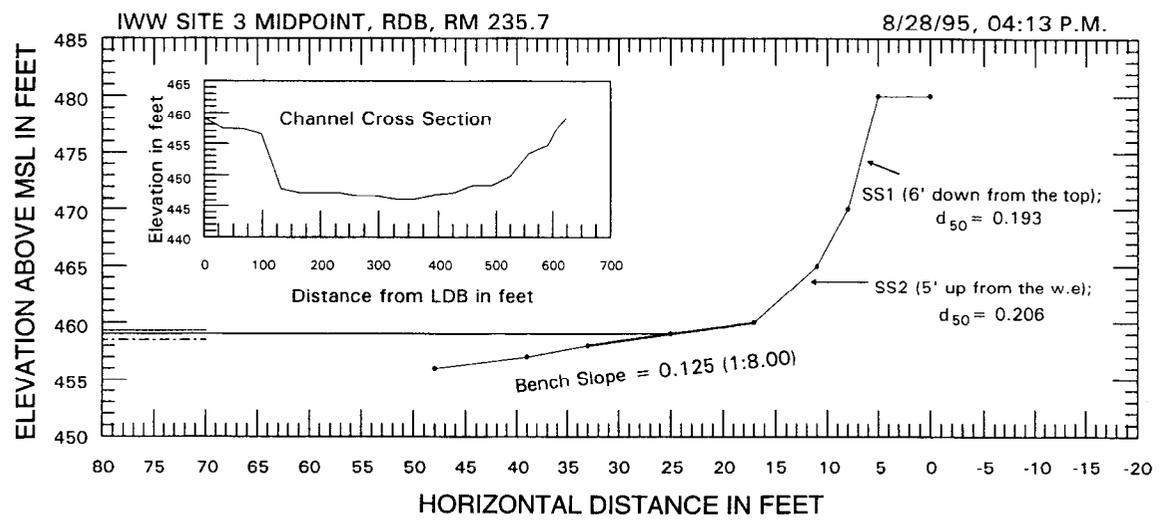
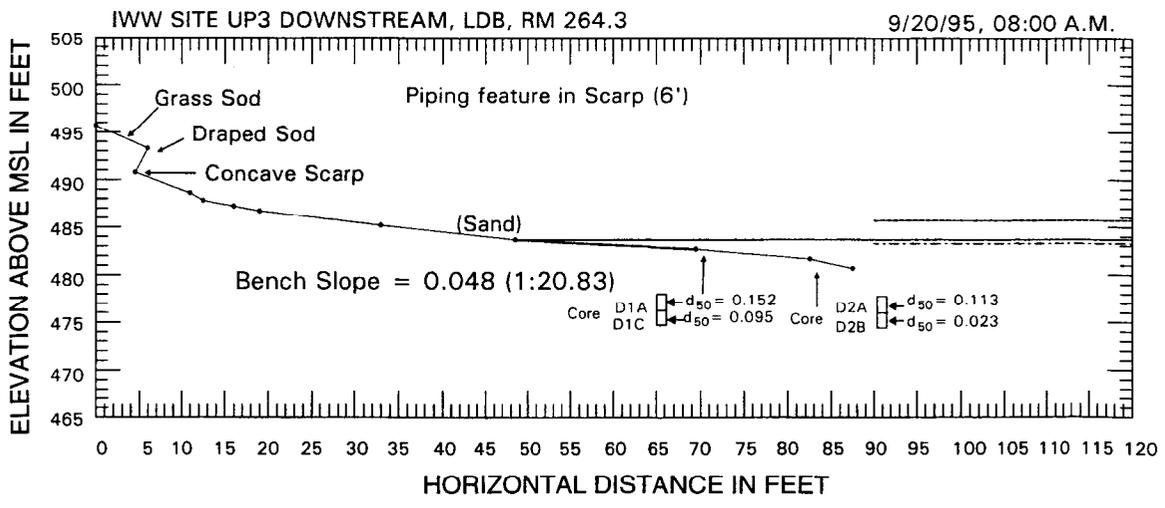
Figure 43. Bank sections at site UP3

At the midsection, the d_{50} varies from 0.023 mm at the top surface of the bank to 0.419 mm for a core sample at a depth of about 2 feet of water. Gradation plots of bank soils and nearshore sediment cores are presented in appendix C. The detailed cross section and coordinates are shown in appendix D.

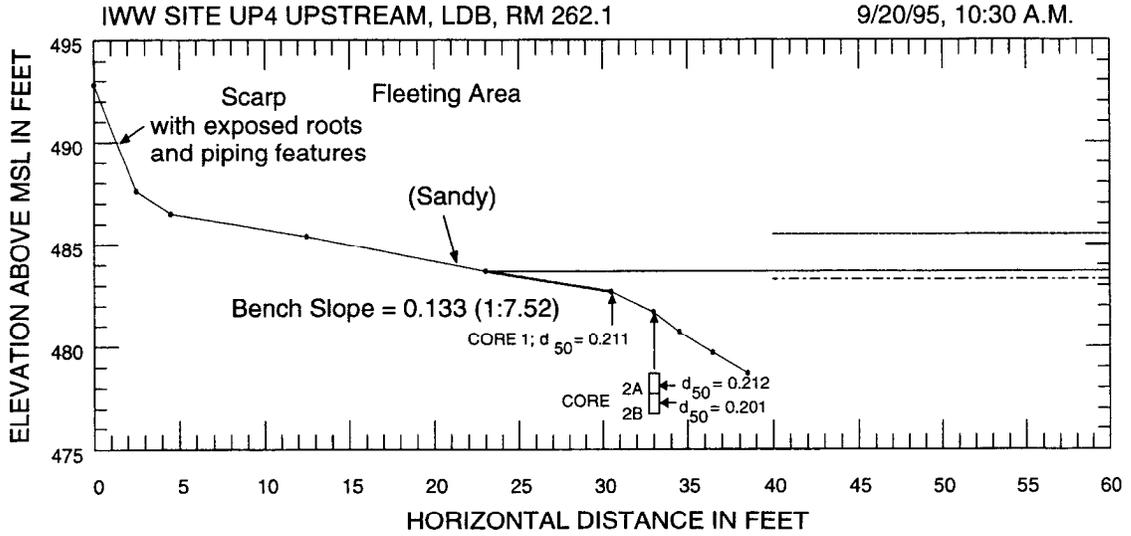
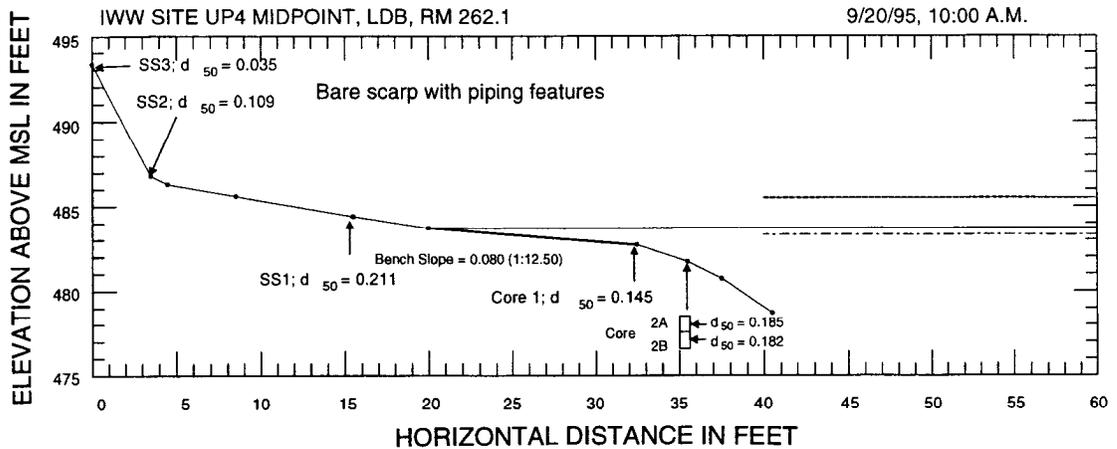
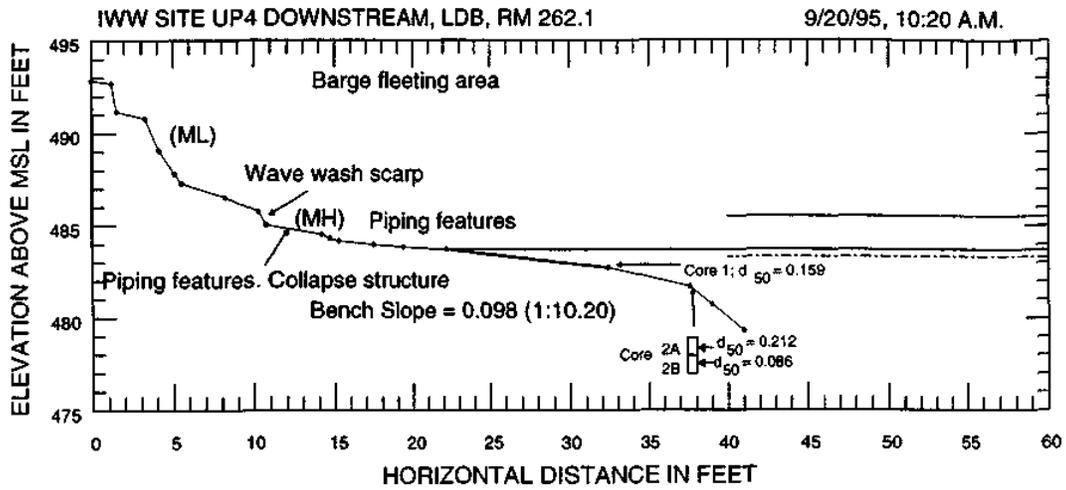
Figure 46. Bank sections at site UP4

At the midsection, the d_{50} varied from 0.035 mm at the top of the bank to 0.185 mm for the top portion of a core sample at a water depth of about 2 feet. The bank scarp consisted of cohesive materials, and the sediments were of fine sand fairly consistently at three sections. Gradation plots of bank soils and nearshore sediment are presented in appendix C. The detailed cross section and coordinates are shown in appendix D.

Bench slopes varied from 1V: 12.5H to 1V:7.5H, and the subaqueous bench becomes steeper. Piping holes at the scarp and moist soils on the lower portion of the bank were noted. This site can be classified as a combination of types 2 and 3 (see figures 22 and 23 and table 9). The bank soils appeared to be cohesive, but the bench was sandy with several clay outcrops. Seepage could weaken the base support and cause the bank to slip, as shown at the downstream section. Failed soils and/or recently deposited sediment on the bench were reworked and transported by wind or tow-generated waves. The steep dropoff in subaqueous benches is indicative of effects of direct vessel contact or traffic-induced velocities.

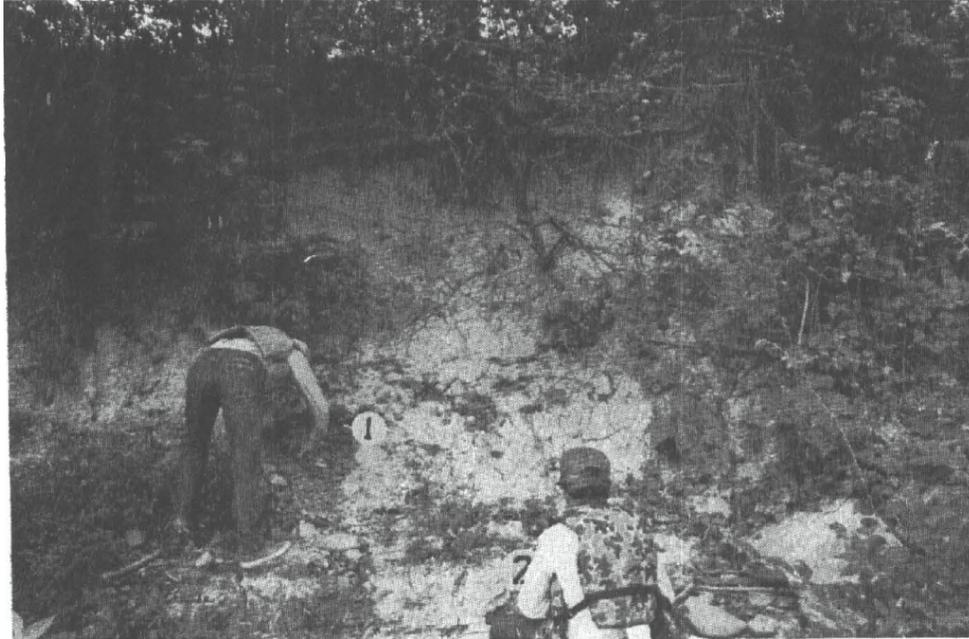
Figure 50. Site 1 on the Illinois River

Neither Bhowmik and Schicht (1980) nor Hagerty (1988) observed erosion at this site. Hagerty (1988) noted rock instead. During this survey a near vertical scarp about 8 feet high was encountered. Exposed tree and grass roots covered the top of the scarp, and some leaning tall trees were found on the scarp. Flat slabs or rocks approximately 1-2 inches in length and only about a quarter inch in thickness were found on the bench at the foot of the scarp. Rocks increased in size to about 4 or 5 inches long near the water's edge. Rock crops out along the Moores Creek. Figure 51 shows the two measured bank sections and a reduced cross section. Available stage data from the Marseilles L & D is used for interpolating stage information at this site (table 16). The OHWE is 460 ft-msl and NP is 458.5 ft-msl. Stages higher than 461.8 feet will submerge the scarp.

Bench slopes varied from 1V:6.1H to 1V:17.2H. This site can be classified as type 1 (figure 21 and table 9). Surficial bank materials slake and are loosened by weathering with subsequent collapse. Reworking and transport of failed materials and recently deposited sediments occurs within bench areas during high flows.

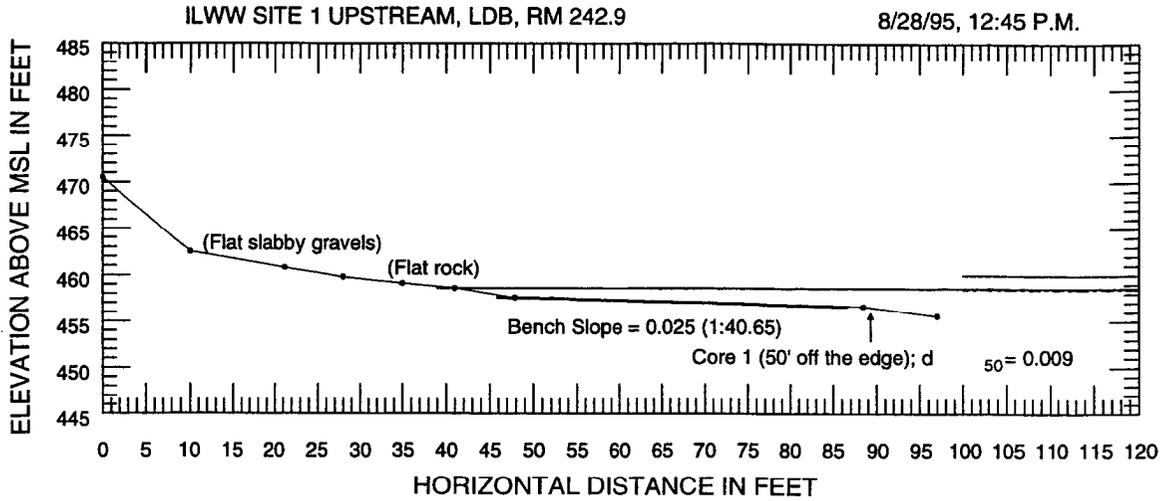
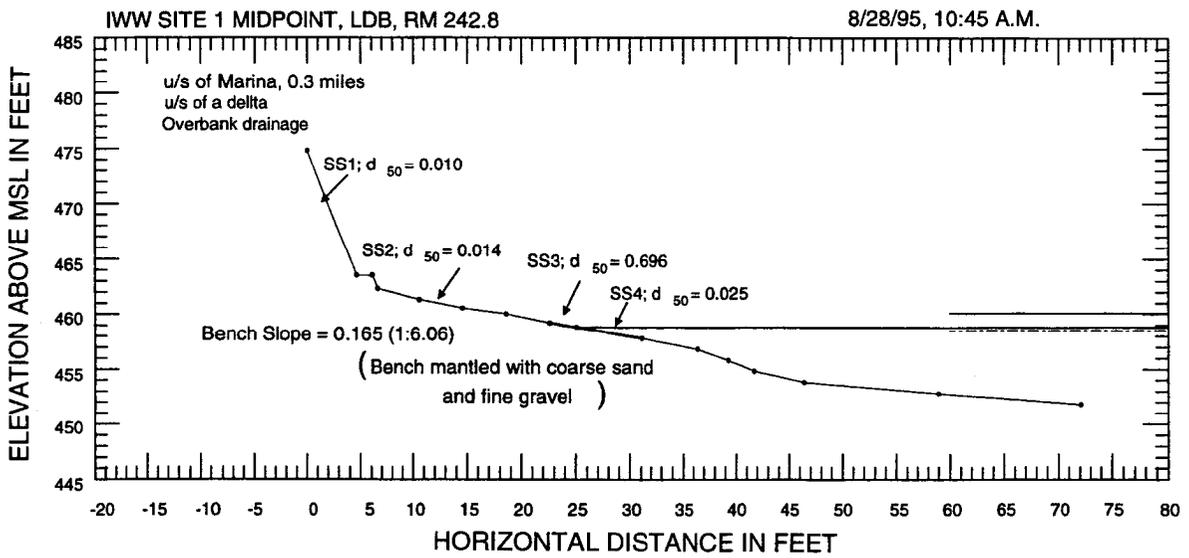
Figure 51. Bank sections at site 1

At the midsection, the d_{50} varies from 0.010 mm at the surface of the bank to 0.696 mm at the edge of water to 0.025 mm for a core sample at a depth of about 1 foot of water. Gradation plots of bank soils and nearshore sediment are presented in appendix C. The detailed cross section and coordinates are shown in appendix D.

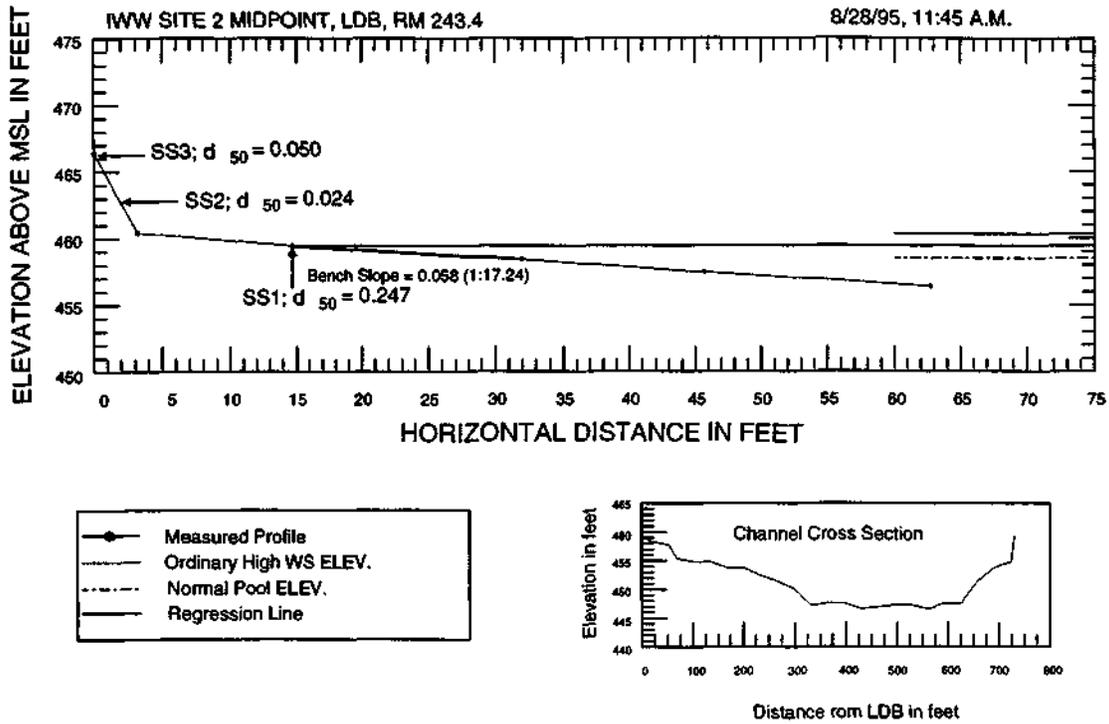
Figure 53. Bank section at site 2

The bench slope was 1V:17.2H, and the bench was covered with noncohesive sandy materials. This site was considered as the combination of types 2 and 6 (figures 21 and 26 and table 9). The scarp was nearly vertical and covered with fine roots. There was a moist layer at the base of the scarp and the subaerial bench was narrow and covered with sand. Several factors contribute to bank failure: tractive forces during floods, wave and current actions at stages above OHWE, and seepage at the base of scarp could all contribute to the rework and erosion of failed bank soils and recently deposited sediment.

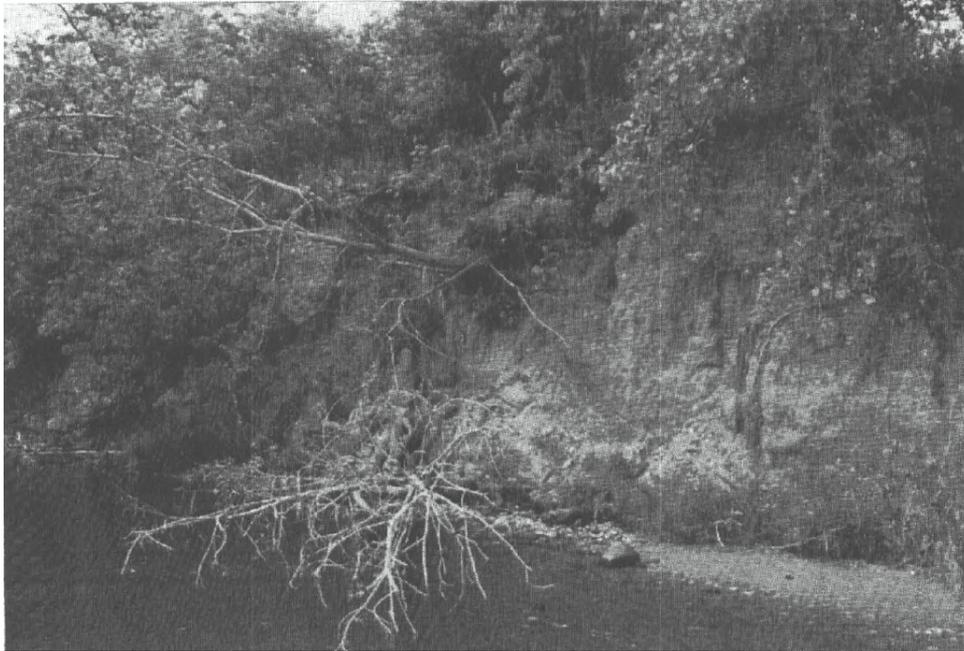
Figure 55. Site 3 on the Illinois River

The bank consisted of a bare face approximately 15-20 feet high. Toppled trees halfway up the bank face supported stems regrown to upright directions. Fine sand and gravel were found at the water's edge. Although the reach is straight, the three sections surveyed all were measured from locally concave banklines. These concavities were about 50 feet wide, and all had either gravel or trees at the water's edge at the upstream end. Several mass failures had occurred at the downstream ends; which indicated the concave sections were widening.

Bench slopes varied from 1V:50H at the upstream section to 1V:8H at the midsection. The bank consisted mostly of noncohesive sandy materials. The three sections can be classified as a combination of types 1 and 6 because of the extended subaqueous bench width (figures 21 and 26 and table 9). Rework and transport of failed soils and recently deposited sediment occur during floods. Eddy currents induced by the trees or gravel upstream of concave sections can cause bank failure, and eddies are generated at stages when the flows are disturbed by trees or gravel.

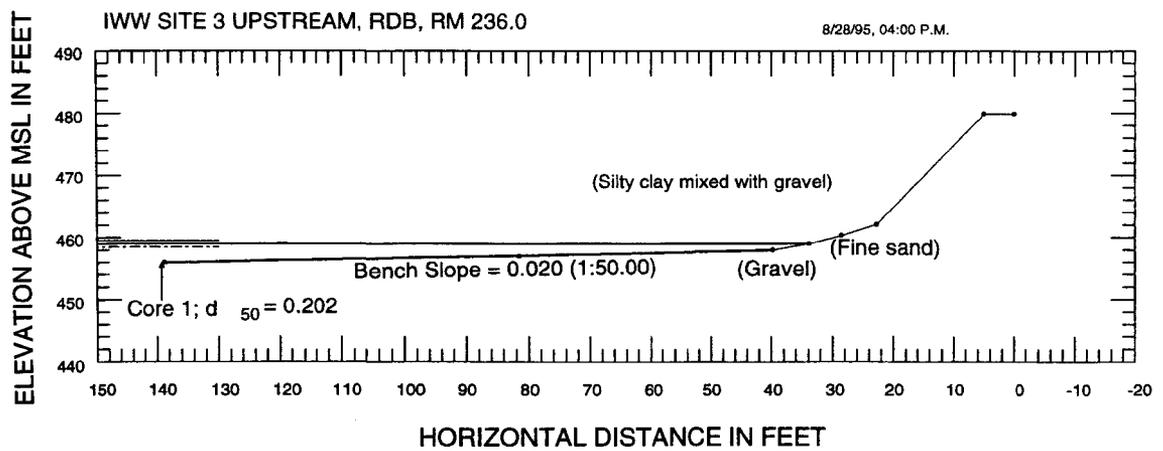
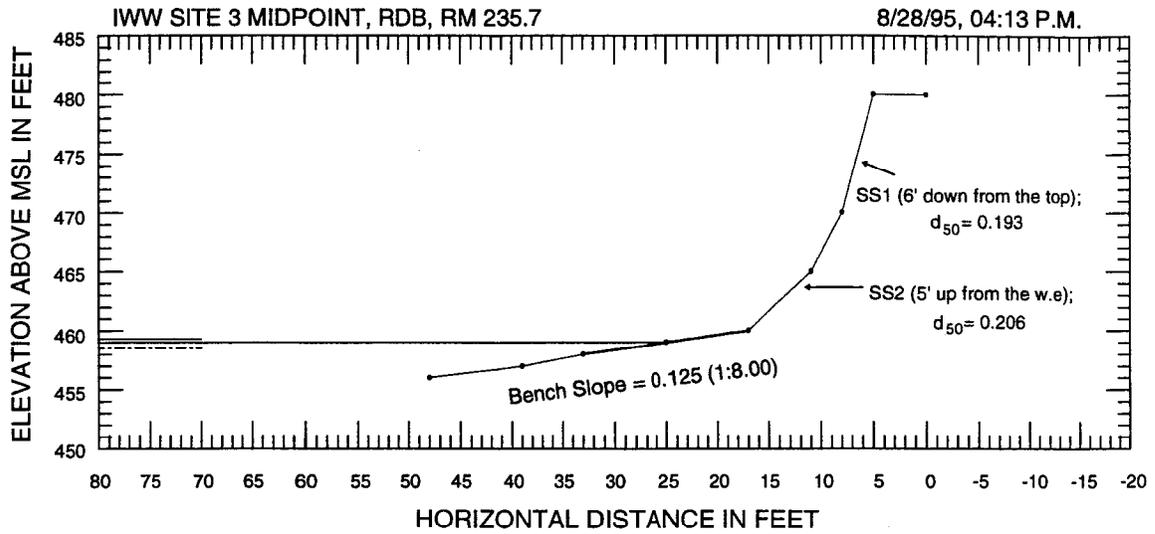
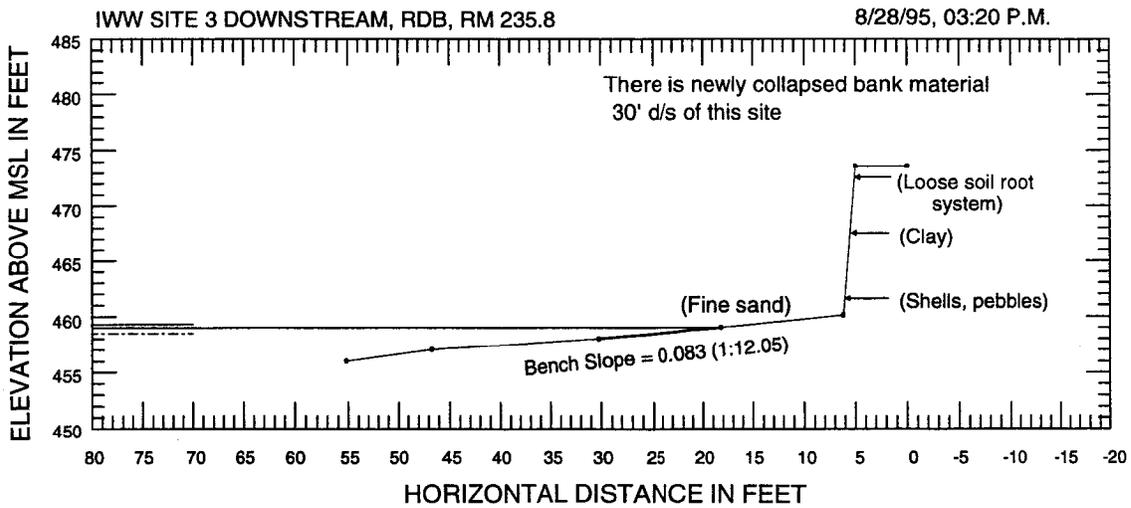
Figure 56. Bank sections at site 3

Figure 56 shows the three measured bank sections and a reduced cross section. The bank slopes were steeper toward the downstream limit. The OHWE is 459.3 ft-msl and NP is 458.5 ft-msl. This range of fluctuation is within the bench area. Ten-year stage data (table 18) shows that only stages with less than 10 percent recurrence frequency can reach the base of the bank face.

At the midsection, the d_{50} varied from 0.193 mm at the upper part of the bank surface to 0.206 mm at the base of the bank. A core sample at 2 feet of depth on the upstream section had d_{50} of 0.202 mm. Gradation plots of bank soils and nearshore sediment are presented in appendix C. The detailed cross section and coordinates are shown in appendix D.

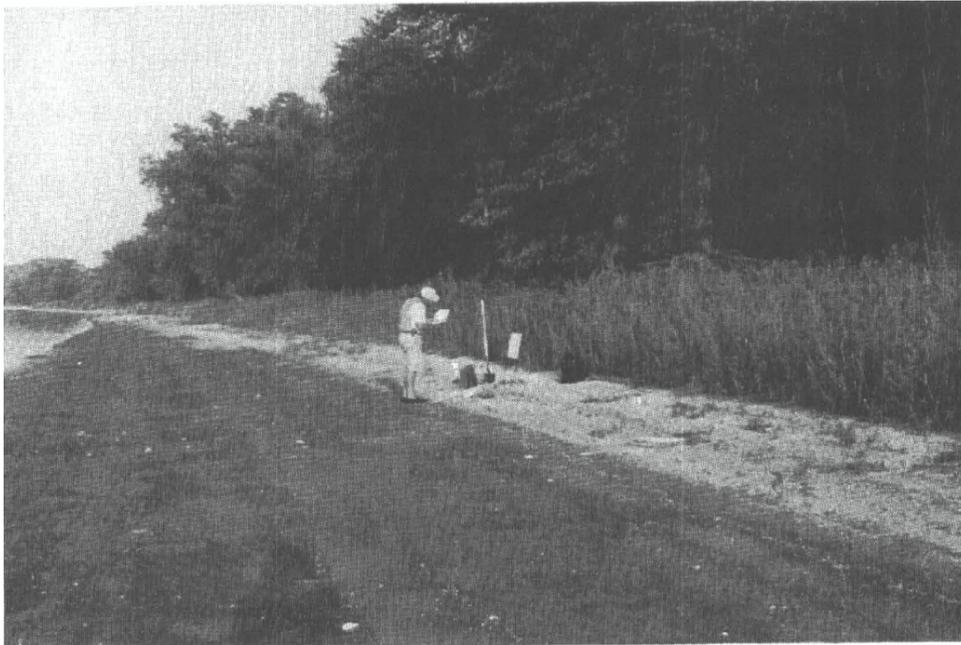
Figure 58. Site 4 on the Illinois River

Site 4 is about 360 feet from the sailing line. No major tributary enters the river at this location, but a state highway bridge crosses the river at RM 229.6. Bhowmik and Schicht (1980) selected both banks as erosion sites (sites 18 and 19) with surveys completed on the RDB and one survey on the LDB (site 20). Erosion of these two sites was indicated on Hagerty's (1988) chart also. At site 4, a mildly sloped bench lies under a small scarp, and mature trees grow behind the scarp. The bench was very wide, sandy, and mostly covered with tall weeds. Tall trees with roots exposed to the air survive in an area between the weed zone and scarps. The root crown is approximately at the same level as the top of the bank. The bench is clay mantled with sand mixed with shells.
