Bank Erosion Survey of the Illinois River Volume 1

by
Nani Bhowmik and David Soong

December 2000

Illinois State Water Survey
Watershed Science Section
Champaign, Illinois

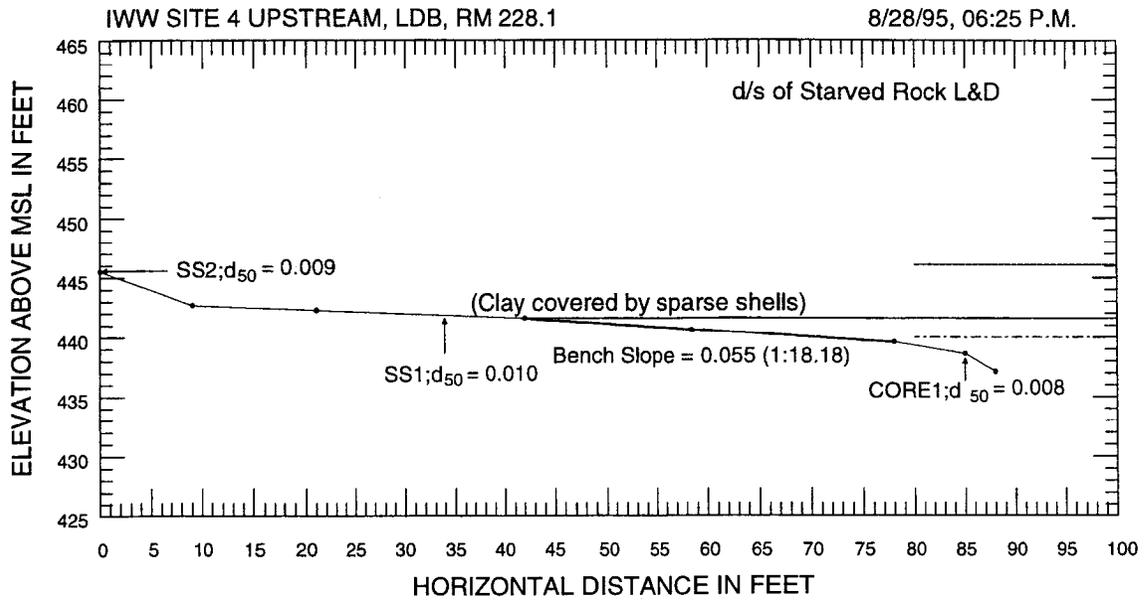
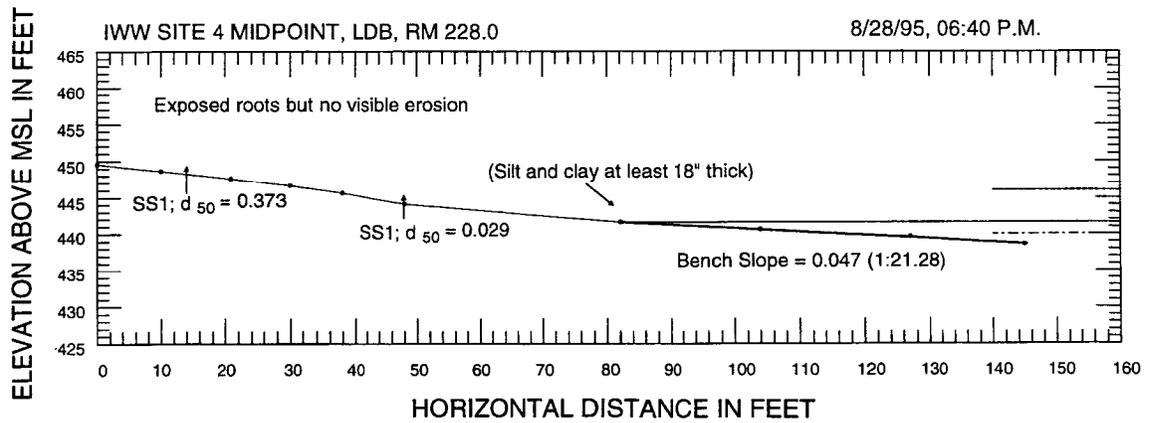
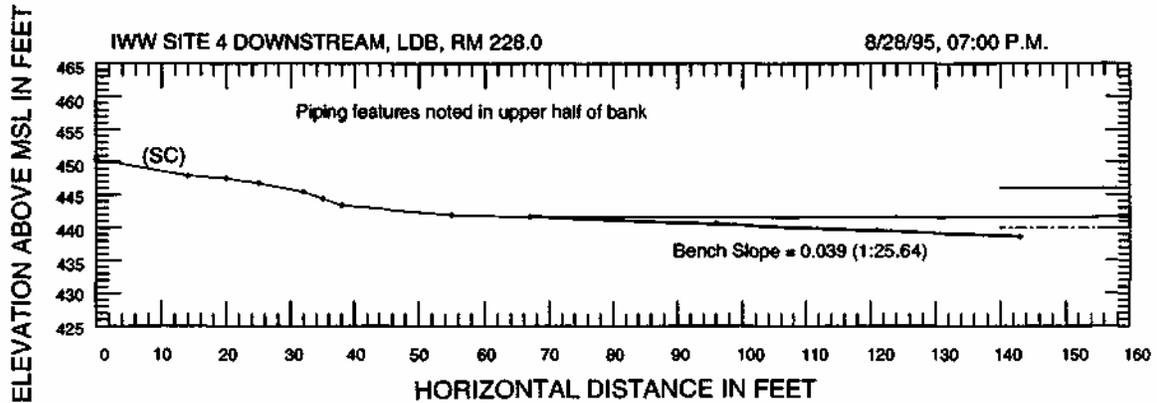
Figure 59. Bank sections at site 4

Figure 59 shows the three measured bank sections and a reduced cross section. Bank sections were fairly uniform at this site. The OHWE is 446 ft-msl and NP is 440 ft-msl. The range of fluctuation between the OHWE and NP covers the entire bench.

Bench slopes varied slightly from 1V: 18.2H at the upstream section to 1V:25.6H at the downstream section. This site can be classified as type 5 (figure 25 and table 9). The bank seemed to be stable in 1995 but was eroded in 1978 (Bhowmik and Schicht, 1980). The elevation of the scarp was fairly high compared to NP or OHWE stages at which piping was noted. Erosion of bench soils or recently deposited sediments can occur during flow at stages higher than OHWE.

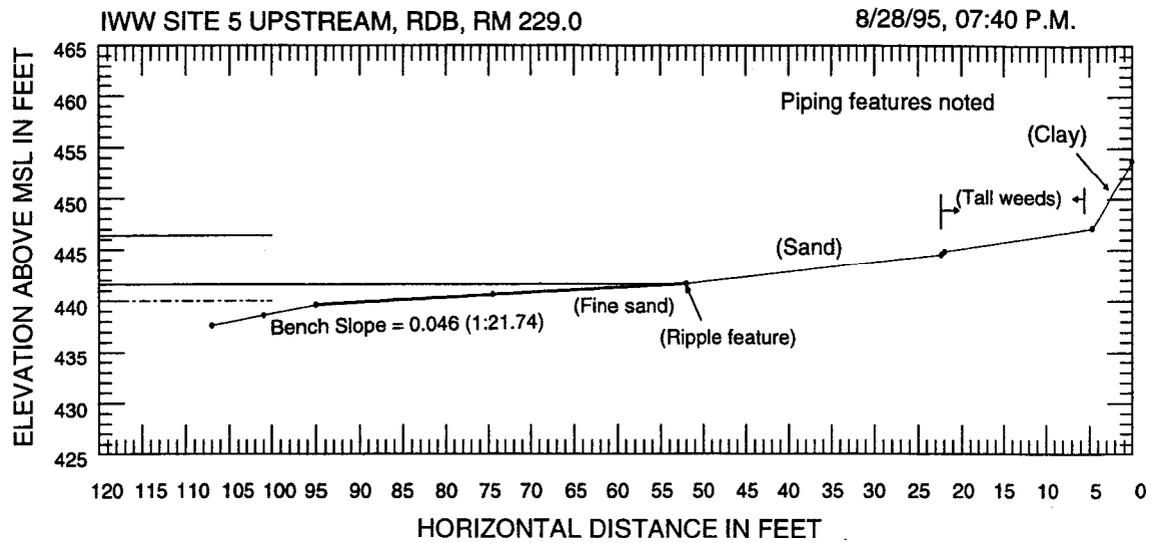
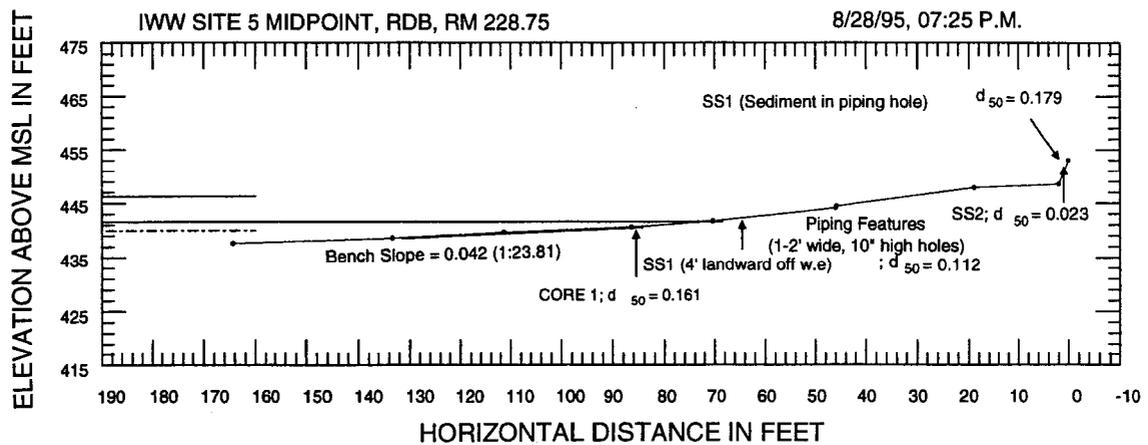
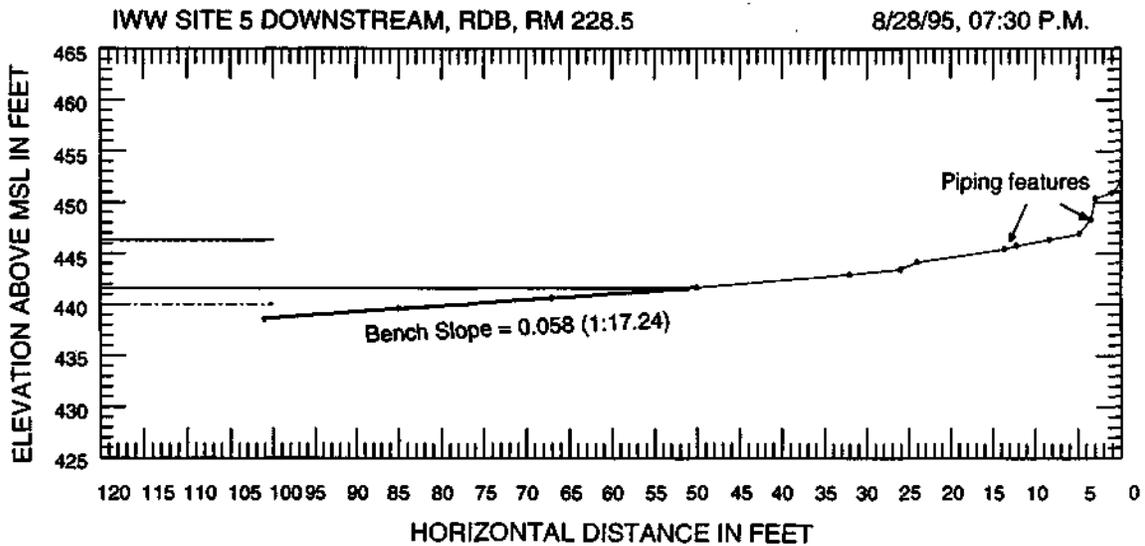
Figure 60. Bank sections at site 5

Figure 60 shows the three measured bank sections and a reduced cross section. The OHWE is 446.2 ft-msl and NP is 440.0 ft-msl. The OHWE elevation was at the base of the scarp at all three sections, and the NP was at a break in the subaqueous slope at the upstream section.

According to the stage analysis using 10-year data (table 20), river stages with 25 percent or less occurrence frequency reach the scarp, and stages with 10 percent or less occurrence frequency top the bank.

Bench slopes varied slightly between 1V:23.8H and 1V: 17.2H. With a scarp over a gentle bench slope, this site is classified as a combination of types 3 and 5 (figures 23 and 25 and table 9). The scarps have layered failure features and were initiated by piping and surface drainage. Waves and currents at OHWE cause erosion of failed soil or recent sediments on the bench area.

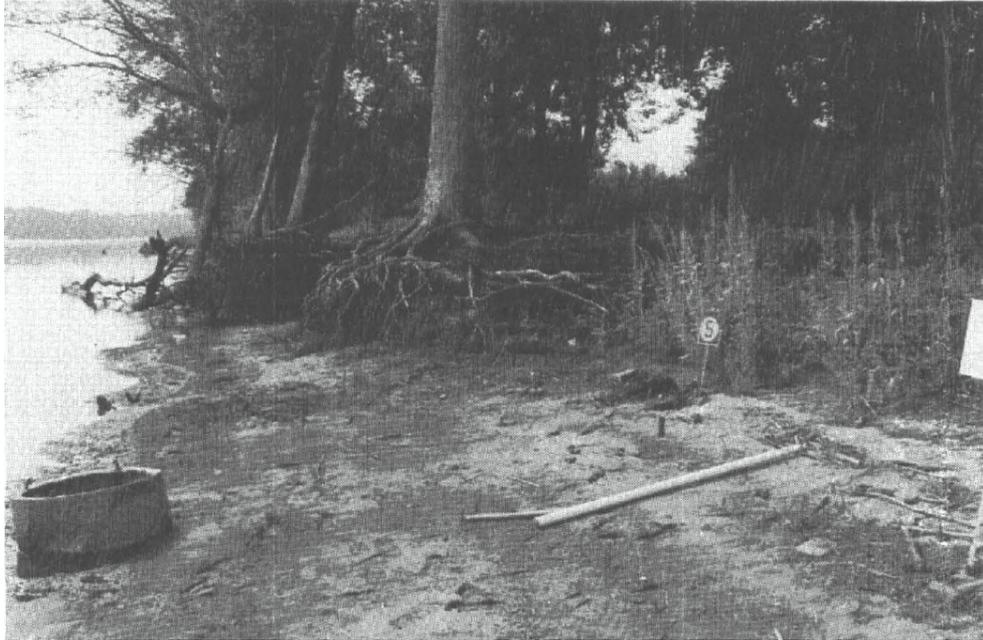
Figure 62. Site 6 on the Illinois River

The site is about 310 feet from the sailing line. In plan form it is on the outer side of a bend. Bhowmik and Schicht (1980) observed erosion on both banks. Hagerty (1988) noted erosion only on the RDB, but his site extended further upstream and downstream from the entrance of the lake. The bank contains small scarps, and the top of the bank is covered with some fine tree roots. Agriculture (corn) is the land use for the upstream section, and woods cover the bank for the other two sections. At the most upstream end point of this reach (immediately downstream from the lake outlet), the subaqueous bench dropped more than 11 feet right off the water's edge, a feature not observed at the remaining sections. Judging from the plan form, this truncation could be caused by tow-induced current passing through the bend. Small worm holes existed on the truncated bench face near the water's edge.

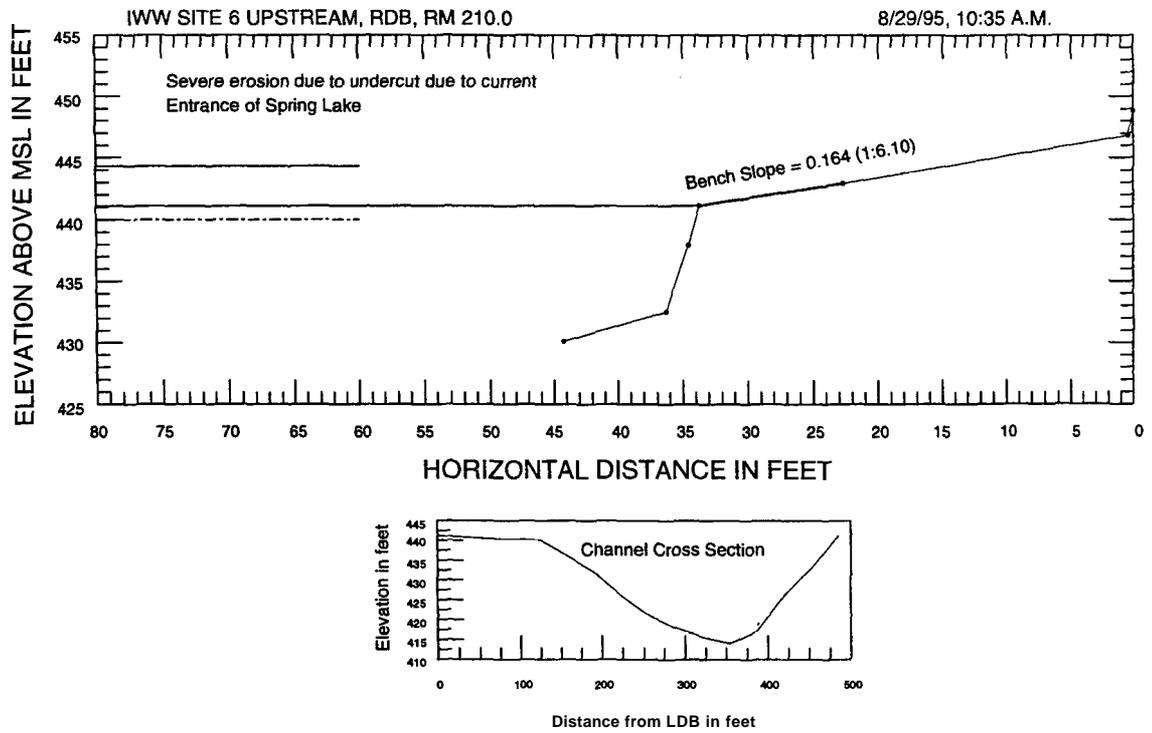
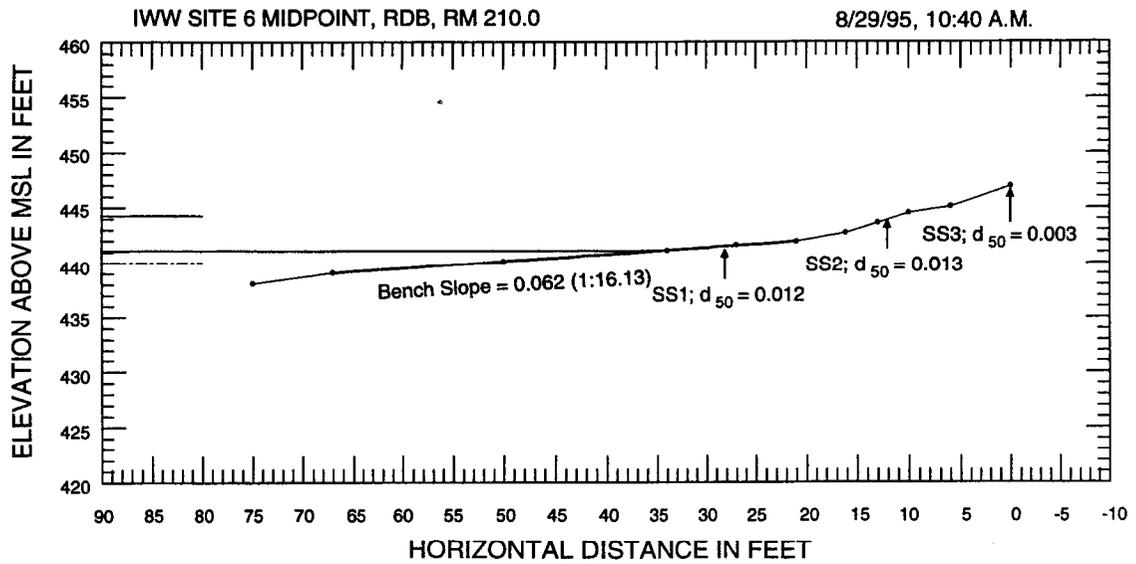
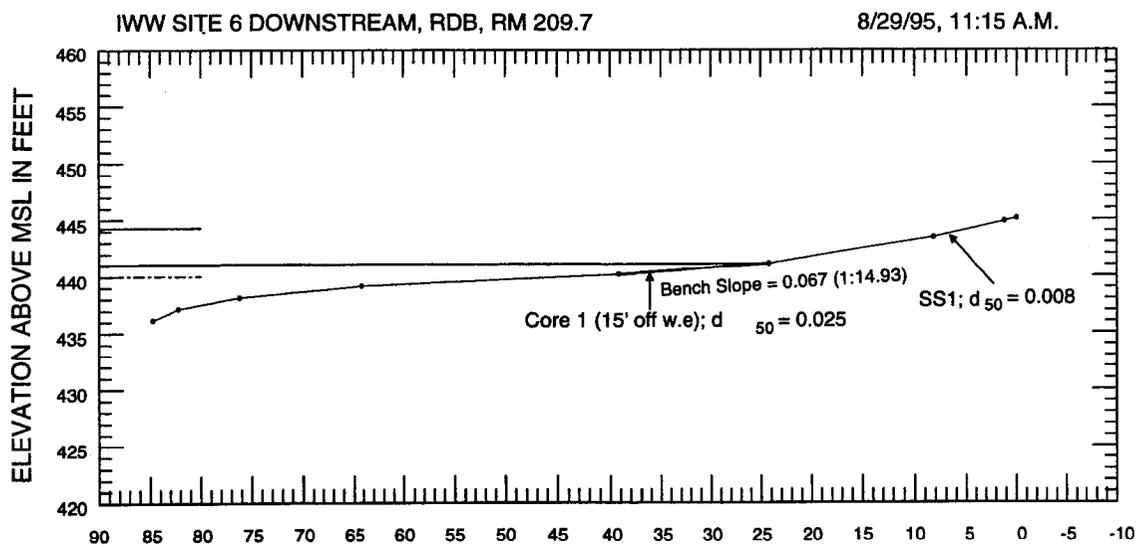
Figure 63. Bank sections at site 6

Figure 63 shows the three measured bank sections and two reduced cross sections. The thalweg was farther away from the water's edge downstream. The OHWE is 443.2 ft-msl and NP is 440.0 ft-msl. Mature trees were growing at the water's edge; the midsection and downstream section were measured between trees. Banks between the trees were eroded. The crown of the tree roots appeared to be higher than the bank top. A flood stage higher than 10 percent recurrence frequency will overtop the bank (see table 21). Standing (but dead) trees were in place in water at the NP level.

Bench slopes varied only slightly from 1V:16.1H at the midsection and downstream section. The three sections, from upstream to downstream, are classified as types 4, 5, and 6 (figures 24-26 and table 9). Traffic-induced currents appear to be a significant factor for the subaqueous scarp at the upstream section. Small worms nesting in the bank soils also will weaken the bank strength. Eddy currents, induced by fallen trees or nearshore land features, exist at the midsection and downstream section. These eddy currents can cause local scours. Other erosion mechanisms include surface drainage for the upstream section, piping, and floods for the whole reach.

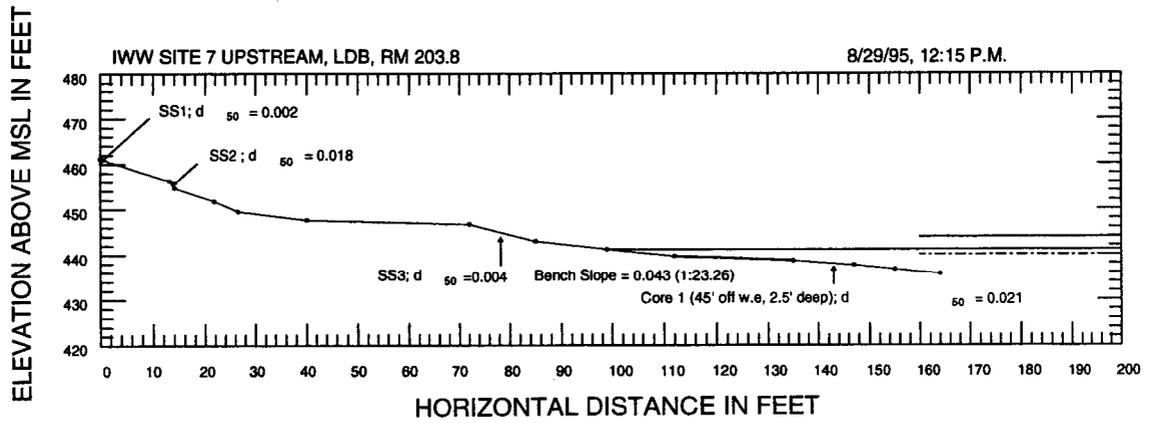
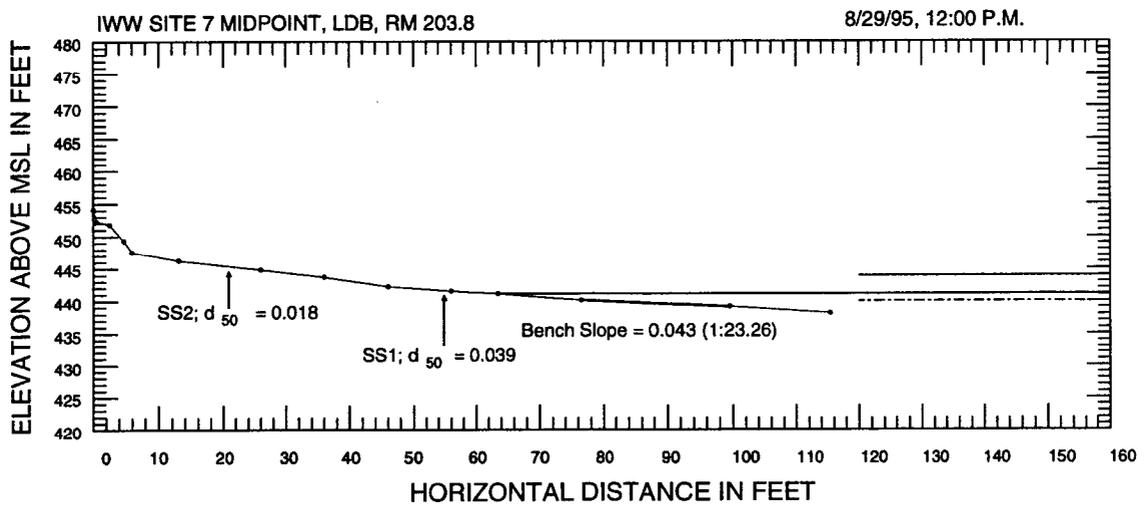
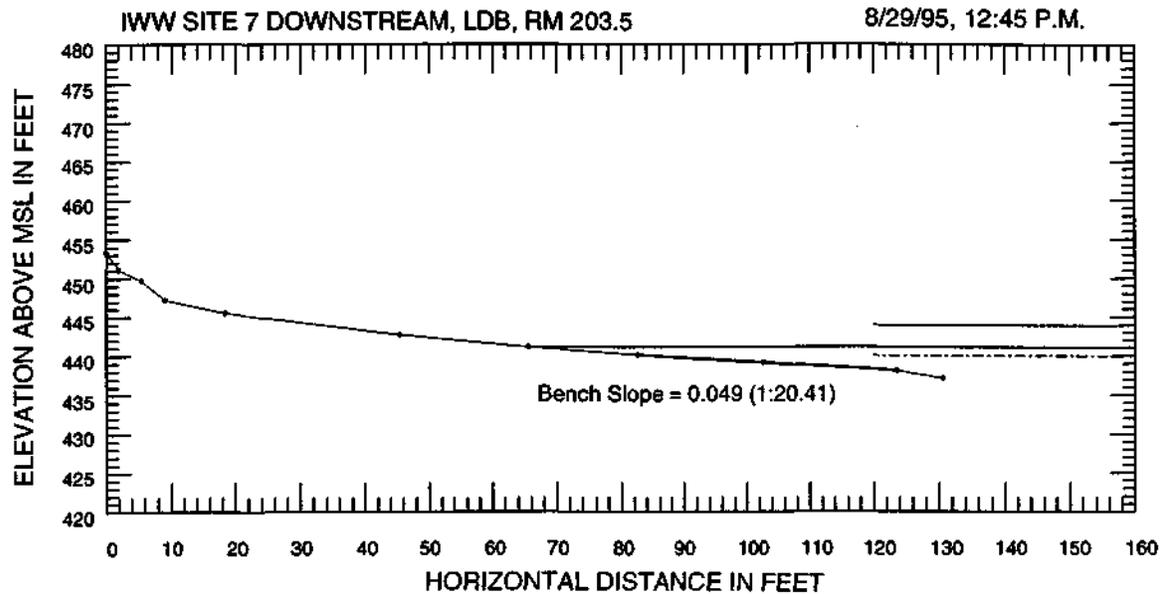
Figure 66. Bank sections at site 7

At the site, a scarp 3-5 feet high was located about 2-4 feet below the levee crown. Tall weeds were growing on the berm, and many small scarps were observed on the bench. Figure 66 shows the three measured bank sections and a reduced cross section. The OHWE is 443.9 ft-msl and NP is 440.0 ft-msl. The OHWE corresponded well with the lower edge of the weed zone on the shore, where debris was found, in the bench area. Stages above 447.5 feet (about 10 percent recurrence frequency, see table 22), reach the base of the scarp near the top of the levee.

Bench slopes varied only slightly from 1V:23.3H. This site can be classified as type 5 (figure 25 and table 9). The scarp was located above most flood stages. Rework and transport by wave and currents are major factors in removing failed soil or recent sediments from the bench.

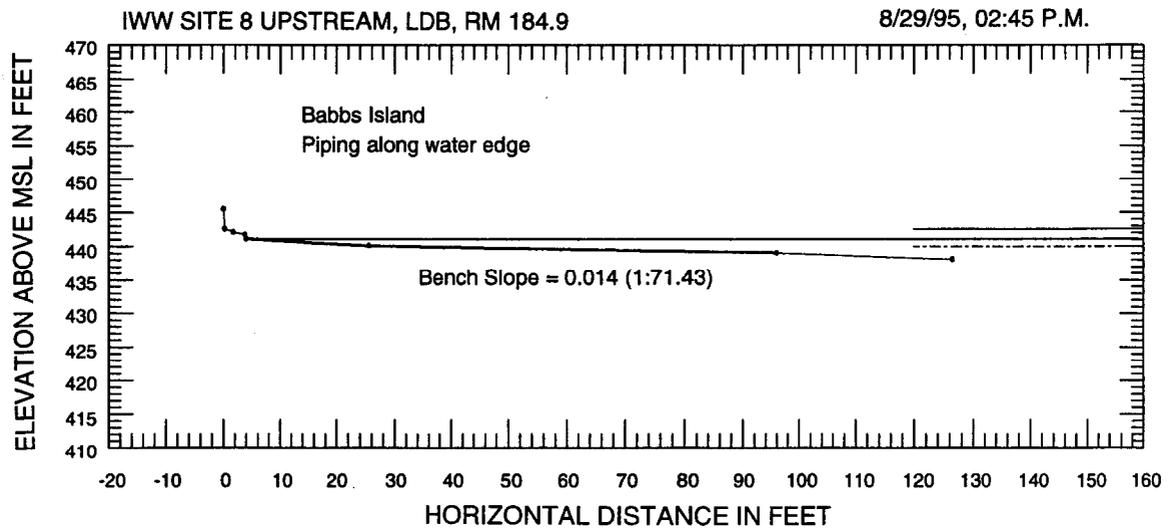
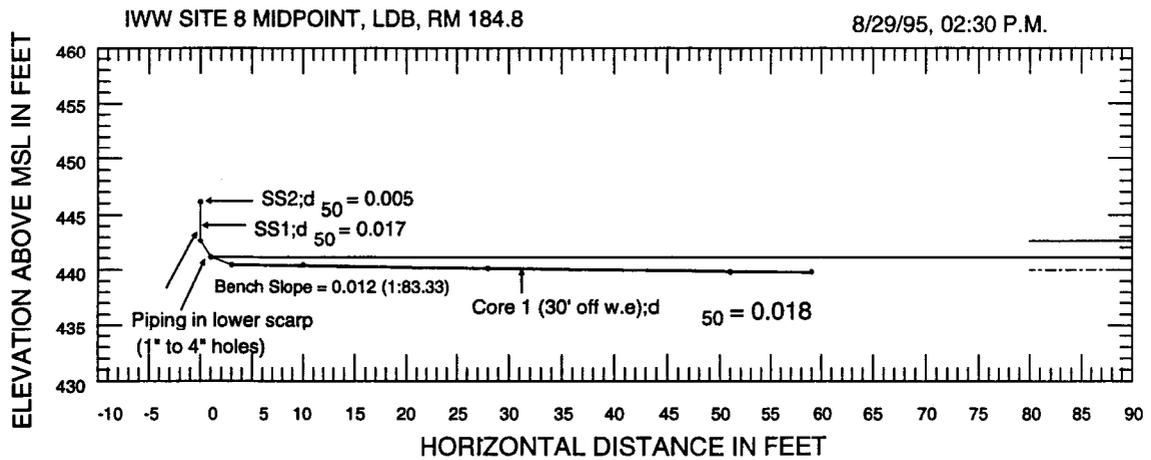
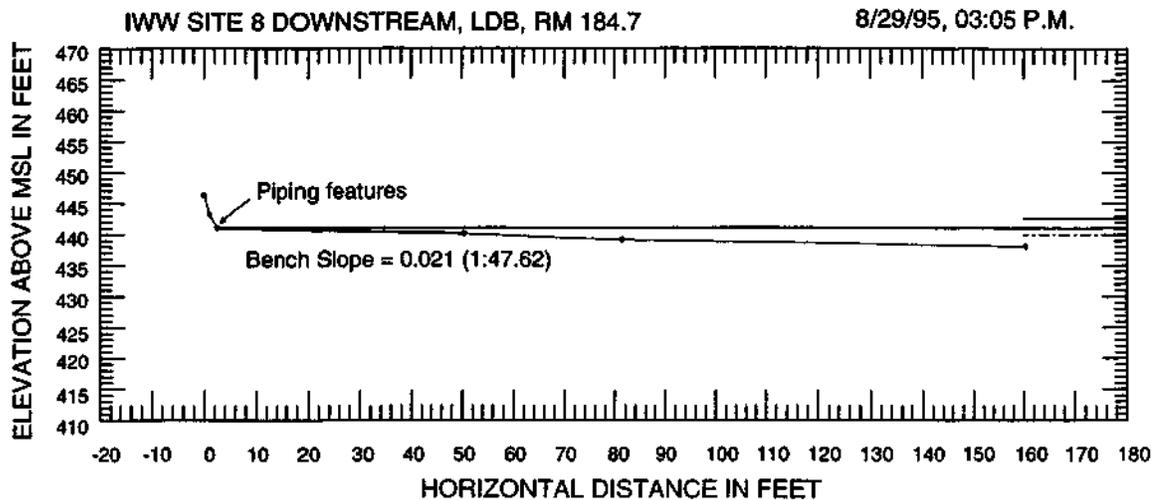
Figure 69. Bank sections at site 8

Figure 69 shows the three measured bank sections and a reduced cross section. The OHWE is 442.6 ft-msl and NP is 440.0 ft-msl. The OHWE corresponds to the base of the scarp. Floods with stage higher than 447.5 feet (about 10 percent recurrence frequency) overtop the bank (table 23).

Bench slopes varied from 1 V:83.3H to 1V:47.6H. This site is classified as a combination of types 4 and 5 (figures 24 and 25 and table 9). Bank failures are initiated by piping or burrowing activities from riverine animals. Rework and transport of failed bank soils by wave action at NP appeared to be significant. Wave action probably was responsible for an erosion scarp at water's edge.

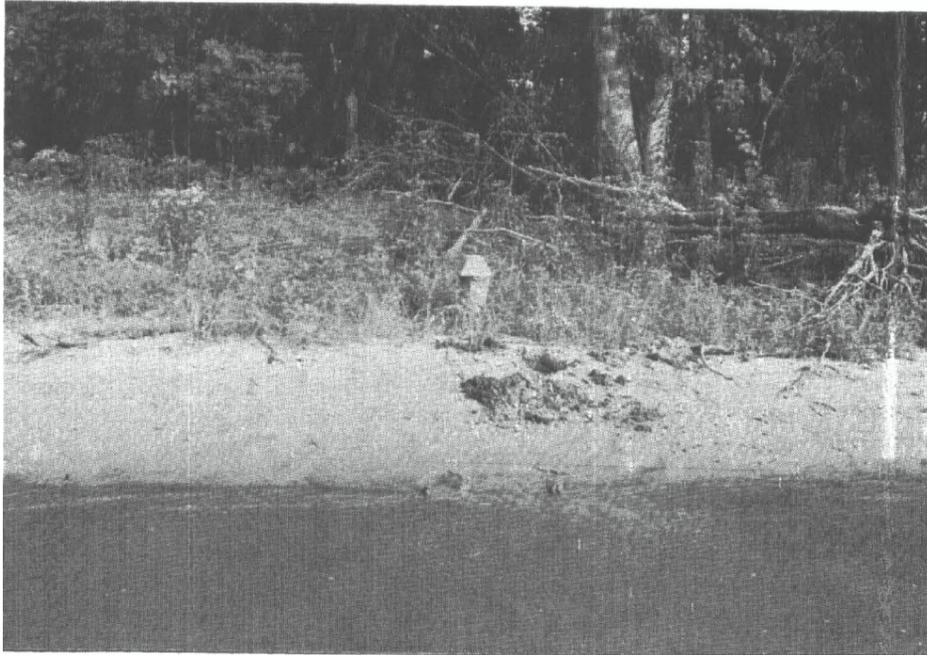
Figure 71. Site 9 on the Illinois River

The site is about 310 feet from the sailing line, and the Chillicothe Sports & Marine Small Boat Harbor is located across the river. Bhowmik and Schicht (1980) and Hagerty (1988) marked this as an erosion site. The bank was mildly sloped and covered with weeds of medium density. The foundation of an old monument installed by Bhowmik and Schicht (1980) on shore was exposed for about a foot. A scarp about 0.3 foot high existed on the lower bank where the weed zone ends above a sandy bench. A scarp also existed at the water's edge. The wet bench did not support large weights. Submerged nearshore material, however, was hard clay mantled with sand.

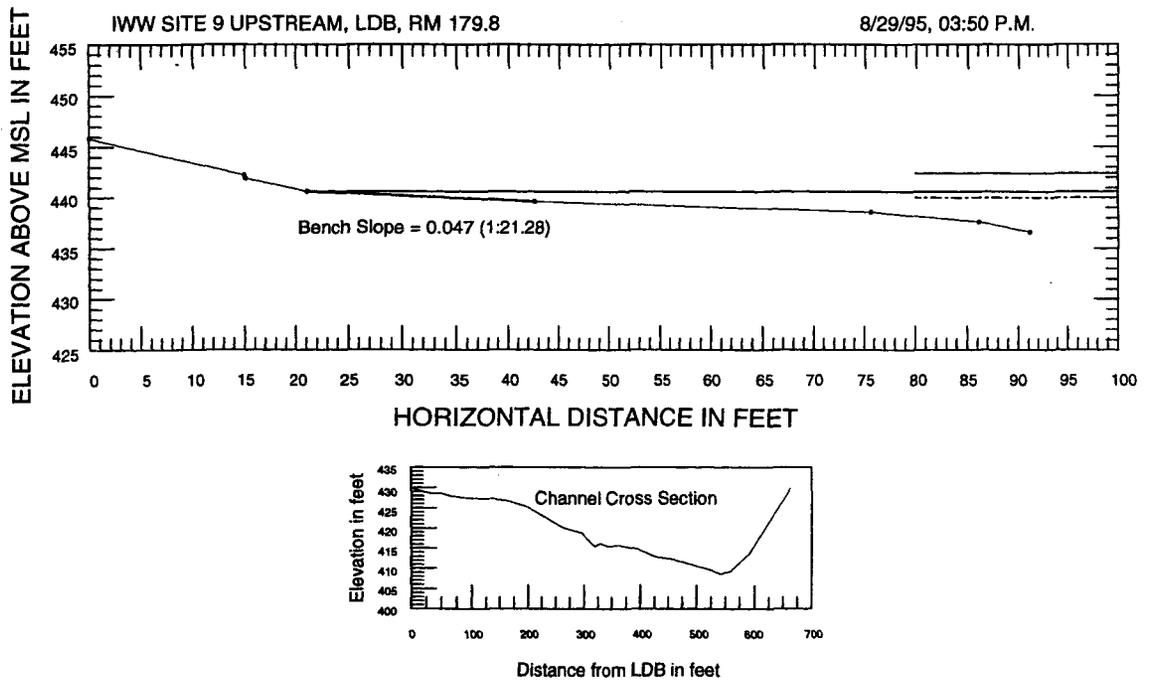
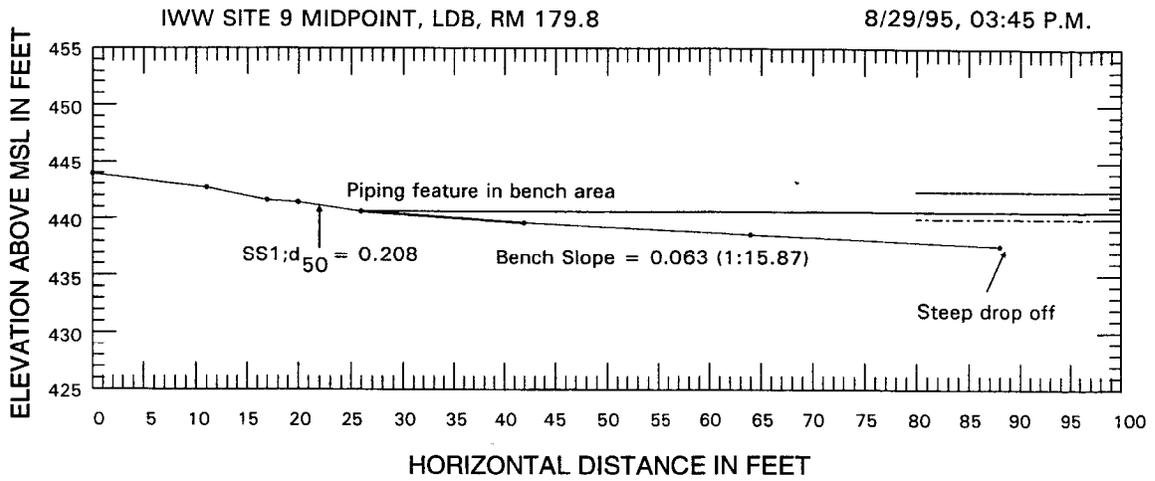
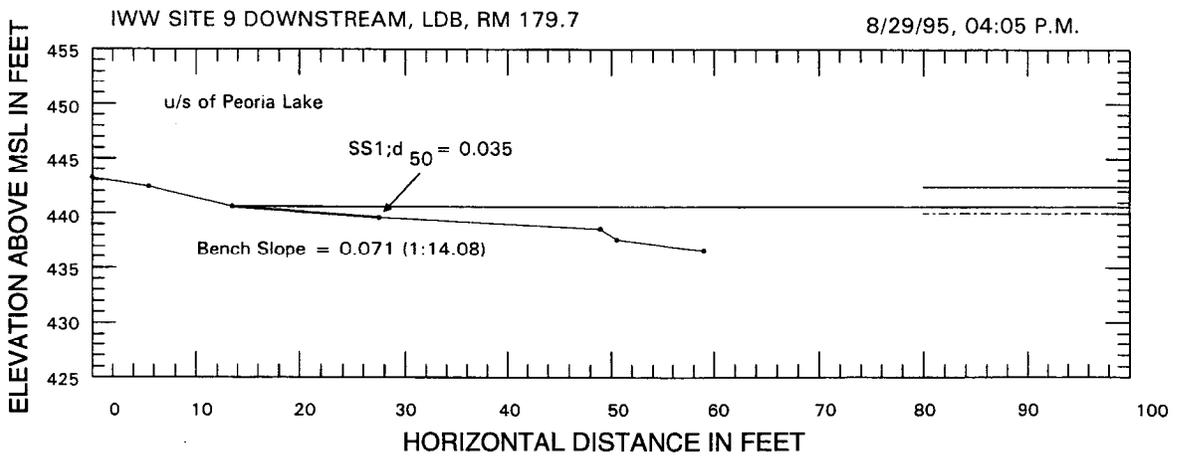
Figure 72. Bank sections at site 9

Figure 72 shows the three measured bank sections and a reduced cross section. The OHWE is 442.4 ft-msl and NP is 440.0 ft-msl. The OHWE corresponds well to the lower edge of the weed zone. High water of a stage exceeding 447.5 feet (10 percent recurrence frequency, table 24) submerges the entire bank.

Bench slopes varied from 1V:21.3H at the upstream section to 1V:14.1H at the downstream section. This site is classified as types 4 and 6 (figures 21 and 26 and table 9). The combinations of wave actions and seepage within the bench near NP elevations could be the major causes of erosion at this site. Recreational and commercial traffic volumes are high at site 9. Traffic-induced waves and current can also be the cause of erosion at this site.

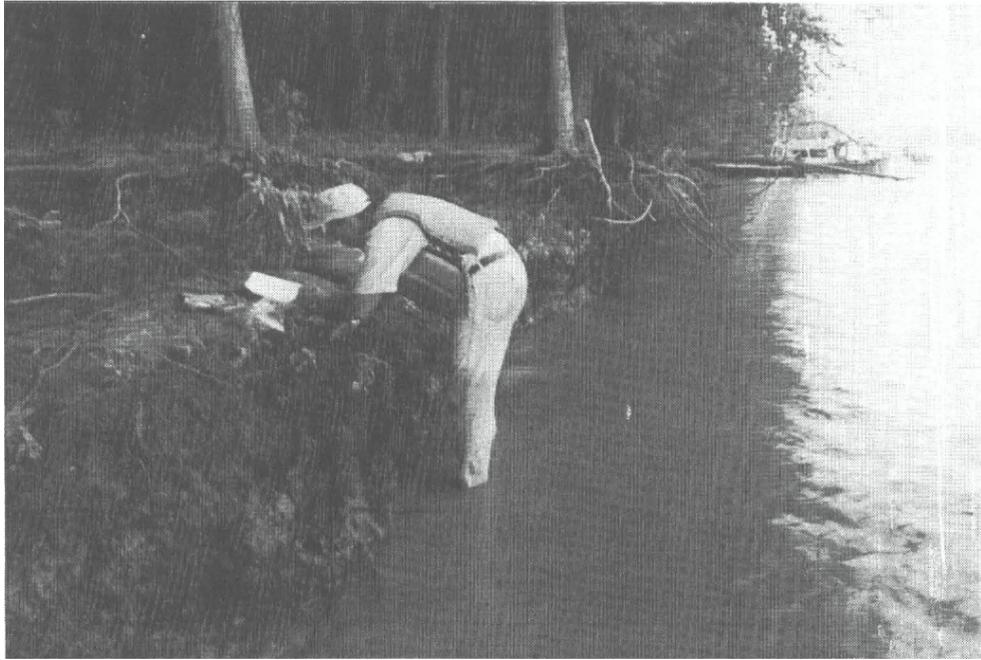
Figure 74. Site 10 on the Illinois River

Site 10 is about 430 feet from the sailing line. Kickapoo Creek enters the river at RM 159.6 on the RDB. At the upstream end of the site a drawbridge is located at RM 160.8. Neither Bhowmik and Schicht (1980) nor Hagerty (1988) recorded the site as an erosion site. Parked barge fleets were noted on the LDB about 1,000 feet upstream from this site. This bank bore some resemblance to site 8, but trees were growing at the water's edge, and there was not much seasonal vegetation on top of the bank. A scarp 3-5 feet high and some piping holes were observed near the water's edge. The underwater bench extended toward the channel, and a thick layer of fine materials was noted on the subaqueous bench. Strong currents were encountered near the bank.

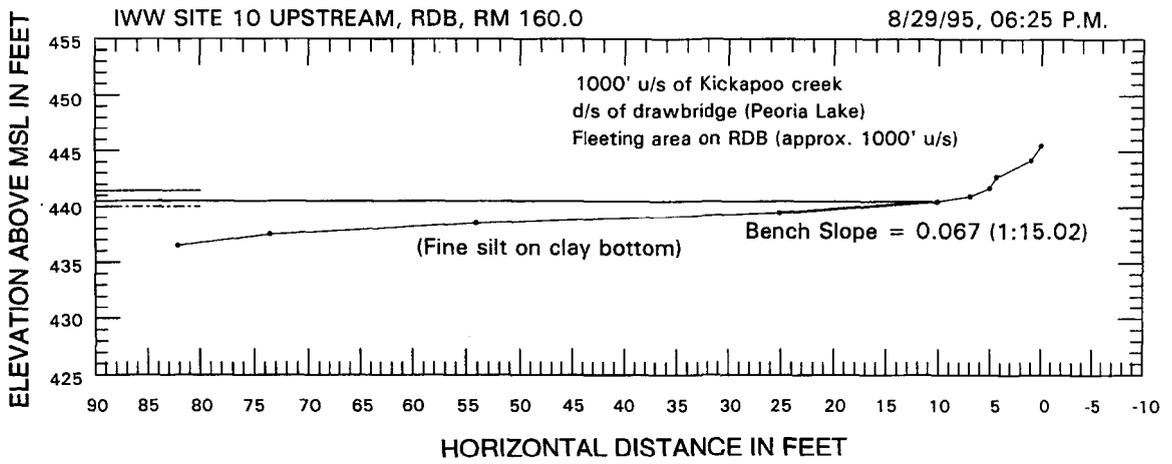
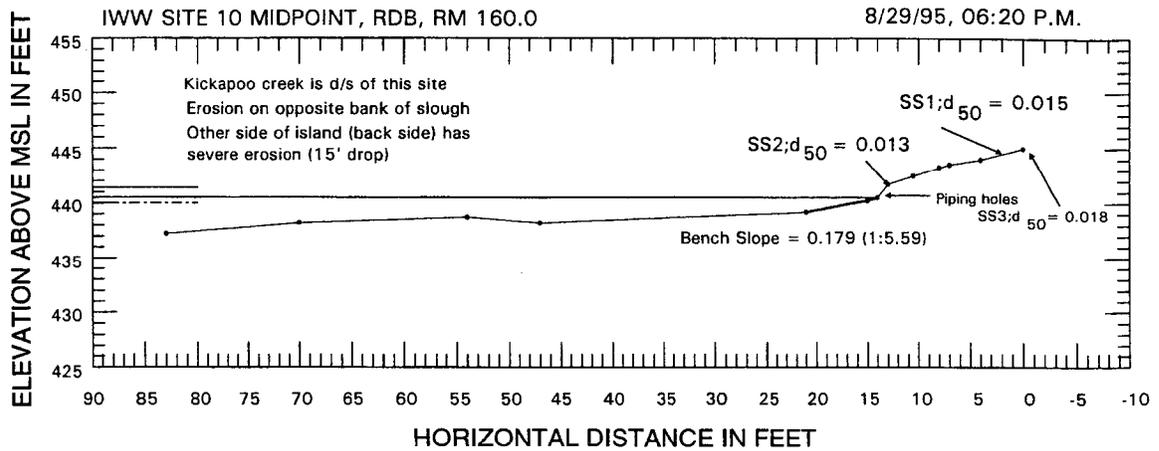
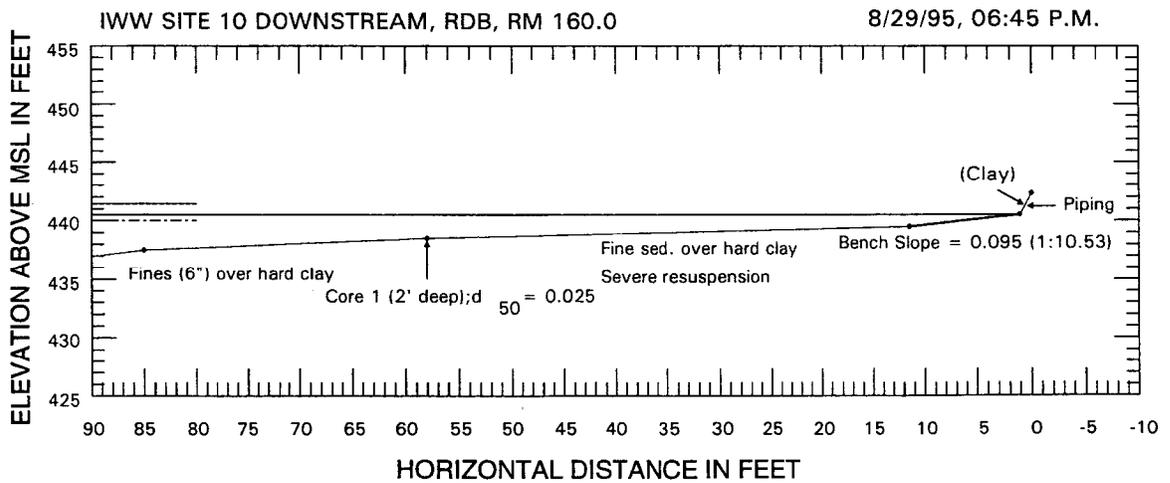
Figure 75. Bank sections at site 10

Figure 75 shows the three measured bank sections and a reduced cross section. The OHWE is 441.4 ft-msl and NP is 440.0 ft-msl. Water surface elevation was at the base of the scarp. At stages corresponding to OHWE, the scarp is mostly submerged. Floods of a stage higher than 445.4 ft-msl (10 percent recurrence frequency, table 25) overtop the bank crest. There was sediment deposition on top of the bank.

Bench slopes varied between 1V:15.0H and 1V:5.6H, and the subaqueous bench extended more than 70 feet. Soils on the scarp were cohesive. The site can be classified as a combination of types 4 and 5 (figures 24 and 25 and table 9). Piping-related internal erosion weakens the bank. Soils exposed and displaced by bank failures are susceptible to removal by wave and current actions during normal stages. Traffic is heavy at this site and could add to the tractive forces by waves and currents.

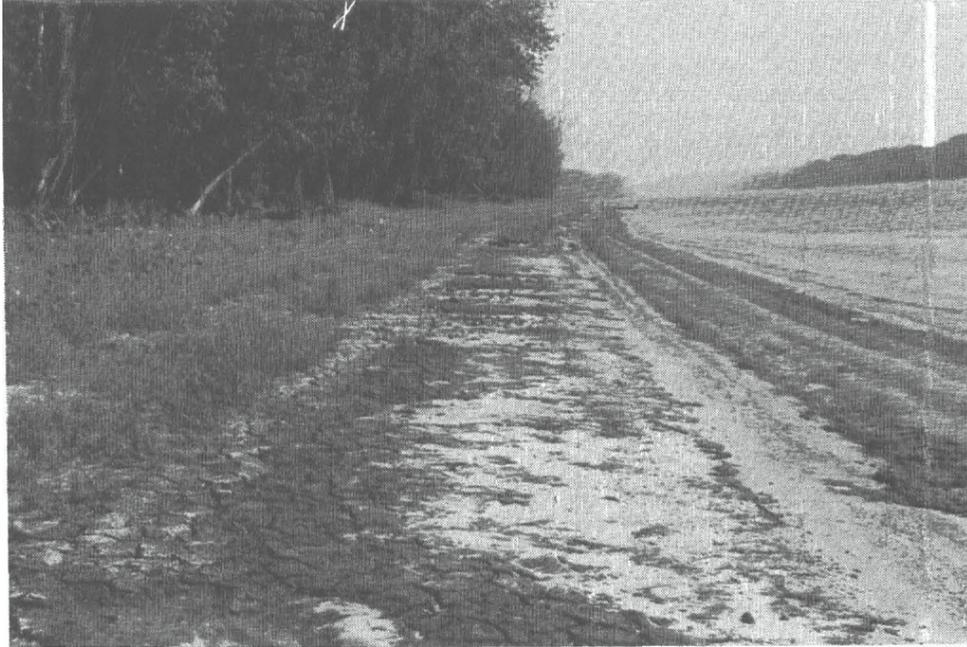
Figure 77. Site 11 on the Illinois River

The navigation sailing line is near the RDB at site 11 (the distance from the navigation chart is about 250 feet). Lick Creek enters the Illinois River from the LDB at RM 156.5. Bhowmik and Schicht (1980) noted some erosion on both banks around RM 156, and Hagerty (1988) noted dredged material cited on the navigation chart for both banks.

Bench slopes varied slightly between 1V: 11.2H and 1V:9.0H. This site is classified as type 6 (figure 26 and table 9). Wave actions are primarily responsible for rework and transport of failed soil or recently deposited sediments on the bench at various stages within the normal range of pool level fluctuations.

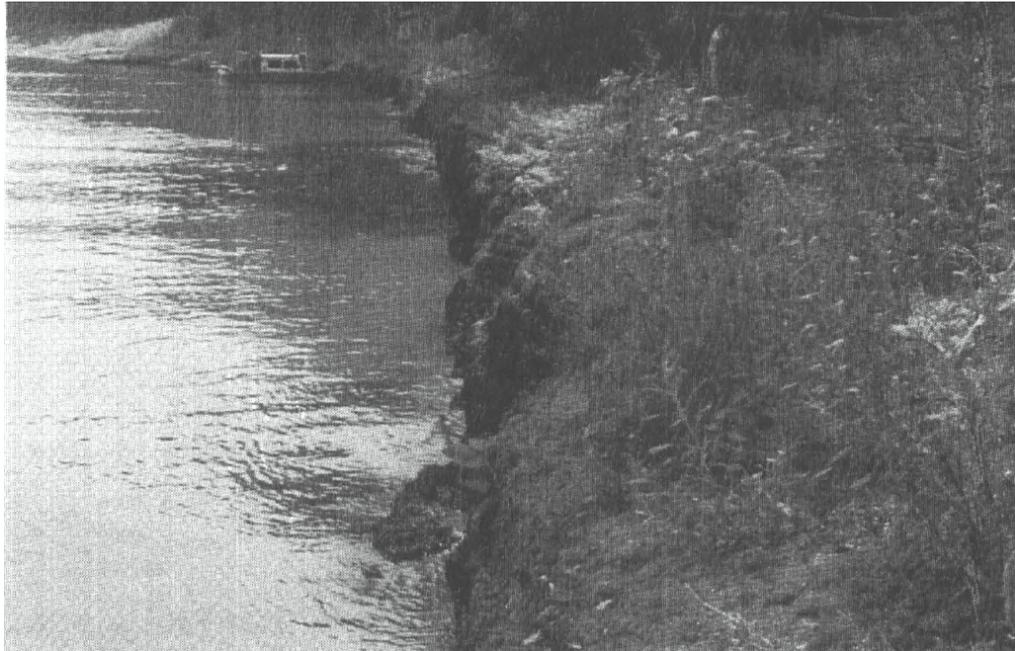
Figure 82. Site 13 on the Illinois River

This site is located on the LDB at RM 150.6 on the outside of a sharp bend. A 3 by 5 foot barge tow would have considerable difficulty in maneuvering through this sharp bend. A delta at the upstream end (RM 150.9) near the mouth of a small creek further reduces the maneuvering space for barge tows and increased flow velocity. The Chicago and Northwestern Railway bridge crosses the river at RM 151.2. All these factors may be responsible for changes in bank sections from upstream to downstream. Figure 81 shows the position of the site on a GIS-based map of the Illinois navigation chart, and figure 82 is a photograph of the site.

Materials on the scarp were cohesive. This site can be classified as type 4 (figure 24 and table 9). Under normal stages, waves and turbulence created by traffic are causes for bank erosion. Rework and transport by current at stages within the normal range of pool level fluctuation can be significant. Seepage and nesting worms can also weaken bank strength.

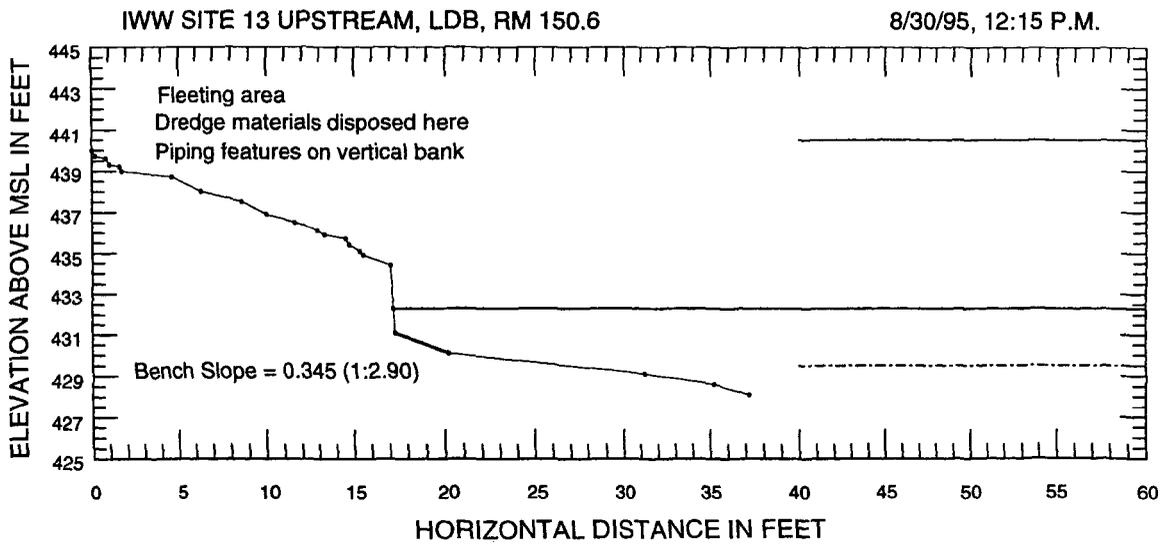
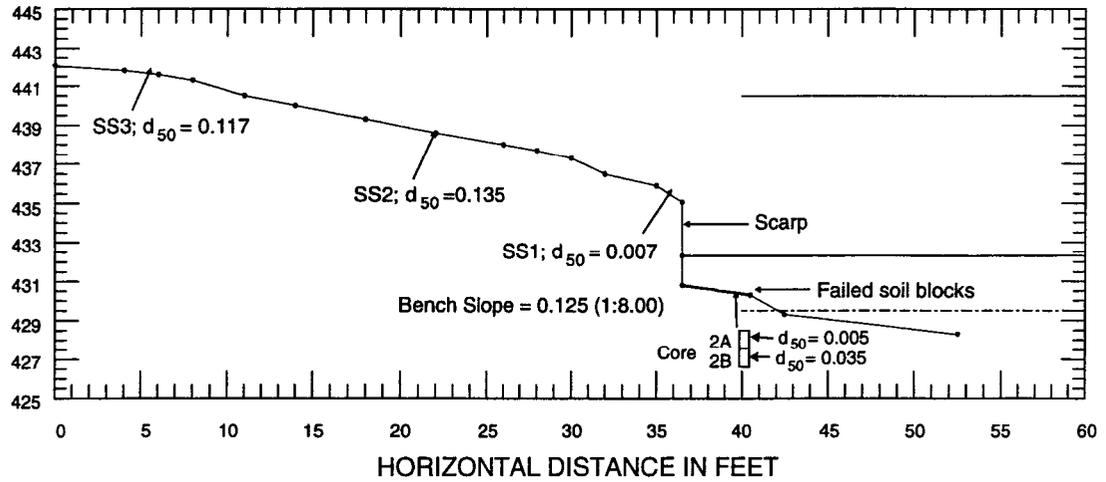
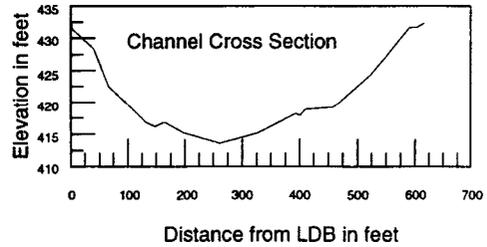
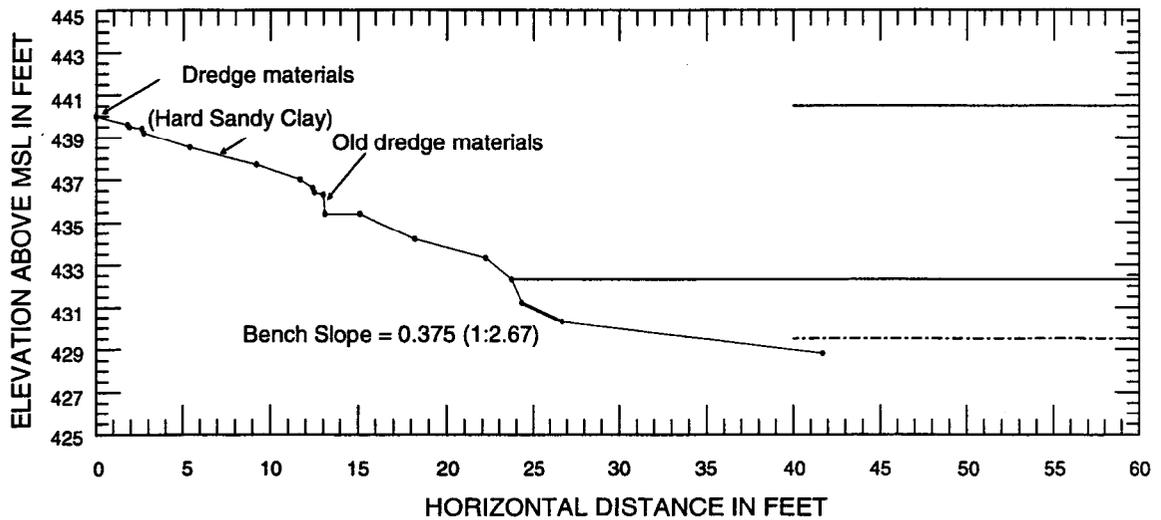
Figure 83. Bank sections at site 13

Figure 83 shows the three measured bank sections and a reduced cross section. The OHWE is 440.5 ft-msl, and NP is 429.5 ft-msl. The NP elevation is about at the base of the berm, and the OHWE reaches the upper part of the bank. Table 28 gives the stages for various recurrence frequencies at this site.

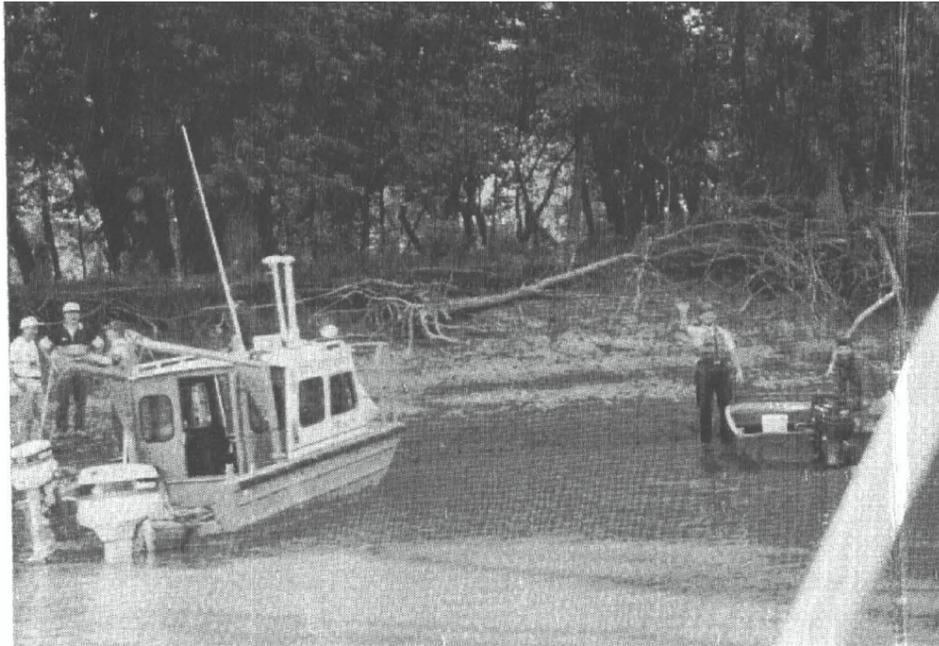
Figure 85. Site 14 on the Illinois River

Site 14 is about 270 feet from the sailing line, and no major tributary enters the river at this location. Approximately 600 feet behind this site is the East Liverpool Levee System. Bhowmik and Schicht (1980) found erosion on the opposite bank on an island. Hagerty (1988) observed erosion on this bank but not on the opposite bank. Trees are close to the bank crest at many locations at this site, and some roots extended beyond the bank face. A scarp about 1.5 feet high was located on the upper part of the bank, which was covered by seasonal grasses. Several breaks in the bank sections appeared to correspond to different erosion mechanisms at this site. Dislodged pedes and some micro-scale piping existed on a bare bench area. The bench between the scarp and the water's edge was covered with moist, soft clay.
