Bank Erosion Survey of the Illinois River Volume 1

by
Nani Bhowmik and David Soong

December 2000

Illinois State Water Survey
Watershed Science Section
Champaign, Illinois

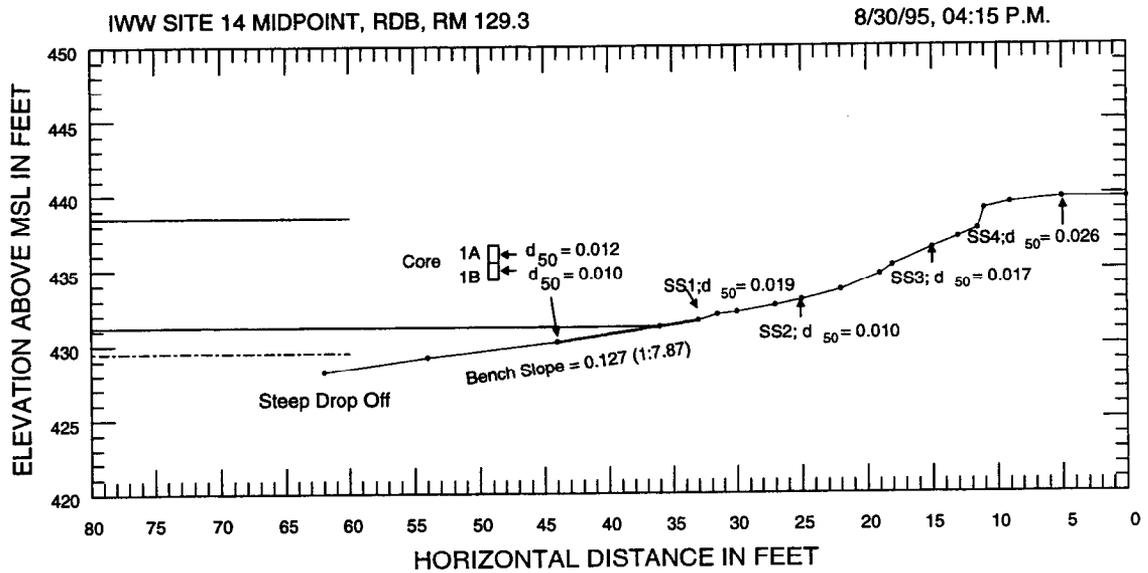
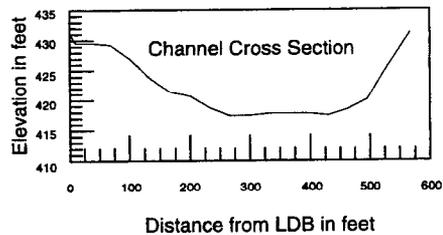
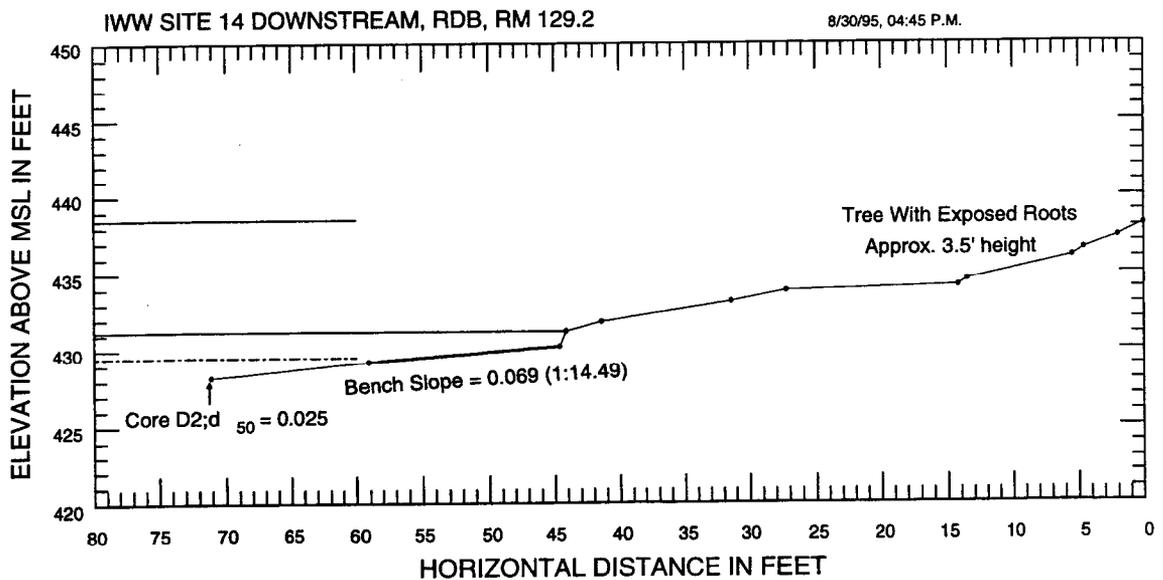
Figure 86. Bank sections at site 14 (concluded)

Figure 86 shows the three measured bank sections and a reduced cross section. The OHWE is 438.5 ft-msl, and NP is 429.5 ft-msl. A scarp was noted at the downstream section, where the NP elevation matched the base of the scarp. The OHWE elevation- is about the same height as the short scarp at the midsection, and any stages higher than the OHWE elevation will top the bank (see table 29 for the recurrence frequencies for various stages).

Bench slopes varied from 1V:10.1H at the upstream section to 1V:7.9H at the midsection. The slope for the subaqueous bench was 1V:14.5H below a water's edge scarp at the downstream section. The site is classified as type 4 (figure 24 and table 9). The subaerial bench was wet due to poor drainage. Wave wash, in combination with piping, appeared to have created the downstream small scarp on the bank. Rework and transport of failed soils and recently deposited sediments at stages within the normal range of pool-level fluctuations could be significant.

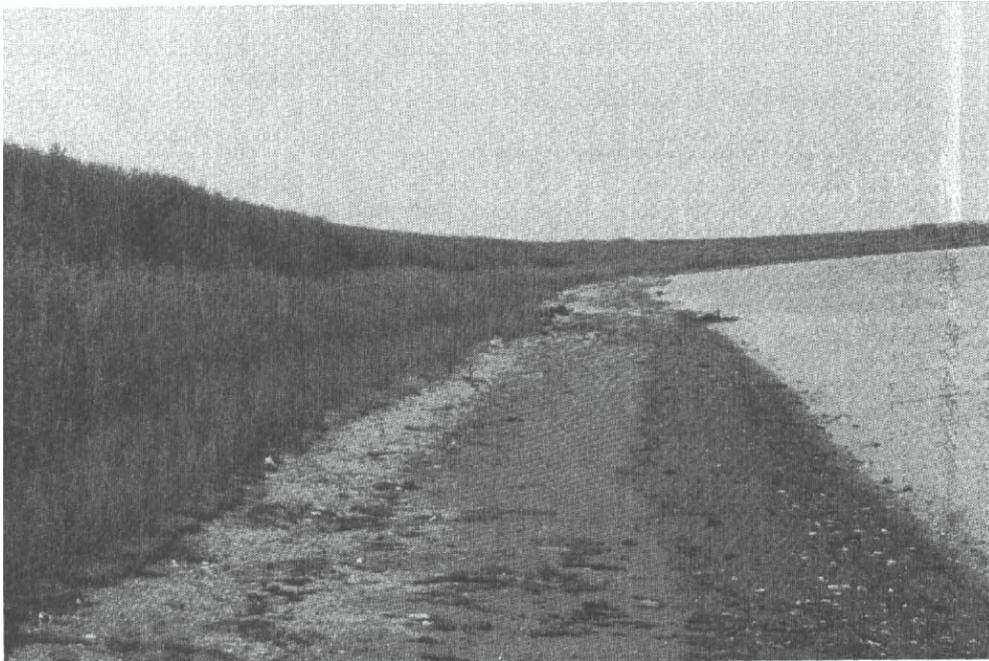
Figure 88. Site 15 on the Illinois River

The site is about 310 feet from the sailing line. No major tributary enters the river at this location. Bhowmik and Schicht (1980) noted erosion along a long stretch of this side of the river, and Hagerty (1988) noted dredged material at the site as well as some old dredged material on the opposite bank. Tall grass covered the bank face, with scarps inside the grass zone. The bench below the grass zone contained a series of small scarps.

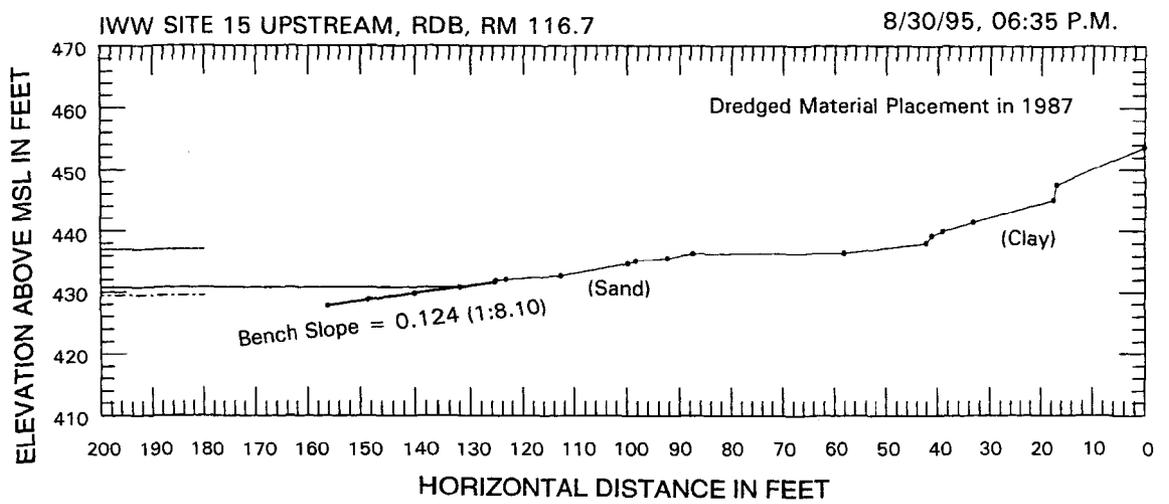
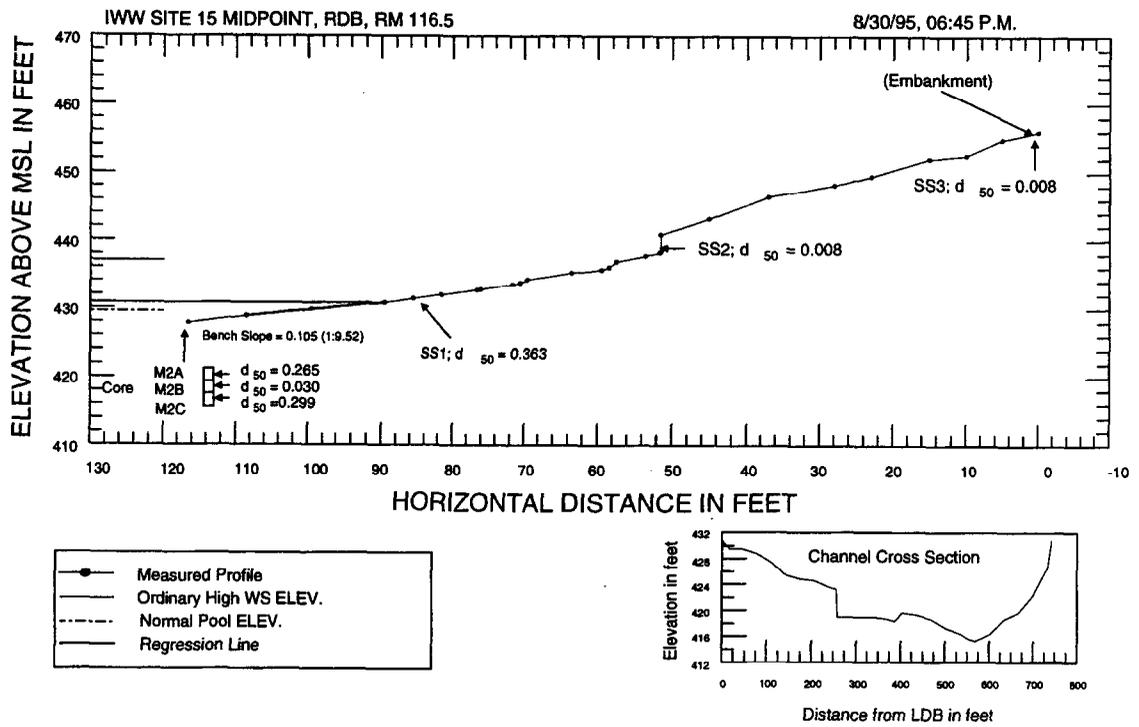
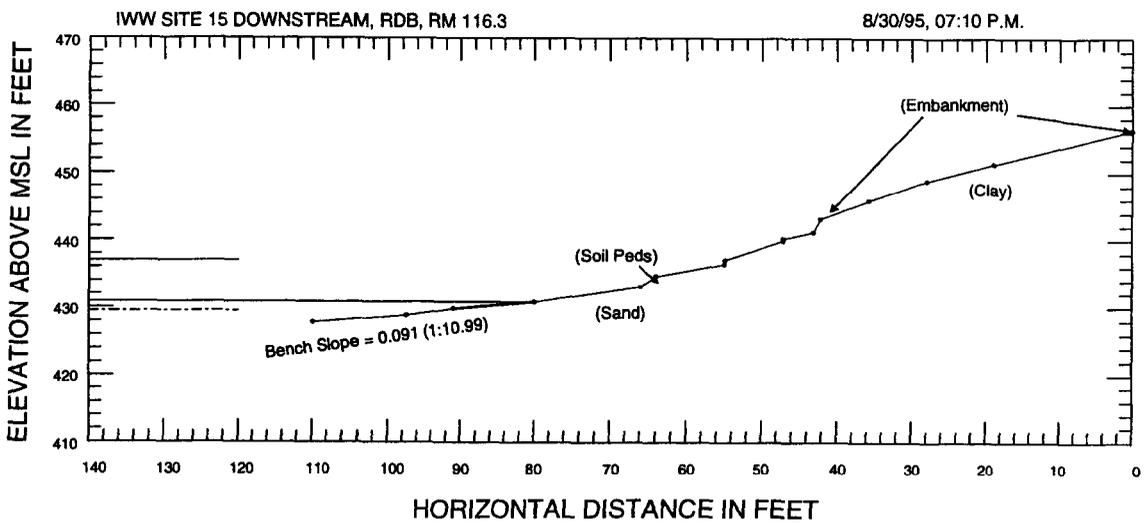
Figure 89. Bank sections at site 15

Figure 89 shows the three measured bank sections and a reduced cross section. The OHWE is 437.0 ft-msl, and NP is 430.8 ft-msl. The NP elevation corresponds to a break in the subaqueous slope. From figure 89, the OHWE elevation corresponds to the base of a small scarp. Table 30 shows the recurrence frequencies for various stages.

At the midsection, the d_{50} varied from 0.008 mm at the top surface of the bank to 0.265 mm at the upper part of a core sample at a water depth of about 2 feet. The nearshore sediment was stratified. Gradation plots of bank soils and nearshore sediment are presented in appendix C. A detailed cross section is shown in appendix D.

Bench slopes varied from 1V:8.1H at the upstream section to 1V:11H at the downstream section. This site is classified as a combination of types 3 and 5 (figures 23 and 25 and table 9). The existing scarp was located at higher elevations that could be caused by floods. The peds indicated seepage activities. Rework and transport by waves and currents on failed soils or recent sediments could also be important at this site.

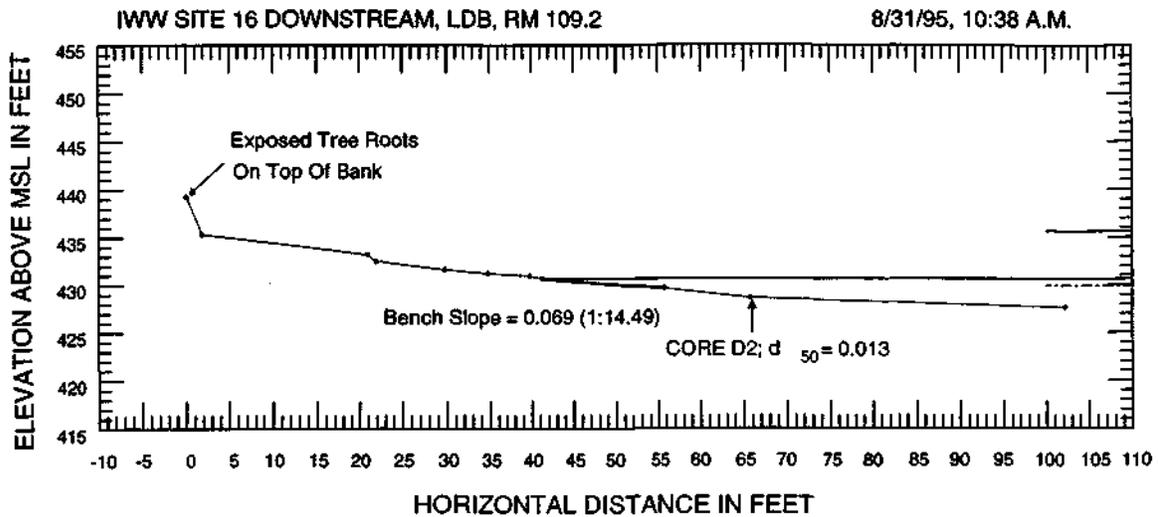
Figure 92. Bank sections at site 16 (concluded)

Figure 92 shows the three measured bank sections and two reduced cross sections. The OHWE is 435.7 ft-msl, and NP is 429.9 ft-msl. The NP elevation corresponds well to a break in the subaqueous bench slope. Water at the OHWE elevation generally reached the base of the scarp or submerged part of the scarp; higher stages (table 31) overtop the bank. Most of the lower scarp and recent sedimentation were observed between NP and OHWE.

Bench slopes varied from 1V:7.0H at the upstream section to 1V:14.5H at the downstream section. The upstream section and midsections are classified as type 2, and the downstream section is classified as type 3 (figures 22 and 23 and table 9). Rework and transport of bench materials occur at stages within the normal range of pool-level fluctuations. Erosion of in-place soils occurs at stages above OHWE. Seepage and piping affect the extent of failure during recession periods when the river stages can drain.

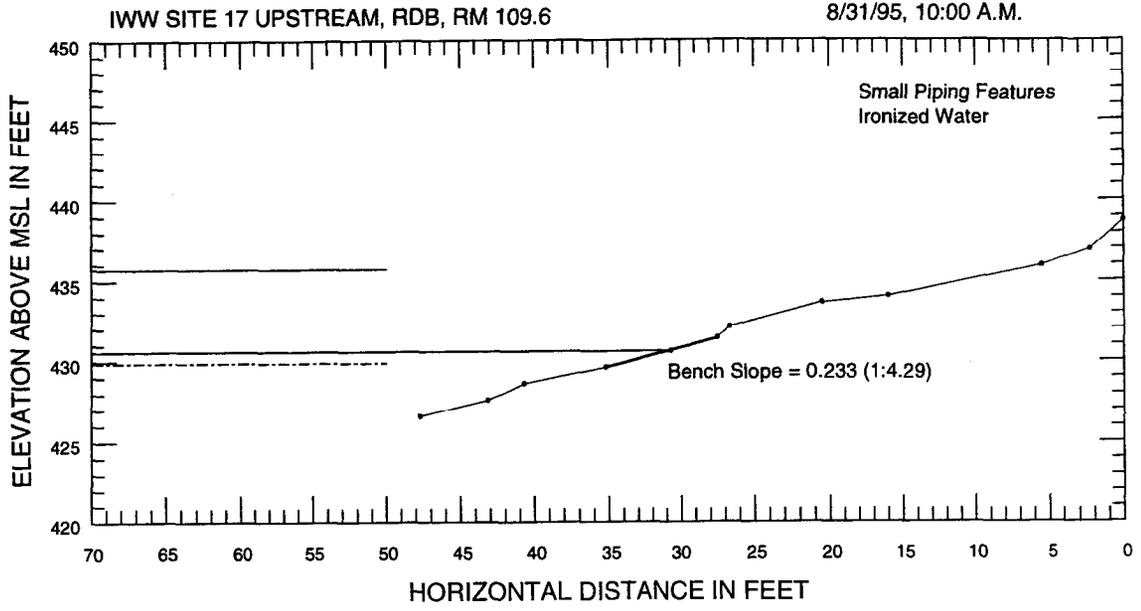
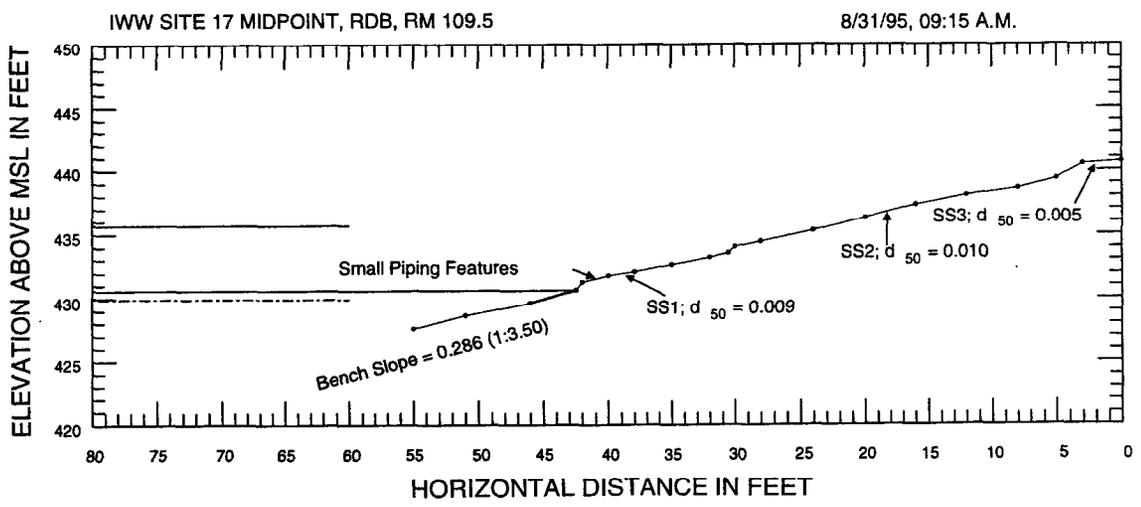
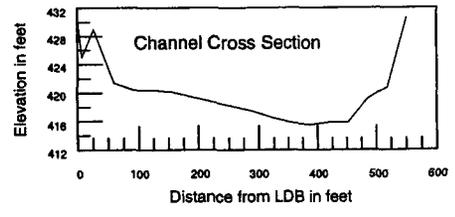
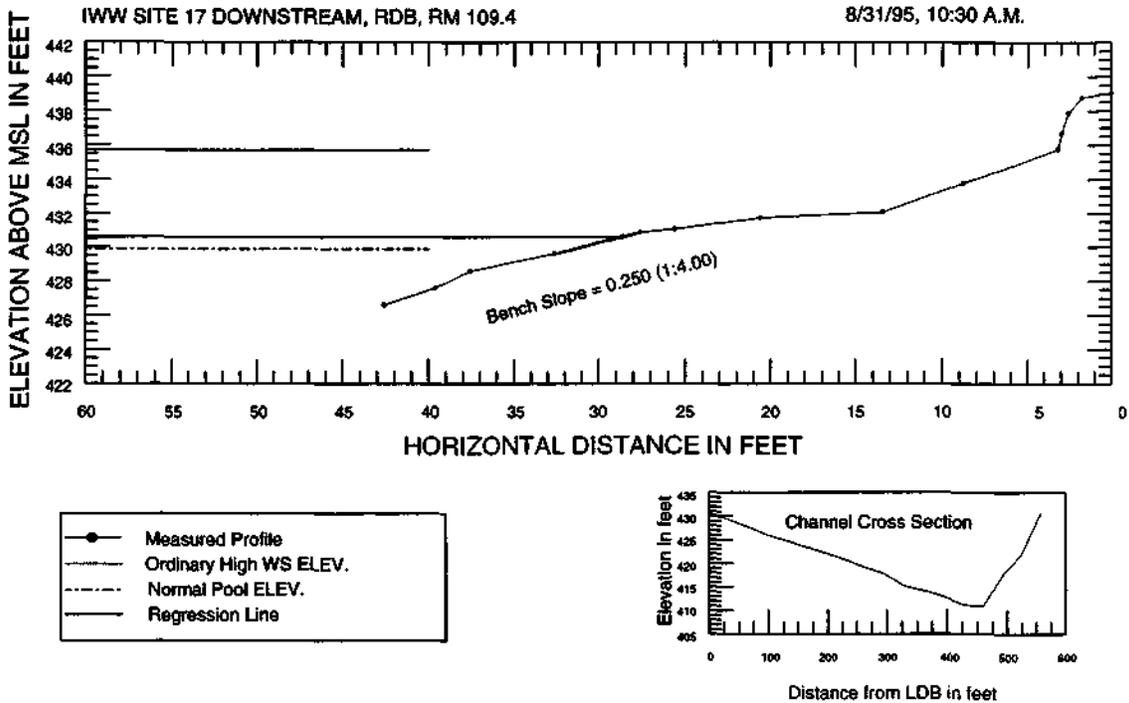
Figure 94. Bank sections at site 17

Figure 94 shows the three measured bank sections and two reduced cross sections. The OHWE is 435.7 ft-msl, and NP is 429.9 ft-msl. There is a scarp near the water's edge and downslope from areas of seepage flows; the OHWE elevation is above a zone of seasonal grasses and the OHWE elevation corresponds well to the base of a scarp on the upper portion of the bank. Other stages and corresponding features are given in table 32.

At the midsection, the d_{50} varied from 0.005 mm at the top surface of the bank to 0.009 mm near the water's edge. Bank materials are similar. Gradation plots of bank soils and nearshore sediment are presented in appendix C. The detailed cross section and coordinates are shown in appendix D.

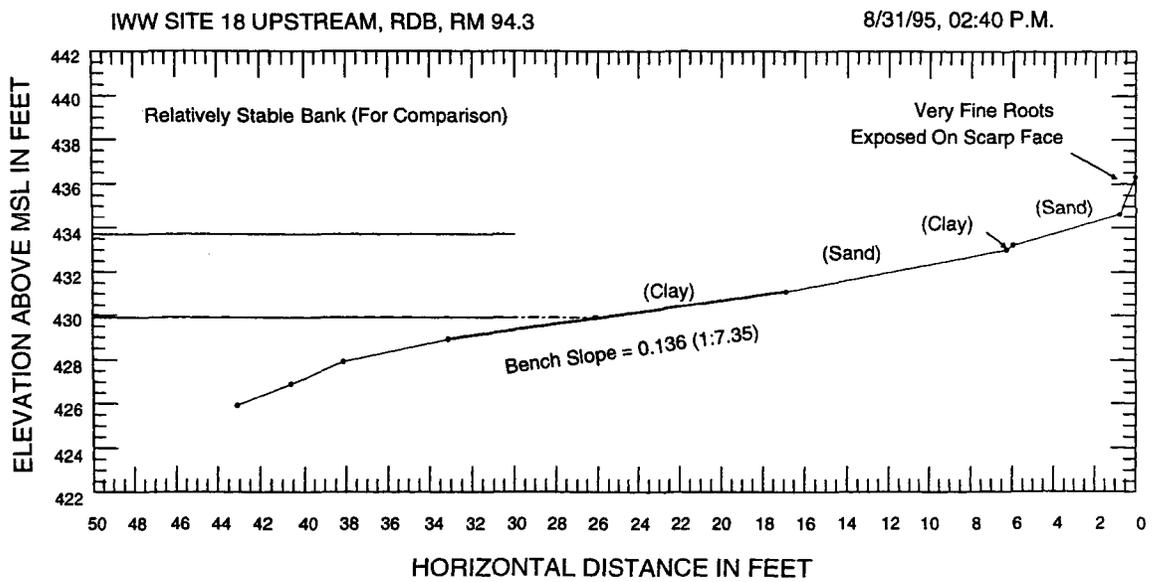
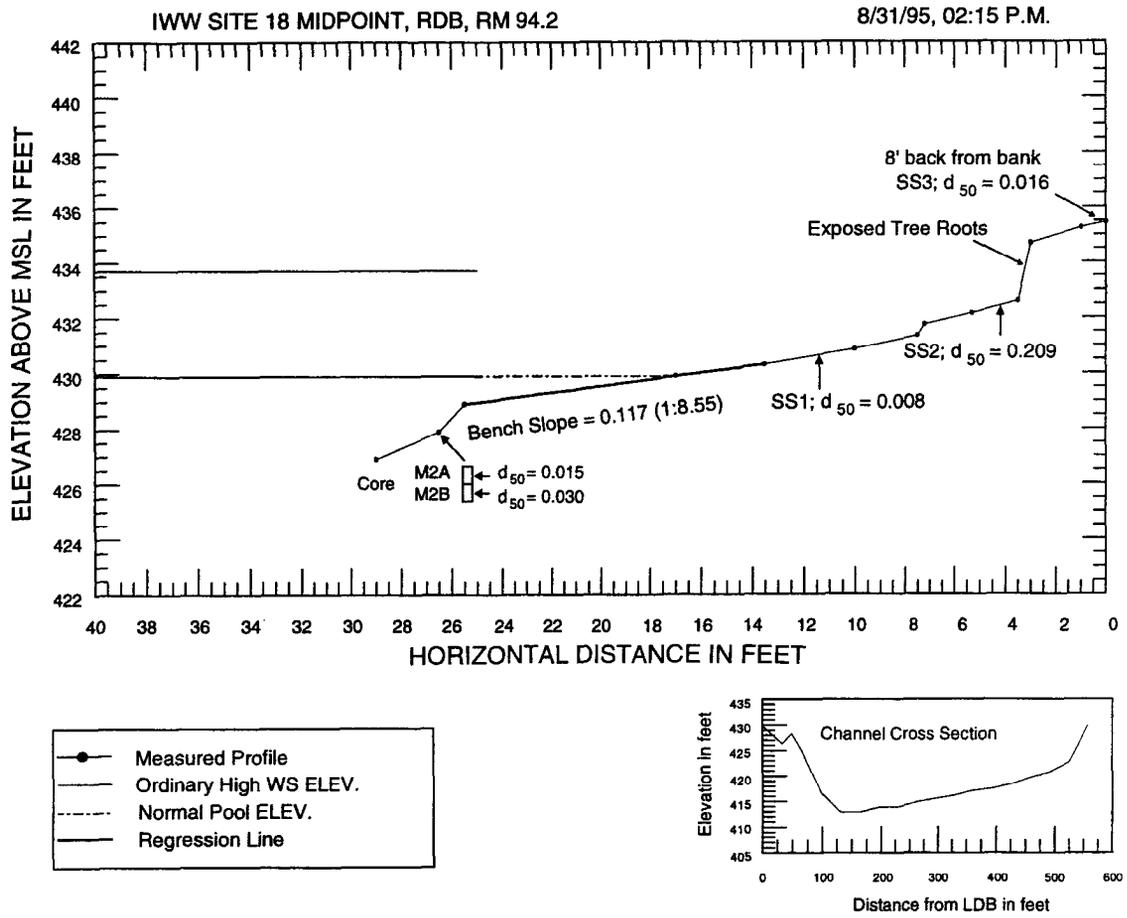
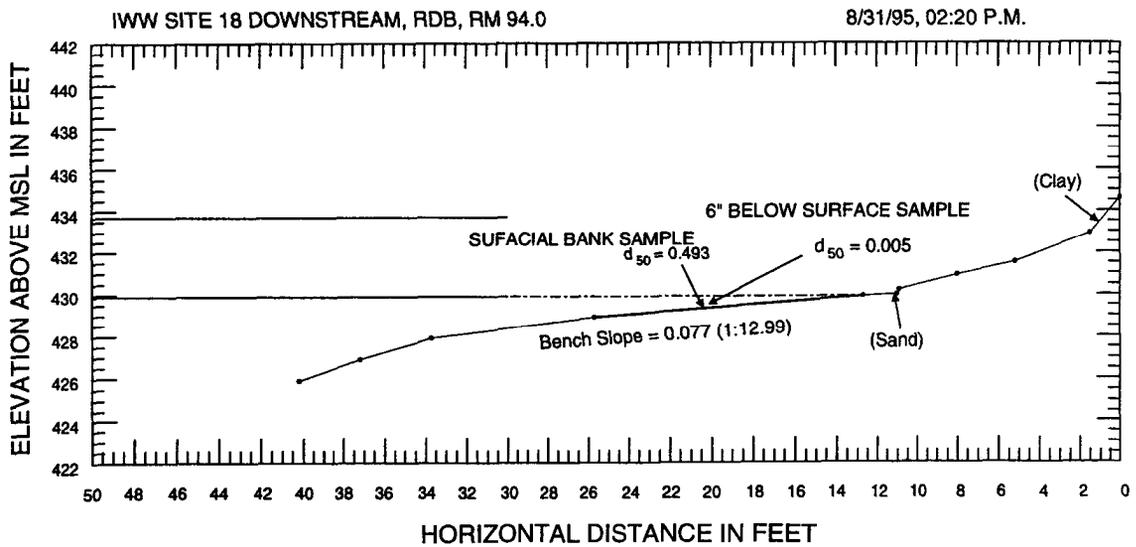
Figure 97. Bank sections at site 18

At the midsection, the d_{50} varied from 0.016 mm at the top surface of the bank to 0.015 mm at the upper part of a core sample at a water depth of about 2 feet. Gradation plots of bank soils and nearshore sediment are presented in appendix C. The detailed river cross section and coordinates are shown in appendix D.

The bench slopes varied from 1V:7.4H at the upstream section to 1V:13.0 at the downstream sections. The subaqueous bench dropped off quickly at the midsection at this site. Both the upstream and downstream sections are classified as type 4, but the midsection is classified as a combination of types 2 and 4 (figures 2 and 4 and table 9). The bank crest was

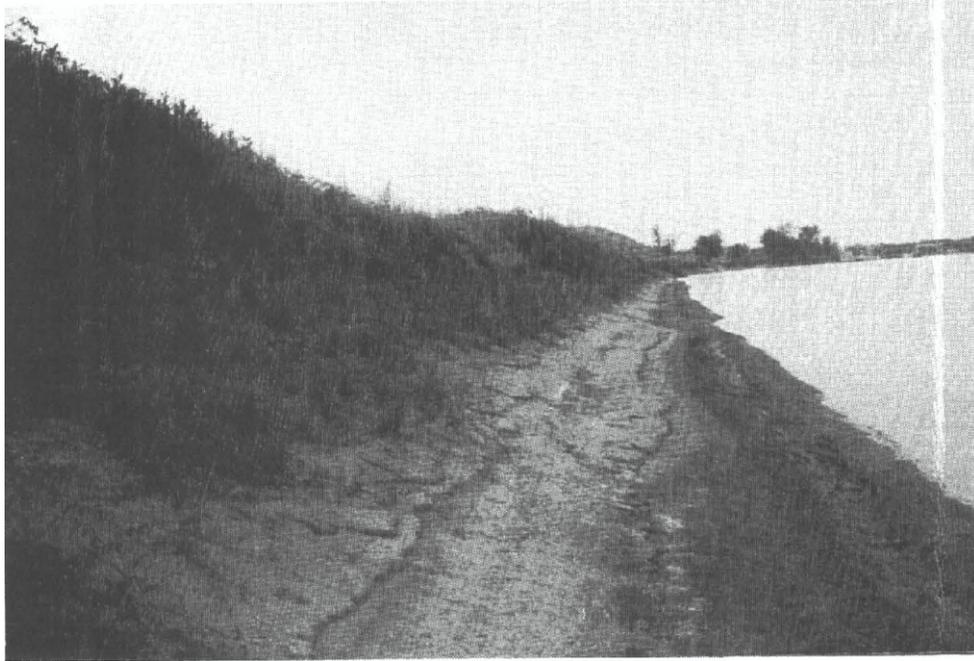
Figure 102. Site 20 on the Illinois River

At the midsection, the d_{50} varied from 0.023 mm at the top surface of the bank to 0.004 mm near the water's edge. Seepage water quickly filled a trench dug on the bank (figure 102) even though the bank material was hard and cohesive. Gradation plots of bank soils and nearshore sediment are presented in appendix C. The detailed river cross section and coordinates are shown in appendix D.

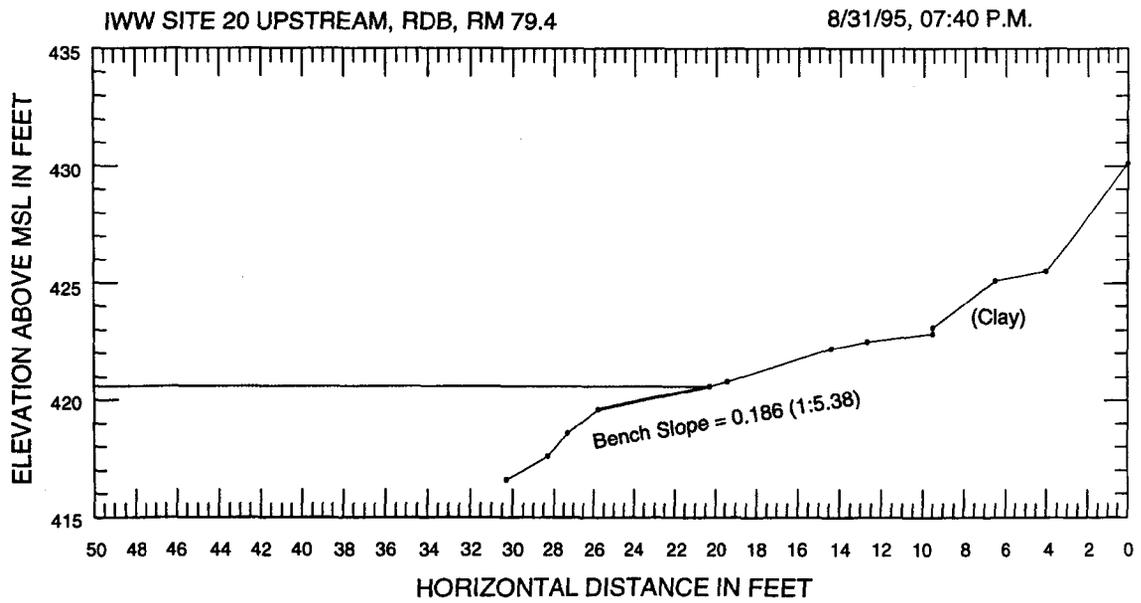
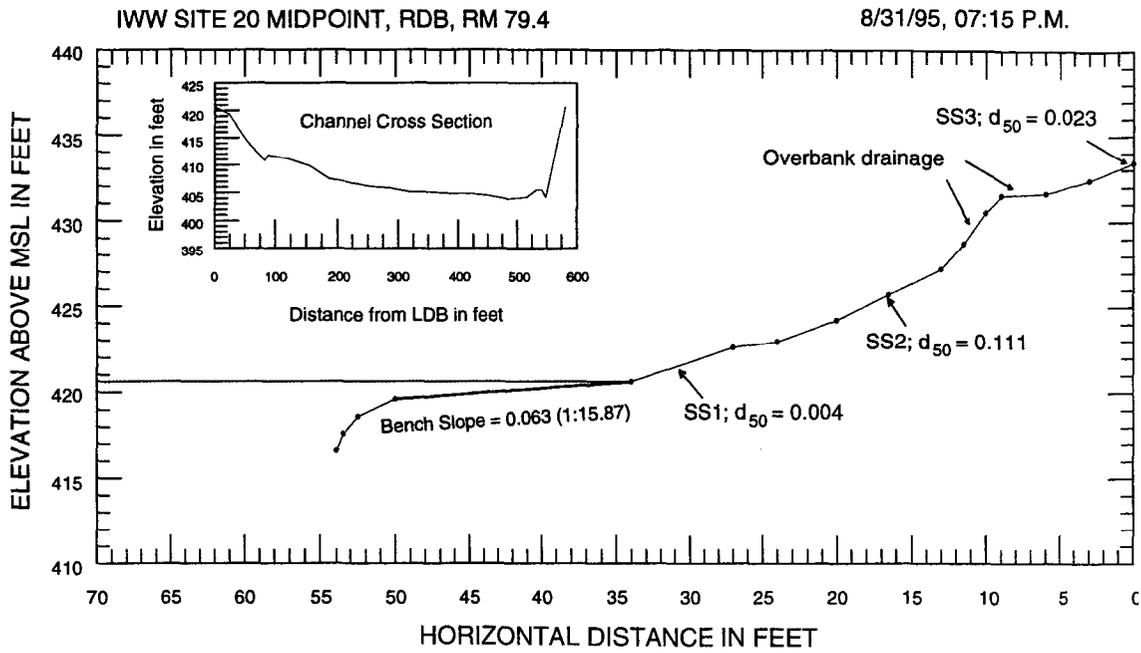
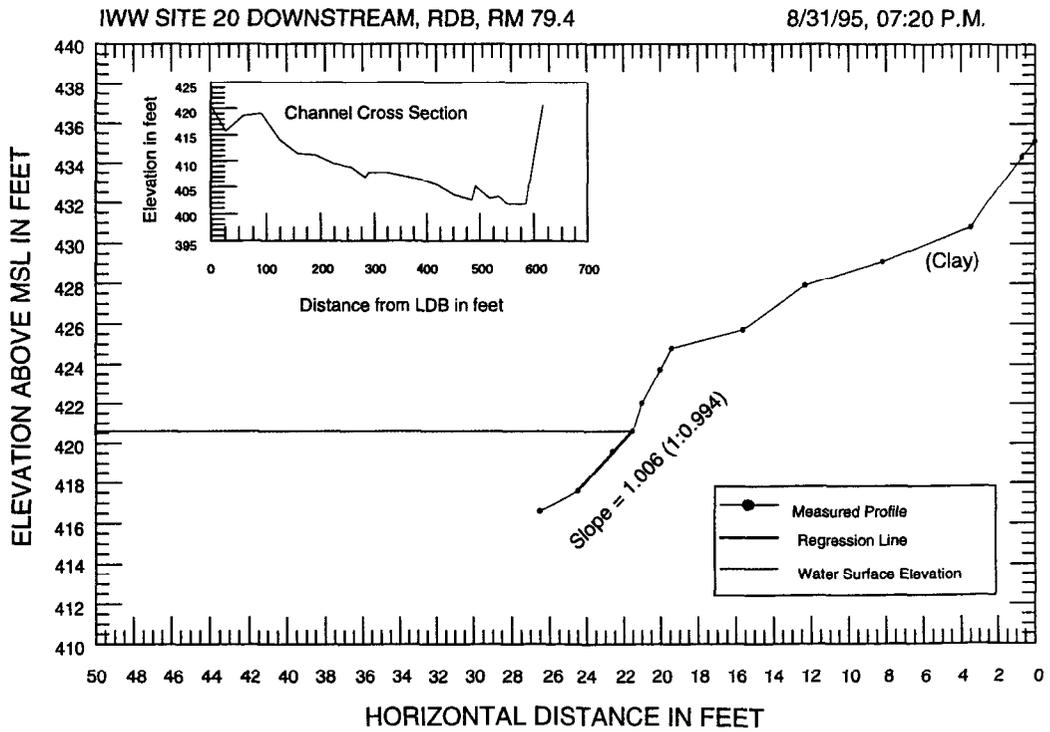
Figure 103. Bank sections at site 20

Figure 103 shows the three measured bank sections and two reduced cross sections. The bench narrowed at the downstream section. The OHWE and NP elevations were not available for the Alton Pool, but analysis of the historical data indicated that the river stage at the time of the survey had a recurrence frequency of about 90 percent. As shown in table 35, the bare bank area lies between the NP level and the 50 percent recurrence frequency stage (425.7 ft-msl).

Bench slopes varied from IV:5.4H to IV:15.9H to IV:0.99H from upstream to downstream sections. This site can be classified as type 2 (figure 22 and table 9). Traffic approaching the La Grange Lock and Dam gets close to this site. High velocity flows released from the lock of the La Grange Lock and Dam, and turbulence induced by navigation traffic appeared to be the major causes of erosion at this site, but seepage effects also appeared to be significant.

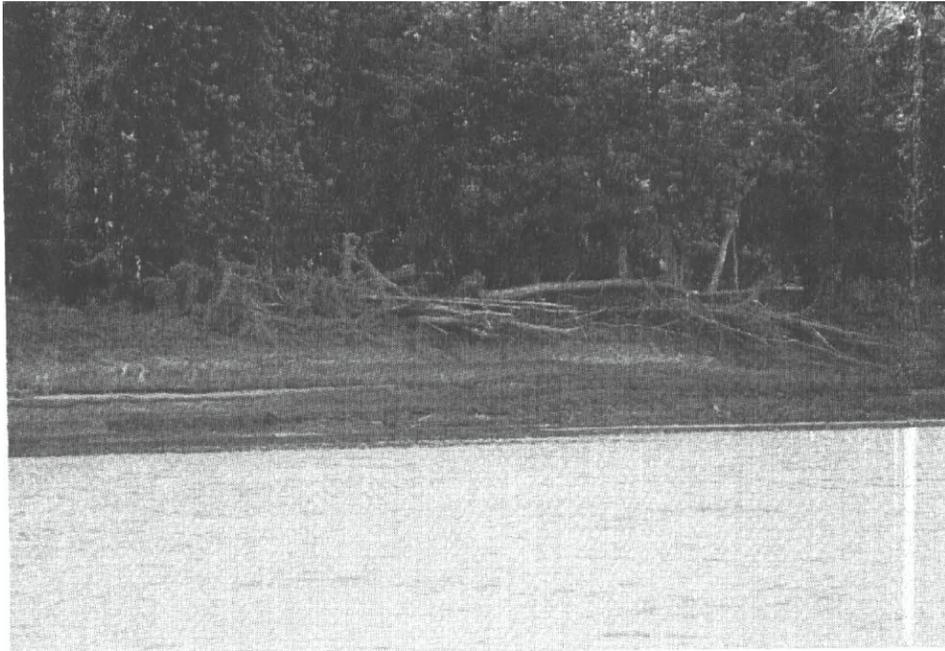
Figure 105. Site 21 on the Illinois River

The navigation channel is close to this site; the bank is about 230 feet from the sailing line. A pumping station is on the opposite bank, and there are several wing dams upstream in this reach. Bhowmik and Schicht (1980) did not note erosion in 1978, but Hagerty (1988) observed erosion around RM 61.9 on this bank. Silver maples are growing on the edge of the bank. Slaked blocks were mantled with grass and trees; tree roots extended out on the scarp.

Seasonal grasses were growing on the upper portion of the bank face. A bare bench with springs coming out of clay layers extended from the failed soil blocks to the water's edge. Dead trees were present on the upper part of the bench.

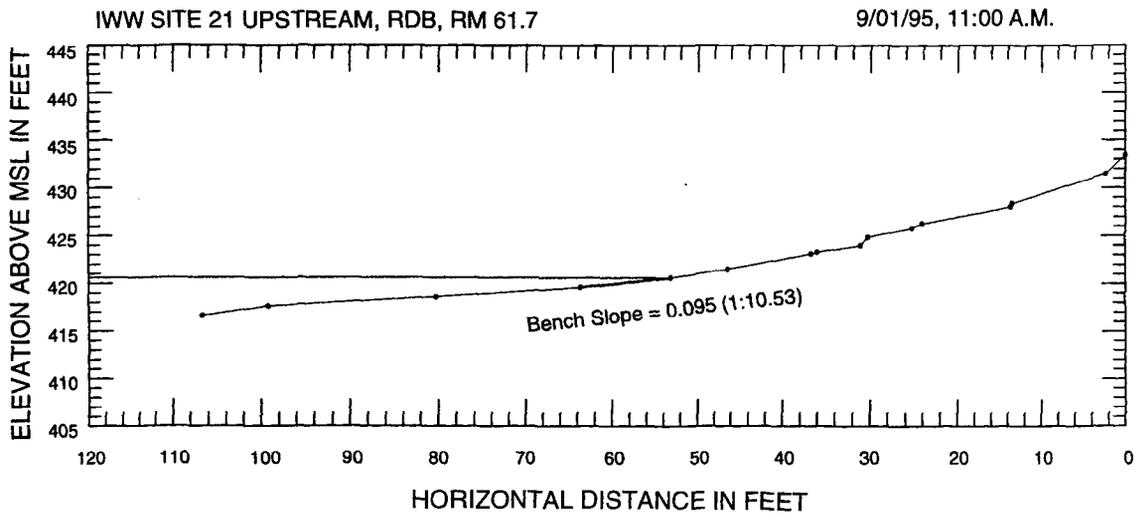
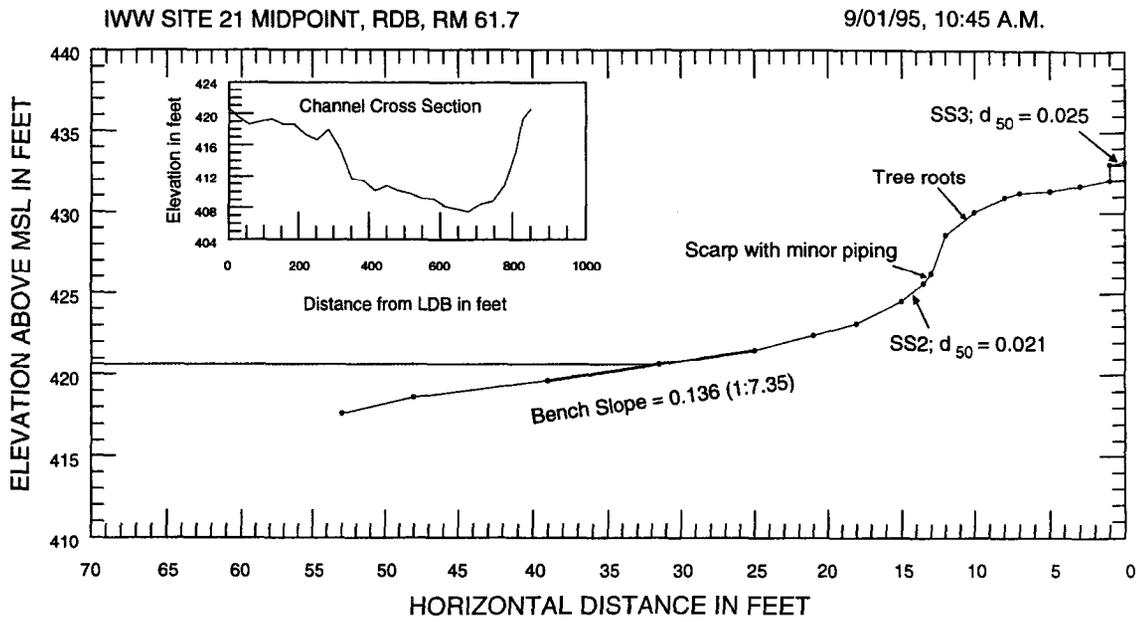
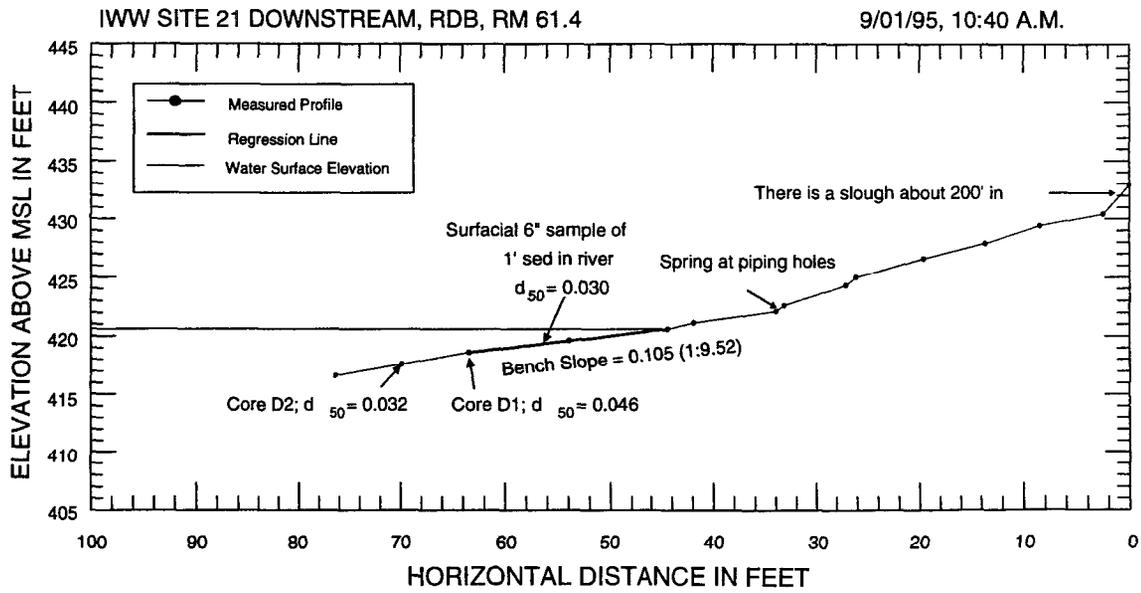
Figure 106. Bank sections at site 21

Figure 106 shows the three measured bank sections and a reduced cross section. The bank sections at the midsection differs from the up- or downstream sections. The stage at the time of the survey corresponded to approximately 90 percent recurrence frequency. The scarps observed in the upstream and downstream sections were present in the range of stage fluctuation between 50 percent and 25 percent (424.5 and 429.1 feet, respectively, see table 36); this was also the range of scarp in the midsection.

Bench slopes varied from IV:10.5H to IV:7.4H. The upstream and downstream sections were classified as type 5, and the midsection was classified as Type 4 (figure 24 and 25 and table 9). Wave wash apparently produced some small scarps on the bench area. Springs and seepage weakened the bench soils and made them susceptible to wave erosion. Currents at high stages or during floods can erode in-place bank soils.

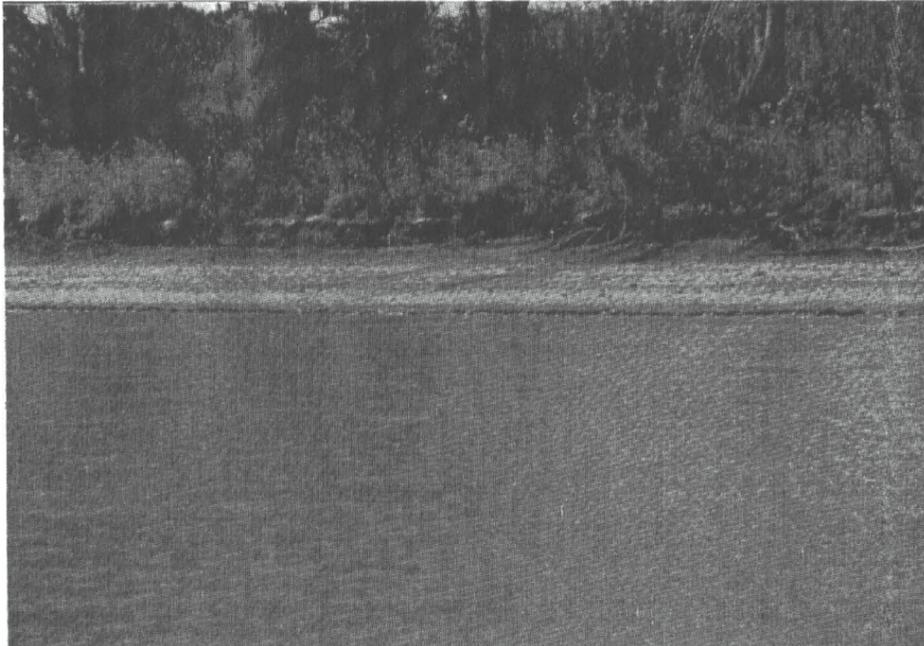
Figure 108. Site 22 on the Illinois River

A soybean field was behind the top of the bank. The upper bank was covered by a zone of dense grasses with some tall matured trees. The grass zone ended at a scarp about 12-18 inches high. Below the scarp, a bench was composed of very soft, silty soil with many peds on the silt surface. The bench was fairly moist.

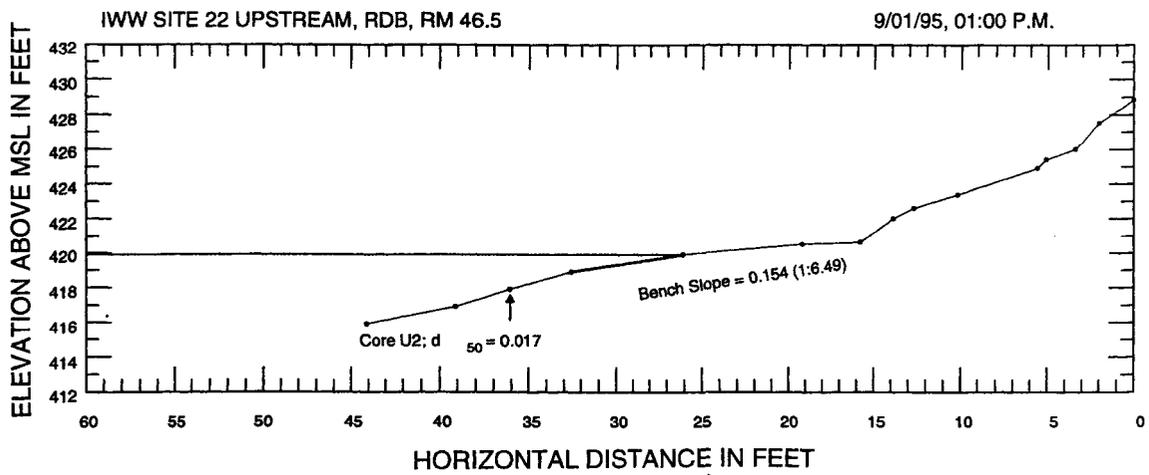
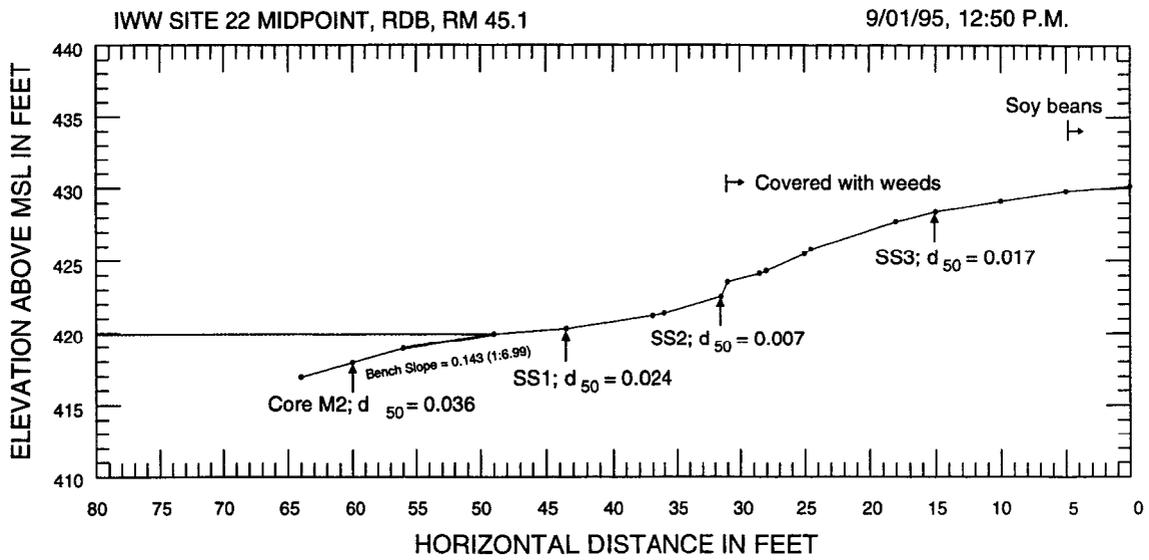
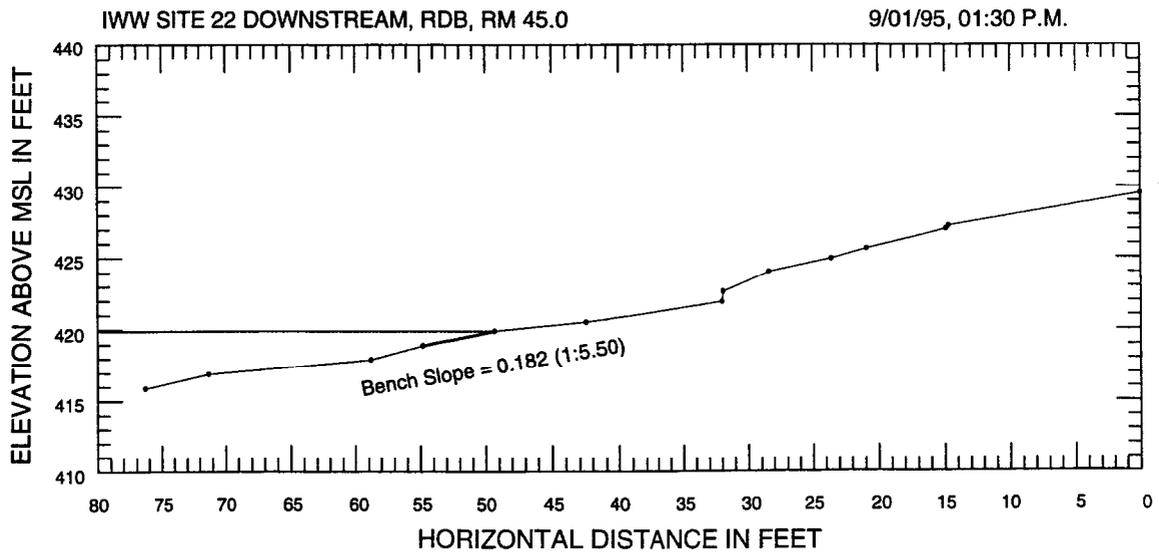
Figure 109. Bank sections at site 22

Figure 109 shows the three measured bank sections and a reduced cross section. The stage at the time of measurement corresponded approximately to the 85 percent recurrence frequency. The 50 and 25 percent recurrence stages (table 37) are 422.4 and 425.9 ft-msl, respectively. The base of the scarp at the end of the weed zone was about 422.4 ft-msl.

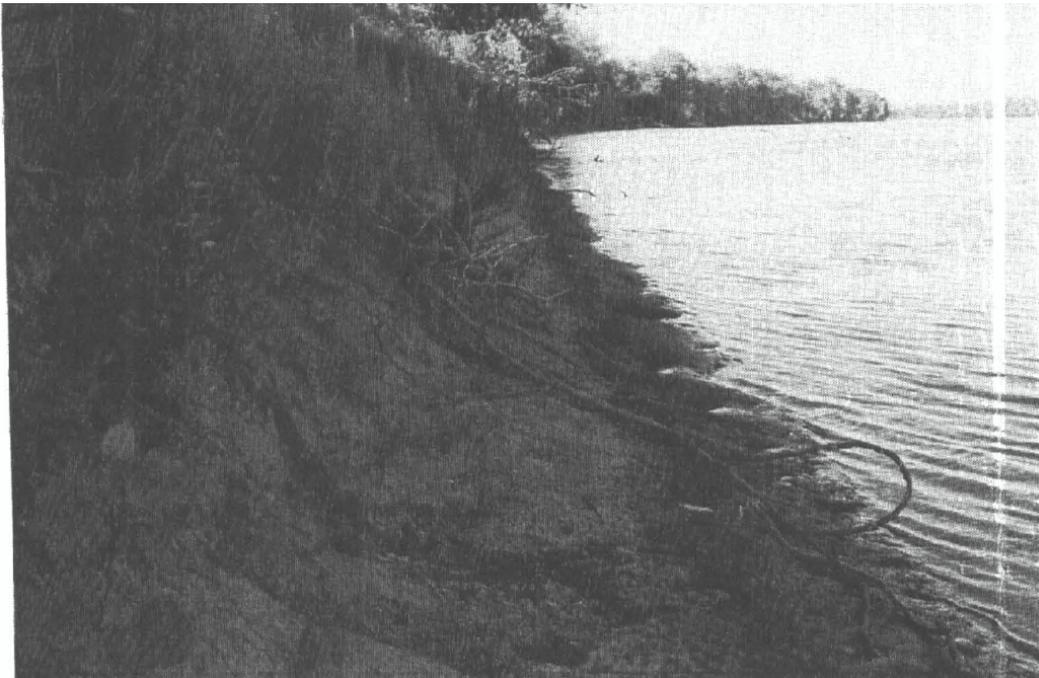
Figure 111. Site 23 on the Illinois River

The navigation channel is close to this site; the bank is about 180 feet from the sailing line. Bhowmik and Schicht's (1980) Reach 1 was located at RM 24.0 on the opposite bank. Hagerty (1988) noted erosion on both bank sections, but eroded reaches were shown in several segments. For this site, Hagerty (1988) noted 6 feet of bare scarp.

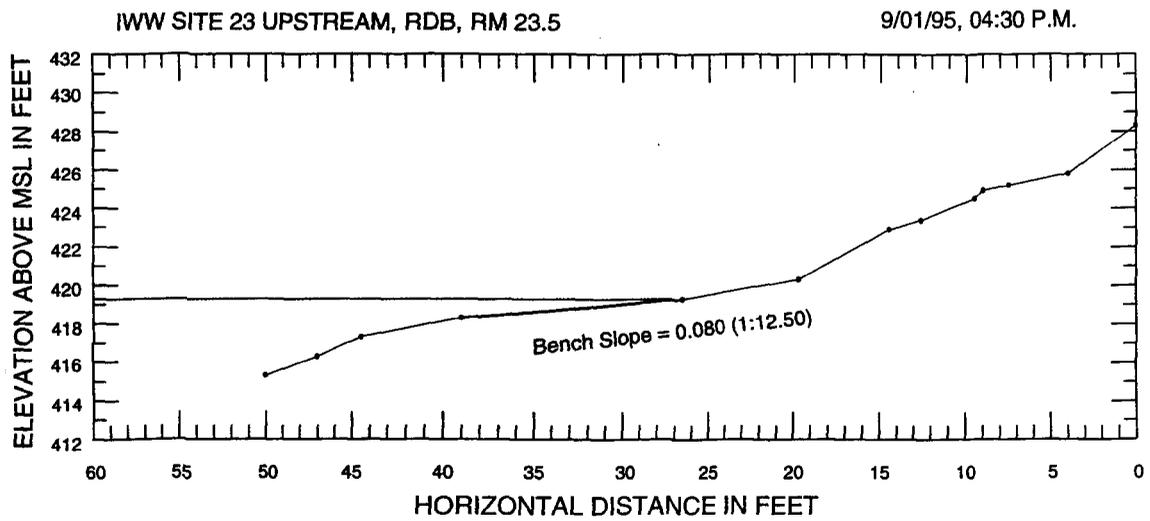
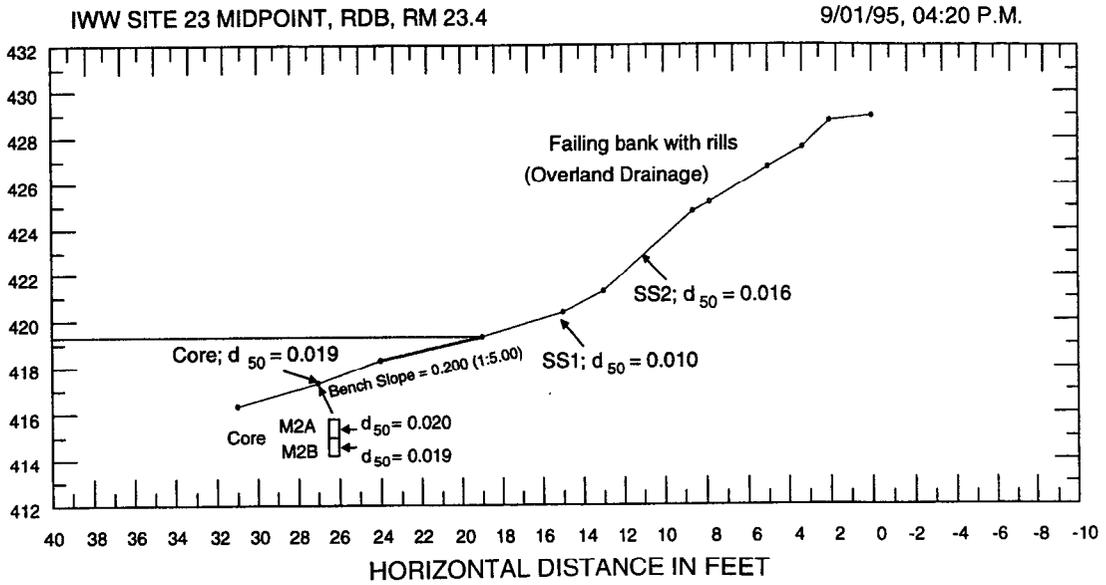
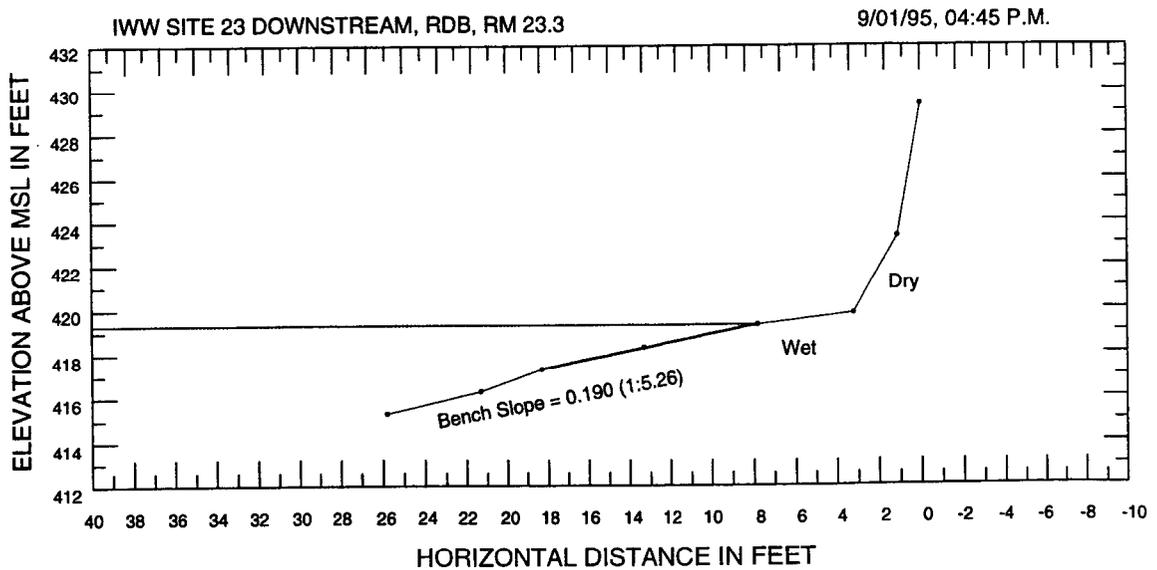
Figure 112. Bank sections at site 23

Figure 112 shows the three measured bank sections and a reduced cross section. The stage at the time of survey was at about the 90 percent recurrence frequency stage. Dense seasonal vegetation covered the upper portion of the bank face, and the bank slope was steeper

downstream. Bank materials were similar to those at other bank sections in the Alton Pool, with a hard clayey layer at the upper part of the bank, and a lower bank covered by moist, soft clayey soil. Algae were growing near the water's edge. As shown in table 38, the bare bank face corresponds well to the stage ranging between 50 and 25 percent recurrence frequencies. The 50 percent recurrence stage is about 420.3 feet at the base of the scarp.

Bench slopes varied from 1V:12.5H at the upstream section to about 1V:5.0H at the mid- and downstream sections. The upstream section and midsection were classified as type 4, and the downstream section was classified as type 2 (figures 24 and 22 and table 9). There was erosion due to surface drainage; other apparent causes are seepage, rework, and transport by levees and currents at various stages of pool-level fluctuations.
