Bank Erosion Survey of the Illinois River Volume 1

by
Nani Bhowmik and David Soong

December 2000

Illinois State Water Survey
Watershed Science Section
Champaign, Illinois

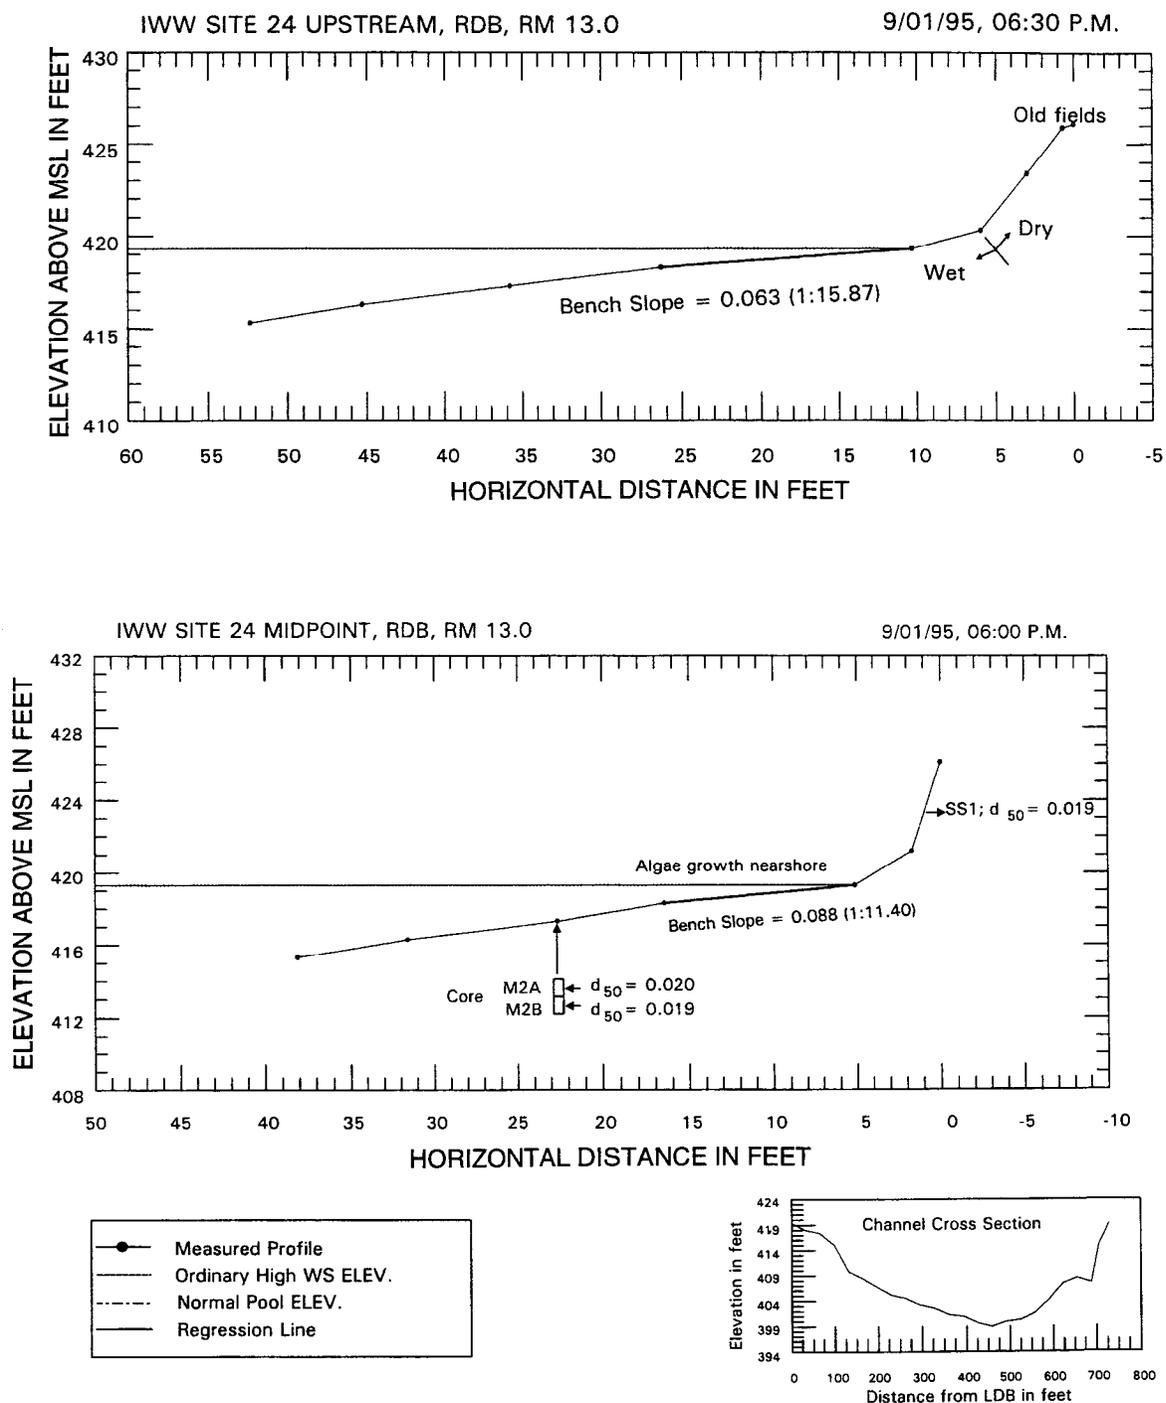
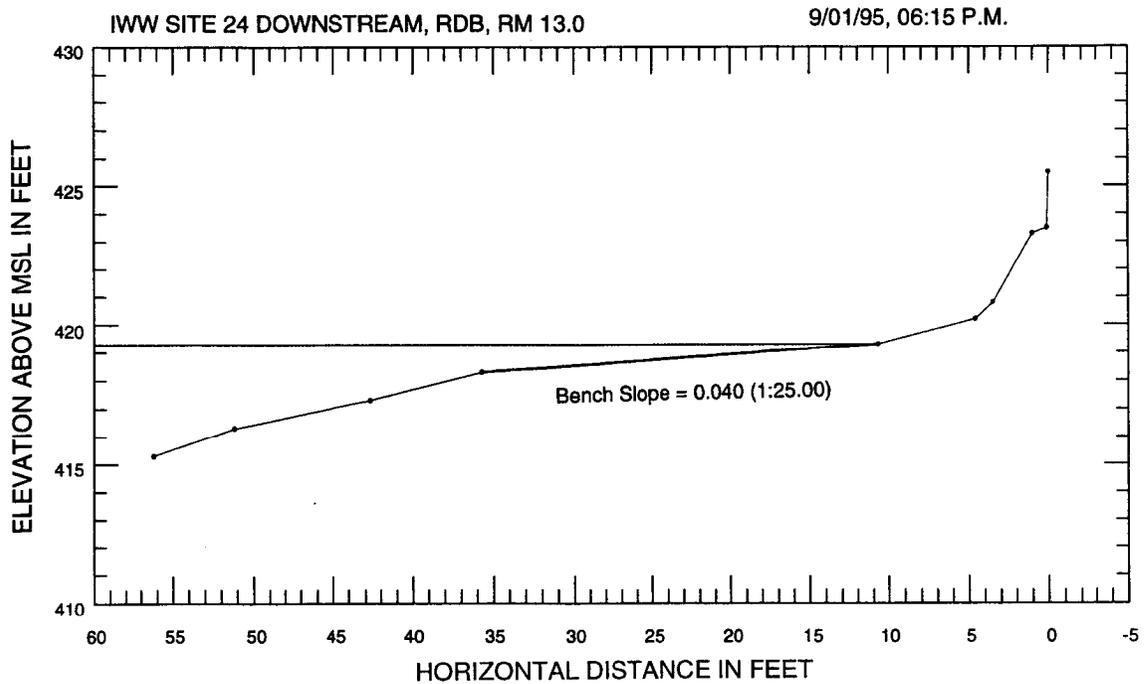
Figure 115. Bank sections at site 24

The bank characteristics are similar to those at other sites in the Alton Pool. Figure 115 shows the three measured bank sections and a reduced cross section. Land cover on the top and upper portion of the bank was dense seasonal vegetation, mostly above the water line. The sloping bank below the vegetation zone was bare. The base of the bare area was moist, and algae was growing near the water's edge. The stage at the time of the survey was at about the 90 percent recurrence frequency stage. The subaqueous bench at the site was broader and flatter than the bench at site 23. The bench was covered with a layer of thick sediment in the nearshore area, but farther riverward the bench surface was hard and closer to the river. The stage analysis (table 39) indicated that the bare bank face was between the 50 and 25 percent recurrence stages. The 50 percent recurrence stage, 420.3 feet, was at the base of the scarp.

Bench slopes varied slightly from 1V:25.OH to 1V:15.9H in this reach. The bank soils were cohesive. This site can be classified as a combination of types 2 and 5 (figures 22 and 25

and table 9). Erosion processes could be traced as initiated by piping; debris-induced local currents and wave wash extend the erosion; rework and transport by waves and currents at various stages of pool-level fluctuation then remove the failed soils or recently deposited sediment.
