Contract Report 2014-01

Continued Operation of a 25-Raingage Network for Collection, Reduction, and Analysis of Precipitation Data for Lake Michigan Diversion Accounting: Water Year 2013

FINAL REPORT

U.S. Army Corps of Engineers, Chicago District

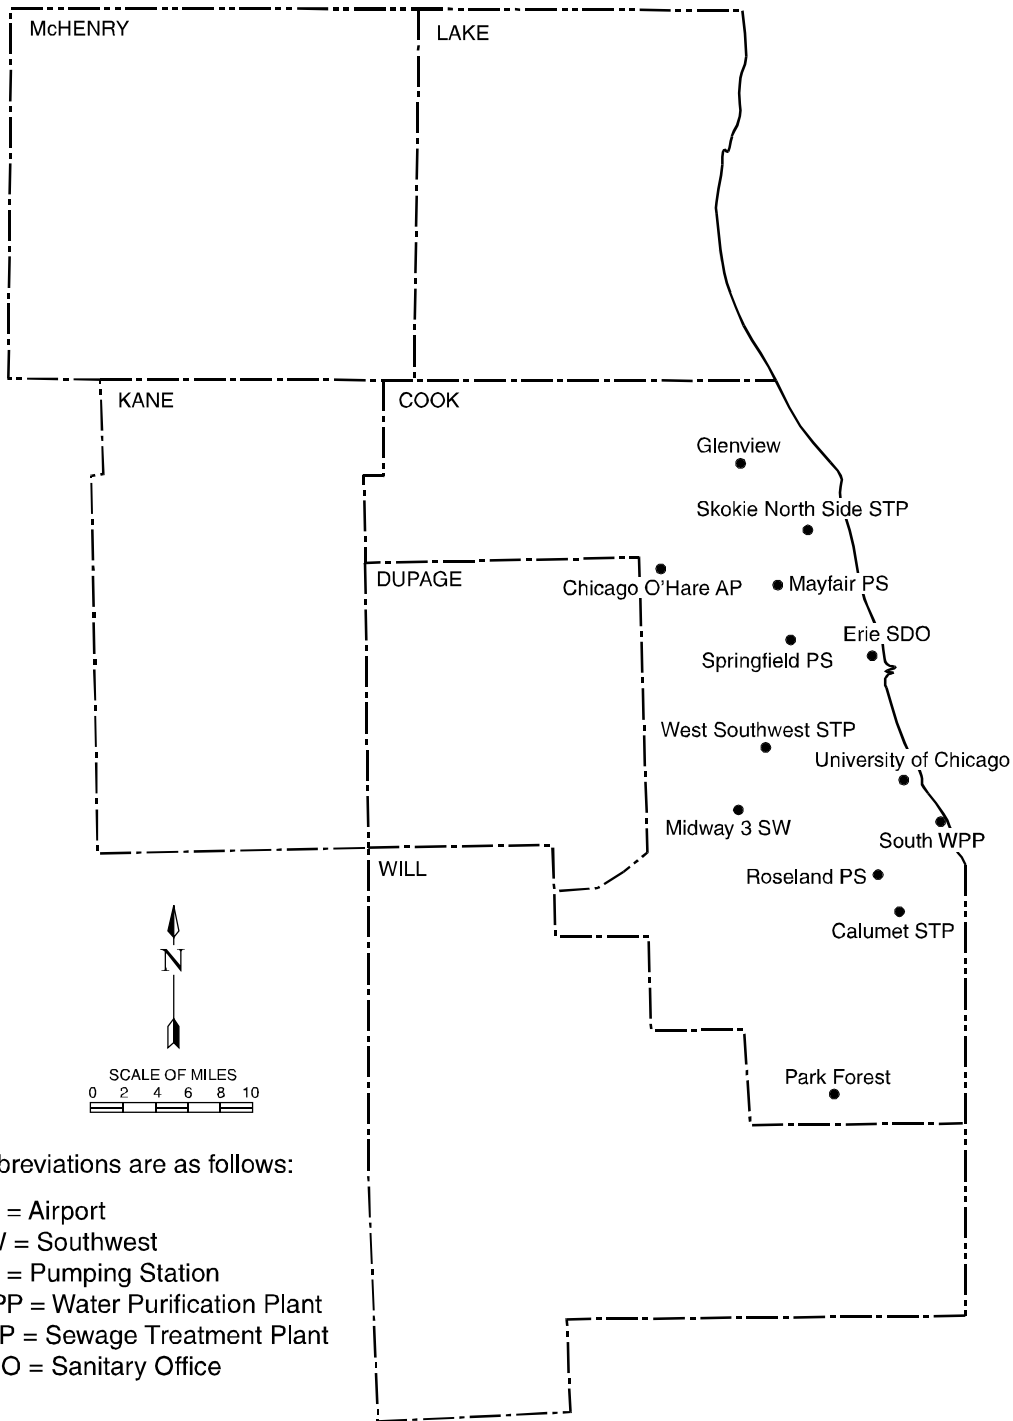
Figure 1. Raingage locations used for diversion accounting purposes prior to Water Year 1990. These include National Weather Service gages located at Chicago O’Hare AP, Midway 3 SW, University of Chicago, and Park Forest; City of Chicago gages located at Mayfair PS, Springfield PS, South WPP, and Roseland PS; and Metropolitan Water Reclamation District of Greater Chicago gages located at Glenview, Skokie North Side STP, Erie SDO, West Southwest STP, and Calumet STP.

The unusual patterns were caused by abnormally low precipitation totals at a select number of the 13 sites used by the accounting procedure (Figure 1). Inspection of these sites (Vogel, 1988), which are irregularly distributed over the region, revealed that low precipitation totals were caused by 1) inadequate raingage exposure (e.g., gages situated on rooftops or too near natural or artificial air flow-restricting

This appendix contains site descriptions of the 25 raingage locations (Figure 1) in the network as of September 30, 2013. Sites that have been relocated since the network began operation in October 1989 are noted in the "Placement" section of the descriptions. Note that there are slight differences in latitude and longitude values from previous years. More accurate GPS readings were obtained for all sites during the summer of 2006.

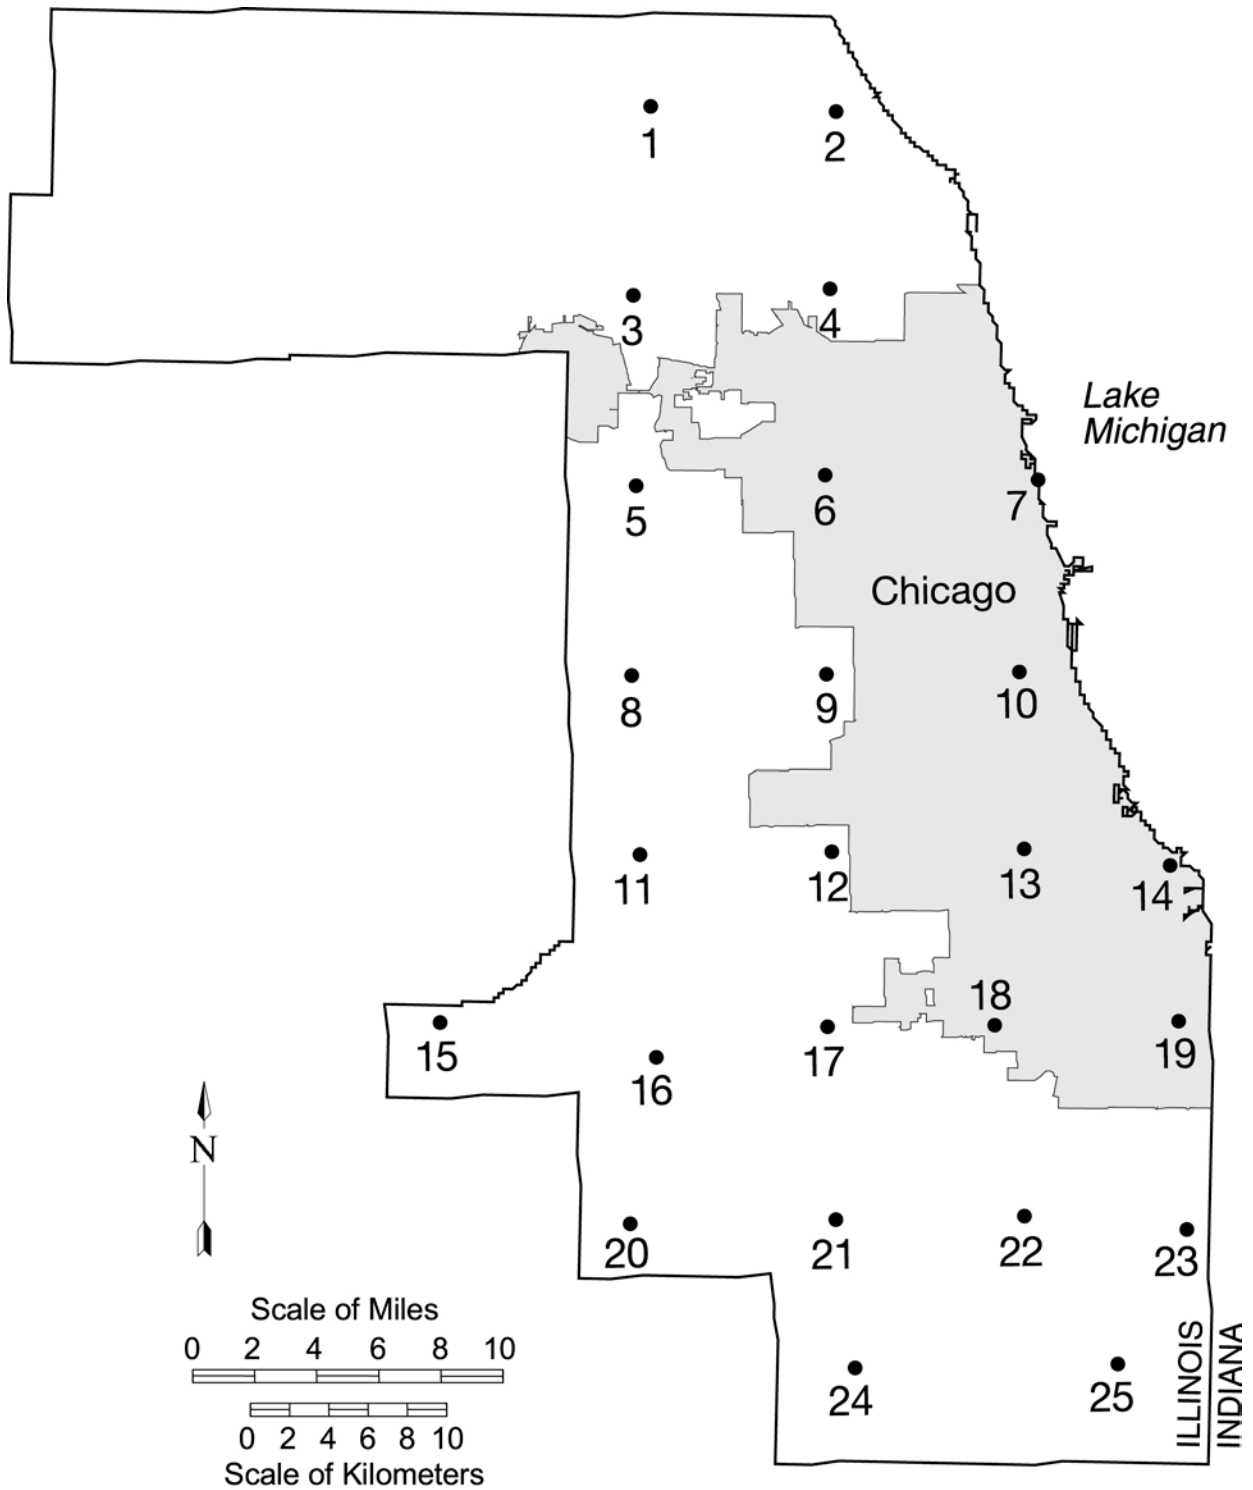
Figure 2. The Cook County 25-site rain gauge network for Water Years 1990-2013. City of Chicago indicated by shading.

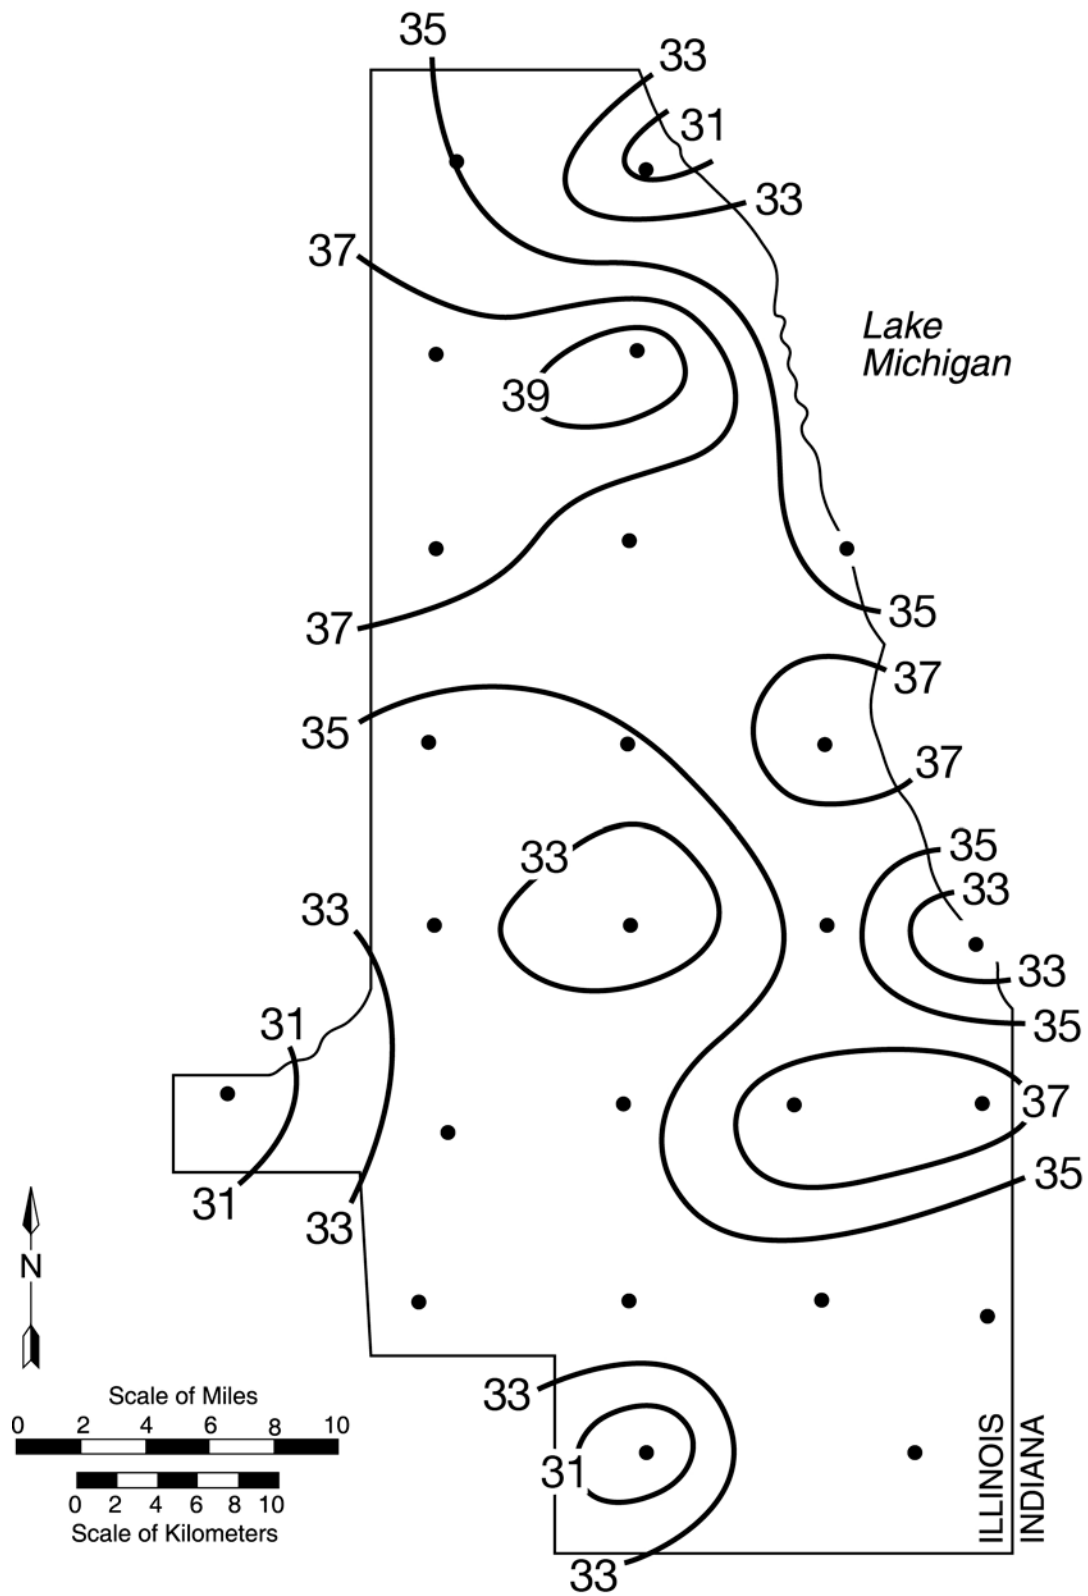
Figure 3. Precipitation pattern (inches) for Water Year 2013

The largest precipitation amounts during Water Year 2013 occurred in the northern and eastern portion of the network (sites #3, #4, #5, #10, #18, and #19, Figure 3). See Figure 2 and Appendix I for site information. The lightest amounts occurred in the southwestern and near-lake portions of the network (sites #12, #15, #24, #2 and #14). The heaviest precipitation in the network during Water Year 2013 fell at site #4 (39.34 inches), while the lightest fell at site #15 (30.07 inches).

As in the case of the other network water year patterns, the spatial pattern for Water Year 2013 (Figure 3) does not contain the anomalies found in an analysis using sites operated by the MWRDGC, the NWS, and Cook County for Water Years 1984–1989 (Vogel, 1988; Pepler, 1993b). Gradients of 15 to 20 inches were common in those analyses. Precipitation data from those sites were the input for diversion accounting before construction of the present network (Pepler, 1993b). For Water Year 2013, there was an 8-inch gradient between Sites #2 and #4. Siting issues may be responsible for this difference. Site #4 is a level and protected location. Changes to Site #2 are under consideration. Site #2 was moved in June 2012 to a protected hillside location. It will be repositioned nearby to a less windy and lower location. These siting differences may accentuate actual precipitation gradients suggested by nearby gages.

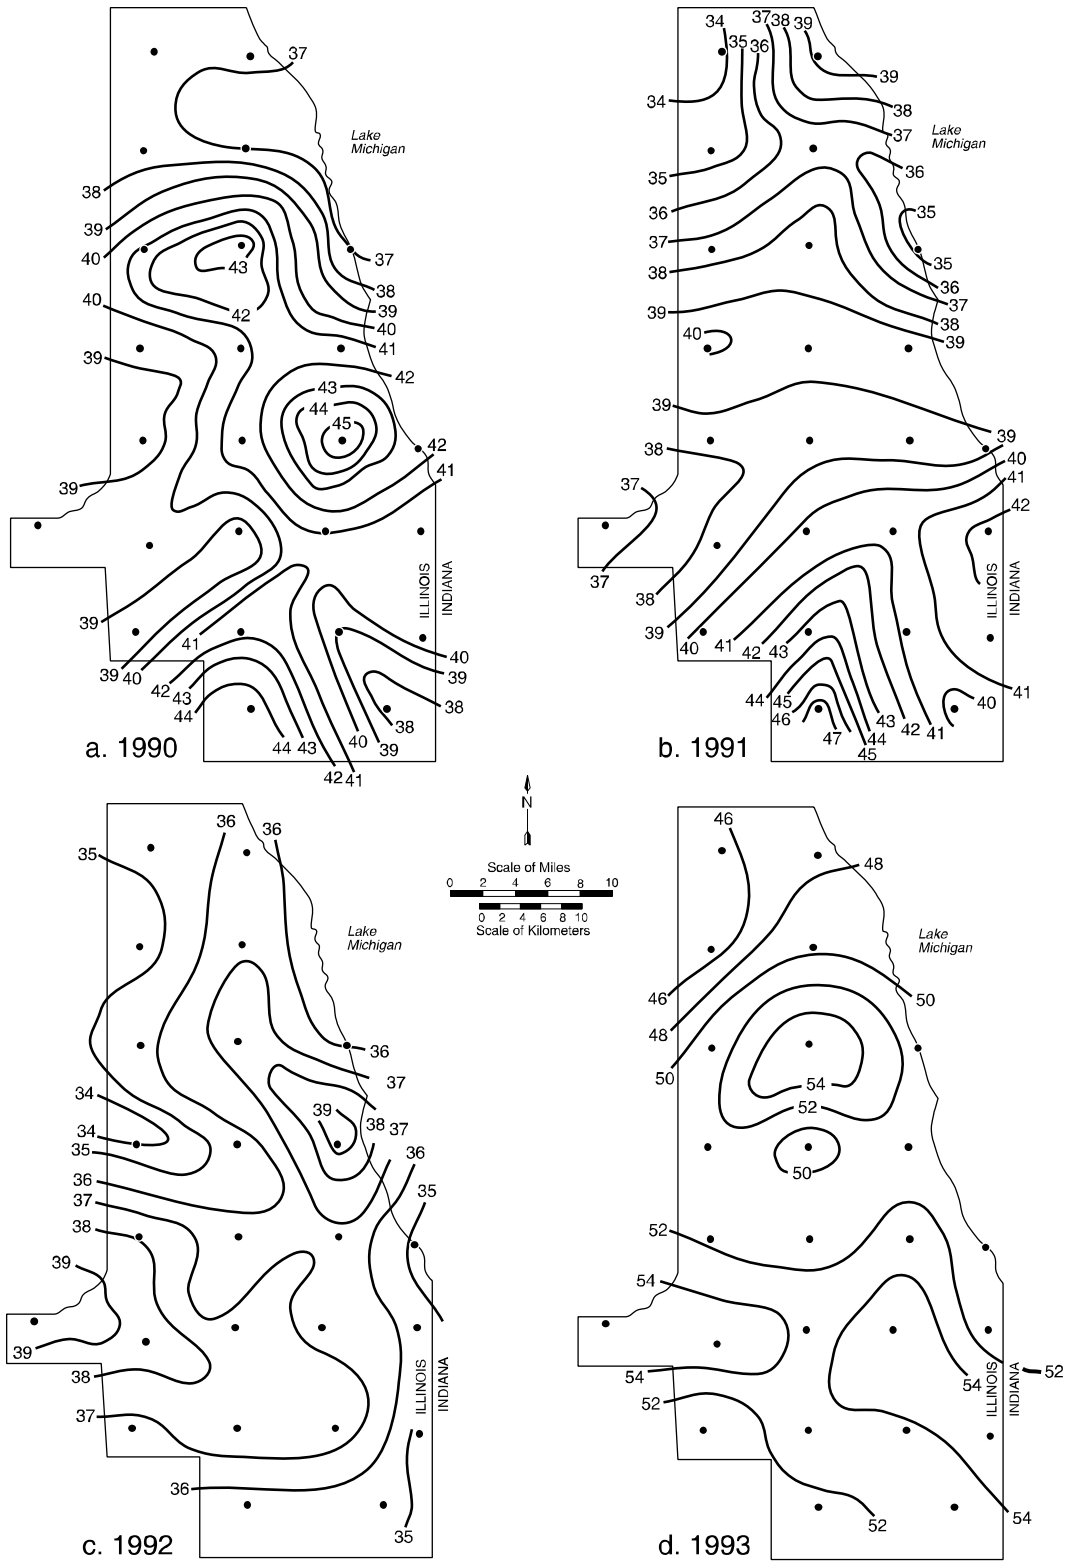
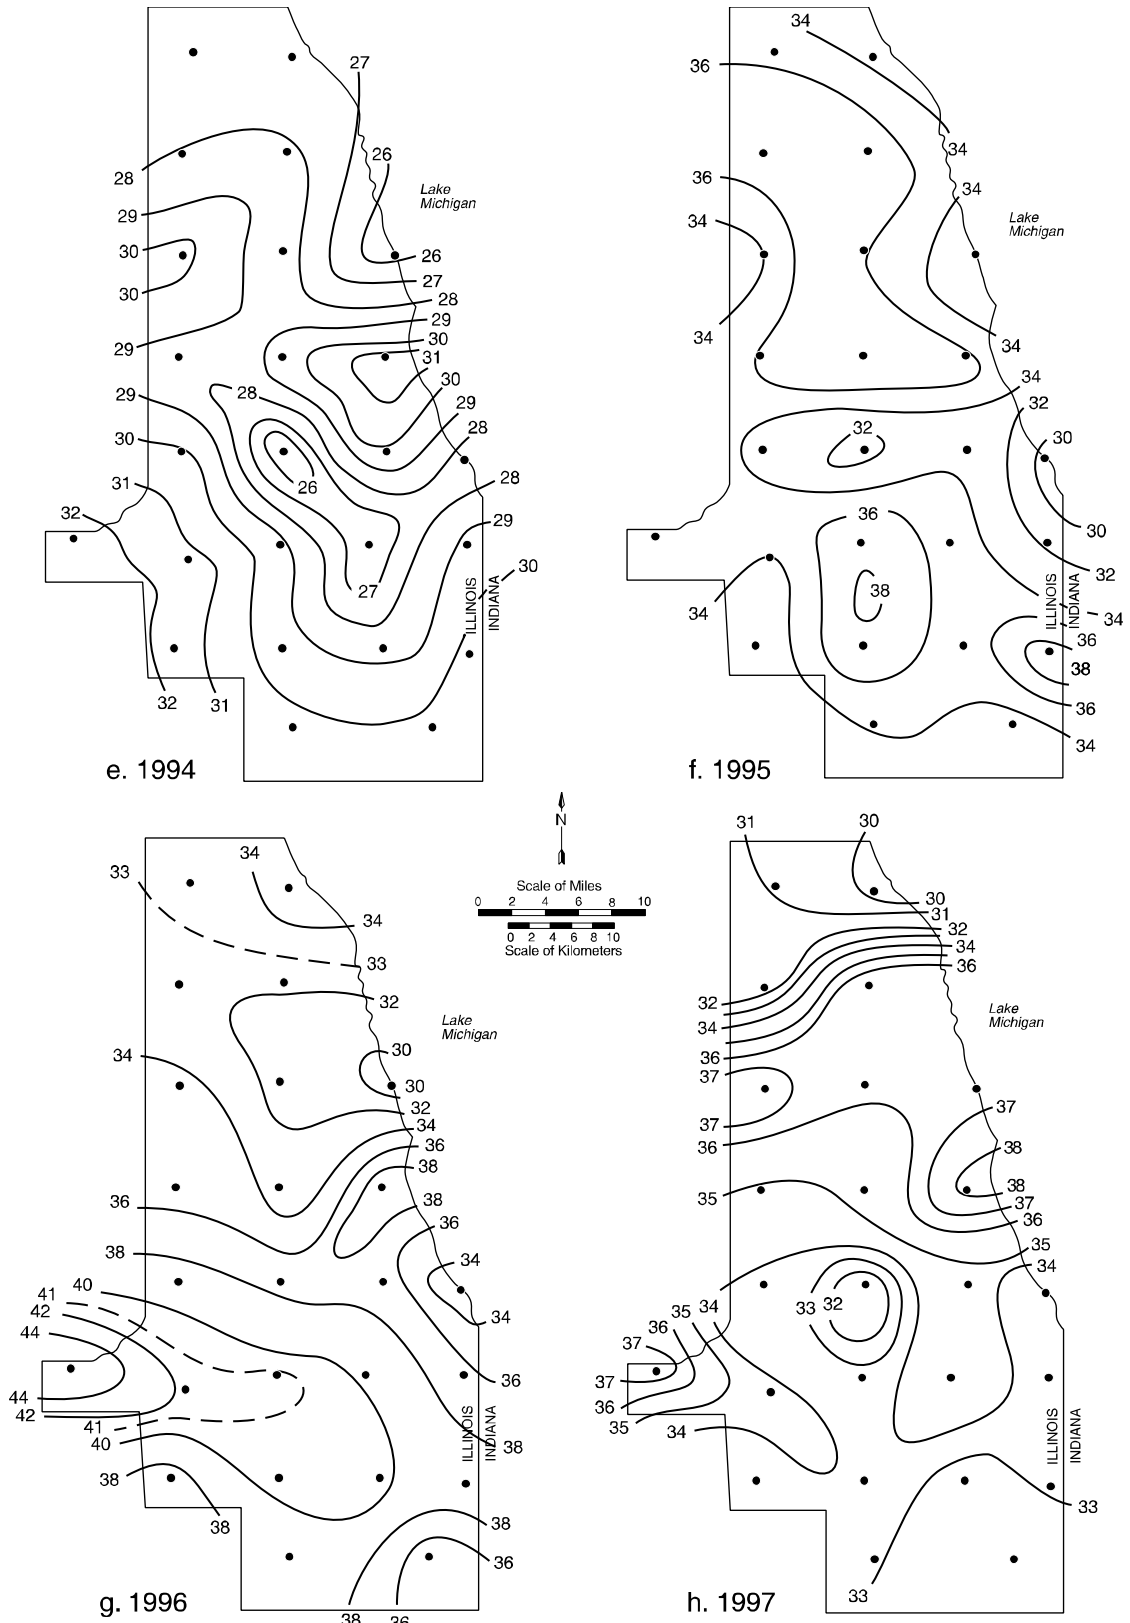
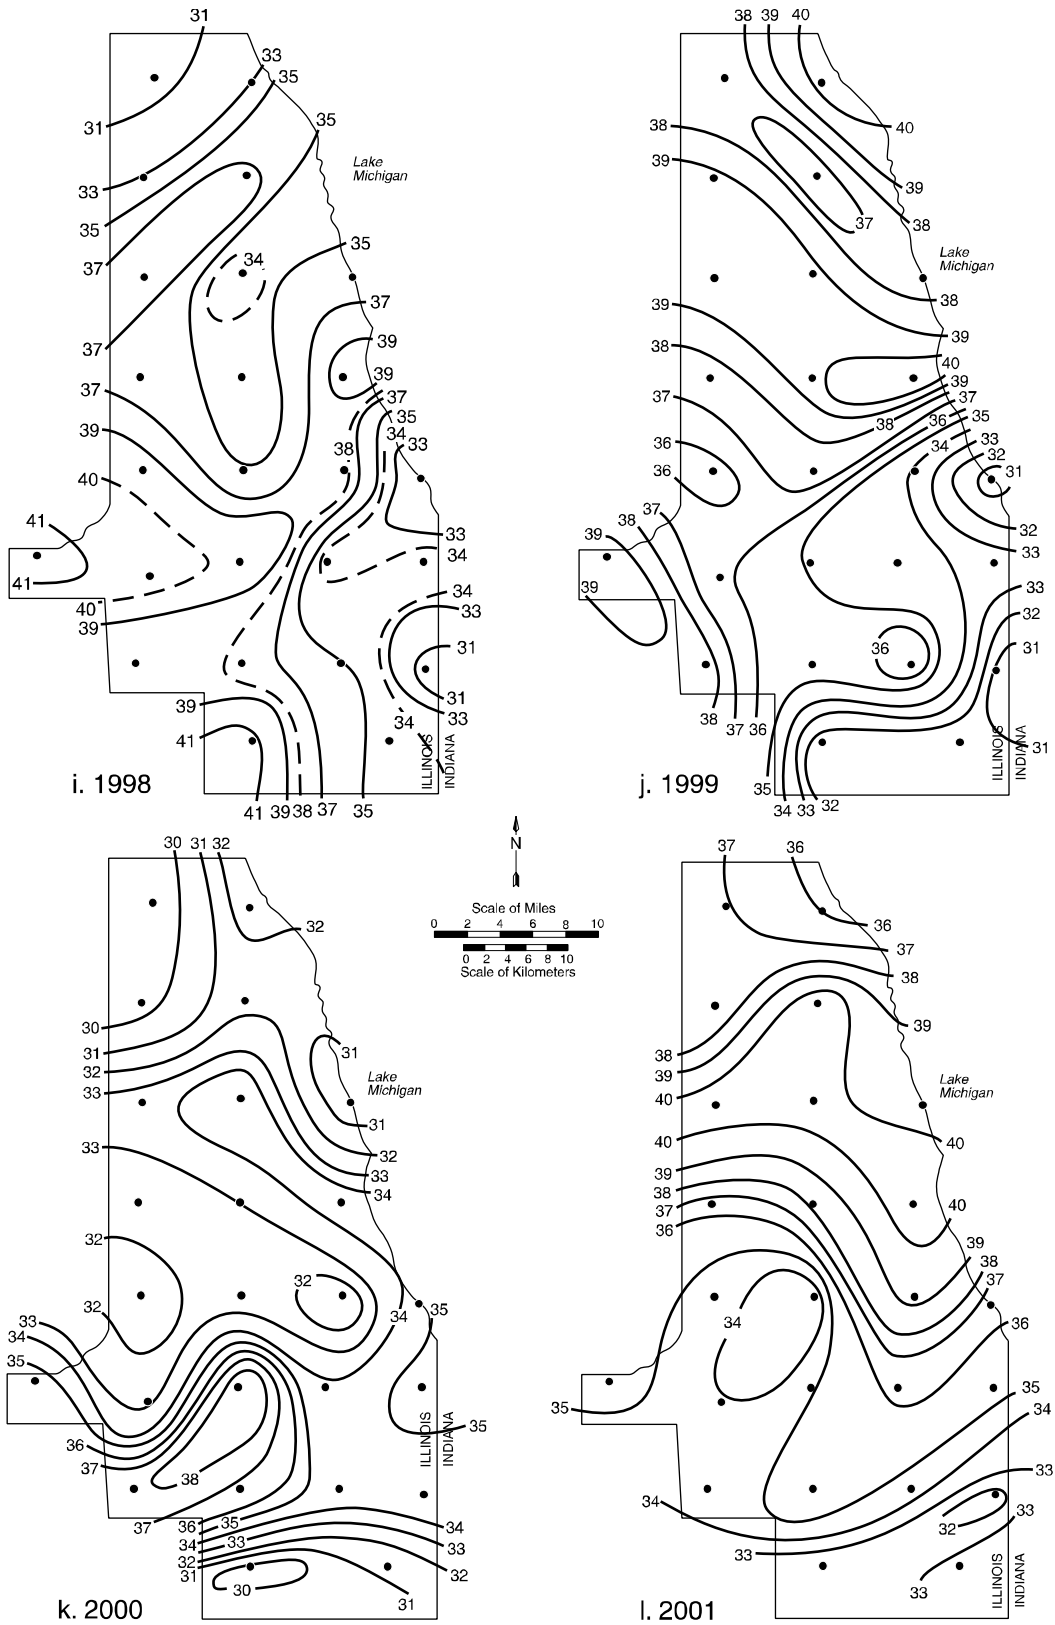
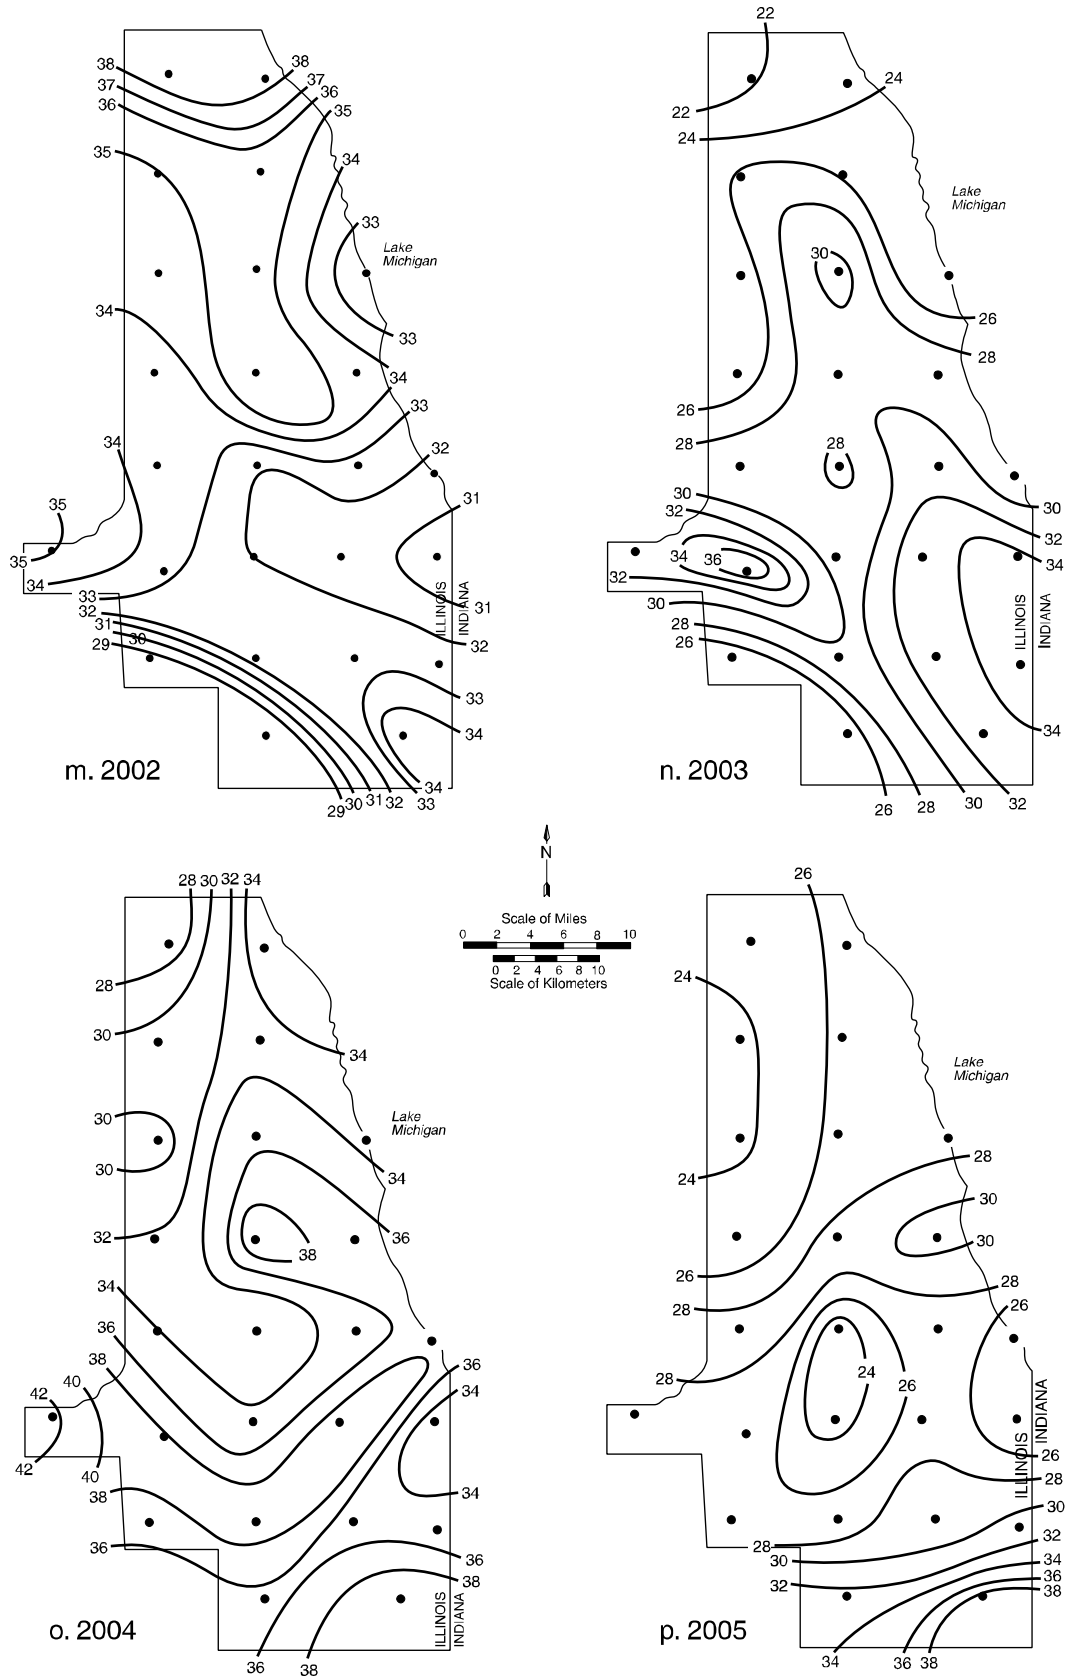
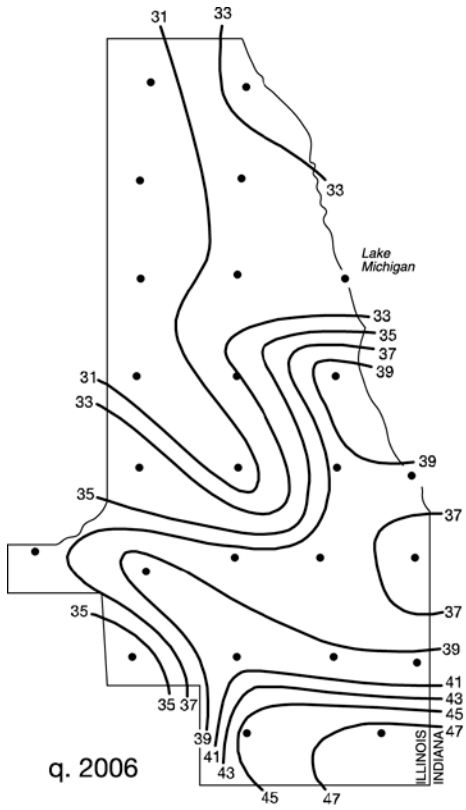
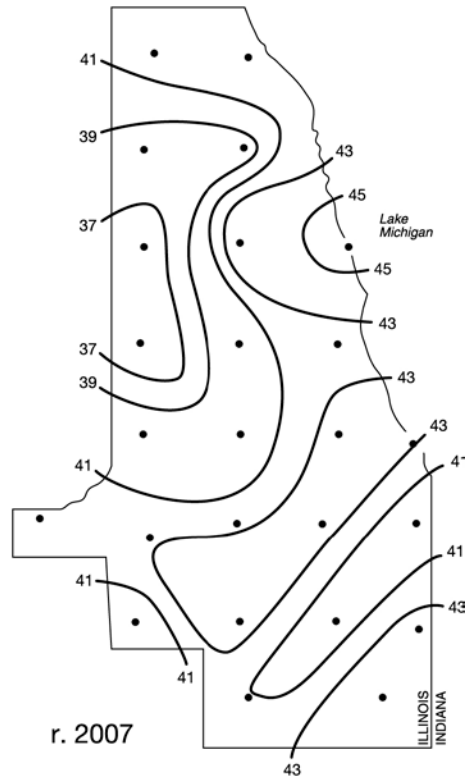
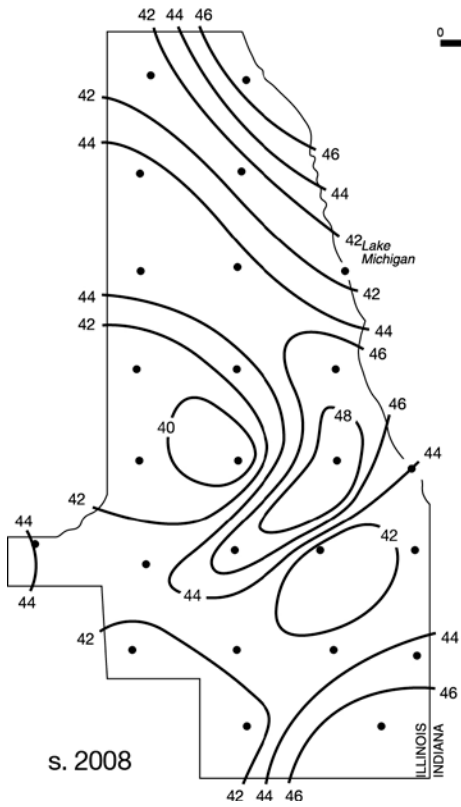
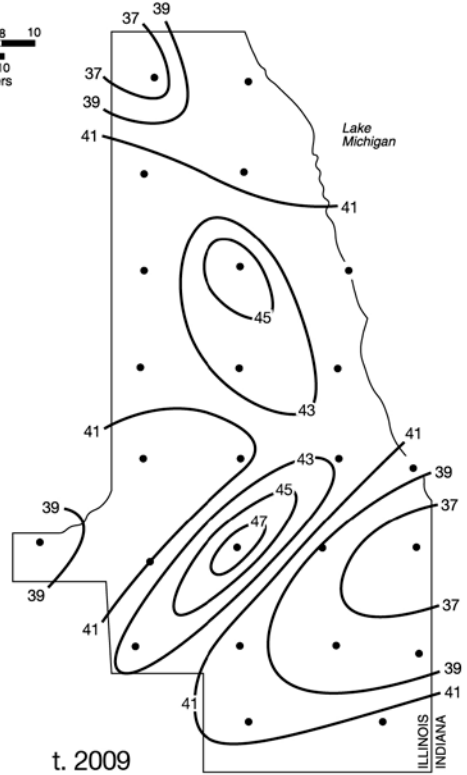
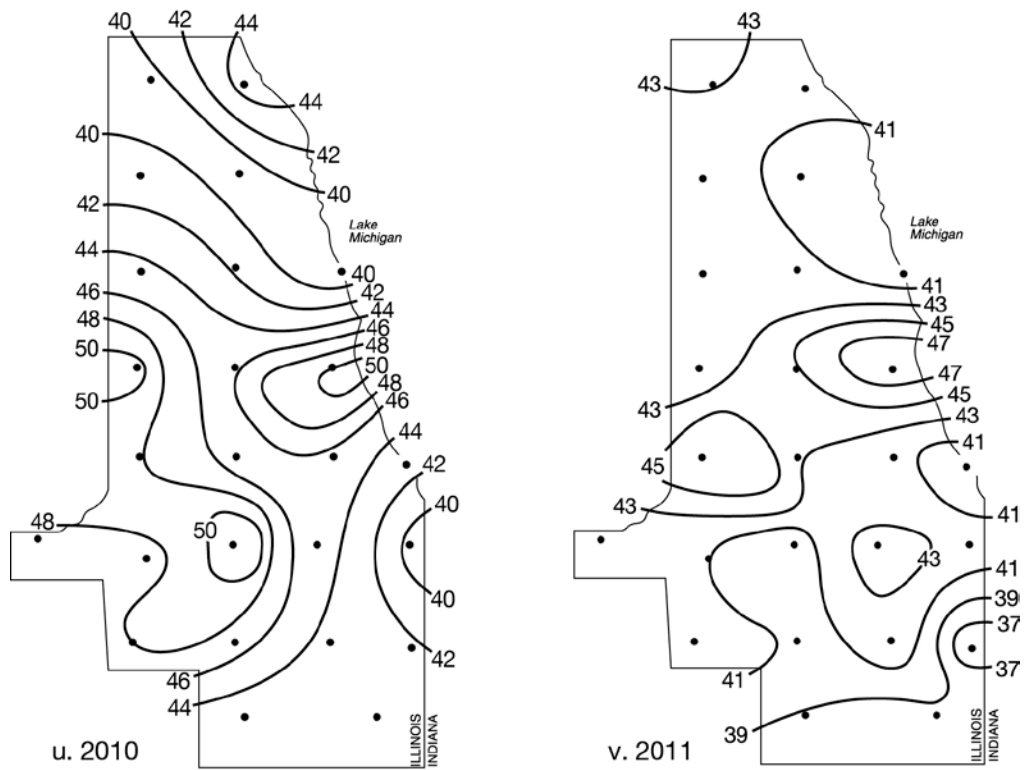
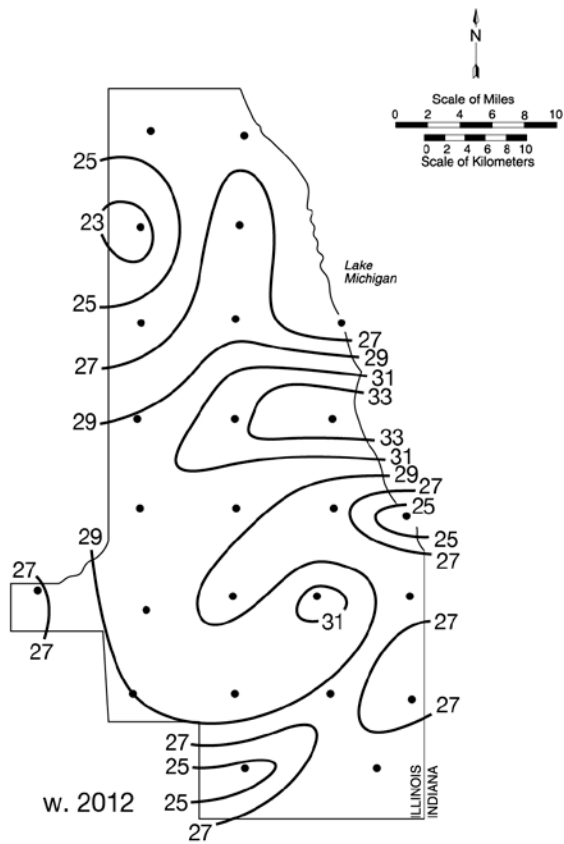
Figure 4. Precipitation pattern (inches) for Water Years 1990–2010

Figure 4 provides maps of precipitation amounts for individual Water Years 1990–2012. The general pattern of high values for Water Year 2013 is similar to that for Water Year 2001, with the largest precipitation in the northern region and the lowest precipitation to the south and west.

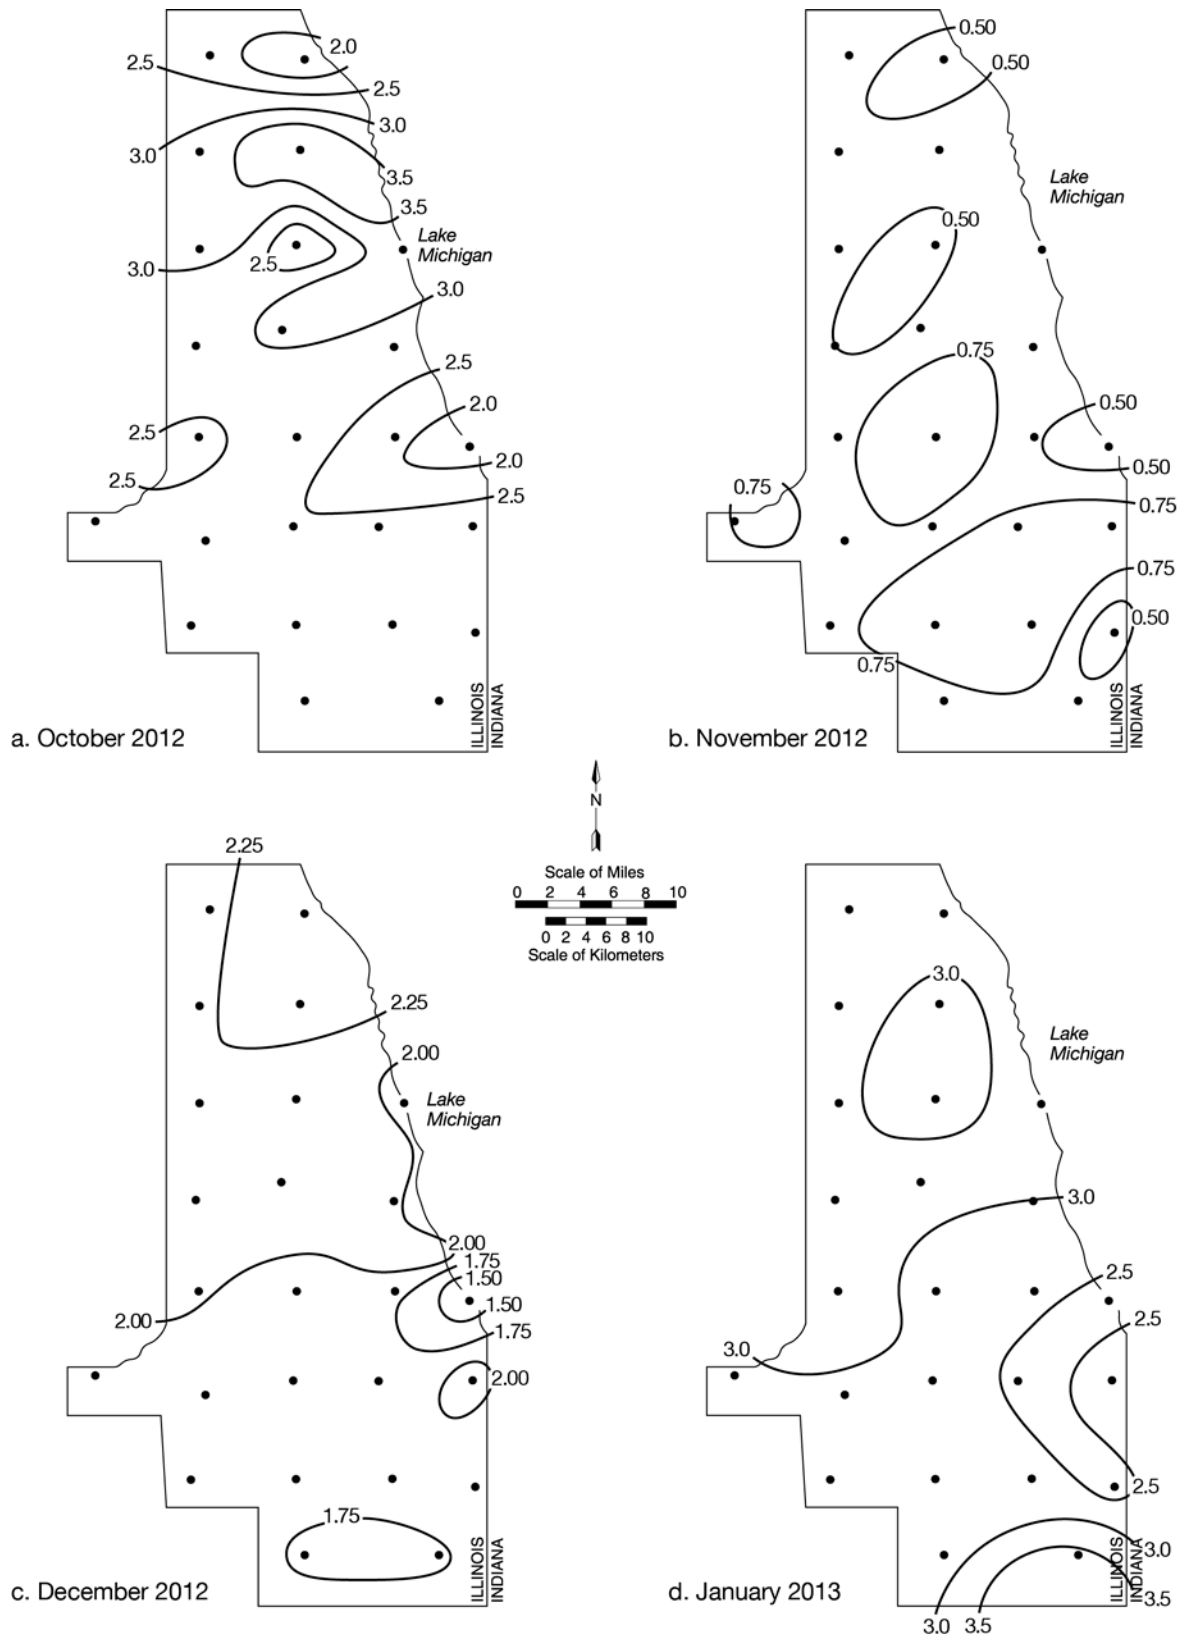
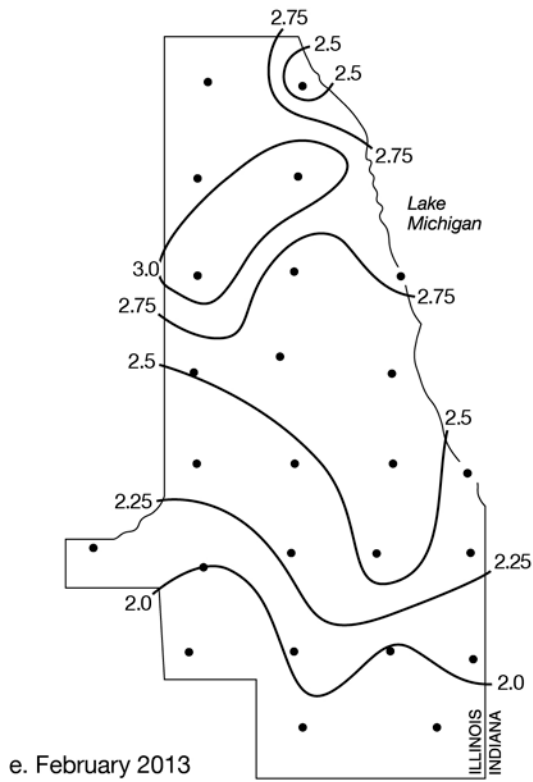
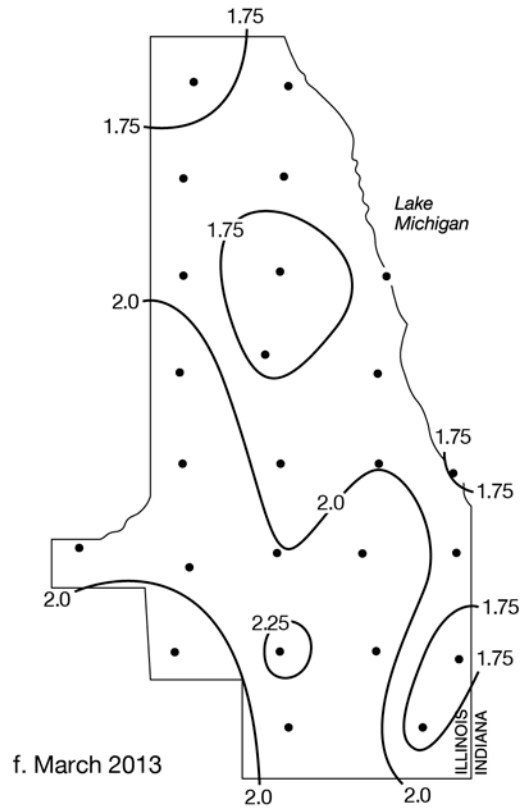
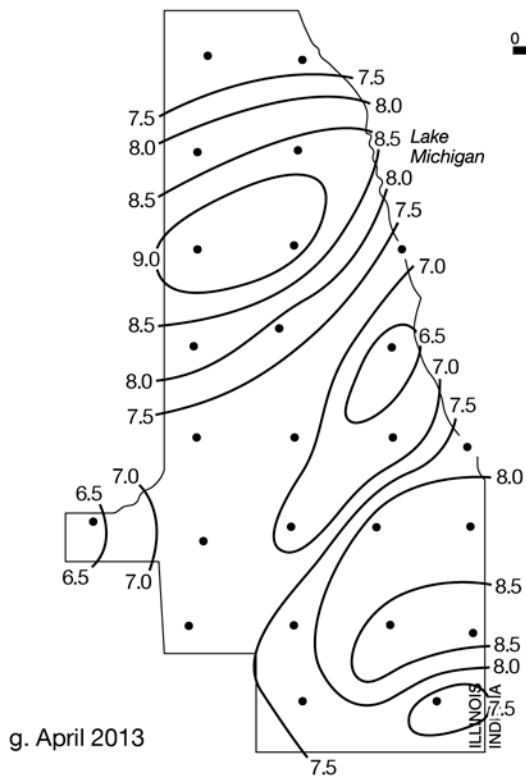
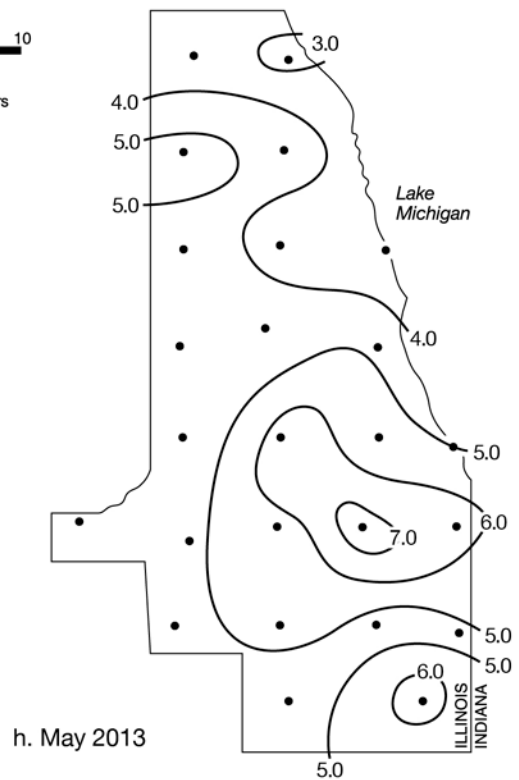
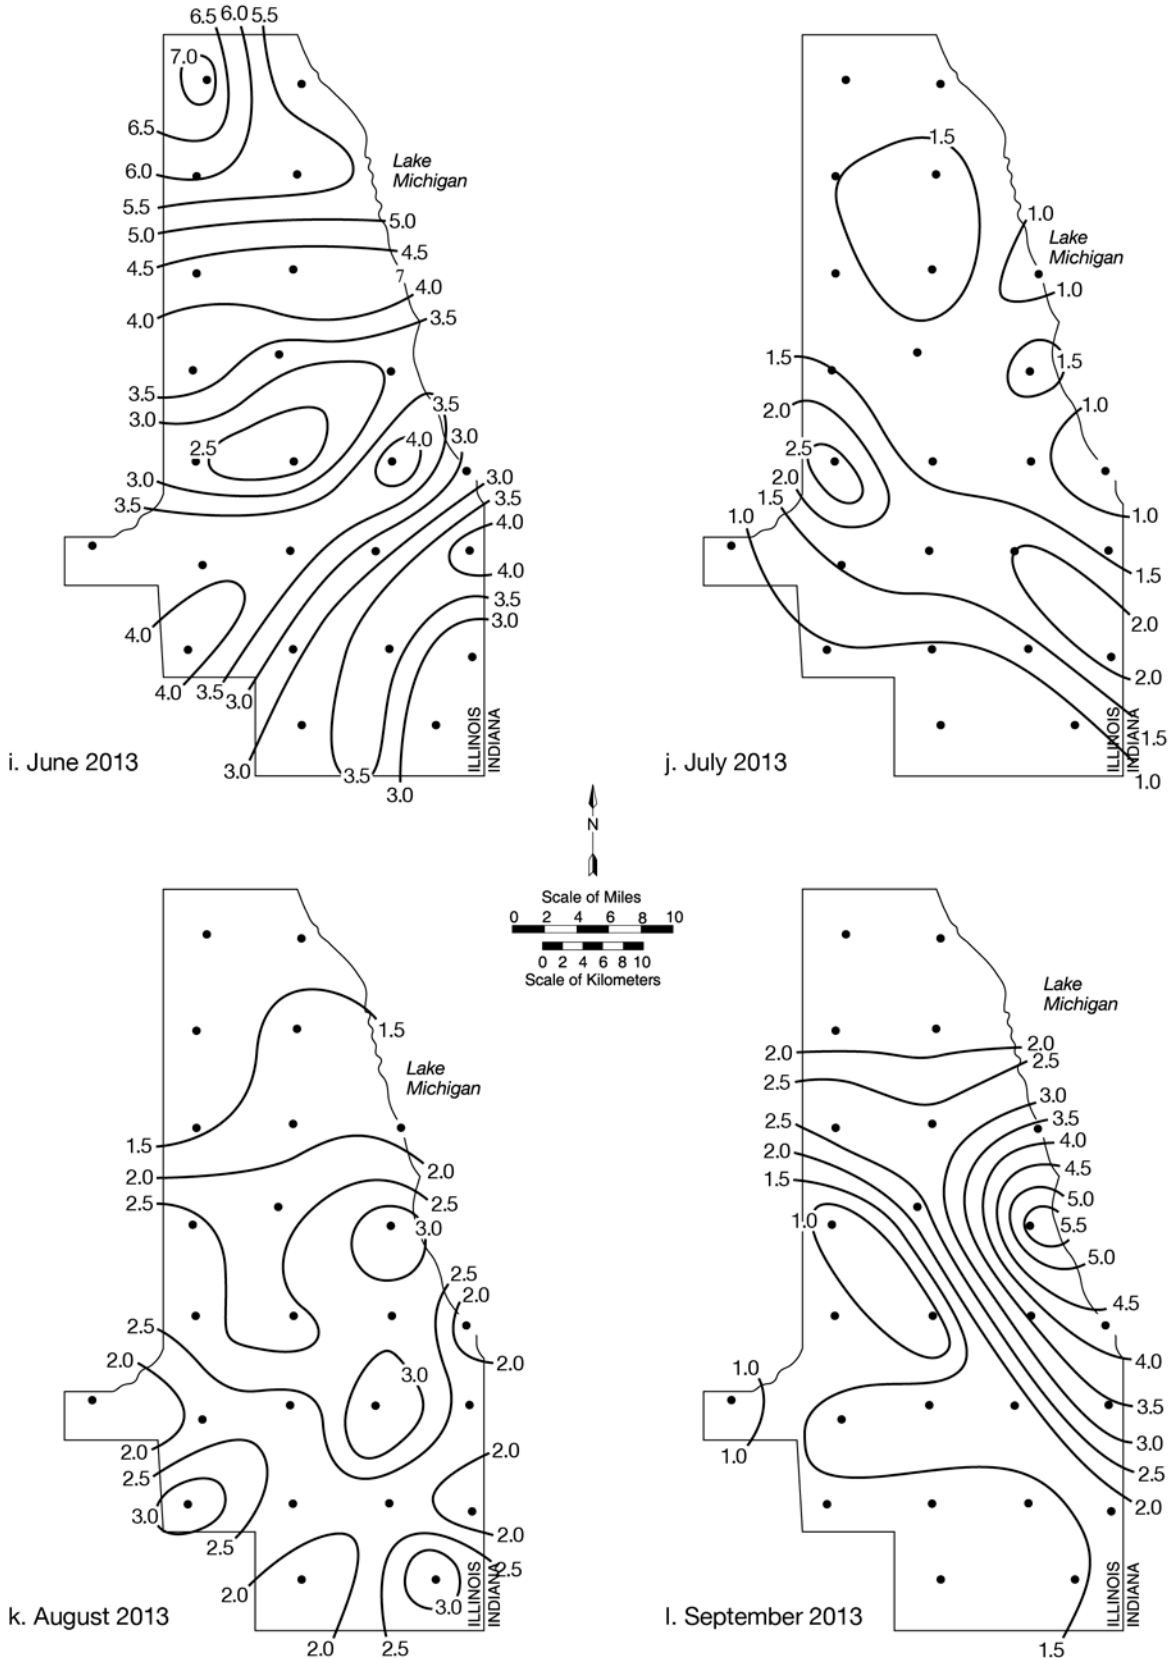
Figure 5. Precipitation pattern (inches) for October 2012–September 2013

Figure 5 presents monthly precipitation patterns for Water Year 2013. The April 2013 network precipitation was 220 percent of the 23-year April average precipitation. Monthly network precipitation amounts were 51 percent or less of the 23-year average in November 2012, July 2013, and August 2013. During the other months, network amounts ranged from 71 to 143 percent of normal. Less than 2.0 inches of precipitation fell in November and December 2012, and March and July 2013. More than four inches of precipitation fell in April and May 2013.

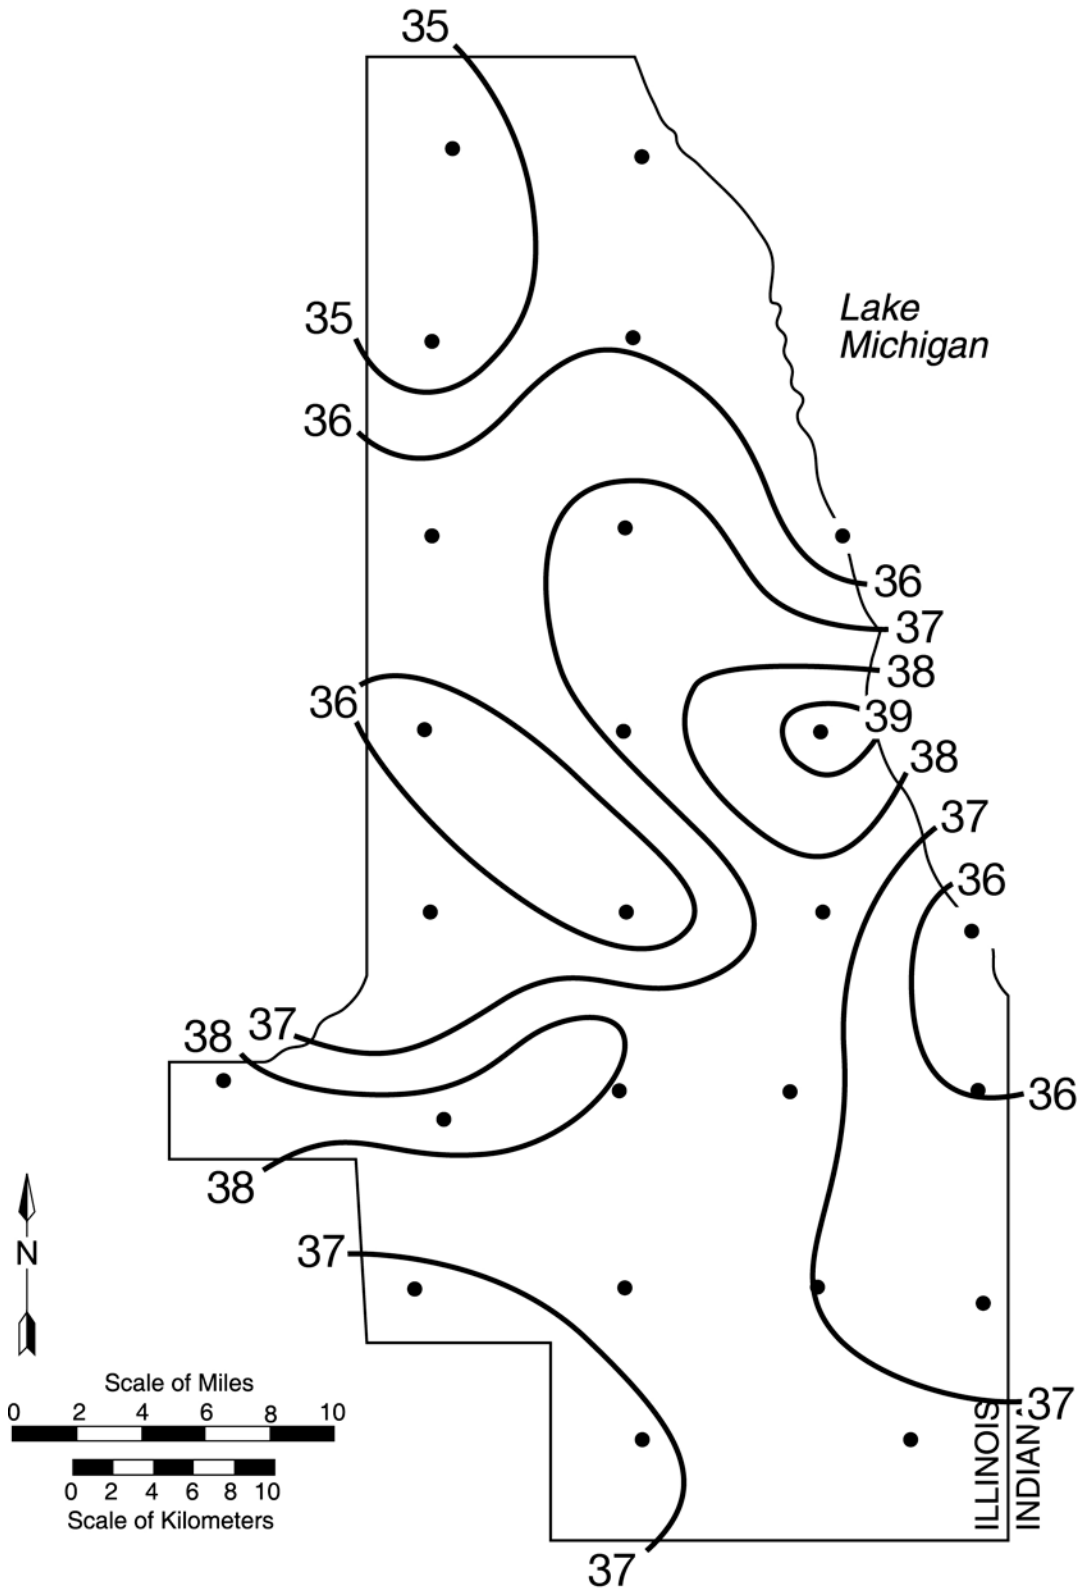
Figure 6. The 24-year average precipitation pattern (inches), Water Years 1990–2013

The 24-year (1990–2013) average precipitation pattern (Figure 6) shows, as in previous years, an area of higher values across southwestern Cook County (sites #15 and #16) and northward to Chicago site #10. Lower values are found at northern sites #1 and #3. The 24-year network-wide average is 36.68 inches.
