Contract Report 2014-01

Continued Operation of a 25-Raingage Network for Collection, Reduction, and Analysis of Precipitation Data for Lake Michigan Diversion Accounting: Water Year 2013

FINAL REPORT

U.S. Army Corps of Engineers, Chicago District

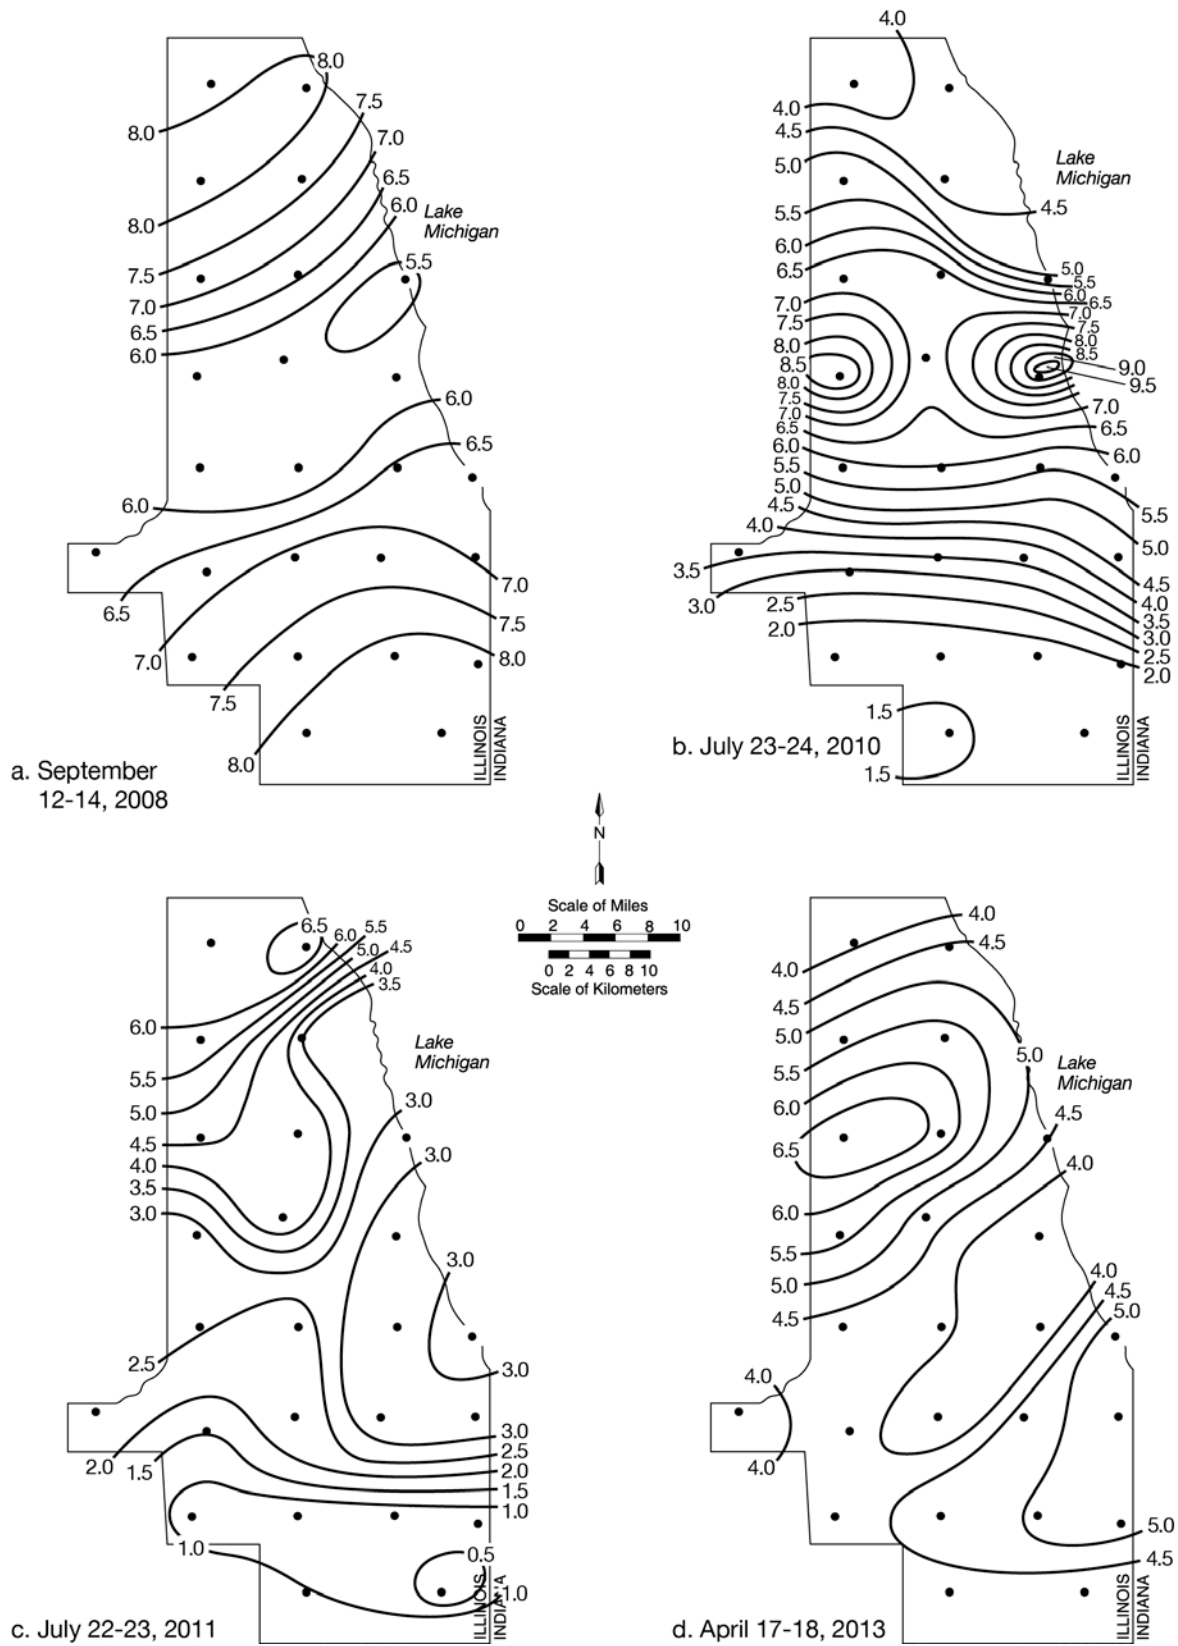
Figure IV-1. The four most intense storm events during Water Years 2008-2013.

The seven heavy precipitation events of Water Year 2013 occurred in the spring and summer months. Events with gages exceeding the 25-recurrence interval occurred on April 17-18, 2013, June 26, 2013 and September 18, 2013. Appendix IV contains specific information concerning the Water Year 2013 precipitation events for gages that exceeded the 1-year recurrence interval. It also presents information concerning the four largest storm events that occurred in Cook County the period October 2007 to September 2013.
