Contract Report 2015-01

Continued Operation of a 25-Raingage Network for Collection, Reduction, and Analysis of Precipitation Data for Lake Michigan Diversion Accounting: Water Year 2014

FINAL REPORT

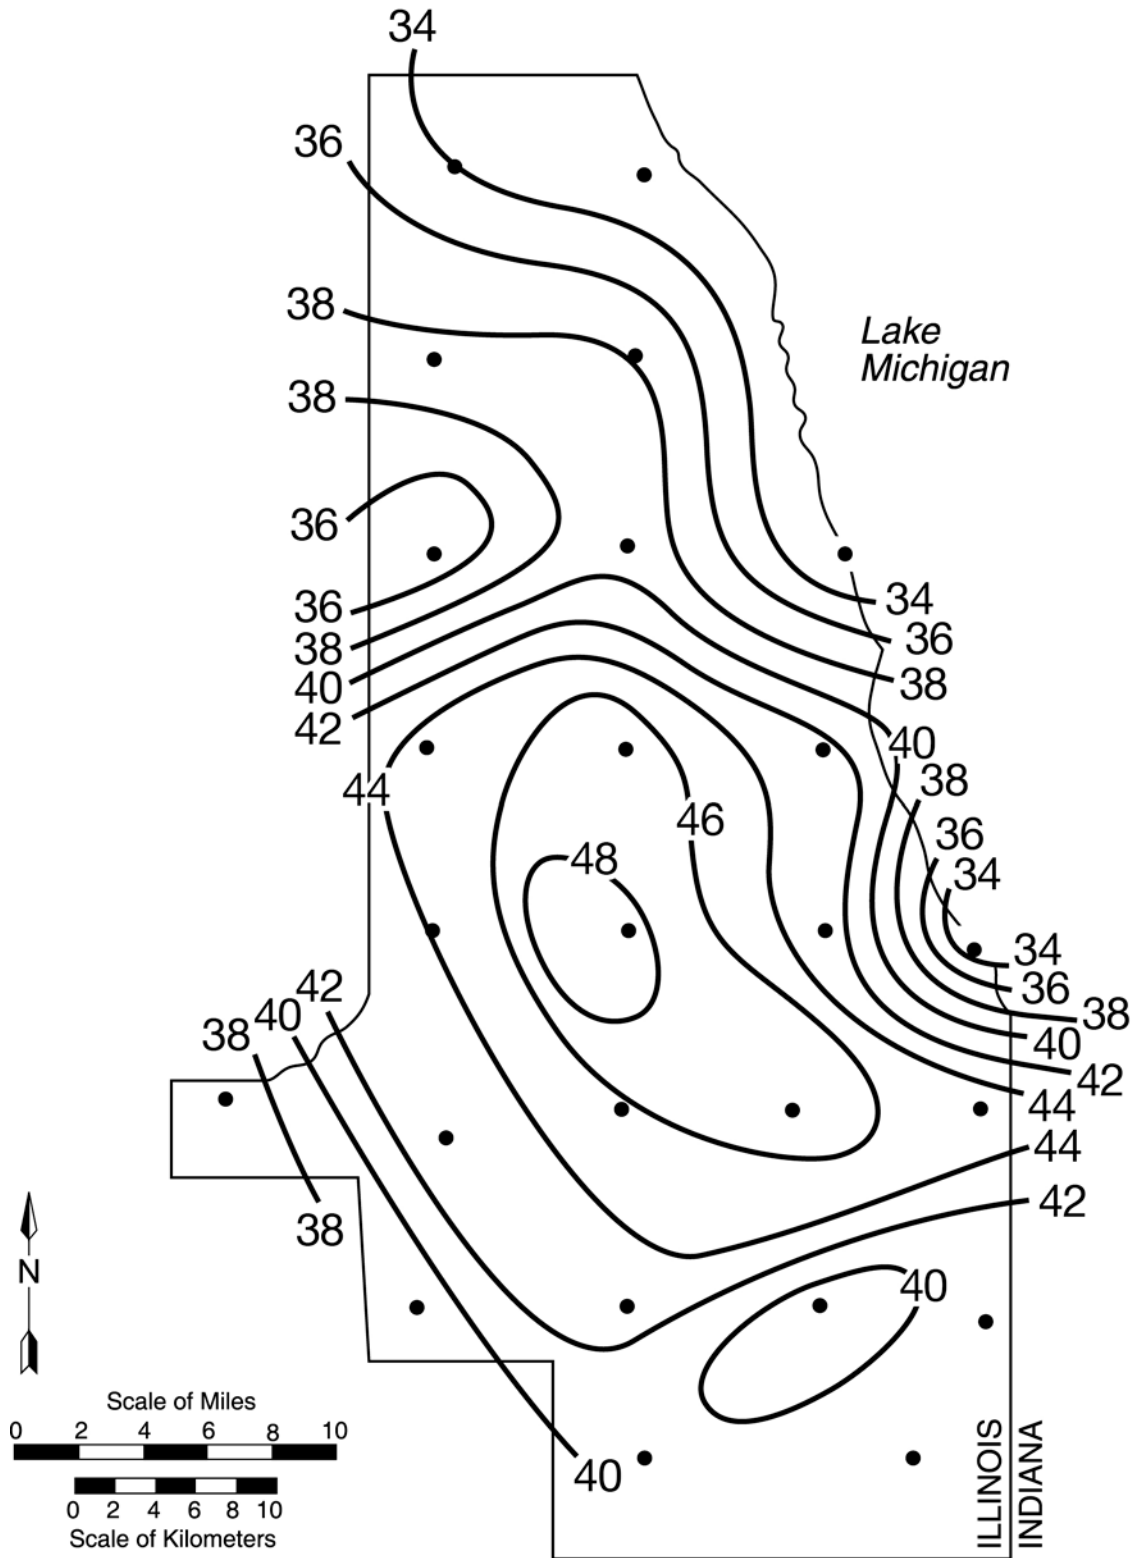
Figure 3. Precipitation pattern (inches) for Water Year 2014

The largest precipitation amounts during Water Year 2014 occurred in the central portion of the network (sites #9, #12, #17, #18, and #19, Figure 3). See Figure 2 and Appendix I for site information. The lightest amounts occurred in the northern, western, and near-lake portions of the network (sites #1, #2, #7, #14, and #15). The heaviest precipitation in the network during Water Year 2014 fell at site #12 (48.07 inches), while the lightest fell at site #2 (32.55 inches).

As in the case of the other network water year patterns, the spatial pattern for Water Year 2014 (Figure 3) does not contain the anomalies found in an analysis using sites operated by the MWRDGC, the NWS, and Cook County for Water Years 1984–1989 (Vogel, 1988; Peppler, 1993b). Gradients of 15 to 20 inches were common in those analyses. Precipitation data from those sites were the input for diversion accounting before construction of the present network (Peppler, 1993b). For Water Year 2014, there were 9-inch gradients between Sites #7 and #10 and between #13 and #1, and an 11-inch gradient between #14 and #19. Lower values may be due to storm location or siting issues. Site #14 is in a very windy location, but has an Alter shield to help reduce wind loss. Site #2 was moved downhill in June 2014 to a less windy location. These siting differences may accentuate actual precipitation gradients suggested by nearby gages.

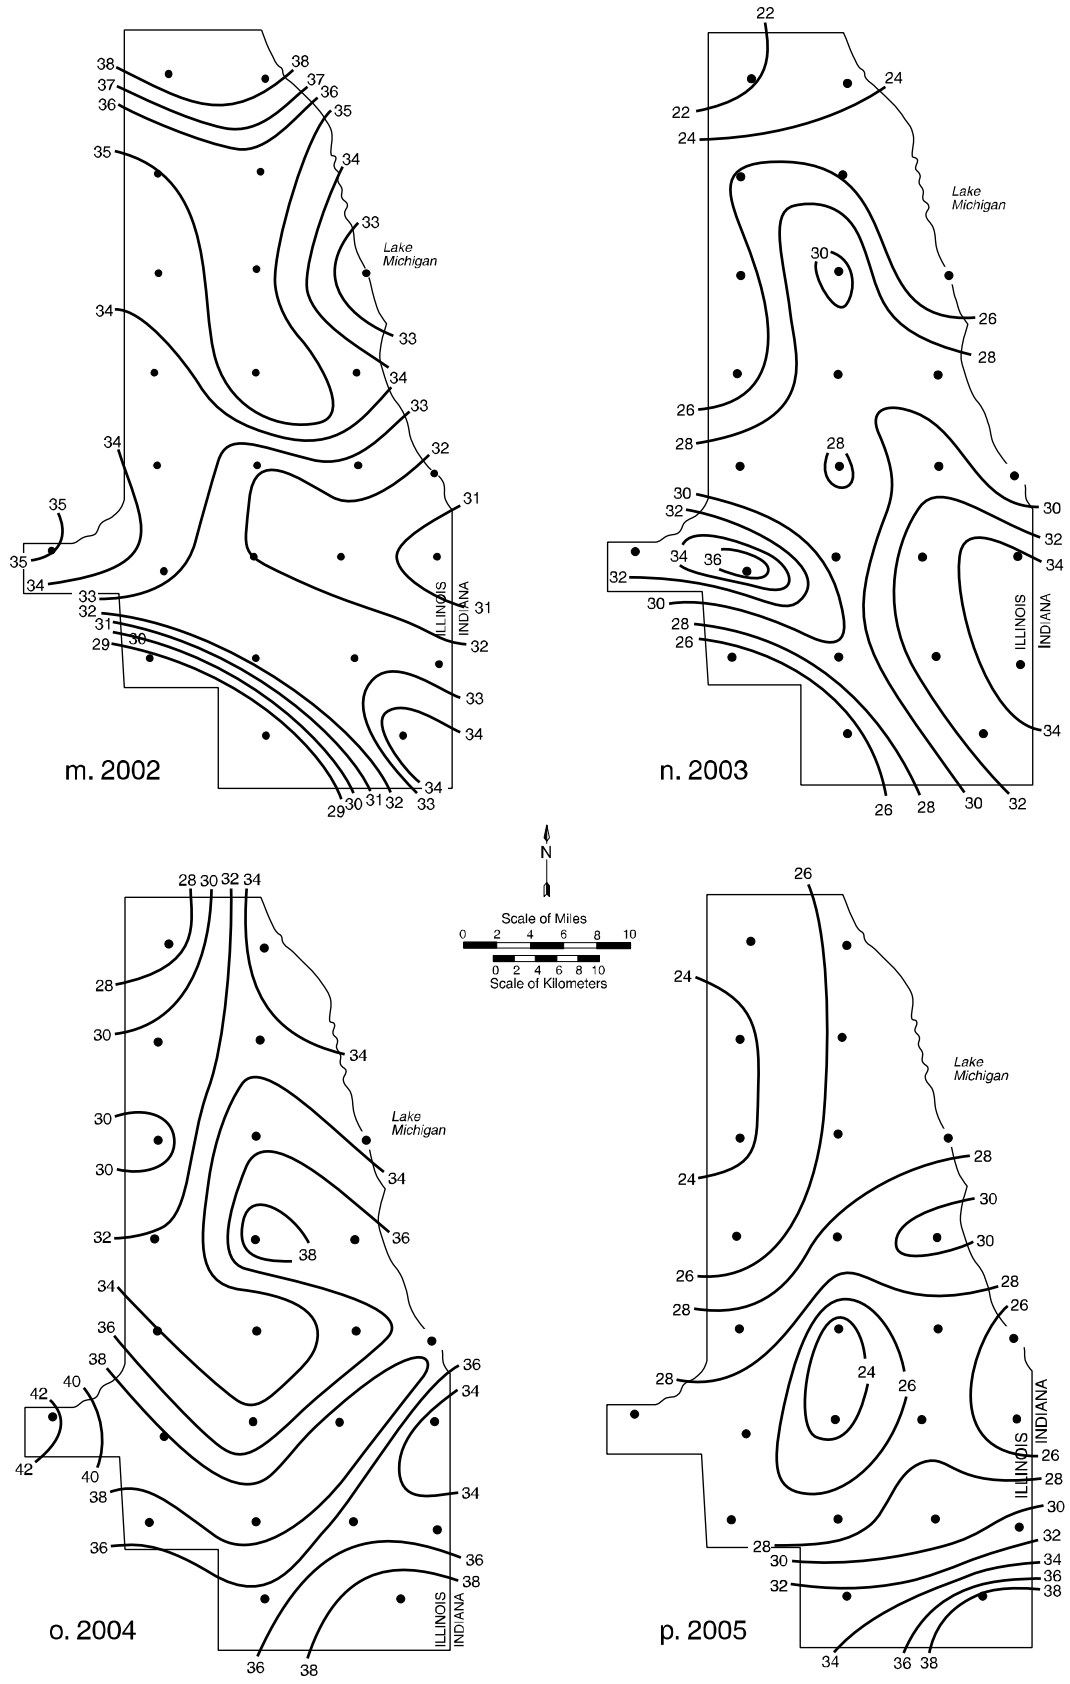
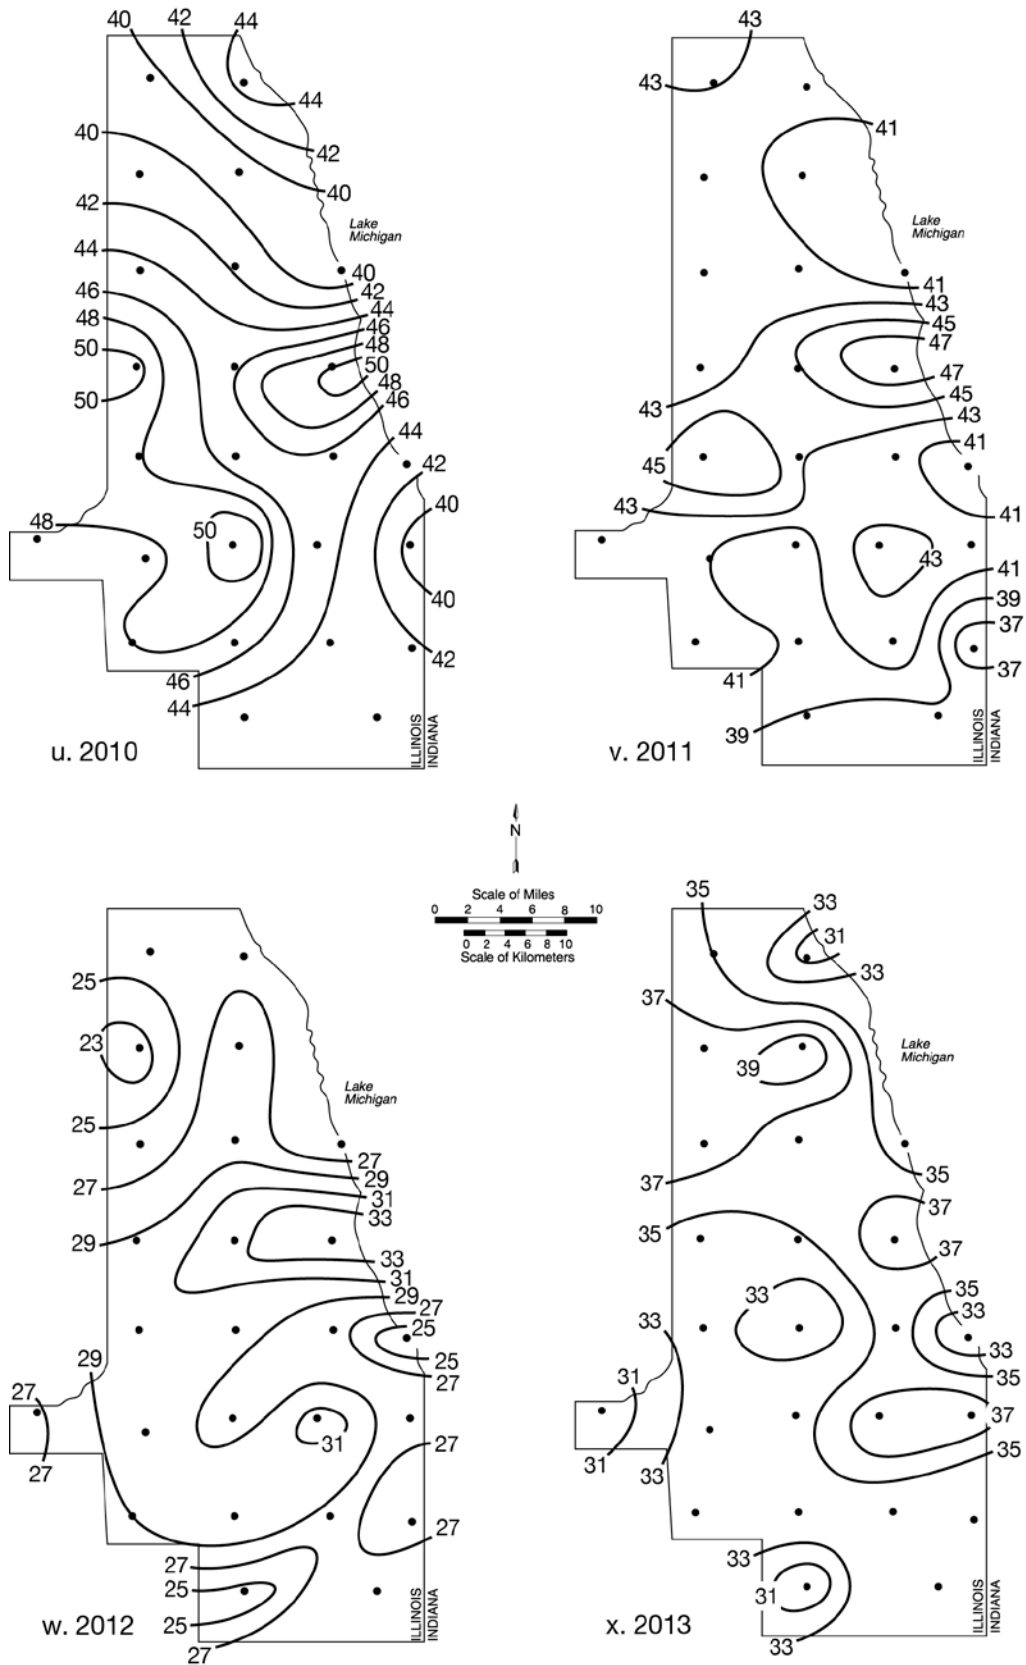
Figure 4. Precipitation pattern (inches) for Water Years 1990–2013

Figure 4 provides maps of precipitation amounts for individual Water Years 1990–2013. The general pattern of high values for Water Year 2014 is similar to that for Water Year 1990, 1992, and 2012, with the largest precipitation in the central region and the lowest precipitation along the lake shore.

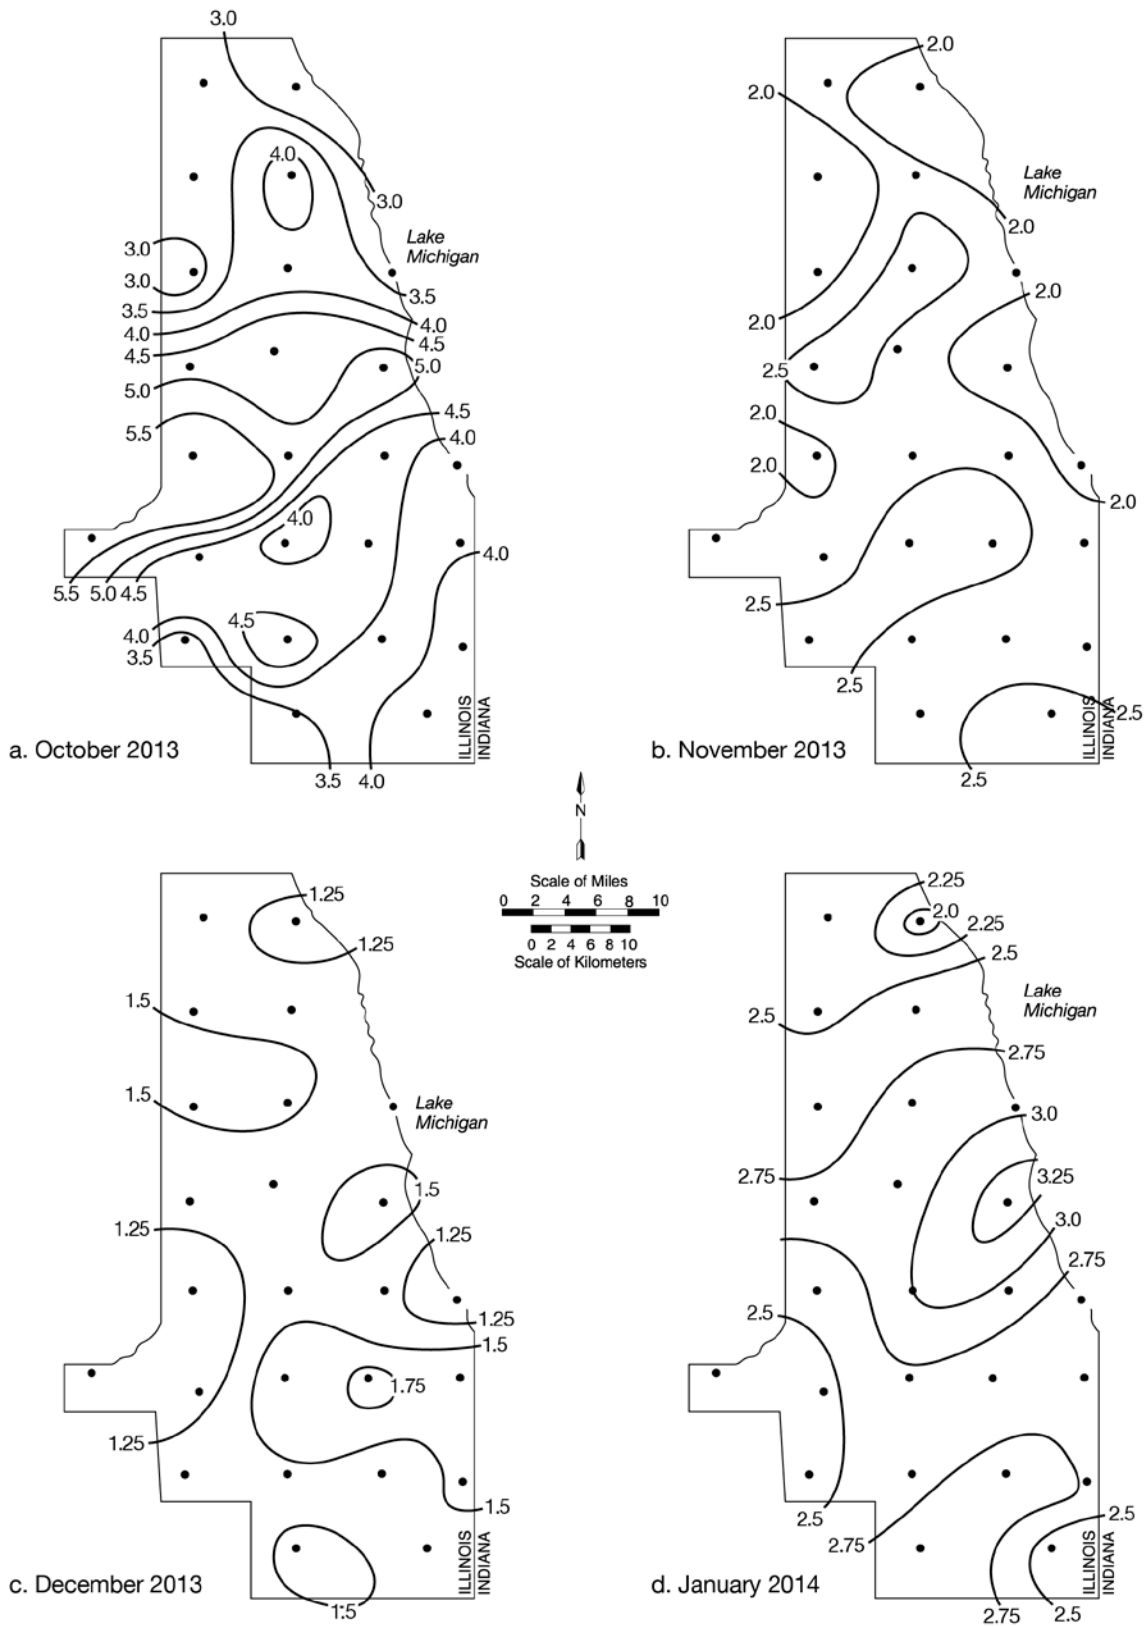
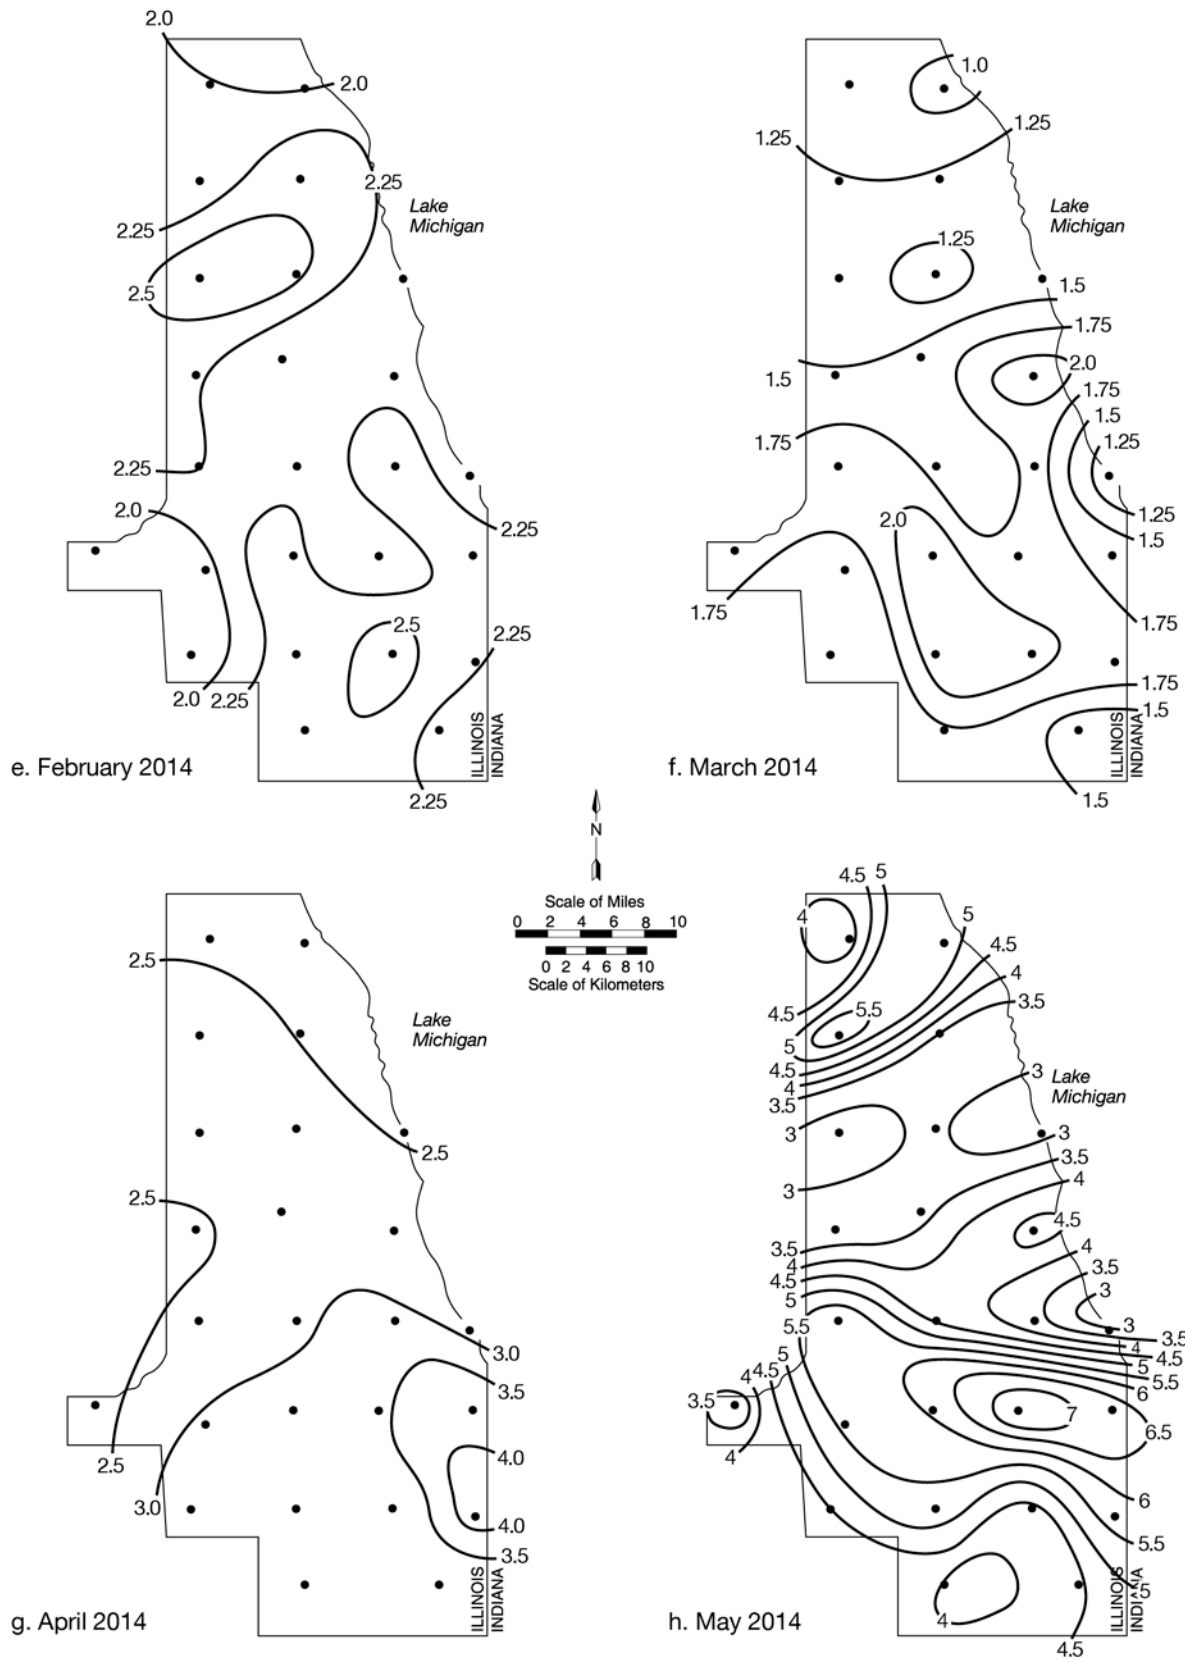
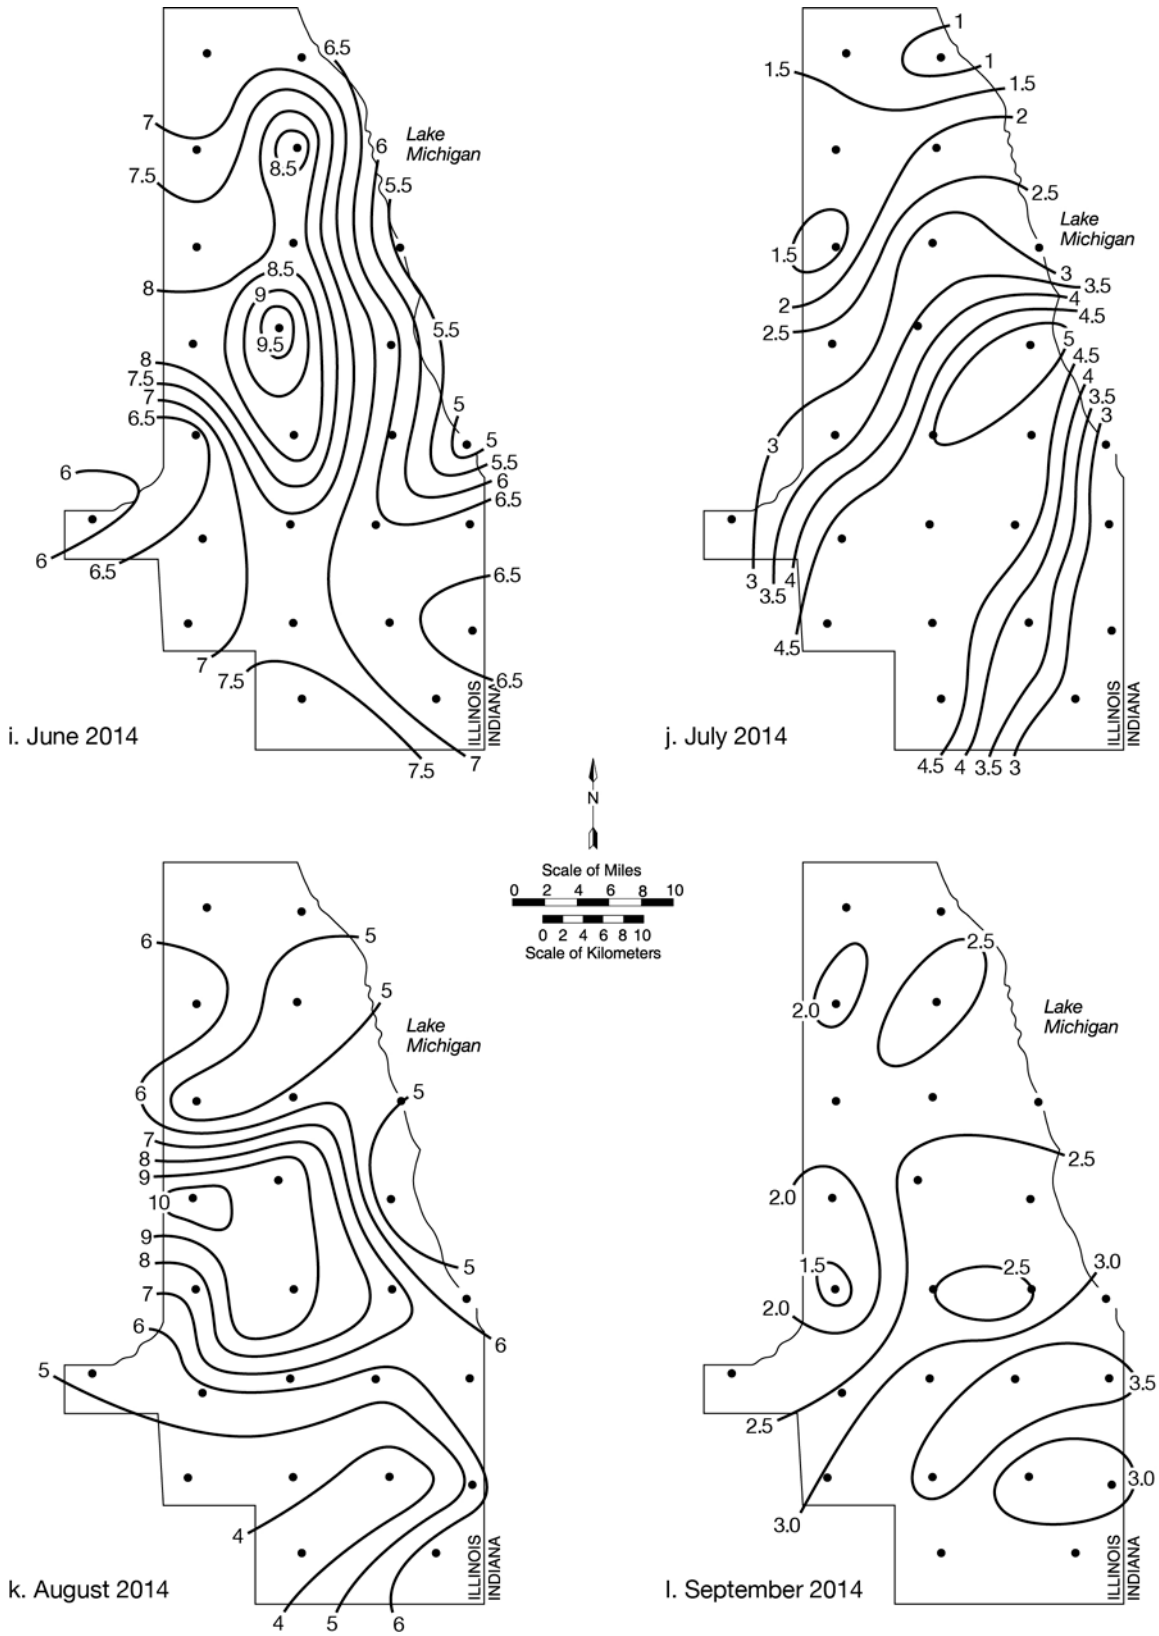
Figure 5. Precipitation pattern (inches) for October 2013–September 2014

Figure 5 presents monthly precipitation patterns for Water Year 2014. The June 2014 network precipitation of 6.98 inches was 161 percent of the 24-year June average precipitation. Monthly network precipitation amounts were 66 percent of the 24-year average in December 2013 and March 2014. During the other months, network amounts ranged from 79 to 144 percent of normal. Less than 2.0 inches of precipitation fell in December 2013 and March 2014. More than 4.0 inches of precipitation fell in October, May, June, and August 2014. From October 2013 through August 2014, there were two storm events that exceeded a network average of more than 2.0 inches with at least one individual gage amount of more than 4.0 inches, on October 30-31, 2013 and on August 21-22, 2014.

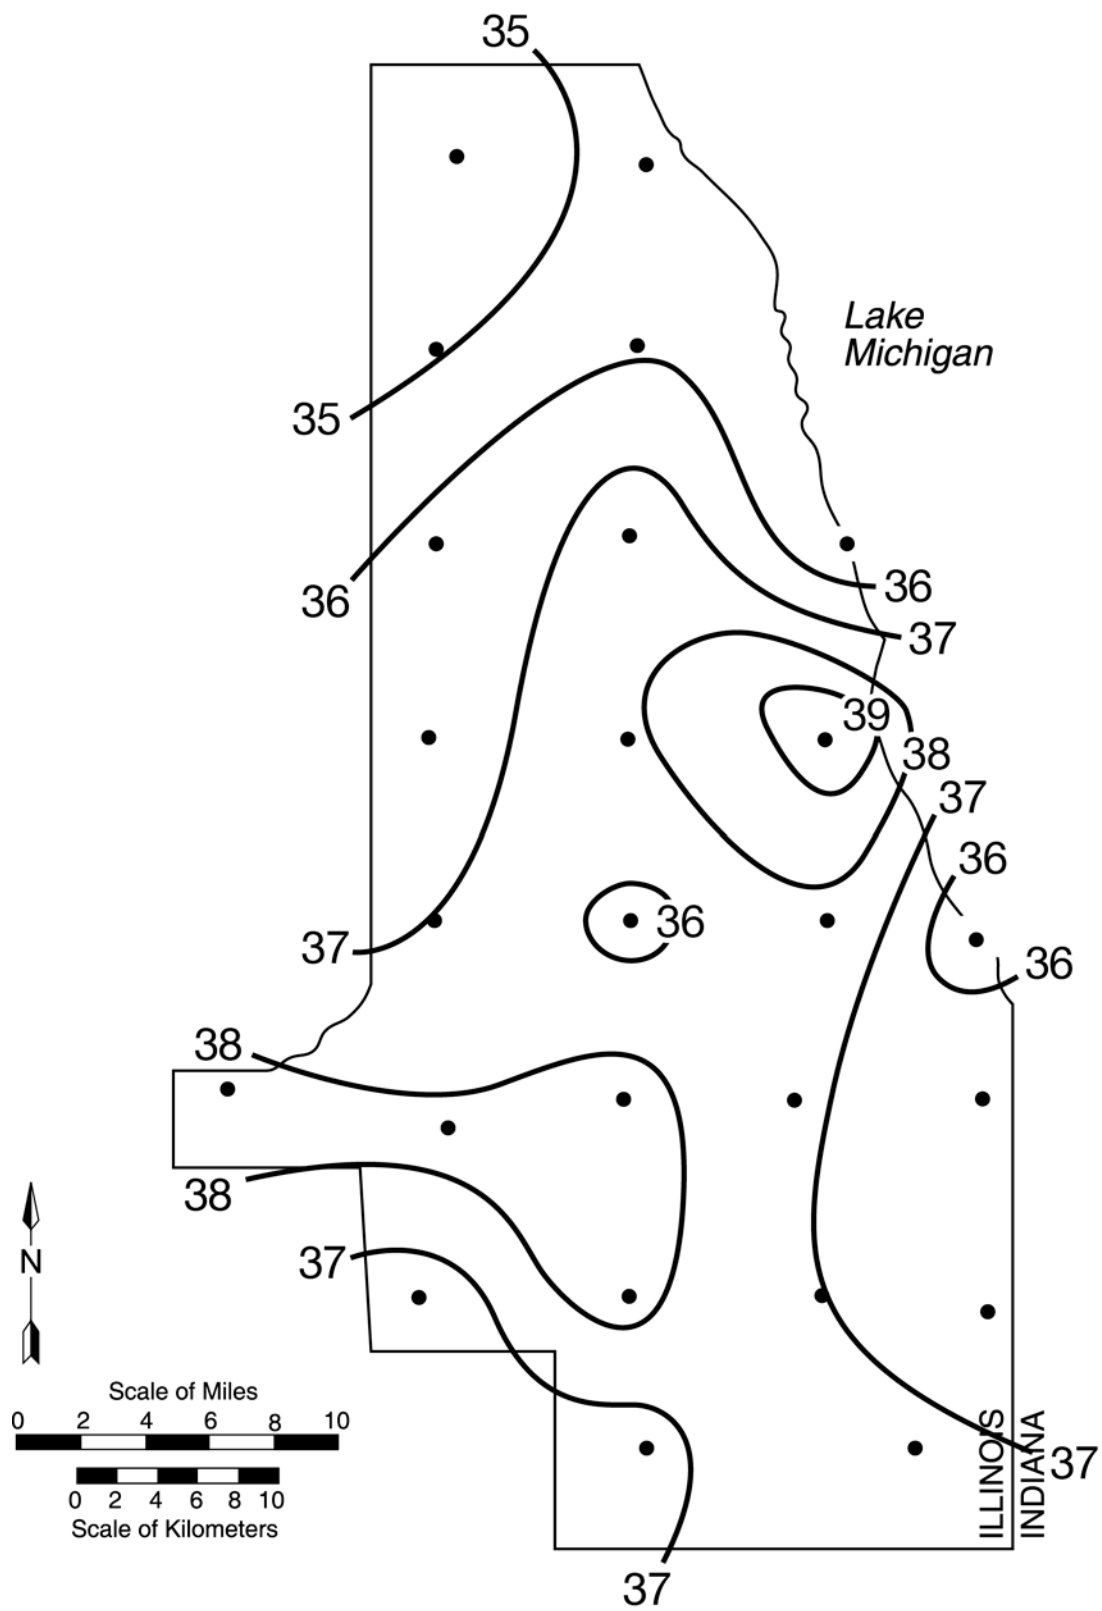
Figure 6. The 25-year average precipitation pattern (inches), Water Years 1990–2014

The 25-year (1990–2014) average precipitation pattern (Figure 6) shows, as in previous years, an area of higher values across southwestern Cook County (sites #15, #16, #17, and #21) and northward to Chicago site #10. Lower values are found at northern sites #1 and #3. The 25-year network-wide average is 36.83 inches.
