Contract Report 2016-01

Continued Operation of a 25-Raingage Network for Collection, Reduction, and Analysis of Precipitation Data for Lake Michigan Diversion Accounting: Water Year 2015

FINAL REPORT

U.S. Army Corps of Engineers, Chicago District

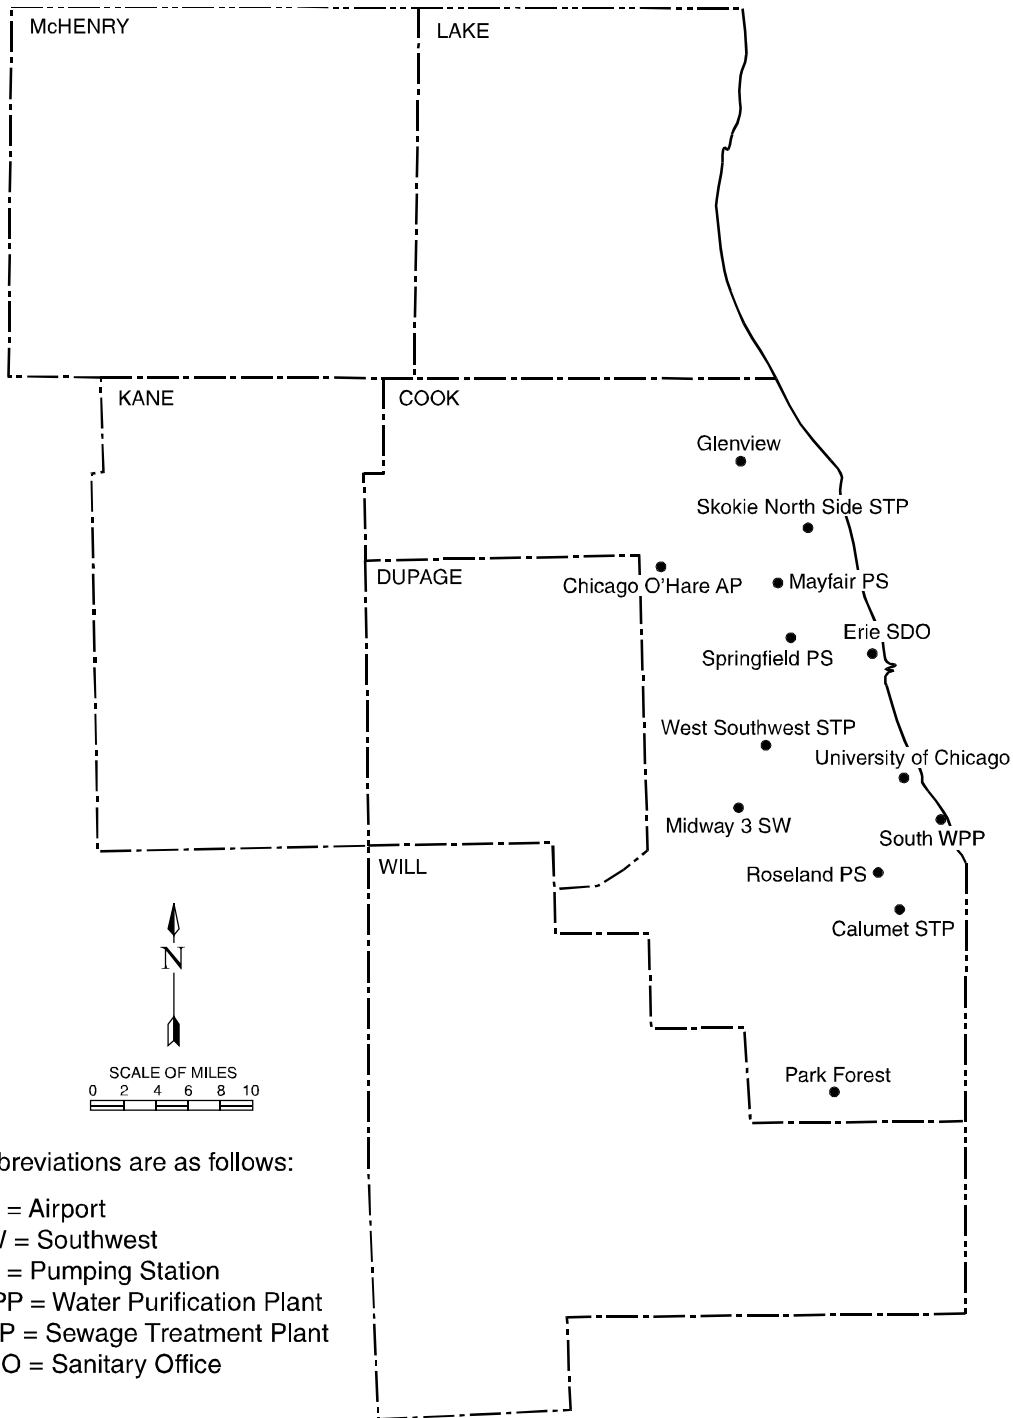
Figure 1. Raingage locations used for diversion accounting purposes prior to Water Year 1990. These include National Weather Service gages located at Chicago O'Hare AP, Midway 3 SW, University of Chicago, and Park Forest; City of Chicago gages located at Mayfair PS, Springfield PS, South WPP, and Roseland PS; and Metropolitan Water Reclamation District of Greater Chicago gages located at Glenview, Skokie North Side STP, Erie SDO, West Southwest STP, and Calumet STP.

The unusual patterns were caused by abnormally low precipitation totals at a select number of the 13 sites used by the accounting procedure (Figure 1). Inspection of these sites (Vogel, 1988), which are irregularly distributed over the region, revealed that low precipitation totals were caused by 1) inadequate gage exposure (e.g., gages situated on rooftops or too near natural or artificial air flow-restricting obstructions) and 2) different observing, data reduction, and quality control practices used by the individual groups responsible for raingage operation and data collection (National Weather Service - NWS, Metropolitan Water Reclamation District of Greater Chicago - MWRDGC, and City of Chicago - CC). Vogel (1988) established that the unusual precipitation patterns began

This appendix contains site descriptions of the 25 raingage locations (Figure 1) in the network as of September 30, 2015. Sites that have been relocated since the network began operation in October 1989 are noted in the "Placement" section of the descriptions. Note that there are slight differences in latitude and longitude values from previous years. More accurate GPS readings were obtained for all sites during the summer of 2006.

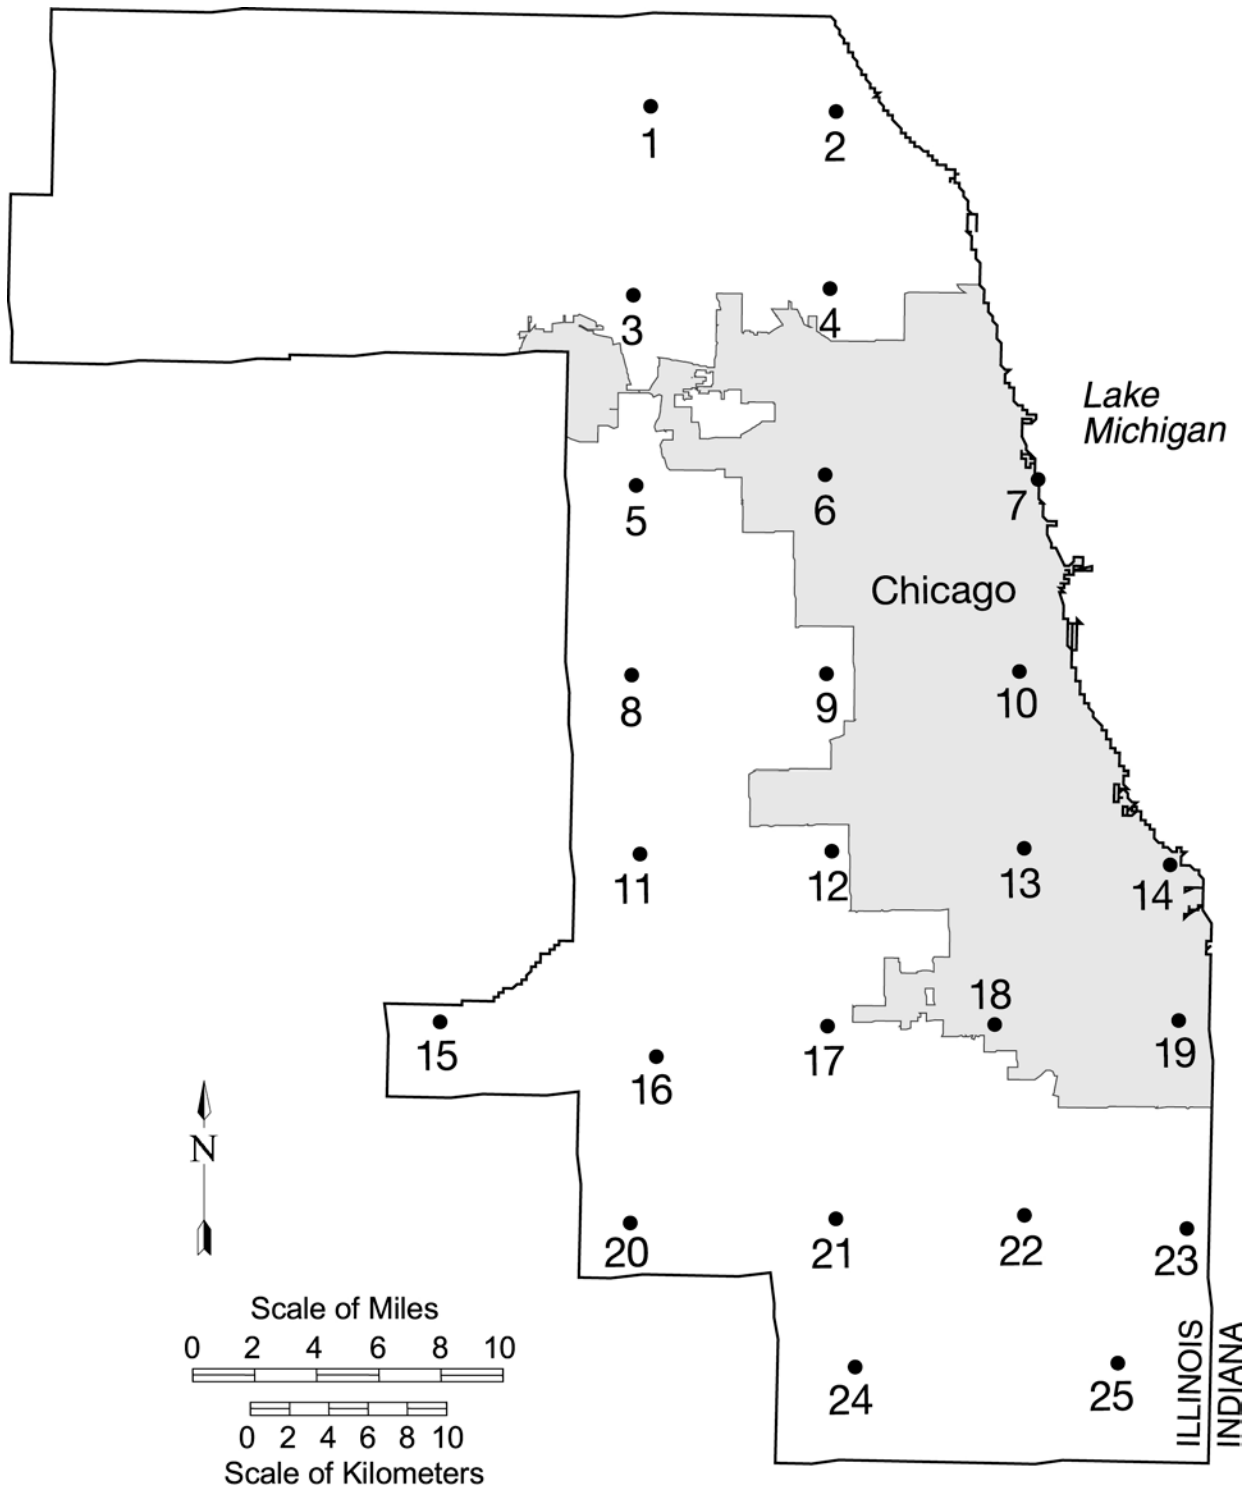
Figure 2. The Cook County 25-site rain gauge network for Water Years 1990-2015. City of Chicago indicated by shading.

The largest precipitation amounts during Water Year 2015 occurred in the central portion of the network (sites #6, #8, #9, #10, #16, #17, and #19, Figure 3). See Figure 2 and Appendix I for site information. The lightest amounts occurred in the northern, western, and near-lake portions of the network (sites #2, #3, #11, #14, #15, #22, and #24). The heaviest precipitation in the network during Water Year 2015 fell at site #9 (38.42 inches), and the lightest fell at site #24 (27.67 inches).

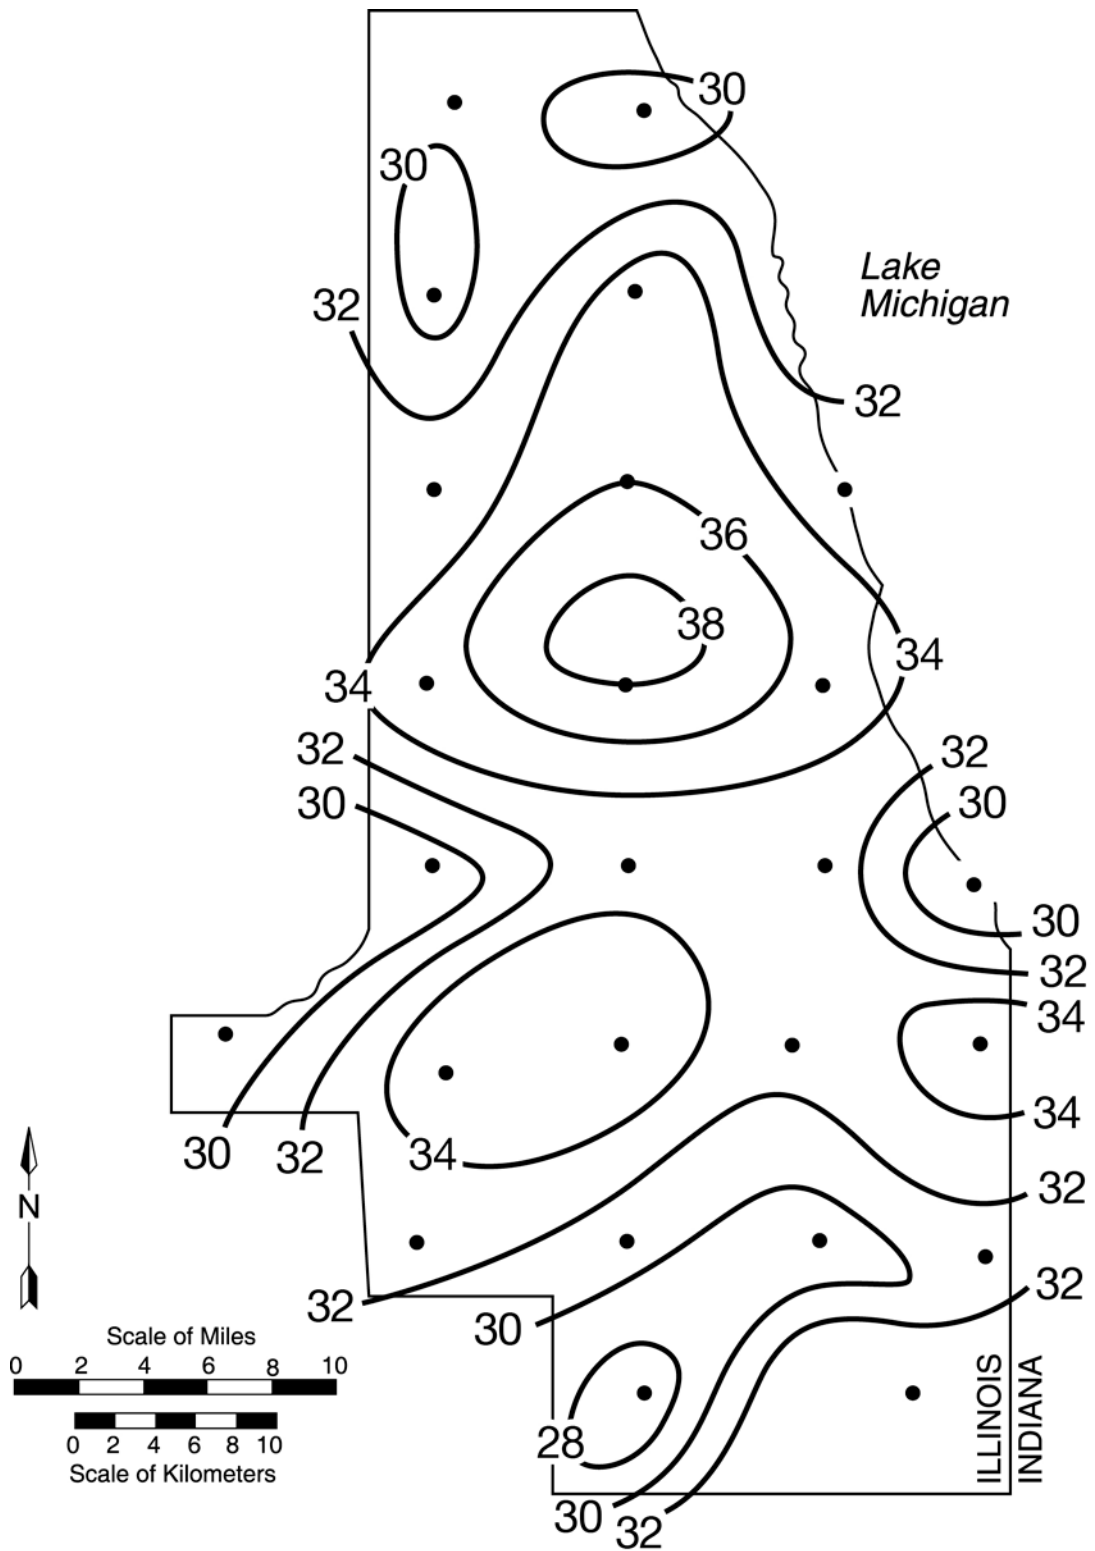
Figure 3. Precipitation pattern (inches) for Water Year 2015

As in the case of the other network water year patterns, the spatial pattern for Water Year 2015 (Figure 3) does not contain the anomalies found in an analysis using sites operated by the MWRDGC, the NWS, and Cook County for Water Years 1984–1989 (Vogel, 1988; Pepler, 1993b). Gradients of 15 to 20 inches were common in those analyses. Precipitation data from those sites were the input for diversion accounting before construction of the present network (Pepler, 1993b). For Water Year 2015, there were 9-inch gradients between Sites #10 and #14. Lower values may be due to storm location or siting issues. Site #14 is in a very windy location, but has an Alter shield to help reduce wind loss. These siting differences may accentuate actual precipitation gradients suggested by nearby gages.

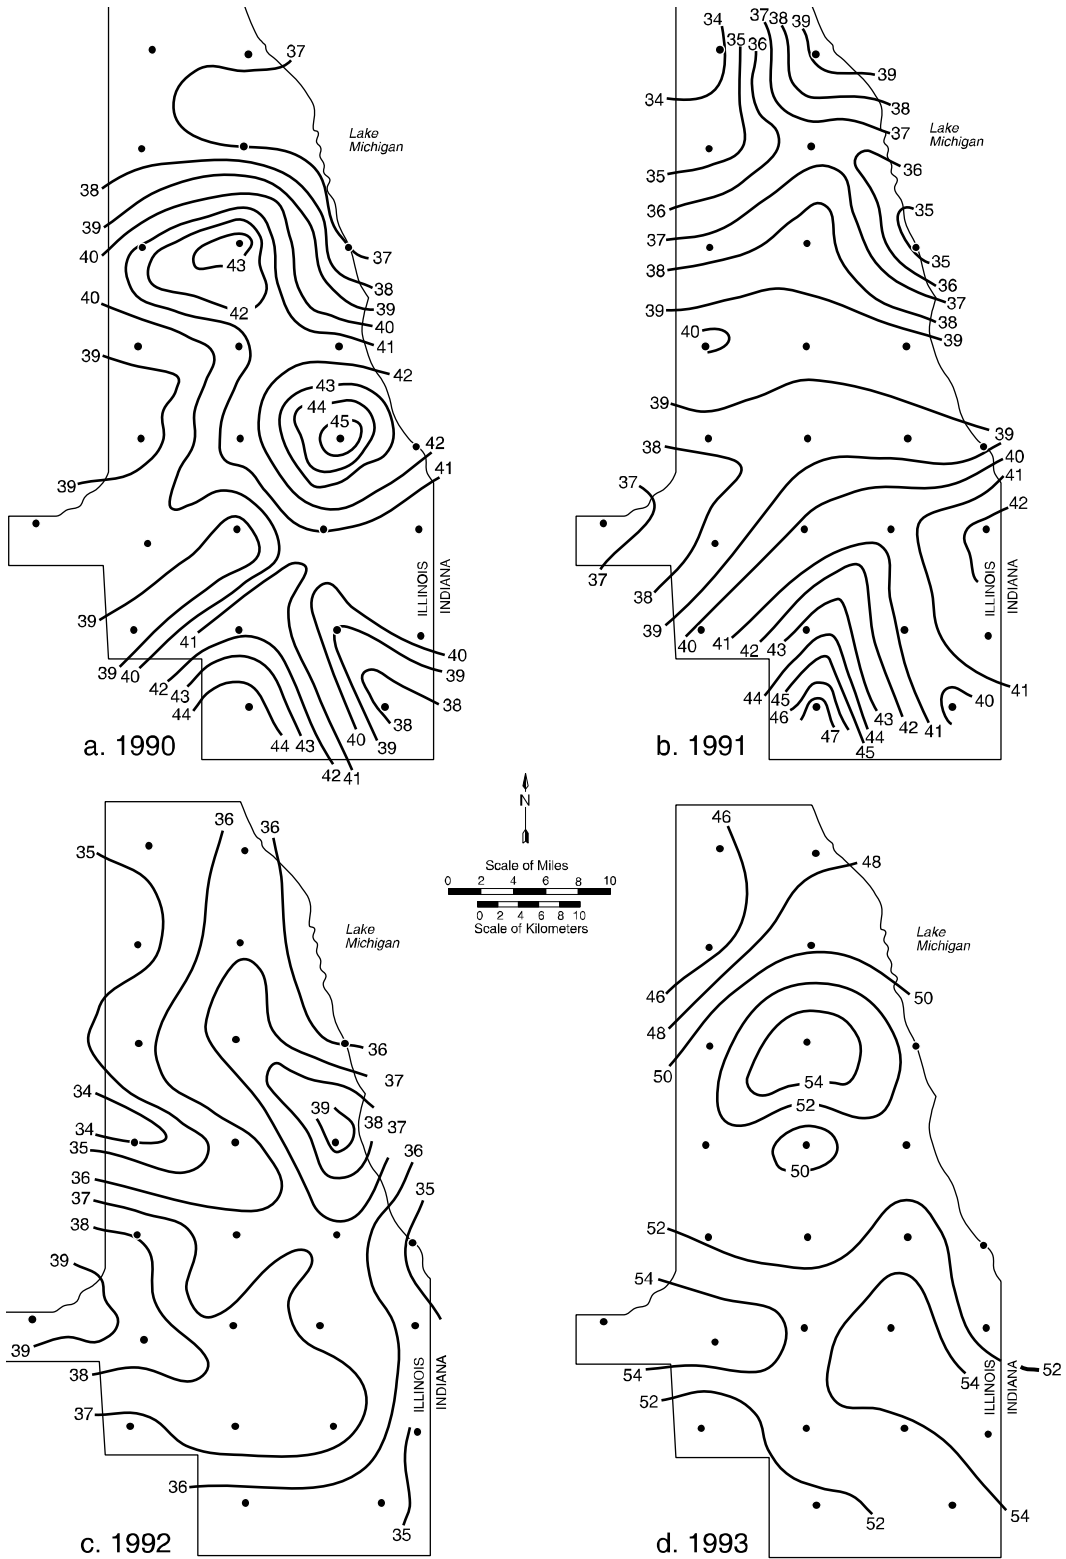
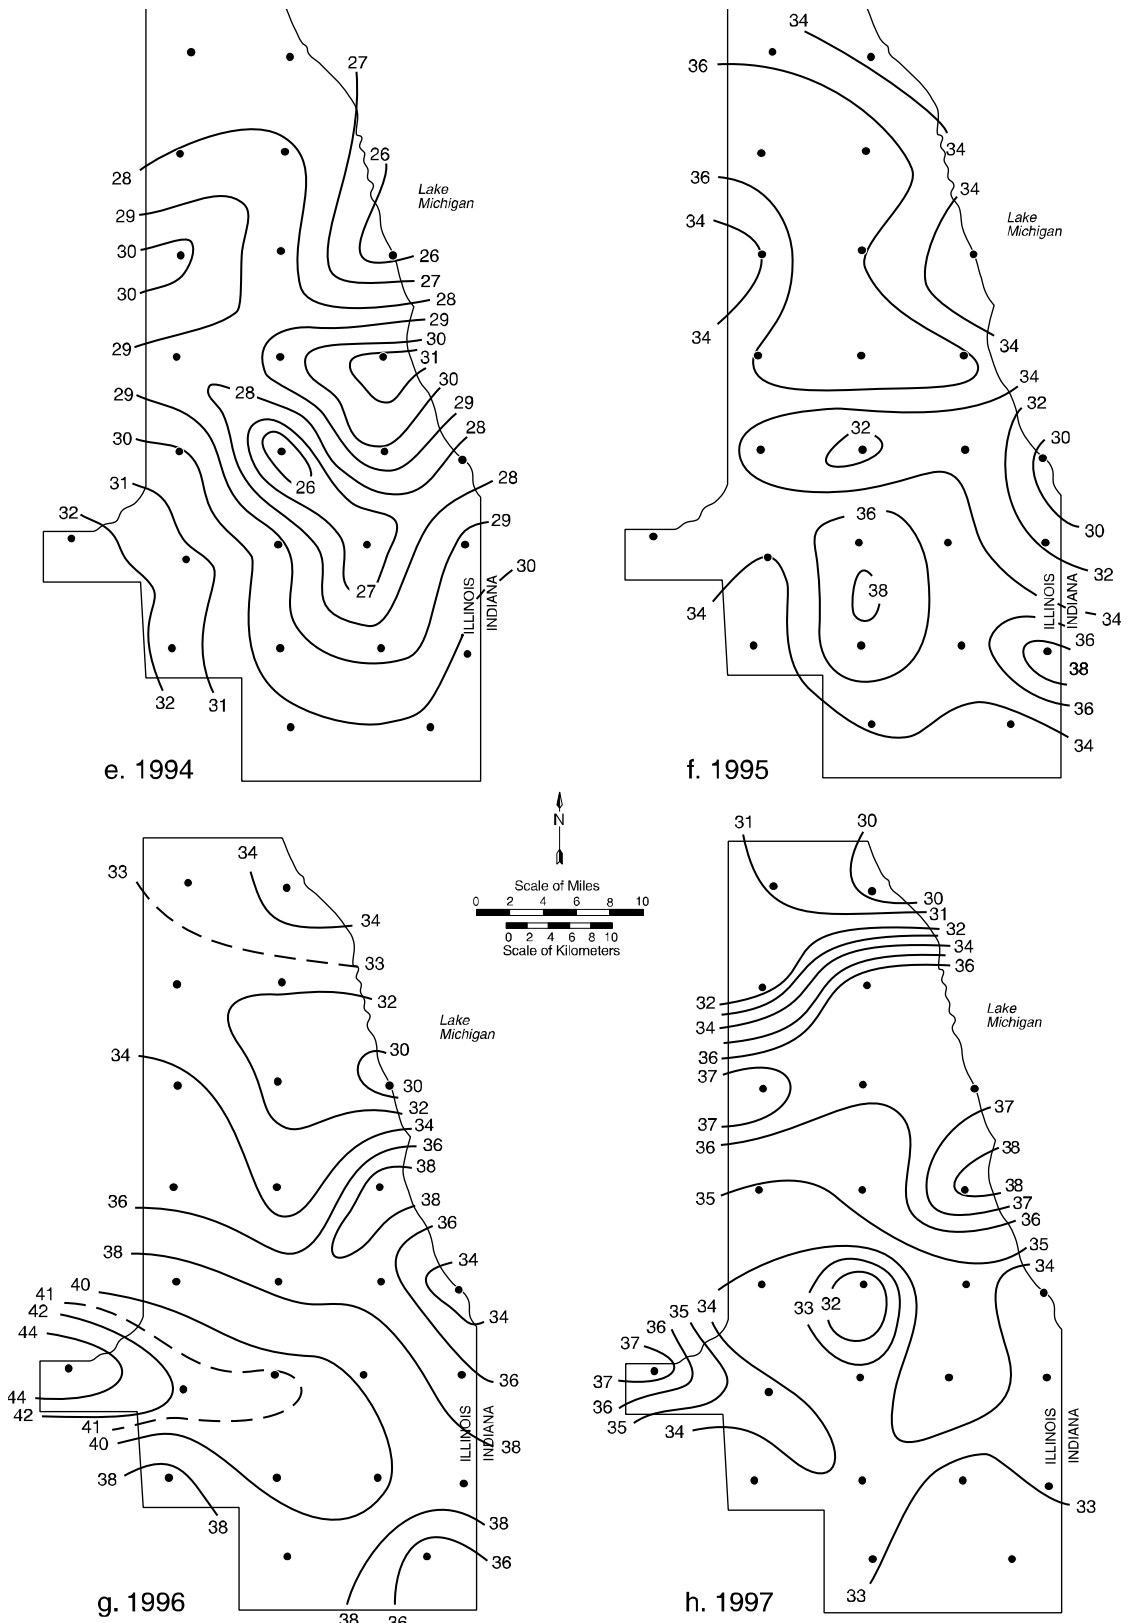
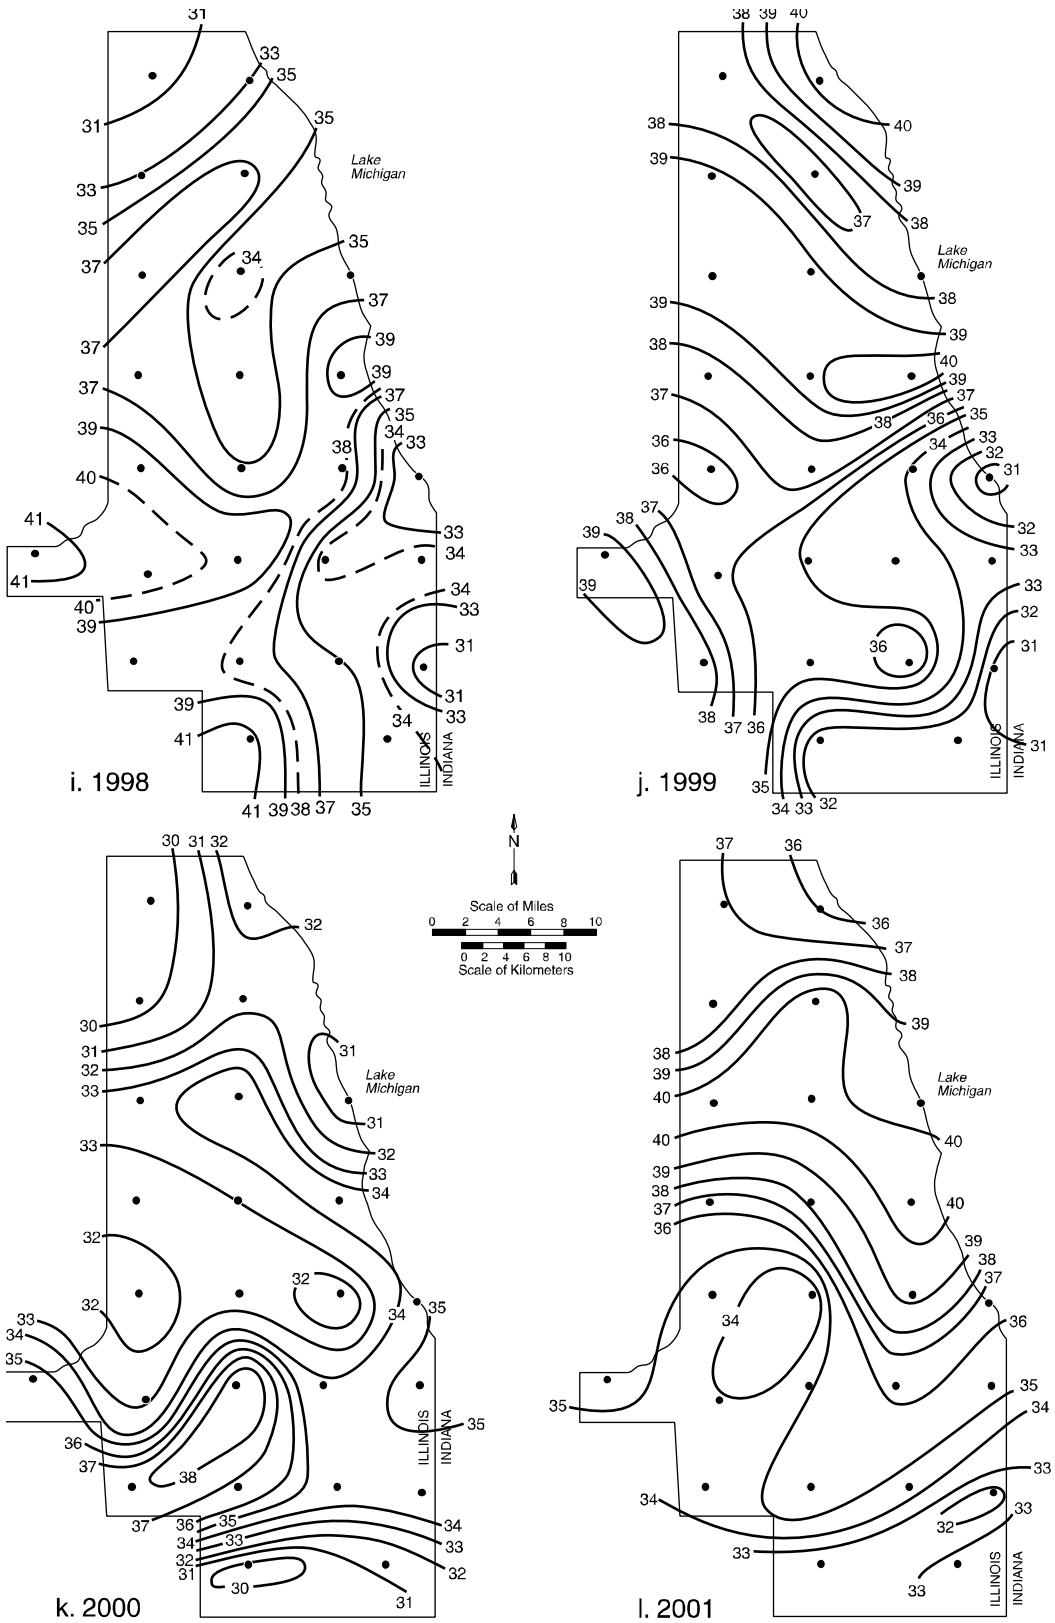
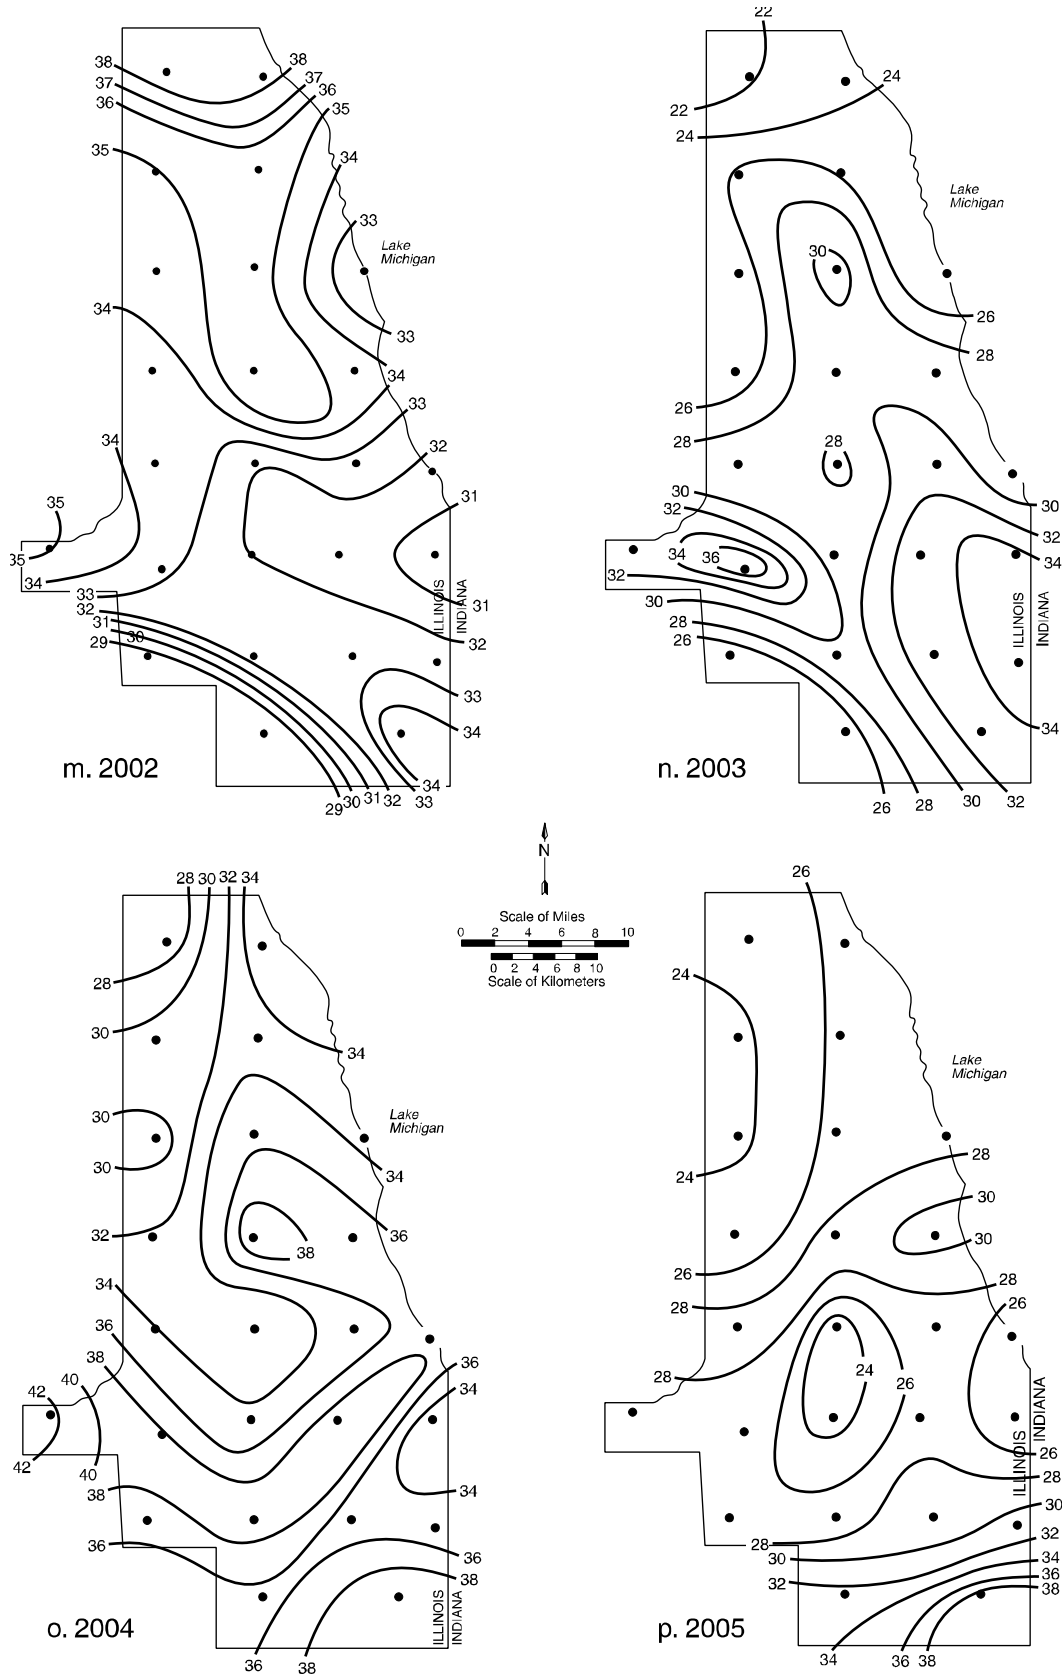
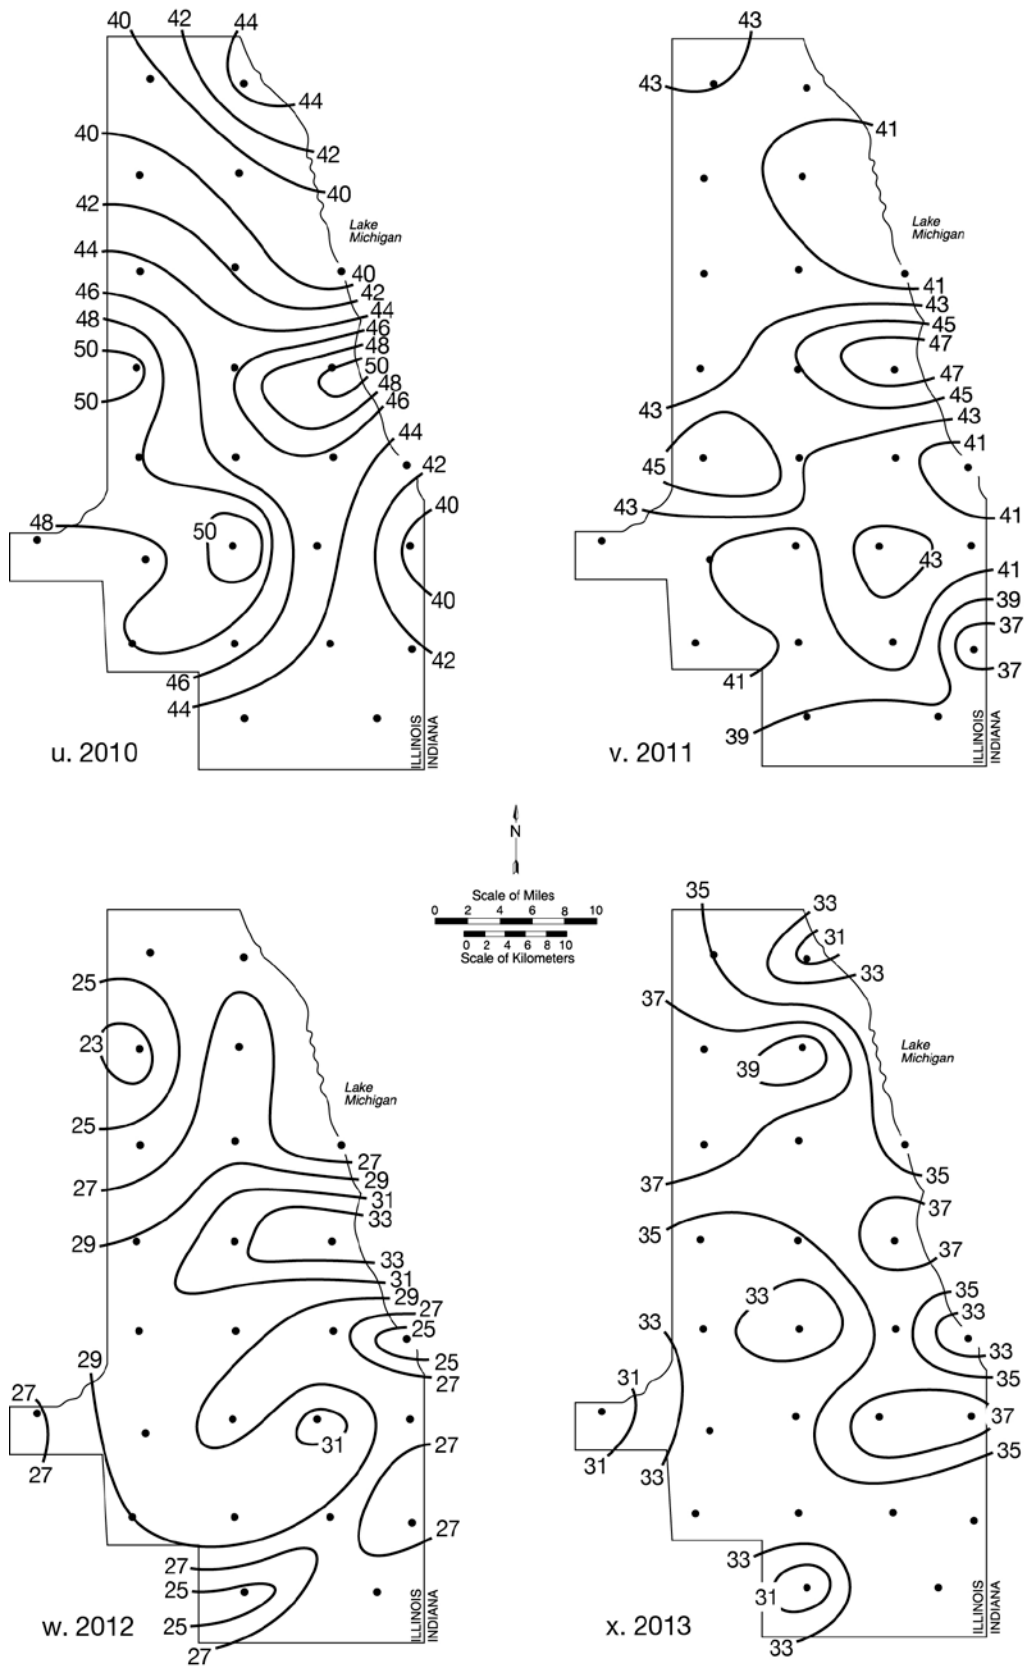
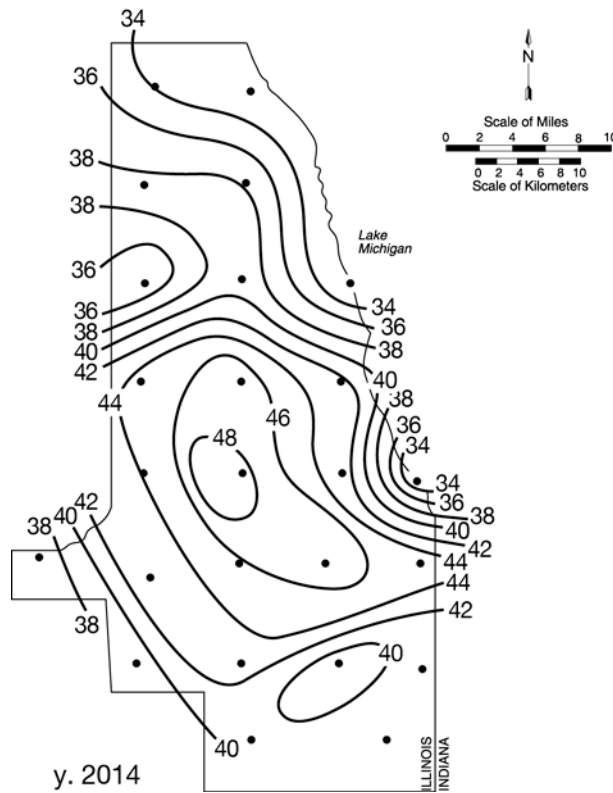
Figure 4. Precipitation pattern (inches) for Water Years 1990–2013

Figure 4 provides maps of precipitation amounts for individual Water Years 1990–2014. The general pattern of high values for Water Year 2015 is similar to that for Water Year 2001 and 2009, with the largest precipitation in the central region and the lowest precipitation along the lake shore and to the north and west.

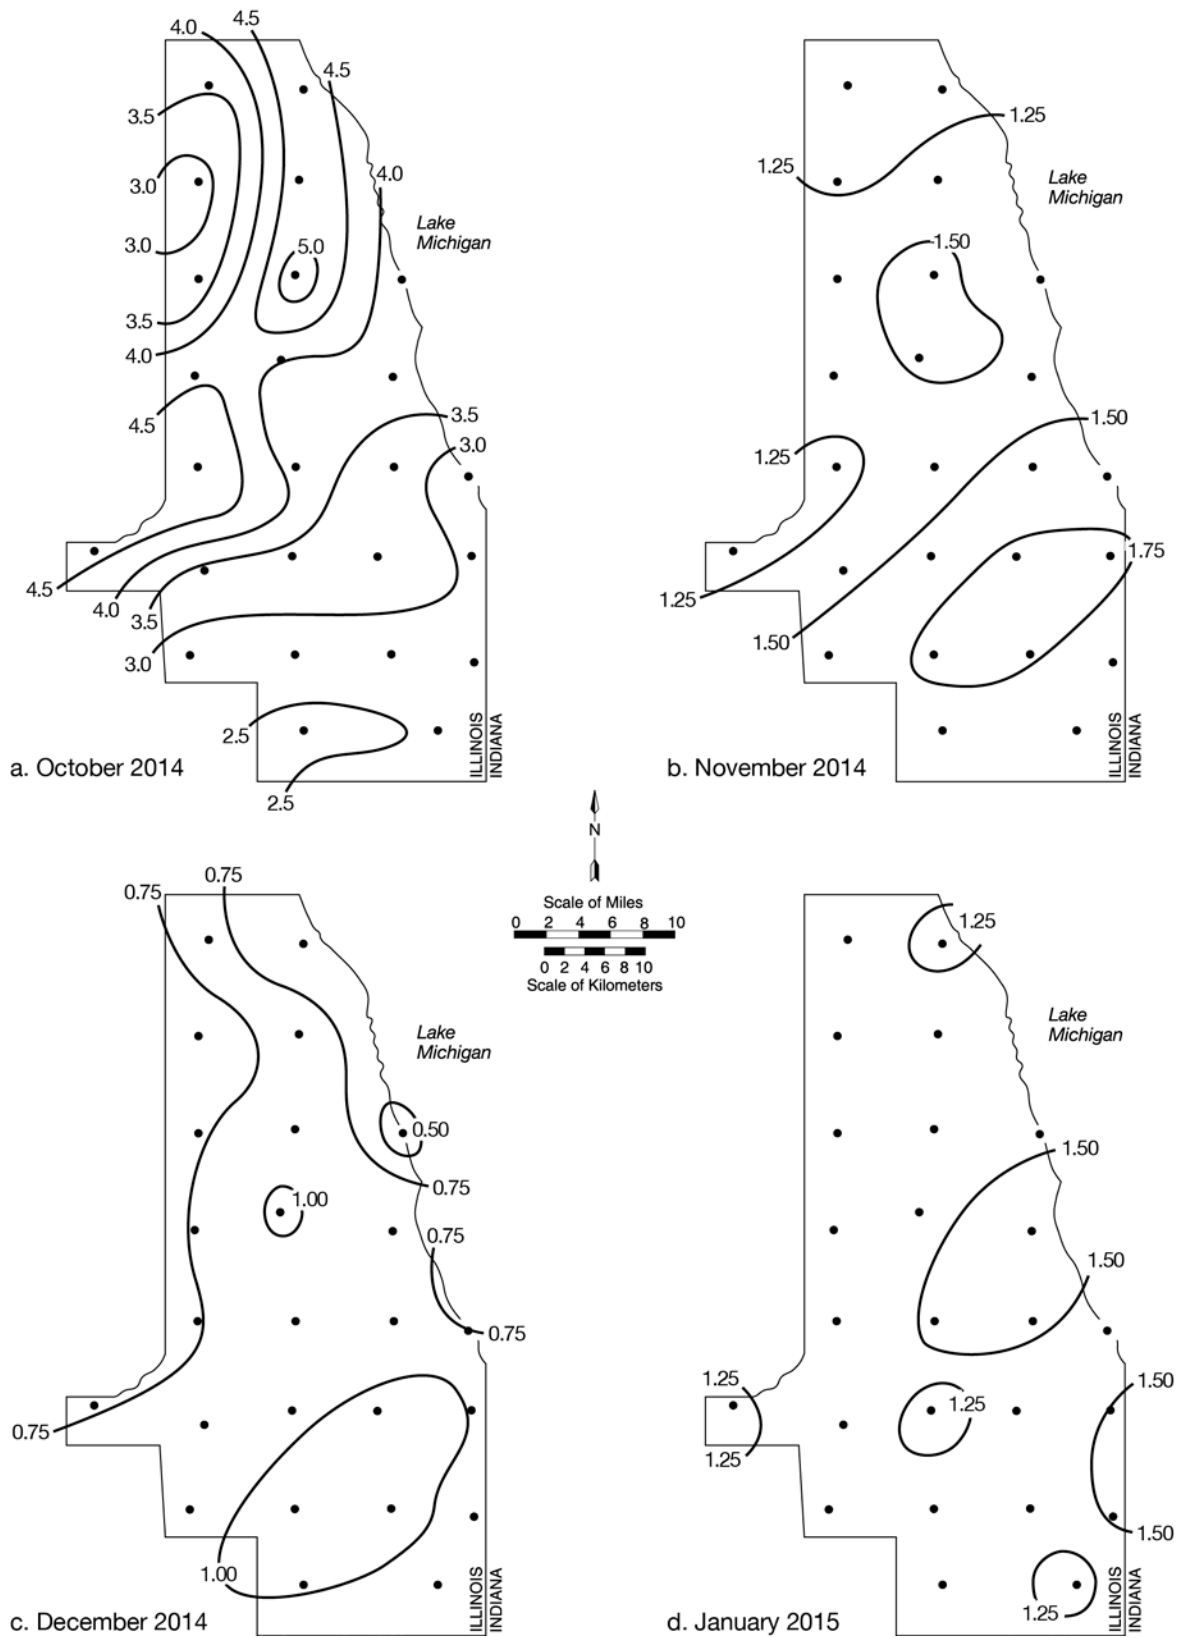
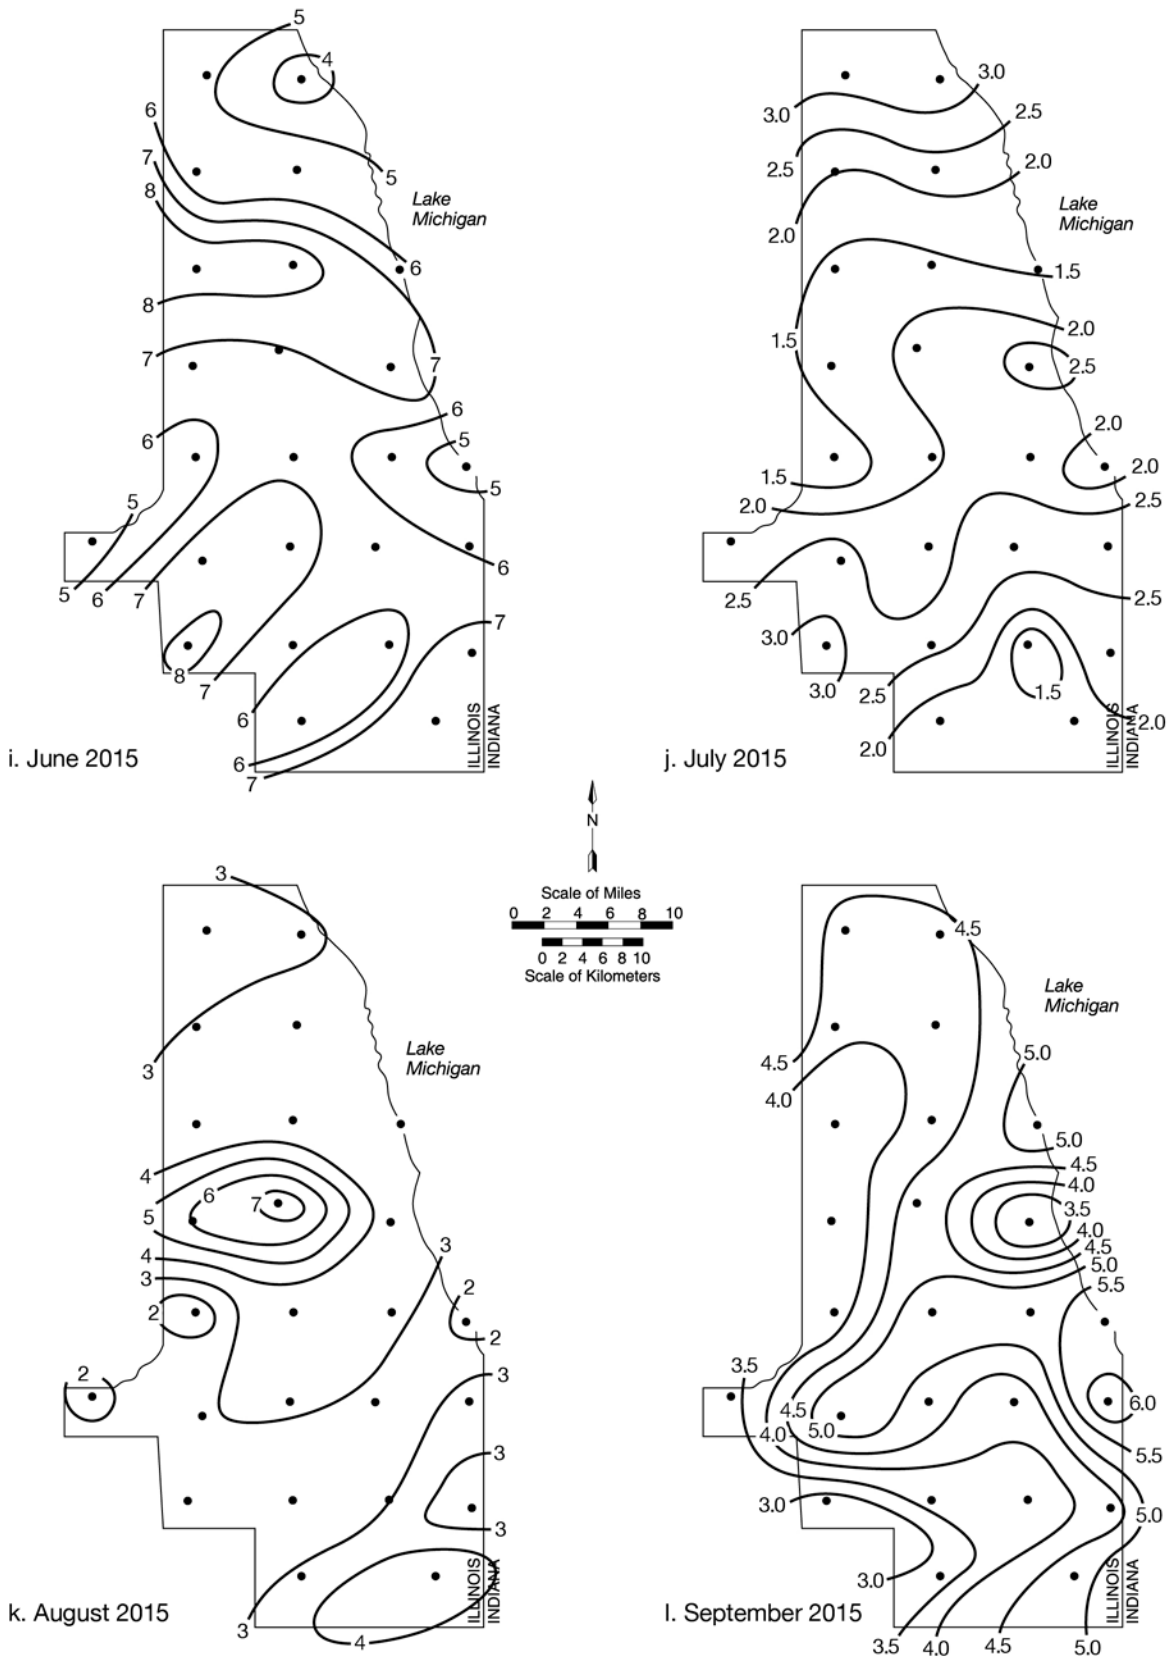
Figure 5. Precipitation pattern (inches) for October 2014–September 2015

Figure 5 presents monthly precipitation patterns for Water Year 2015. The June 2015 network precipitation of 6.26 inches was 157 percent of the 25-year June average precipitation, and the September 2015 network precipitation of 4.33 was 144 percent of the September average. Monthly network precipitation amounts were 66 percent or less of the 25-year average in November and December 2014 and January and March 2015. During the other months, network amounts ranged from 79 to 113 percent of normal. Less than 2.0 inches of melted precipitation per month fell from November 2014 through March 2015. More than 4.0 inches of precipitation fell in June and September 2015. From October 2014 through September 2015, only one storm event (September 17-19, 2015) exceeded a network average of more than 2.0 inches with at least one individual gage amount of more than 3.5 inches.

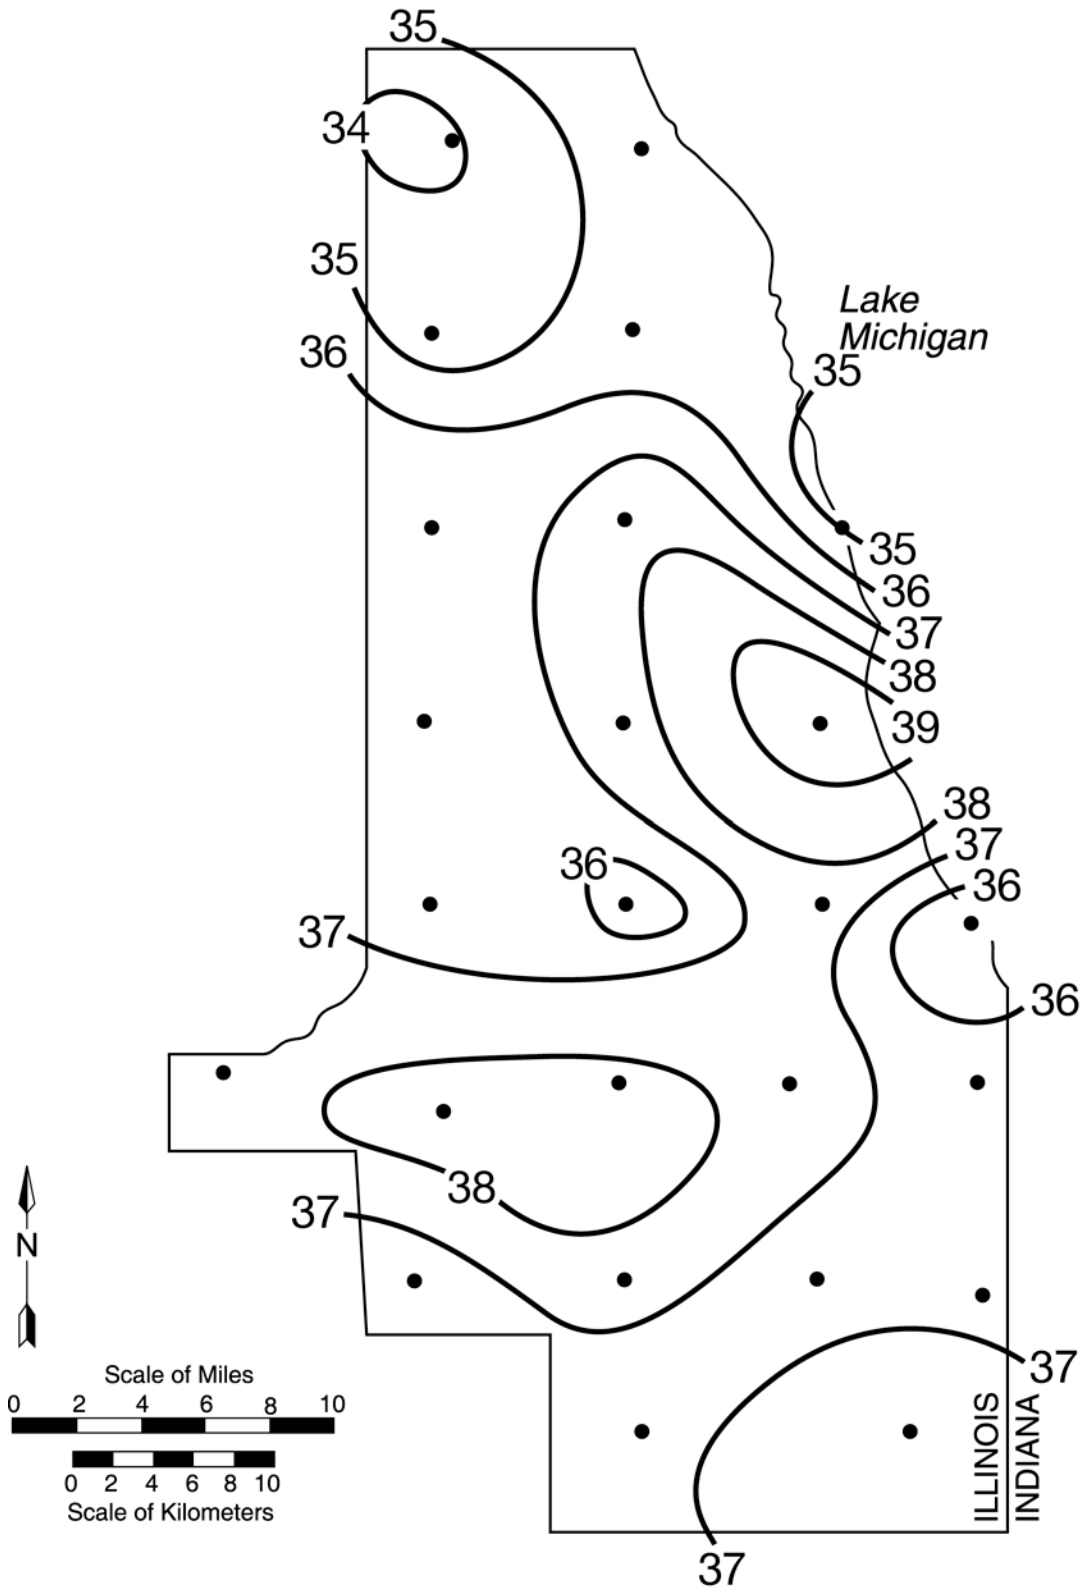
Figure 6. The 25-year average precipitation pattern (inches), Water Years 1990–2015.

The 26-year (1990–2015) average precipitation pattern (Figure 6) shows, as in previous years, an area of higher values across southwestern Cook County (sites #15, #16, #17, #18, and #21) and northward to Chicago sites #13 and #10. Lower values are found at northern sites #1, #3, and #7. The 26-year network-wide average is 36.66 inches.

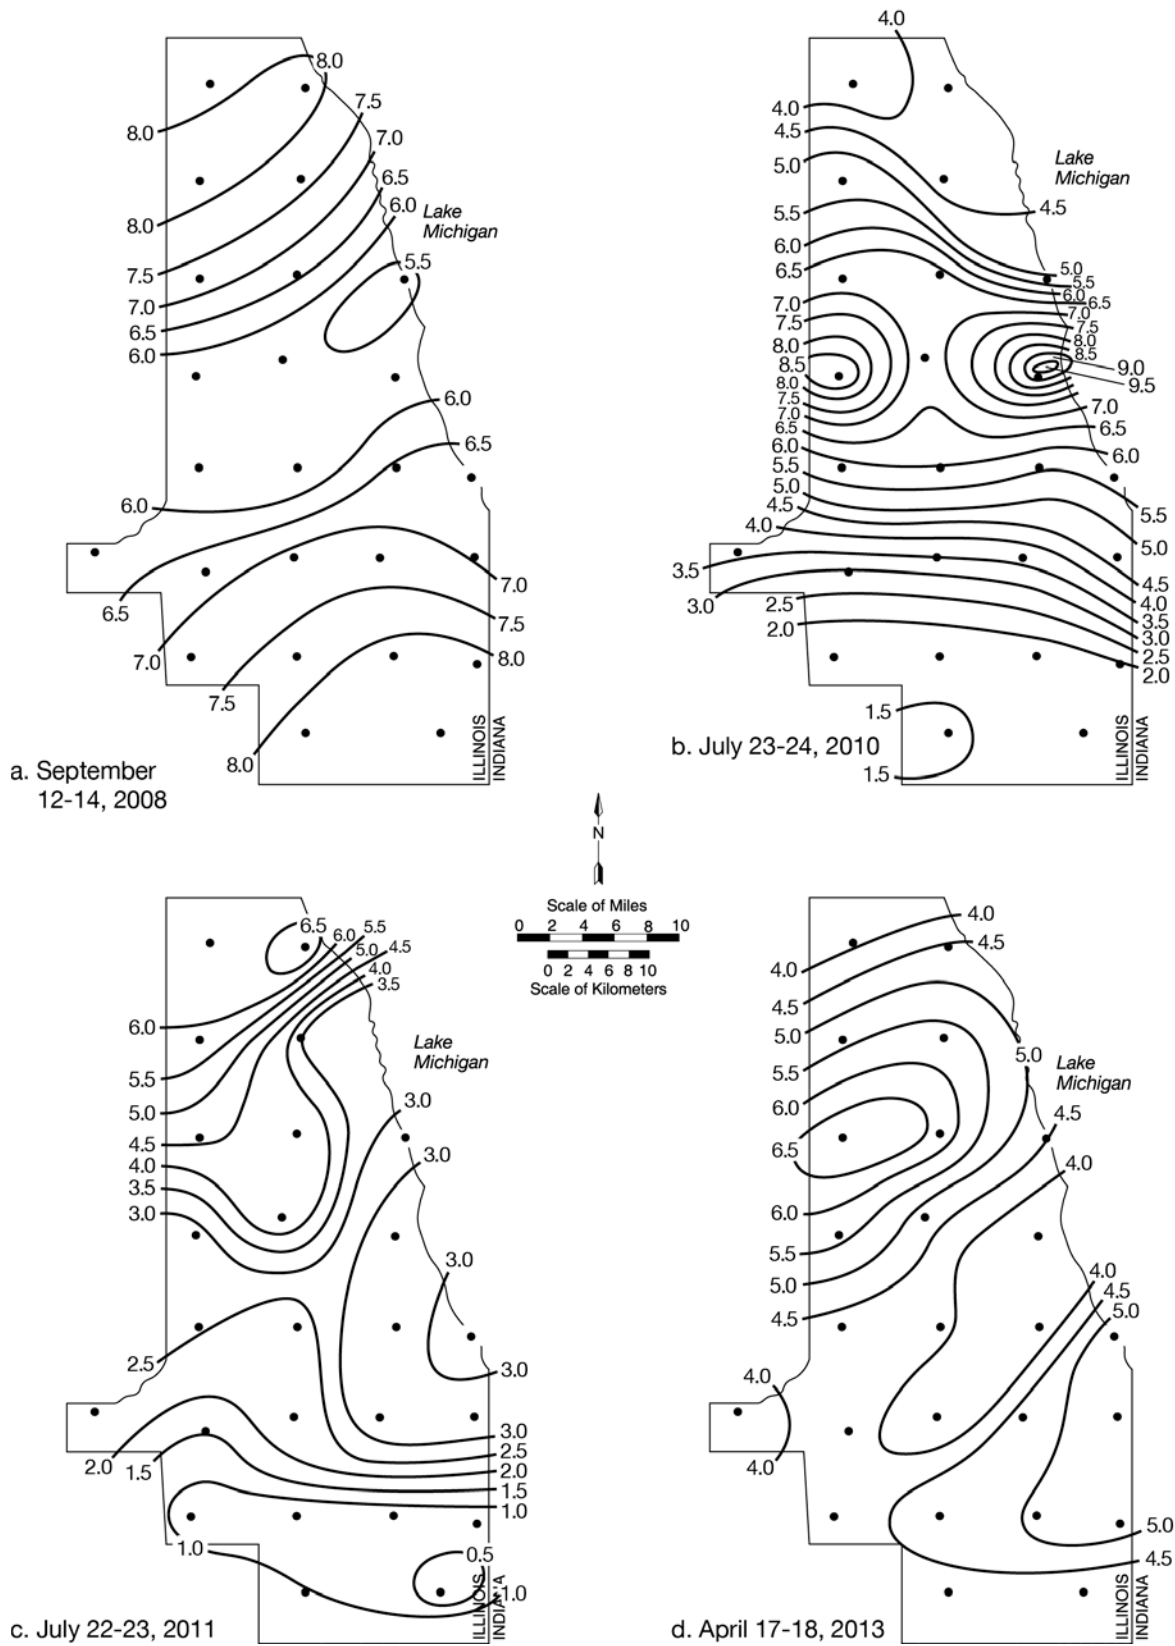
Figure IV-1. The four most intense storm events during Water Years 2008-2015.

The heavy precipitation events of Water Year 2015 occurred during April through October. Appendix IV contains specific information concerning the Water Year 2015 precipitation events for gages that exceeded the one-year recurrence interval. It also presents information concerning the four largest storm events that occurred in Cook County during the period October 2007 to September 2015.
