SWS Contract Report 332

**HYDROLOGIC AND HYDRAULIC INVESTIGATION
OF THE CULVERT #4 WATERSHED
ON THE HENNEPIN CANAL, BUREAU COUNTY, ILLINOIS**

Prepared for the
Illinois Department of Conservation

Champaign, Illinois
October 1983

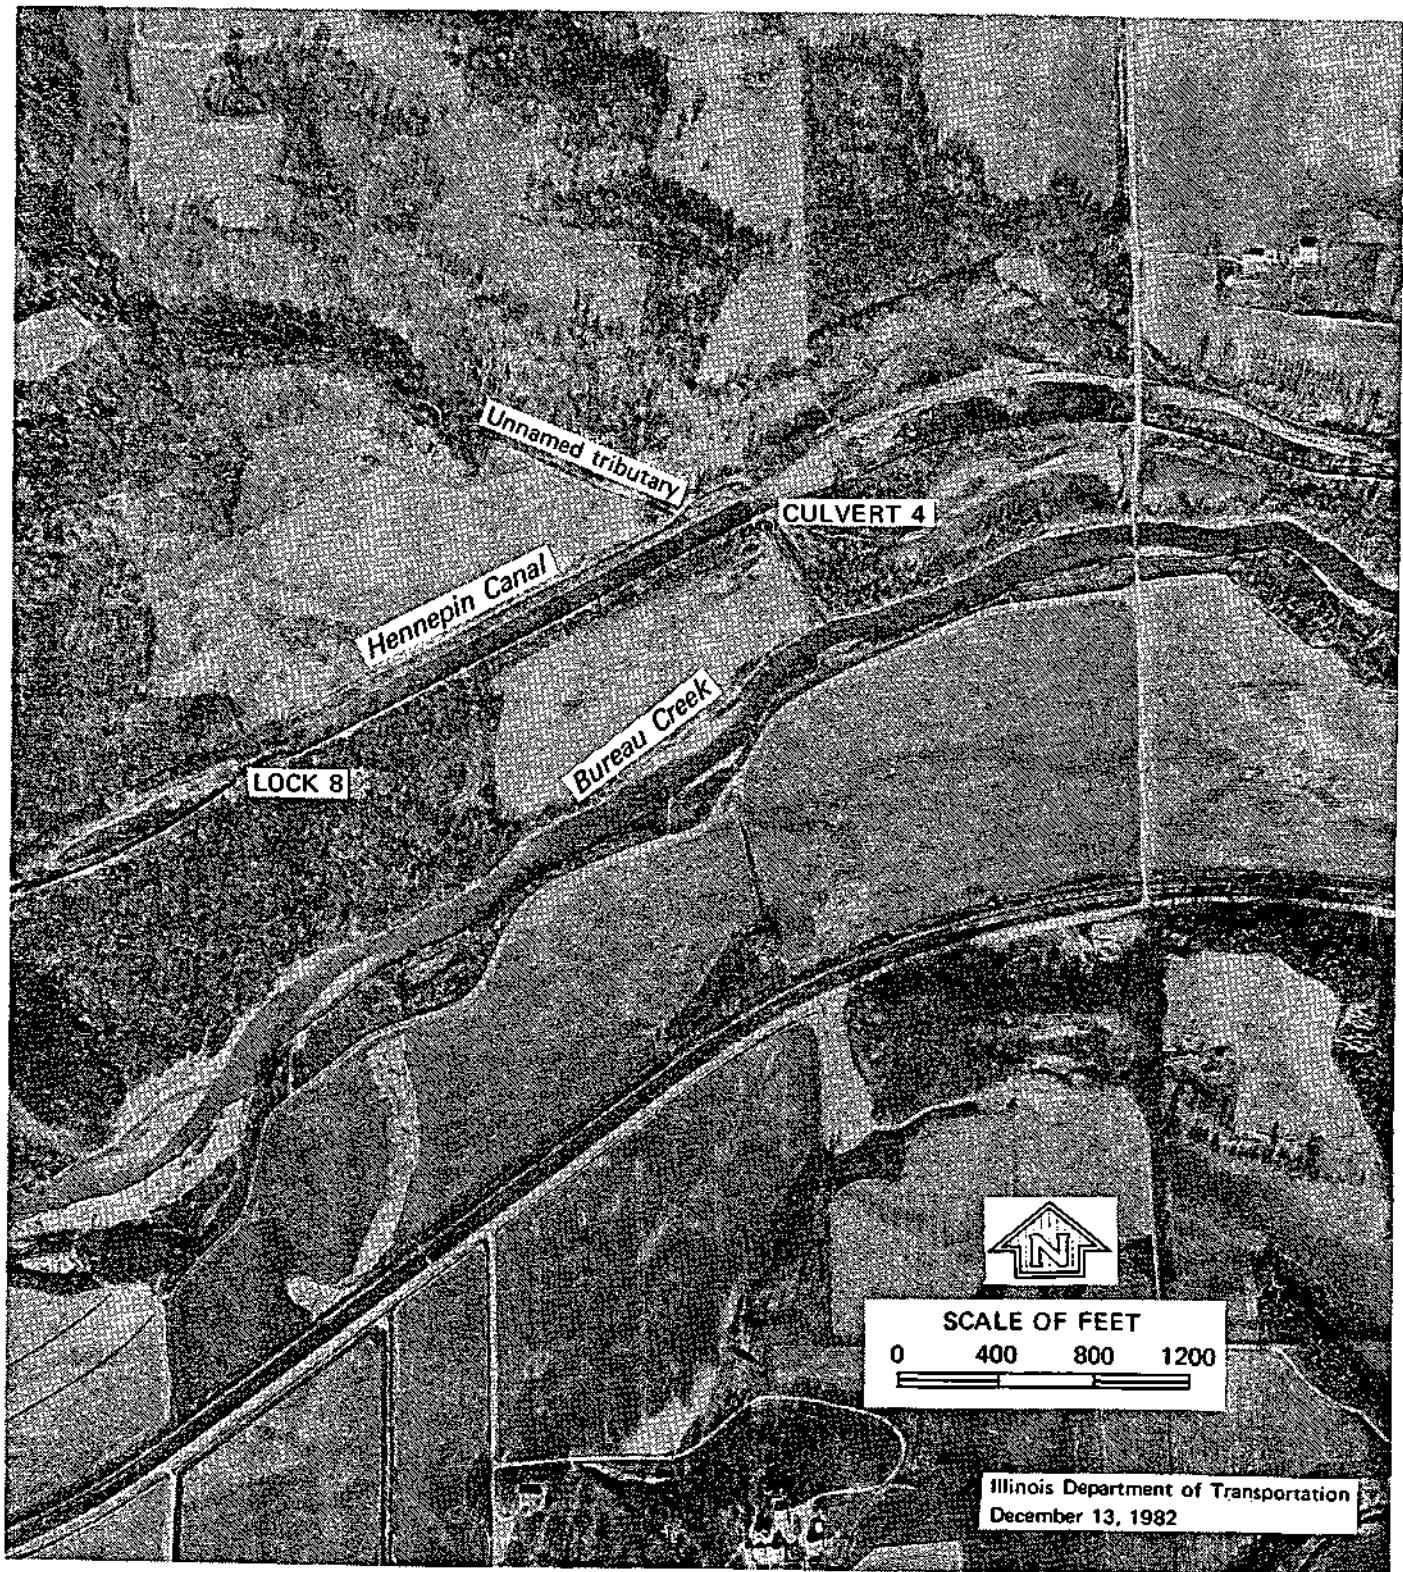
Figure 2. Aerial photograph of the area around Culvert #4

The portion of Bureau Creek that is near Culvert #4 may be seen in the aerial photograph in figure 2. Historical aerial photos show that Bureau Creek has meandered a great deal and changed its location quite often. Between 1958 and 1964, the stream was relocated from its original location and straightened. The locations and elevations for Bureau Creek that are described in this report were collected in June 1983.

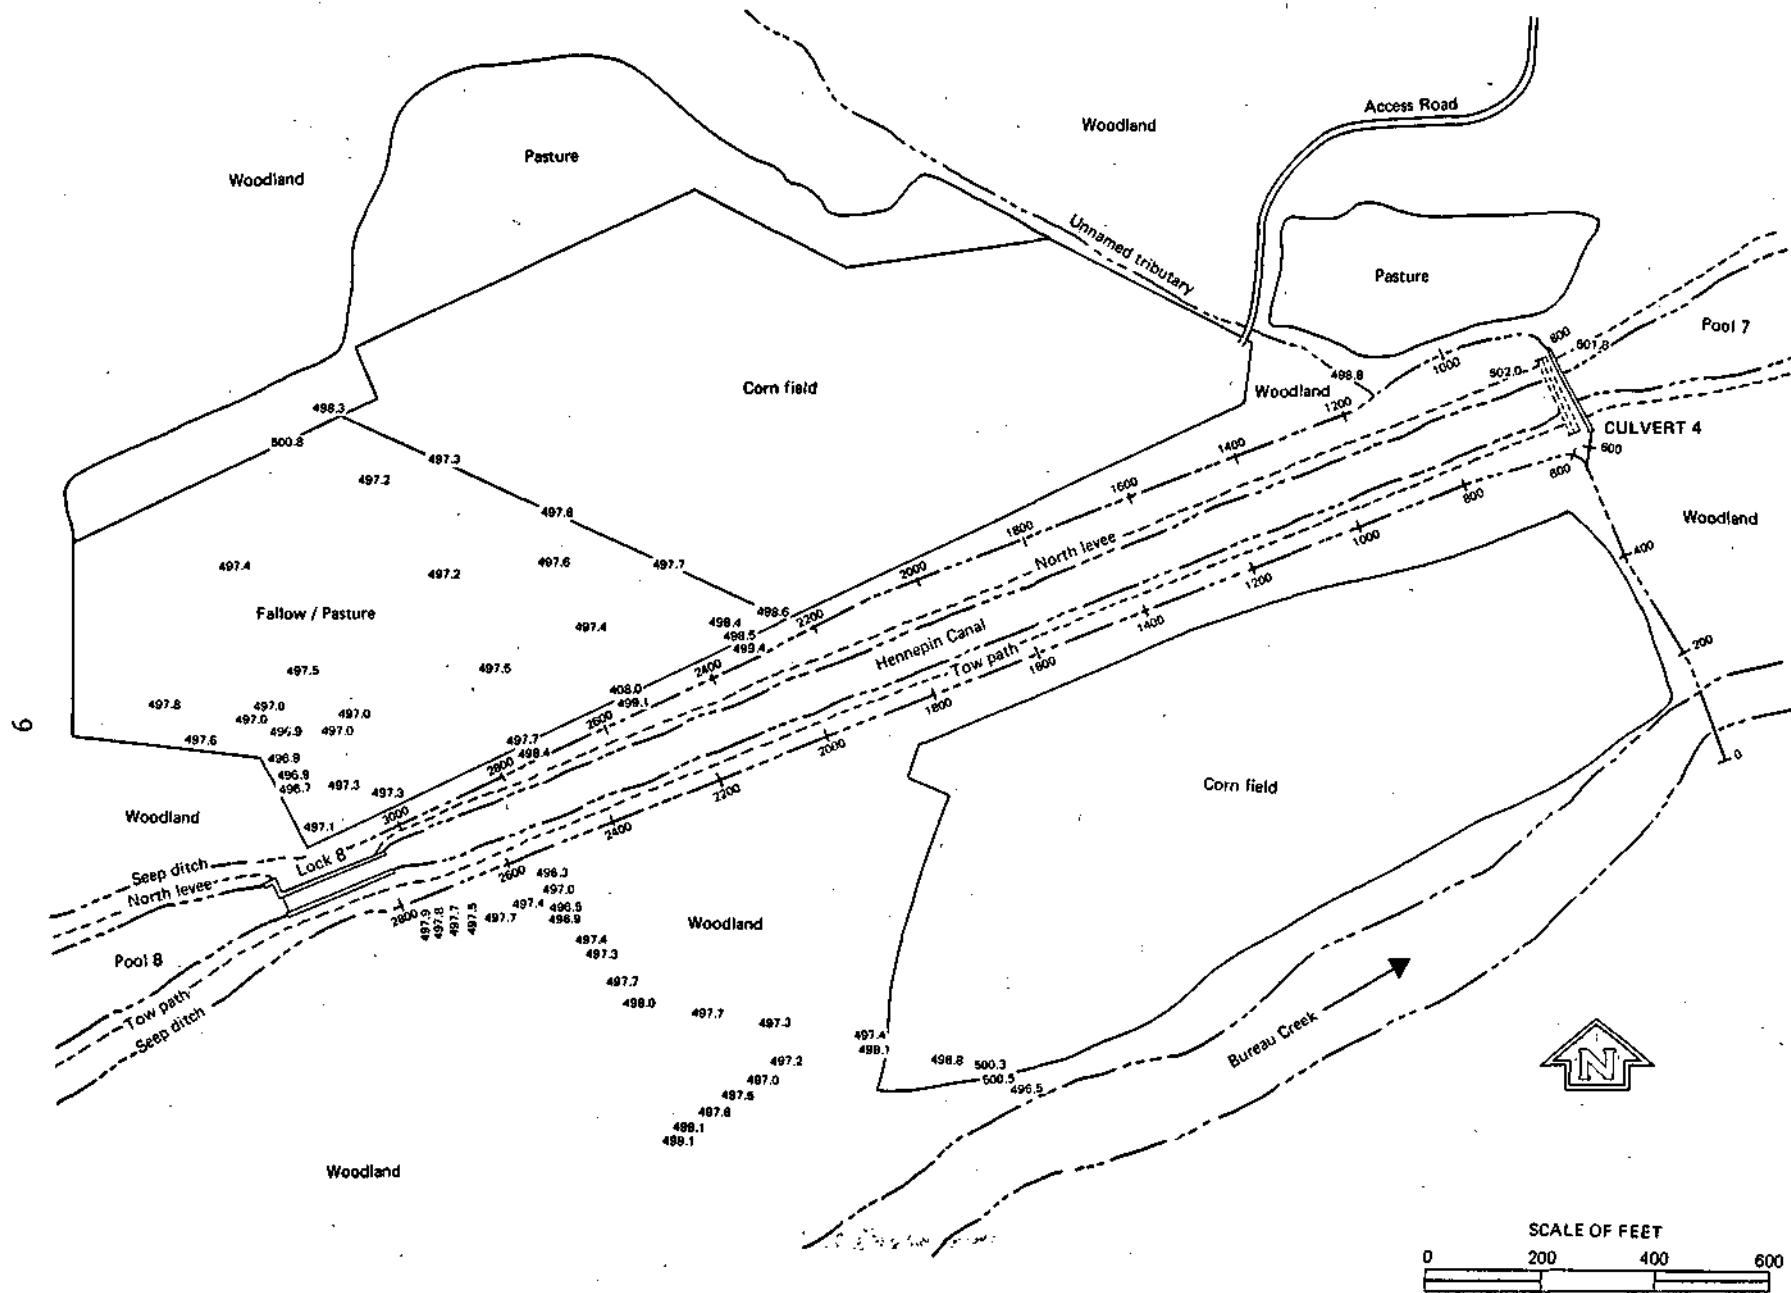
Figure 3. Point elevations around Culvert #4, surveyed June 1983

Figure 3 depicts the surveyed area near Culvert #4. The location of the survey on the south side of the canal was determined in part on the basis of the 1930 COE topographic survey (COE, 1937), which is shown as figure 4. The natural drainage pattern from the area adjacent to Lock 8 appears to have been to the east. In the 1983 survey most of the elevations on the south side of the canal were found to be higher than those on the north side. Since most of the land in this area was disturbed during the construction of the canal and was further disturbed by farmers after the construction of the canal, it is difficult to determine the original natural drainage patterns. A minor depression on the north side of the canal was located, which had standing water in it. This survey showed that the land is fairly flat with only minor undulations, which indicates that surface drainage will be poor and some areas probably will drain by seepage. The banks of Bureau Creek are

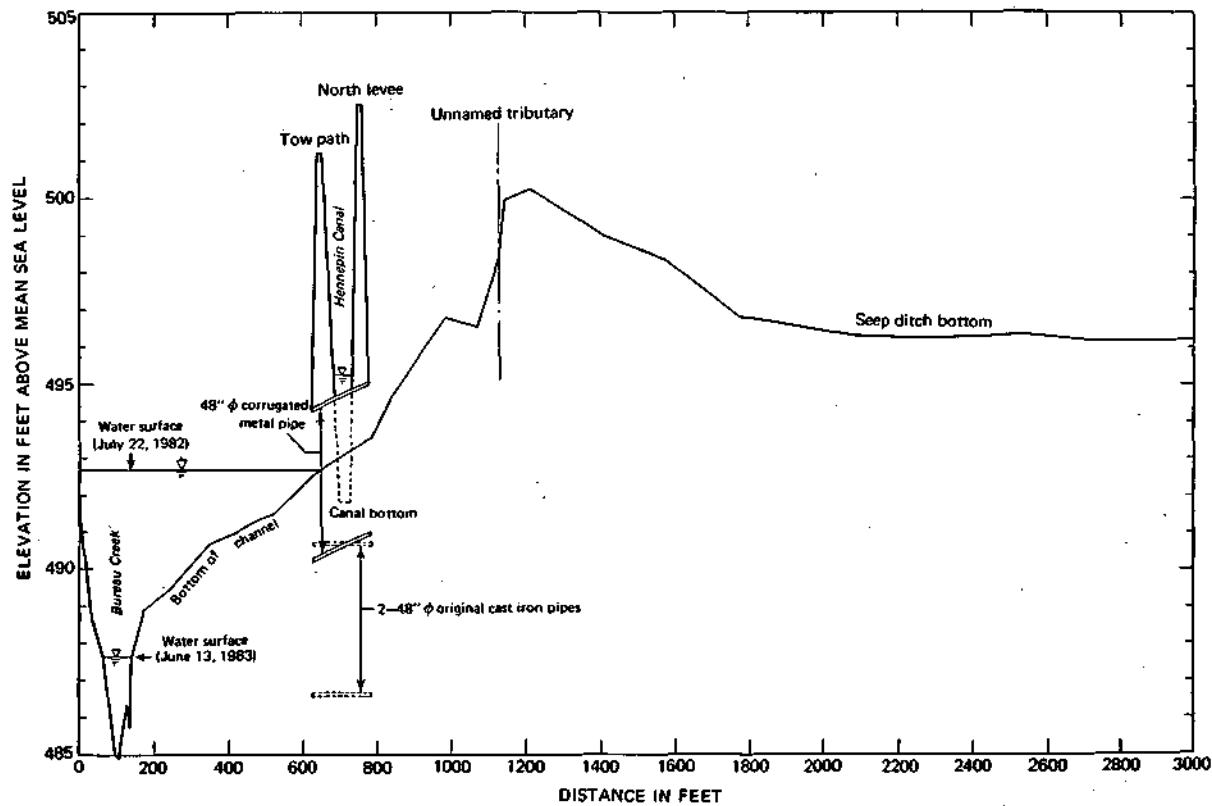
Figure 5. Profile from Bureau Creek to Look 8 along the north seep ditch

Figure 5 shows a profile across Bureau Creek through Culvert #4, including the north seep ditch. From this figure, it can be seen that the two original cast iron (CI) culverts were placed quite low compared to the bed elevation of Bureau Creek. In fact the water surface elevation on Bureau Creek on June 13, 1983, was 1 foot above the invert of the cast iron culverts. There are approximately 2 feet of sediment above the top of the cast iron culverts. No information on the hydraulic design of the culverts is available. The invert of the culverts were probably controlled by the canal bottom; that is, the tops of the culverts were placed just below the bottom of the canal.

Sediment has filled the replacement corrugated metal pipe culvert (CMP) to half of its depth. The water surface elevation in Bureau Creek on July 22, 1982, partially filled the corrugated metal pipe, which reduced the carrying capacity of the pipe.

As shown in figure 5, there is a high mound where the unnamed tributary enters the seep ditch from the north. The seep ditch continues to run southwesterly towards Lock 8. As can be seen in figure 5, the

seep ditch cannot convey surface drainage from the area north of Lock 8 to Culvert #4 due to the mound in the seep ditch. More detail on this subject may be found in the section on soil loss.

face in the north levee of the canal as seen in figure 14. There are many large cobbles deposited at this point. The high point in the seep ditch is found at this location, as was seen in figure 5.

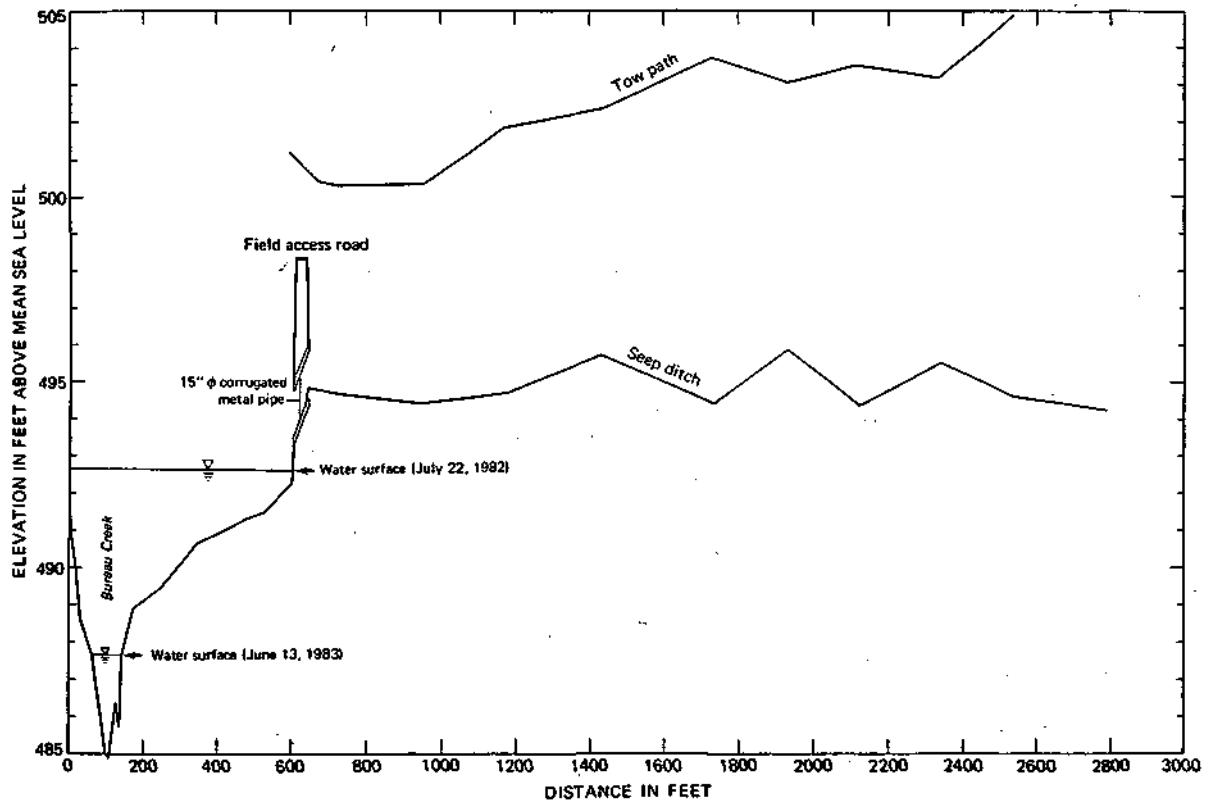
Figure 6. Profile from Bureau Creek to Look 8 along the south steep ditch

Figure 6 shows a profile across Bureau Creek along the south ditch and then along the seep ditch to Lock 8. The overall slope in the south seep ditch from Lock 8 to Culvert #4 is fairly constant but contains a number of undulations, although the overall slope is negative. The downstream control of the south seep ditch is a culvert installed under a field access road, which conveys the south seep ditch flow. There was some organic deposition observed within this culvert, but it contained no sediment. A profile of the tow path is also presented in figure 6.

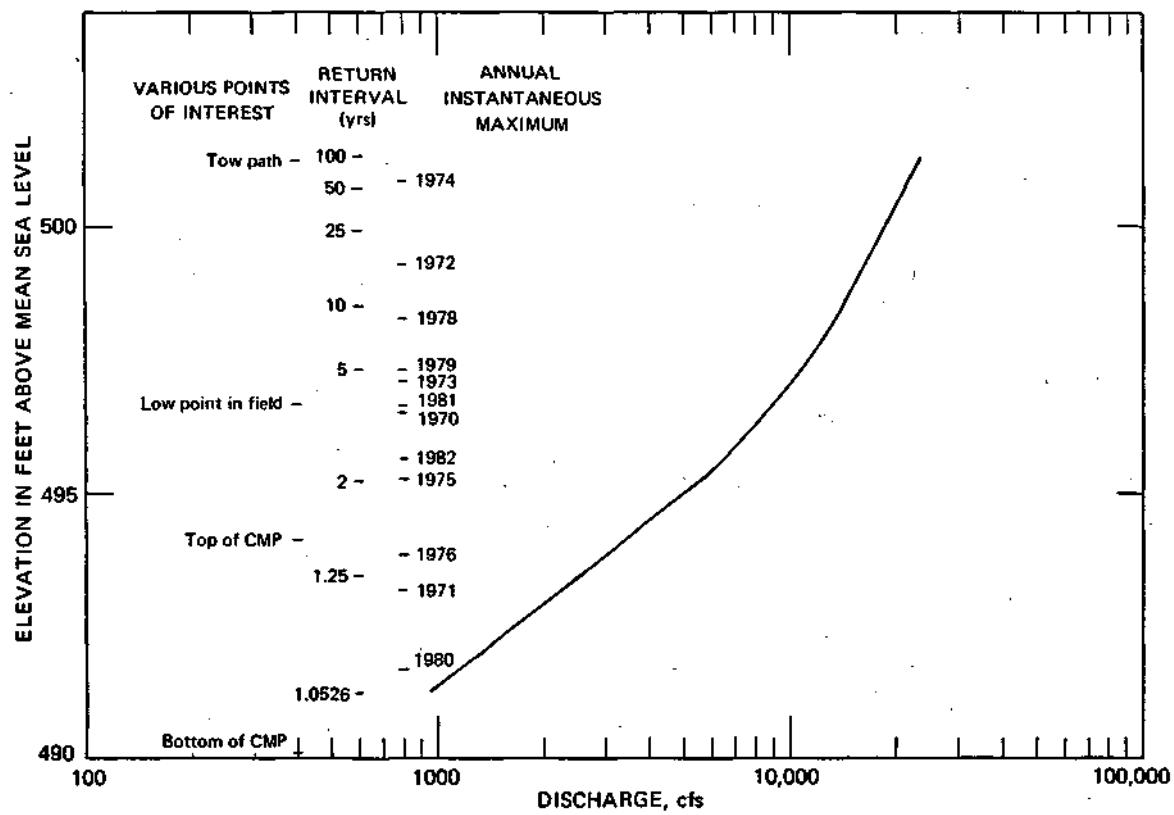
Figure 7. Discharge and water surface elevations in Bureau Creek at Culvert #4

the invert of the new corrugated metal pipe culvert. All flood flows above 2-year recurrence intervals submerge the crown of the corrugated metal pipe. Flows above the 5-year return period would inundate the low portion of the field north of Lock 8. During the period 1970-1982 there were five occurrences in which the instantaneous annual maximum flood elevations were higher than that of the field. There were twelve occurrences in which the annual maximums reduced the conveyance capacity of the culvert since the water surface elevations were above the corrugated metal pipe invert.

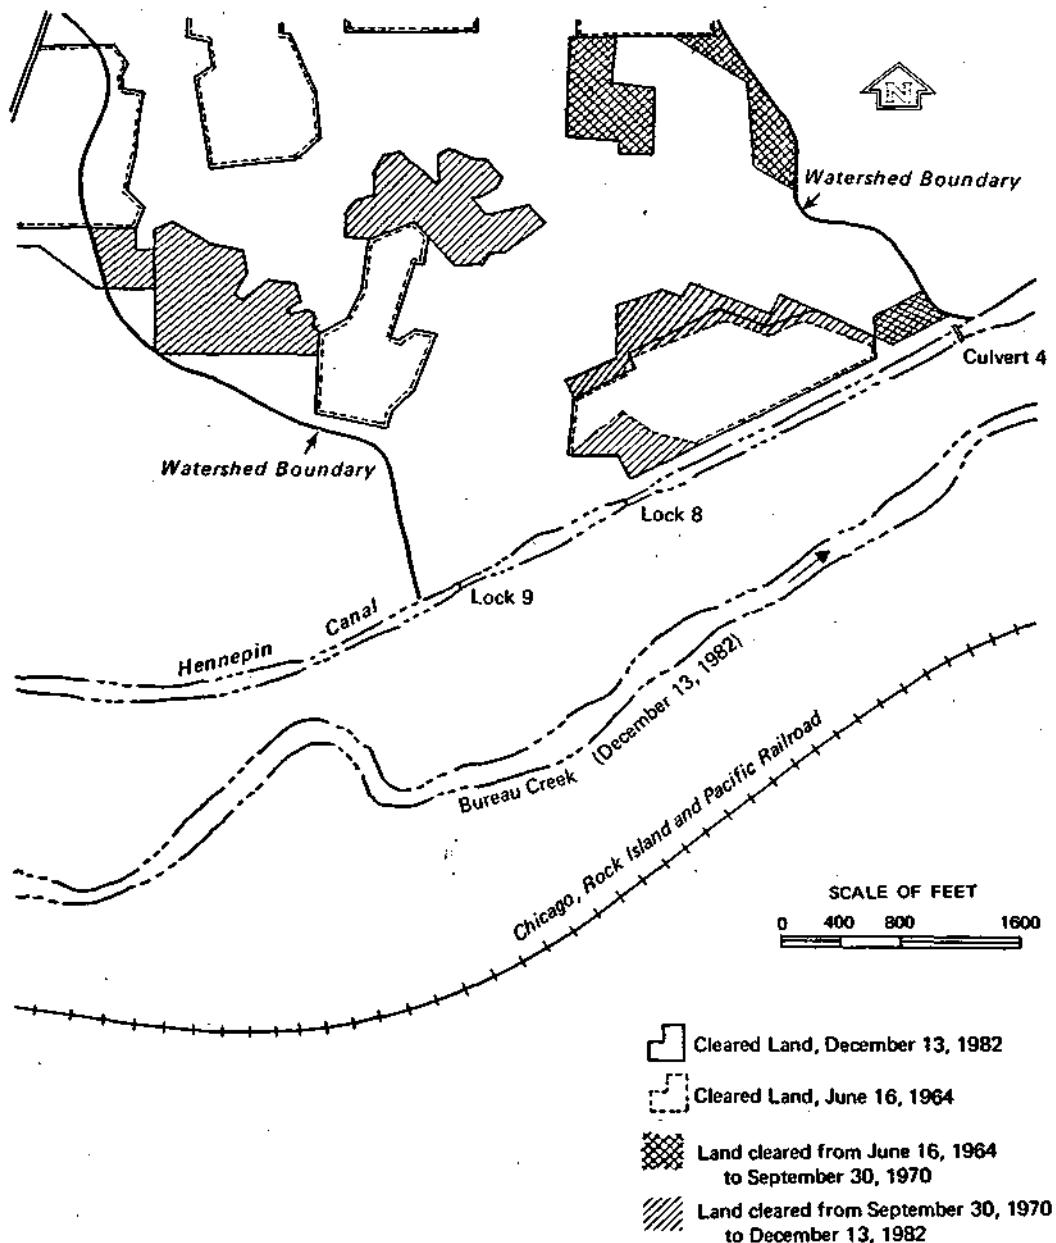
Figure 10. Land use changes within the Culvert #4 watershed

The most dramatic alteration of land use occurred between the years 1970 to 1982. An area 2000 feet north of Lock 9 and an area 2400 feet northwest were cleared as well as the area near Lock 8, as shown by the shaded areas in figure 10.

The area cleared on the bluff will tend to increase the sediment load. In addition the clearing will increase both the volume of runoff and the peak flow rate. The clearing near Lock 8 has little impact on

runoff and sediment load, but about half of the area that cannot sustain row crops was cleared after 1970. The five acres cleared near Lock 8 had not been previously cropped, or at least not since 1941. Prior land uses for this area consisted of meadow, pasture, and woodlands.

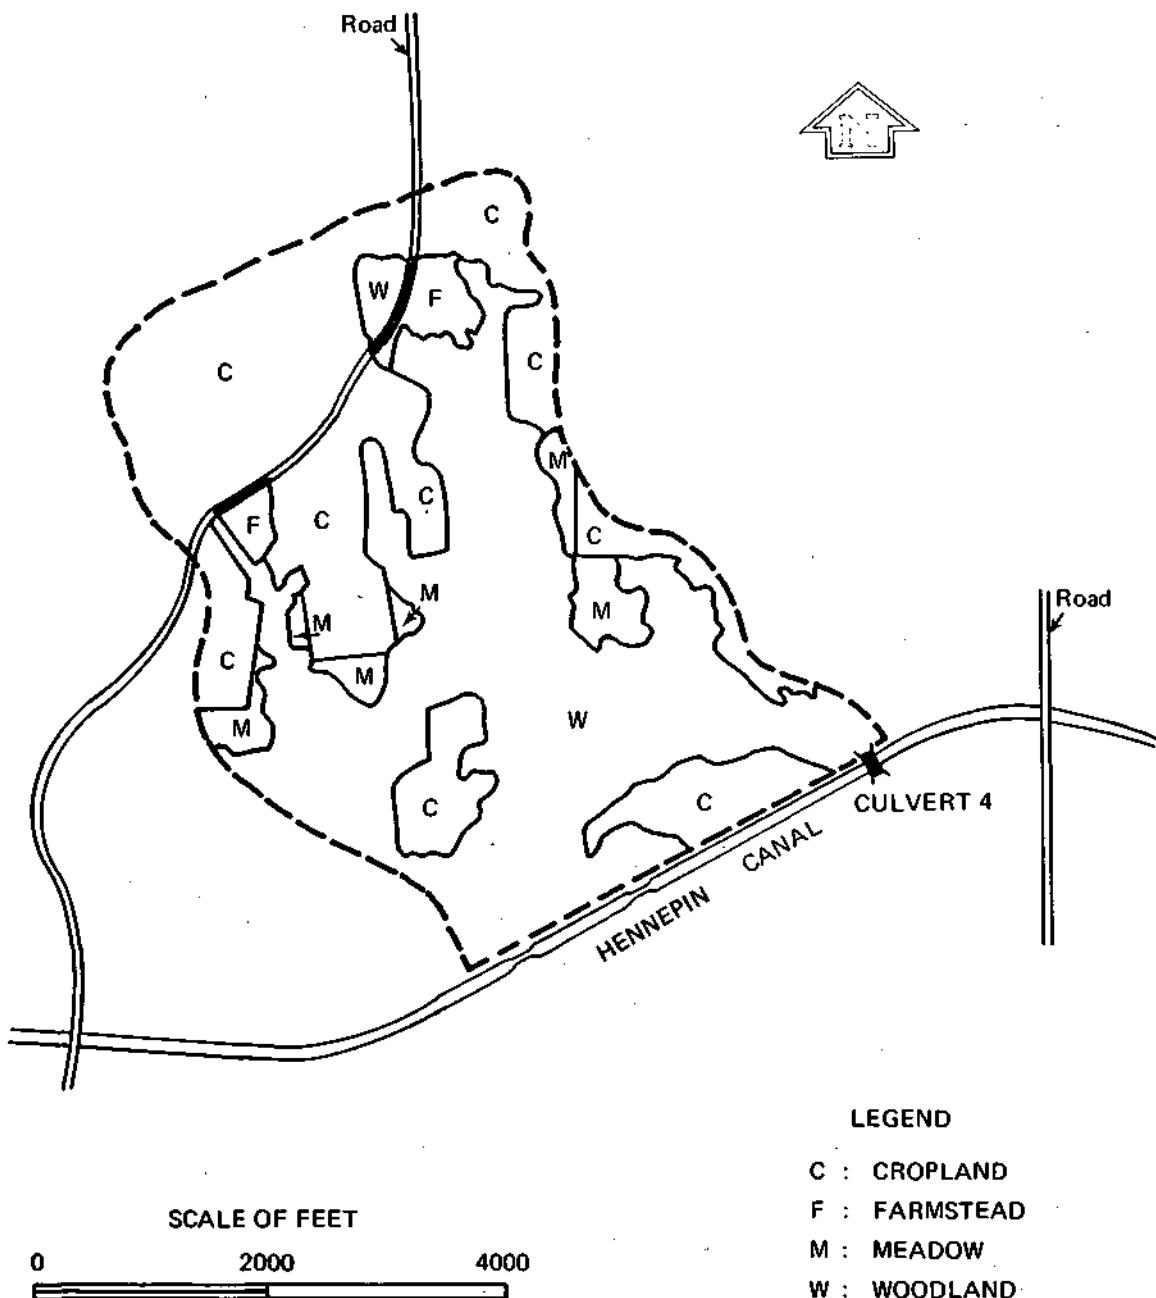
Figure 11. Land use in the Culvert #4 watershed,
September 30, 1970

The assessment of several of the soil parameters involves land use and soil type data. Figure 11 shows the land use map of the Culvert #4 watershed that was developed from aerial photos taken on September 30, 1970. These photos were selected because these were the most recent photos that showed the entire watershed. The additional clearing done since this time would add little to the estimated soil loss. The land uses are divided into woodland, cropland, meadow, and farmstead.

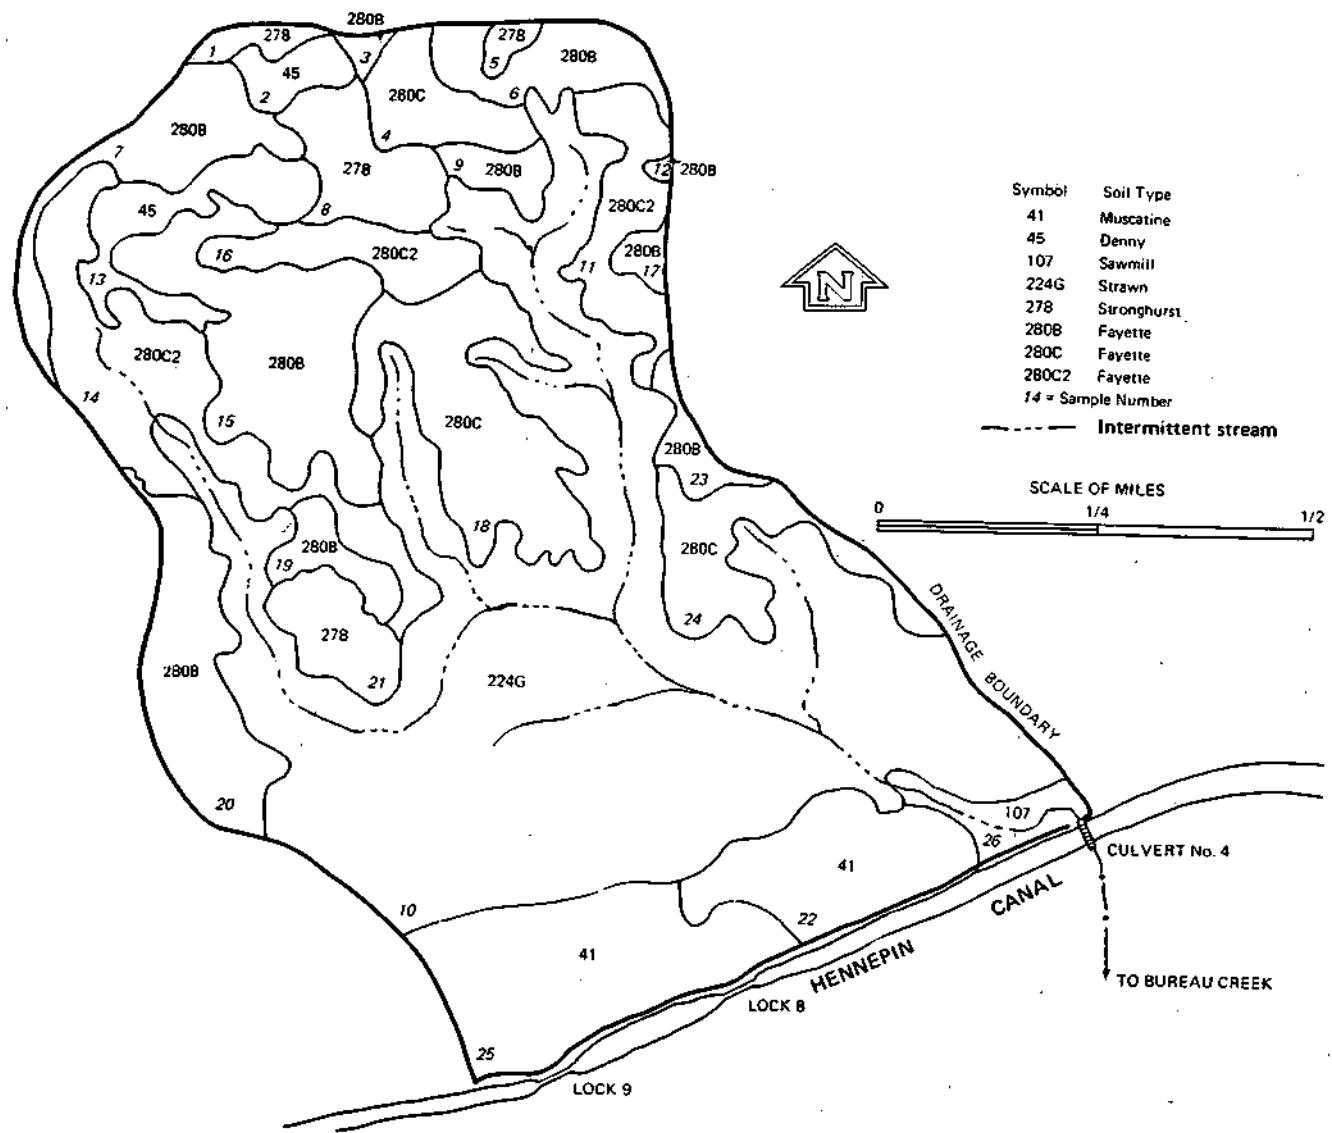
Figure 12. Soil types in the Culvert #4 watershed

A 1950 soil map of the Culvert #4 watershed was obtained from the Soil Conservation Service, USDA, and the soil survey and aerial photos were combined to develop the soil map shown in figure 12. The soil types and their acreages are tabulated in table 13. It can be seen that straw silt loam is the major soil type, covering about 41 percent of the watershed. Several types of Fayette silt loam cover another 39 percent of the area, and other silt loams and some silty clay loams make up the remaining acreage.

Table 14 shows the erosion parameters for the USLE for 26 soil samples, listed according to the sample numbers assigned to the tracts on the soil map in figure 12. The boundaries of each tract were measured for acreage, and the dominant appropriate land use was assigned from the land use map. The rainfall factor, R, for Bureau County is 175. The soil erodibility factor, K, of each soil type was obtained from soil interpretation records provided by the Bureau County Soil Conservation Service. The slope-steepness and slope-length factors were determined from soil slope symbols and topographic map measurements. The cropping factor, C, was assigned as 0.4 on all cropland indicating conventional tillage and corn-soybean rotation. Other cropping factors (conservation practice factors, P) were all specified to be 1.0 since no significant contouring and terracing practices are used on the watershed.
