REPORT OF INVESTIGATION NO. 10

**THE SILTING OF LAKE BRACKEN**  
Galesburg, Illinois

B.O.Larson, KM.Smith, ELSauer, and  
S.W. Melsted

Galesburg, Illinois

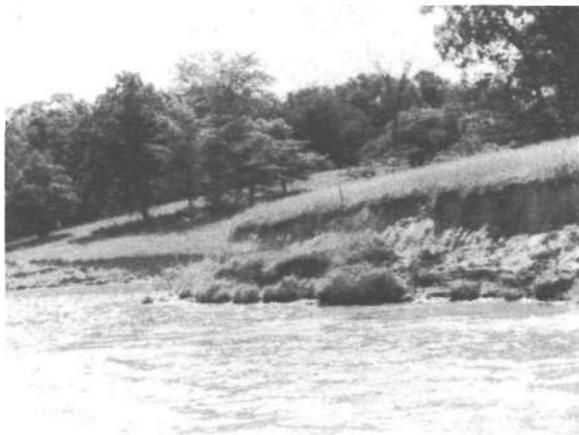
FIG. 5. SHORELINE EROSION, LAKE BRACKEN.

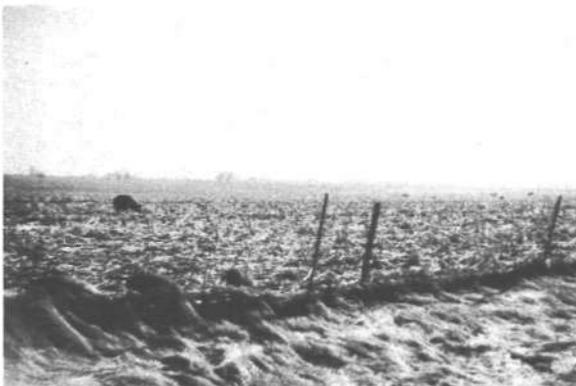
FIG. 10. LEVEL LAND CAN BE CROPPED TO CLEAN-TILLED CROPS HALF-TIME WITH VERY LITTLE SOIL LOSS.

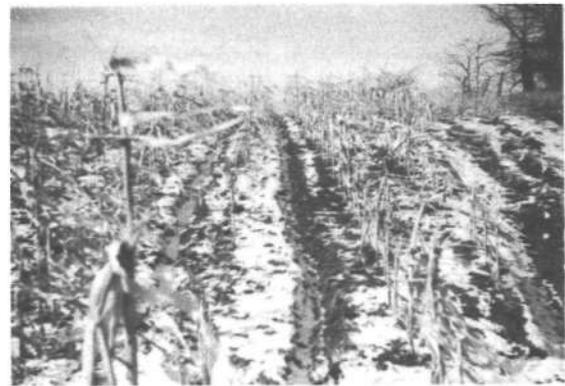
FIG. 11. SOIL LOSSES OF 50 TONS PER ACRE PER YEAR ARE NOT UNCOMMON WHEN SLOPES ARE CROPPED TO CORN AND SOYBEANS.

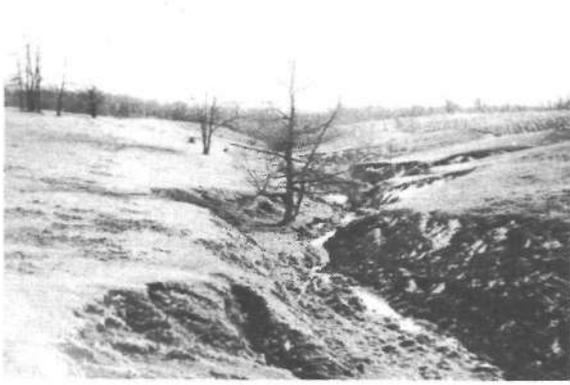
FIG. 12. EXCESSIVE SHEET EROSION RESULTS IN GULLIES BEING FORMED.

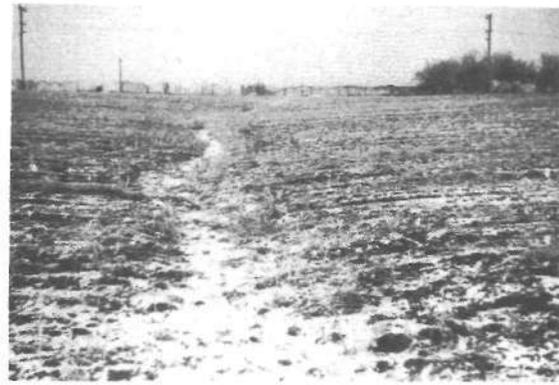
FIG. 13. GRASS WATERWAYS ARE NEEDED IN CULTIVATED FIELDS.
